March 15, 2023

Via FedEx & Email (mmccann@tuckahoe-ny.com)

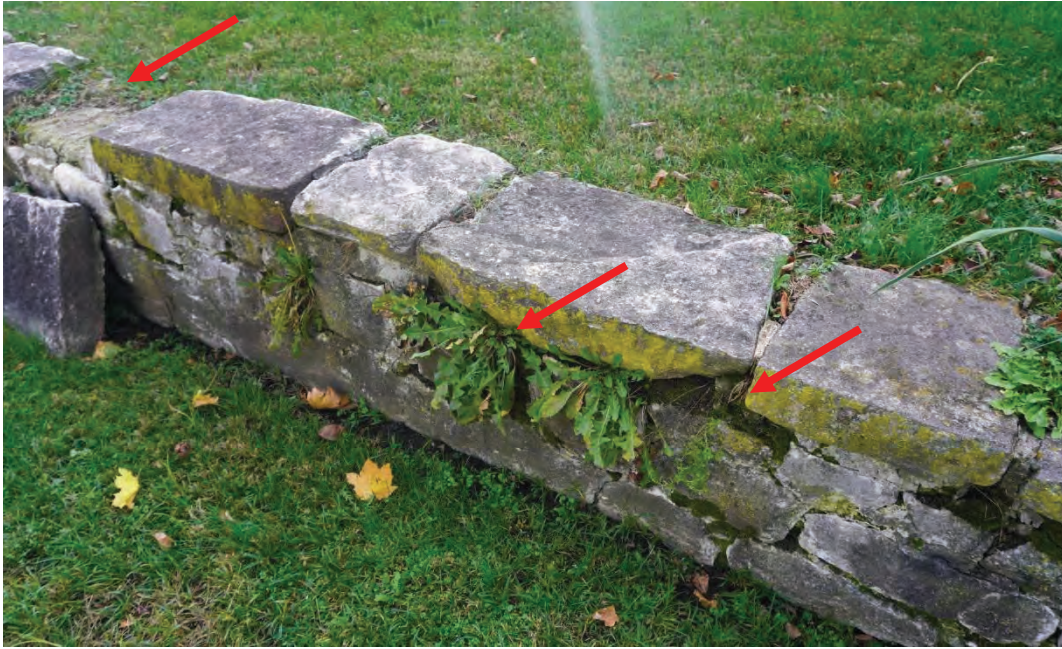
Photo #1: Retaining wall that runs from between front entrance and driveway is deteriorating throughout. Joints have filled with dirt. Multiple stone pieces no longer attached.

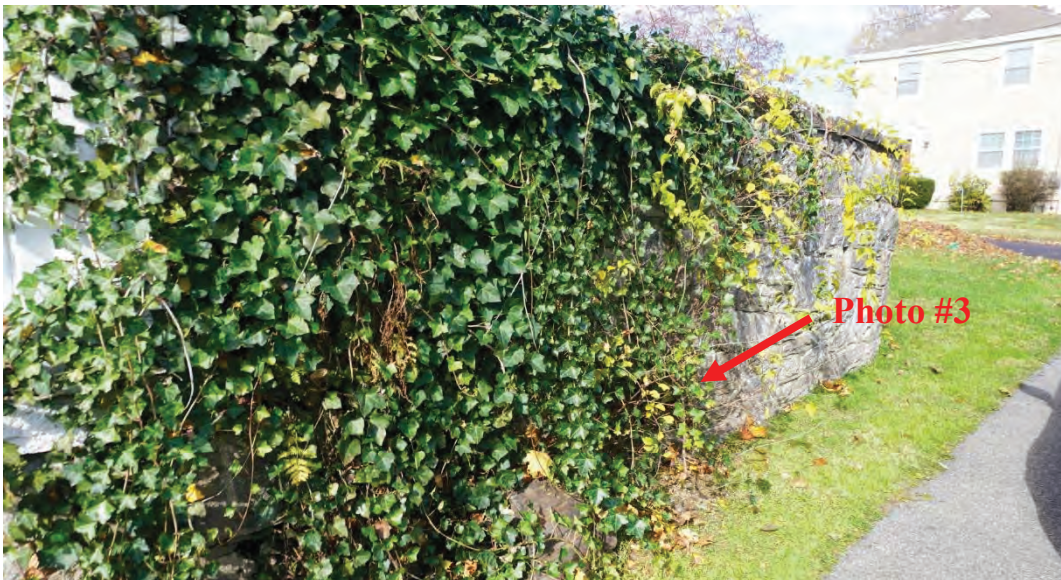
Photo #2: Retaining wall that runs from between front entrance and driveway is deteriorating throughout. Roots/ large weeds growing through joints of walls multiple locations.

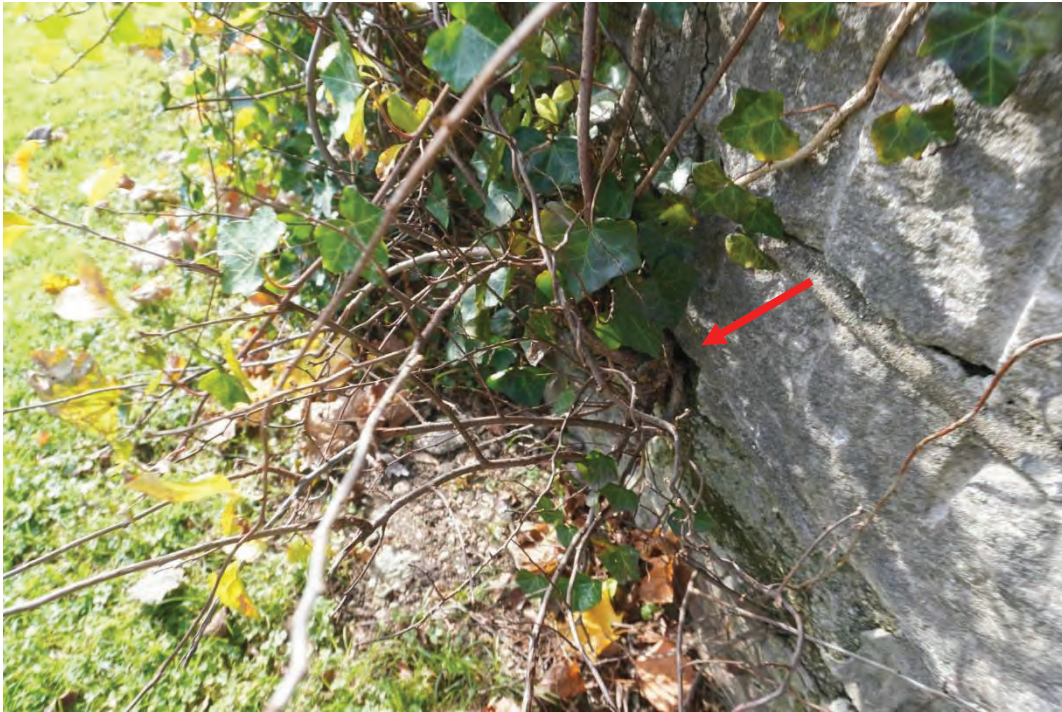
Photo #3: Retaining wall that runs from between front entrance and driveway is deteriorating throughout. Roots/ large weeds growing through joints of walls multiple locations.

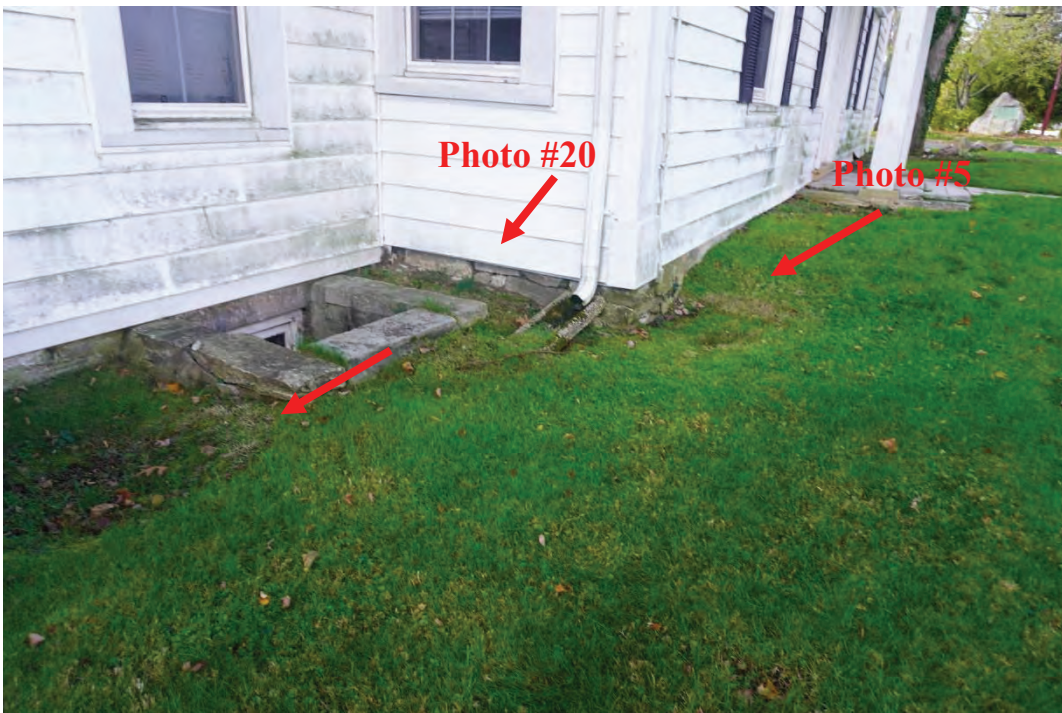
Photo #4: Negative grading front of home between entrance and northeast corner of original structure. Water pooling up against foundation wall and most likely infiltrating into crawlspace.

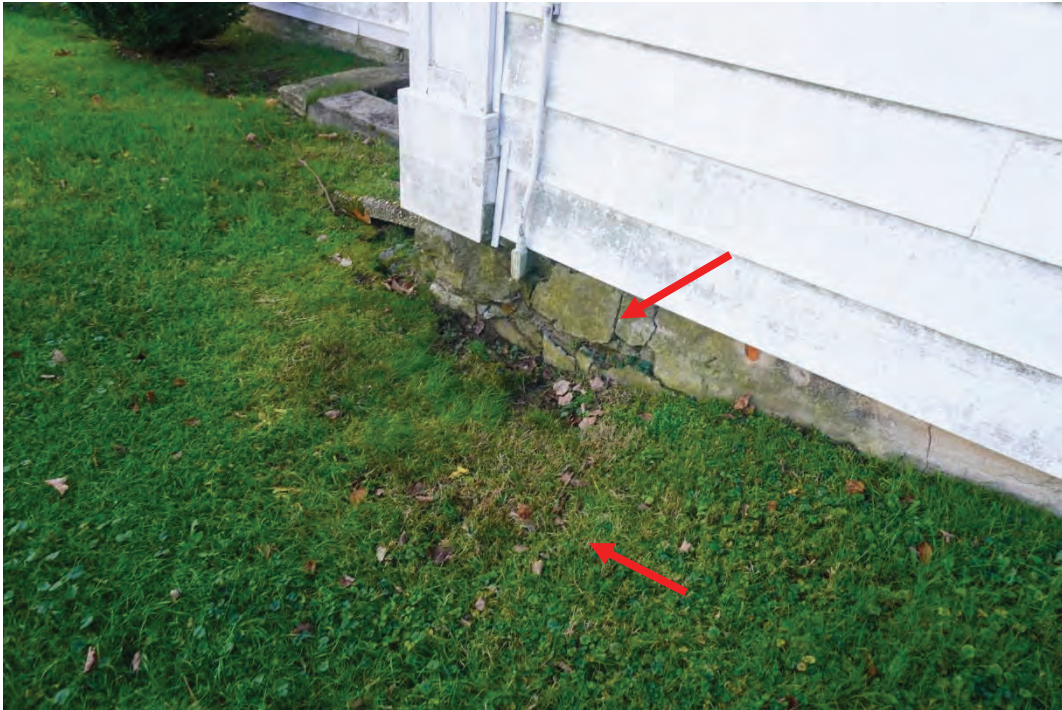
Photo #5: Negative grading front of home between entrance and northeast corner of home. Water pooling up against foundation wall and most likely infiltrating into crawlspace. Signs of foundation deterioration.

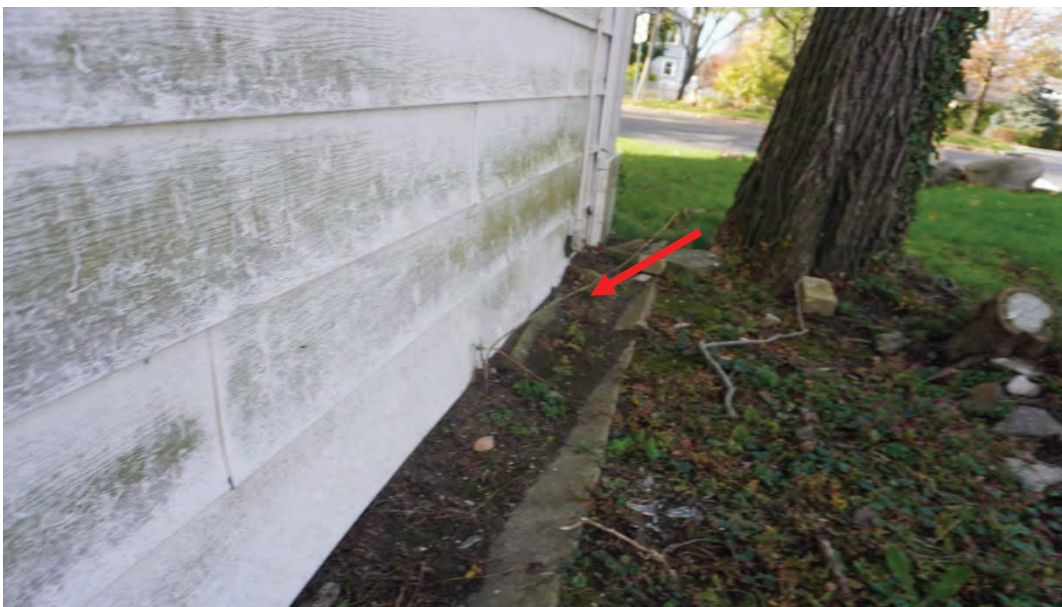
Photo #6: Negative grading front of home between entrance and northwest corner of home. Water pooling up against exterior foundation wall of crawlspace.

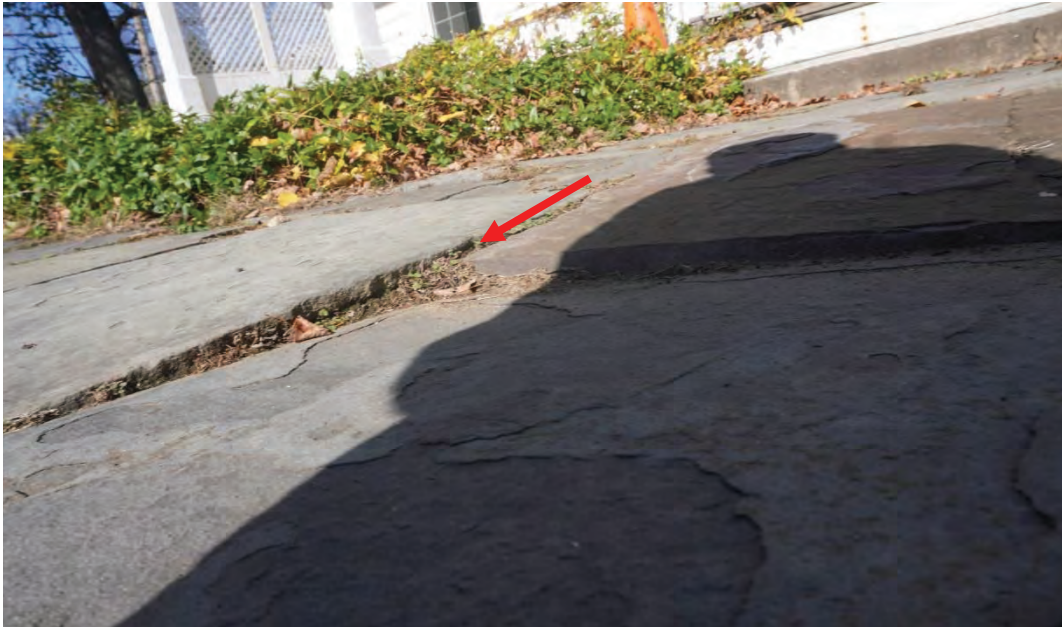
Photo #7: Stone slabs have settled/heaved creating multiple trip hazards, stone walkway rear yard.

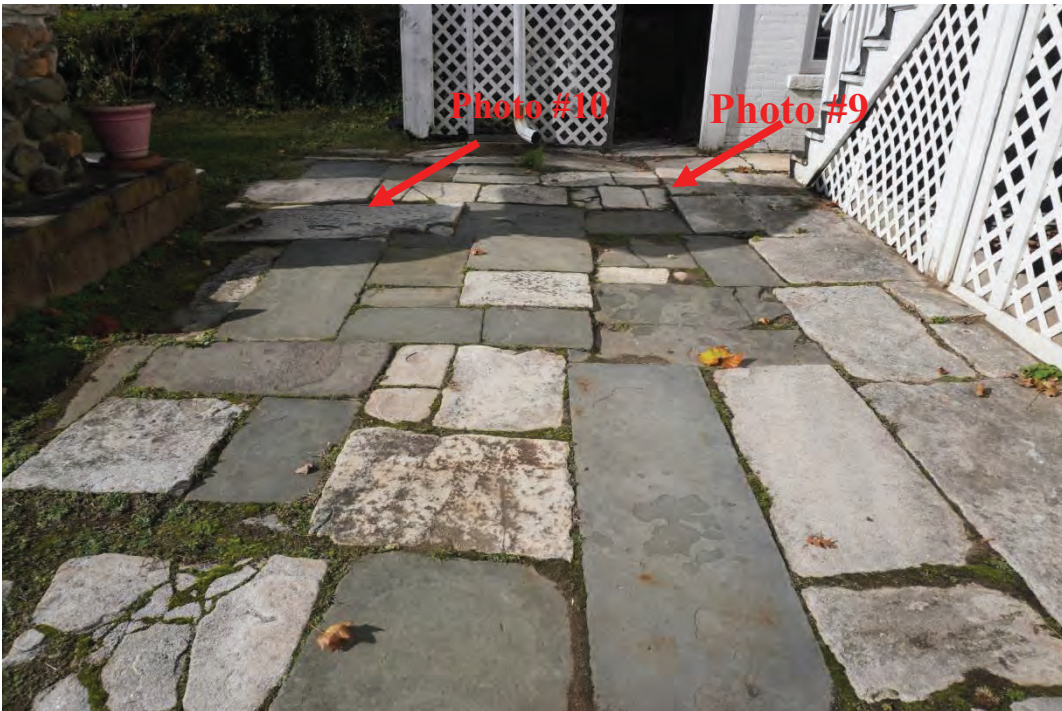
Photo #8: Stone slabs have settled/ heaved creating multiple trip hazards, stone patio rear yard.

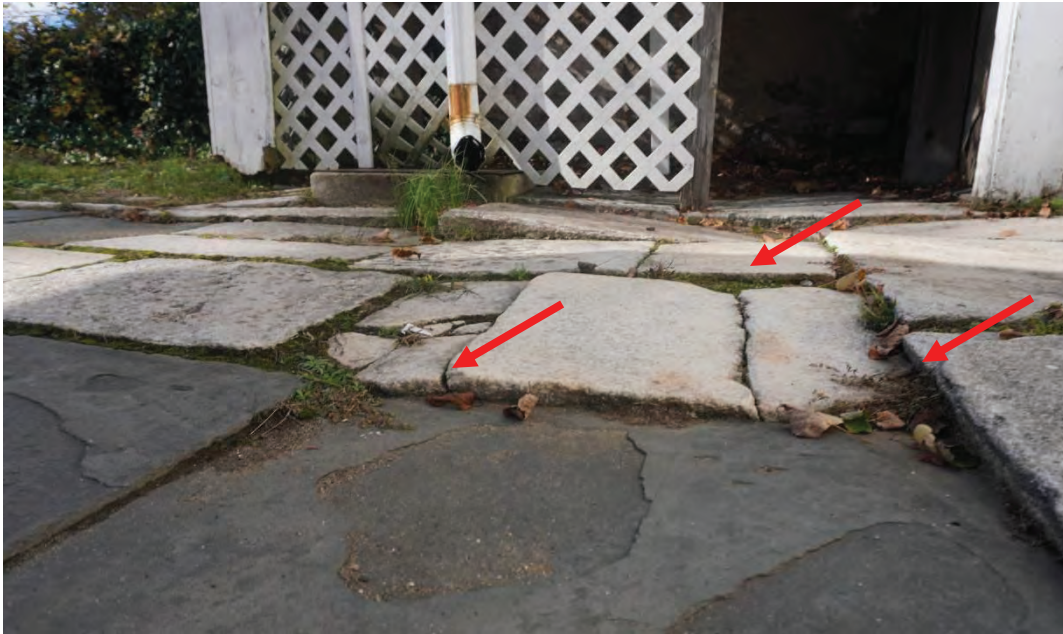
Photo #9: Stone slabs have settled/ heaved creating multiple trip hazards, stone patio rear yard.

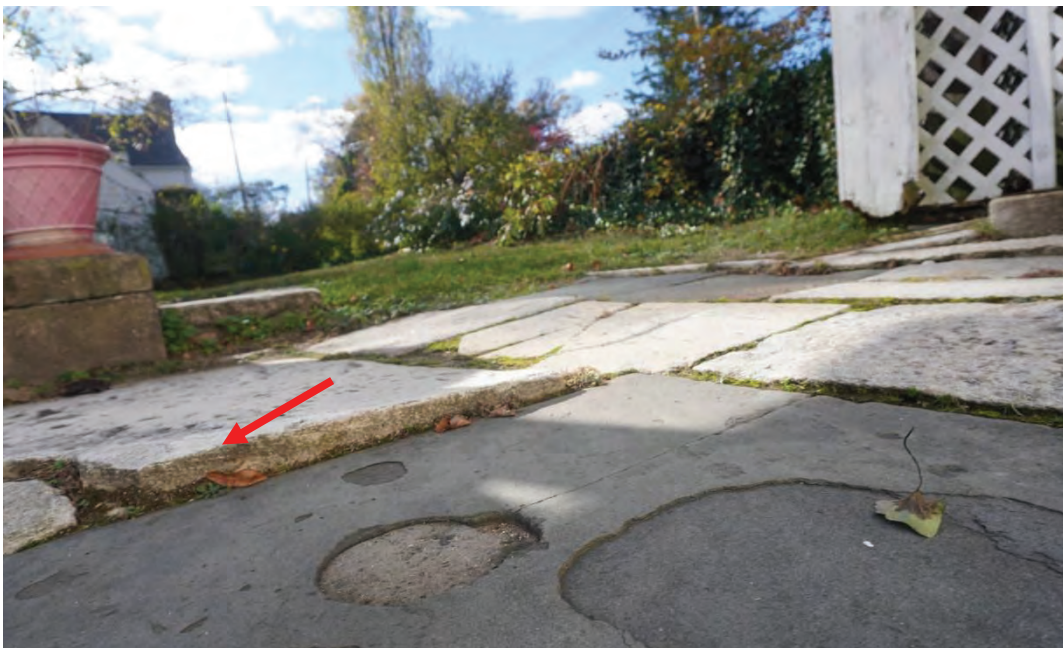
Photo #10: Stone slabs have settled/ heaved creating multiple trip hazards, stone patio rear yard.

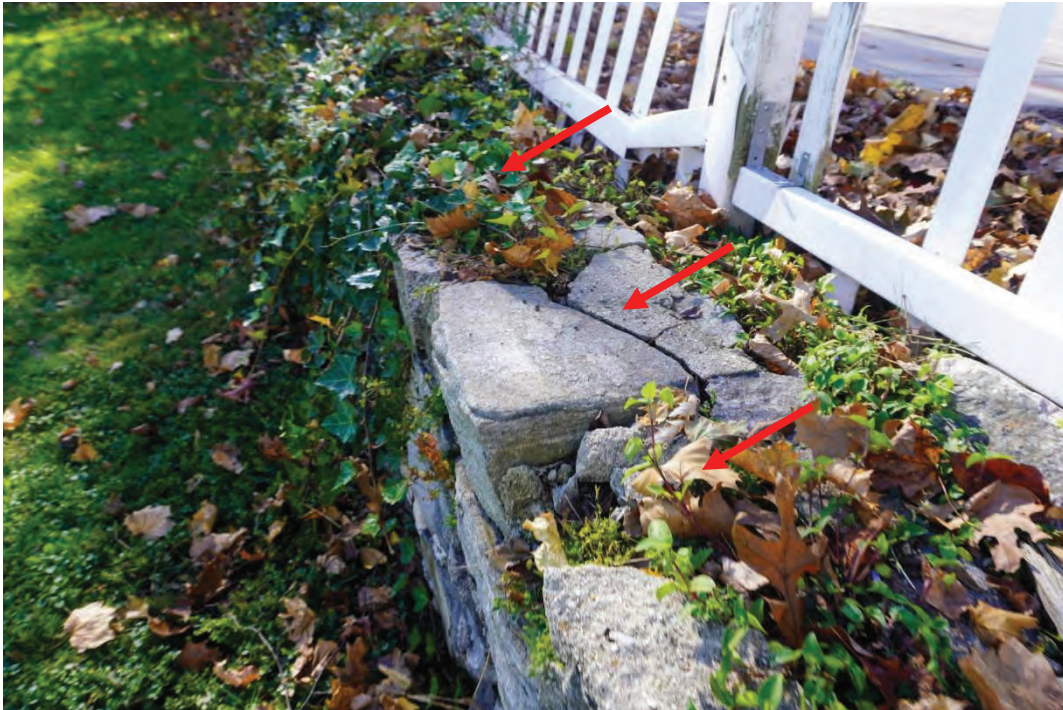
Photo #11: Retaining wall that runs between rear yard and adjacent sidewalk deteriorating throughout. Broken stones and joints between stones have filled with dirt/ organic growths.

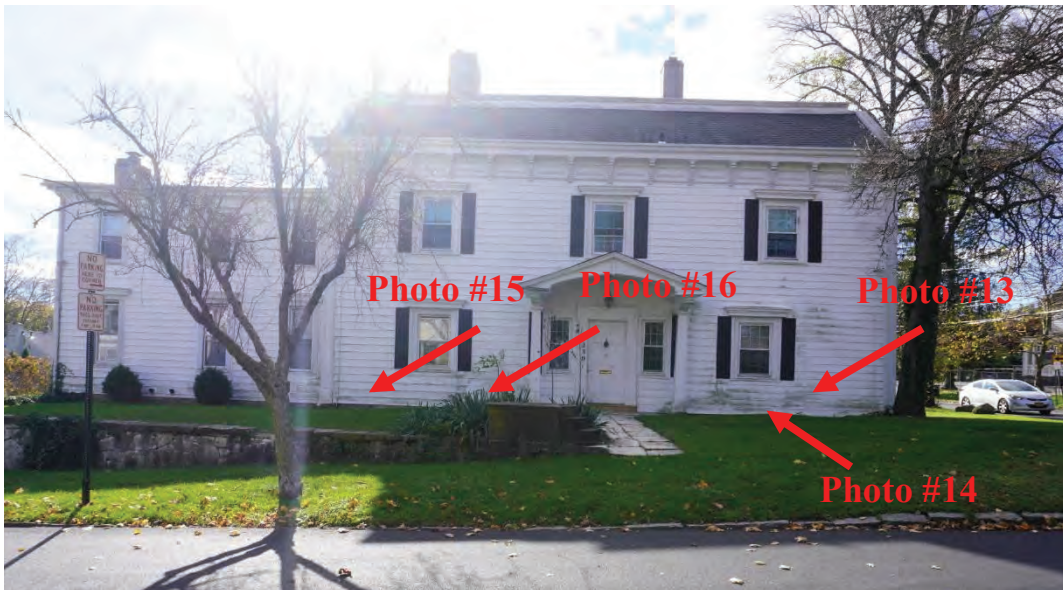
Photo #12: Foundation along front façade of original structure is low and at same level as grading. Water can infiltrate above foundation wall and rot out wood sill beam that runs along top of foundation.

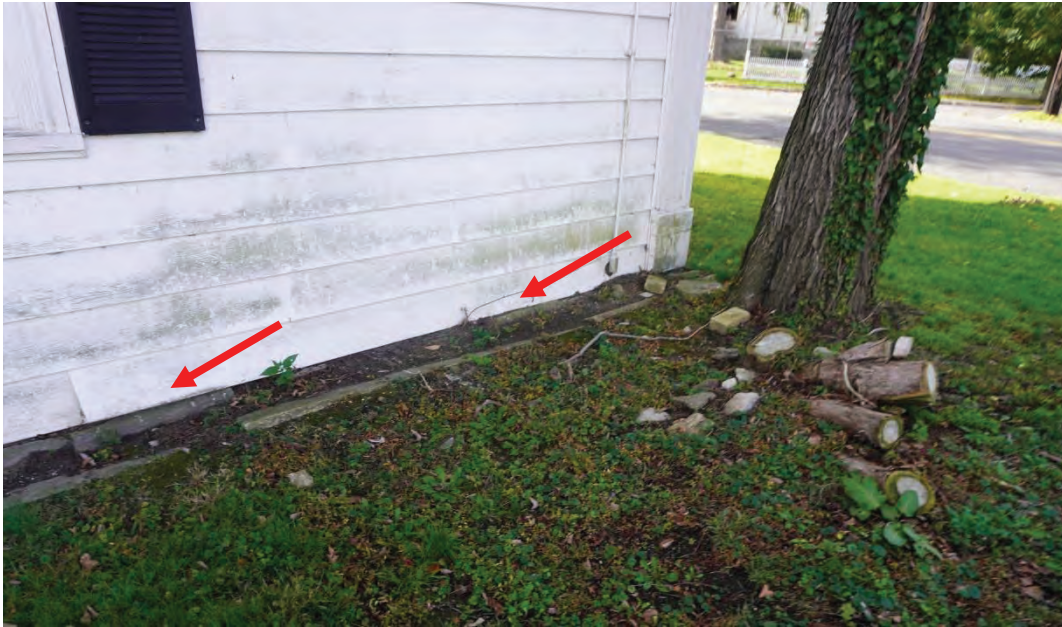
Photo #13: Foundation along front façade of original structure is low and at same level as grading. Water can infiltrate above foundation wall and rot out wood sill beam that runs along top of foundation.

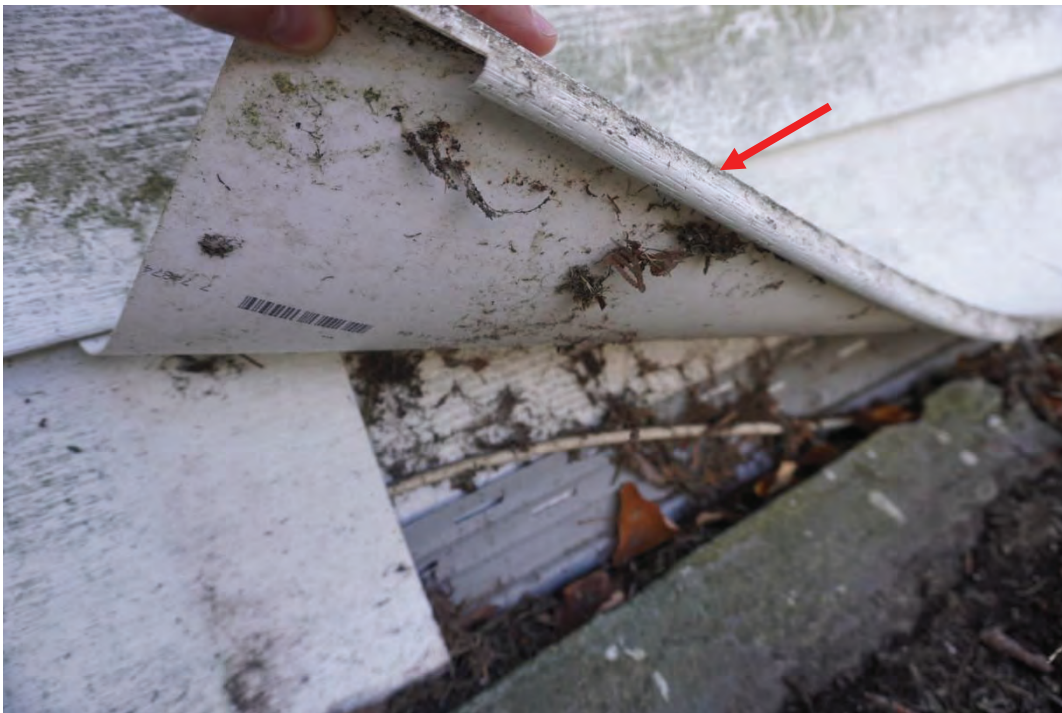
Photo #14: Exterior of building covered in vinyl siding which is not the homes original exterior building material.

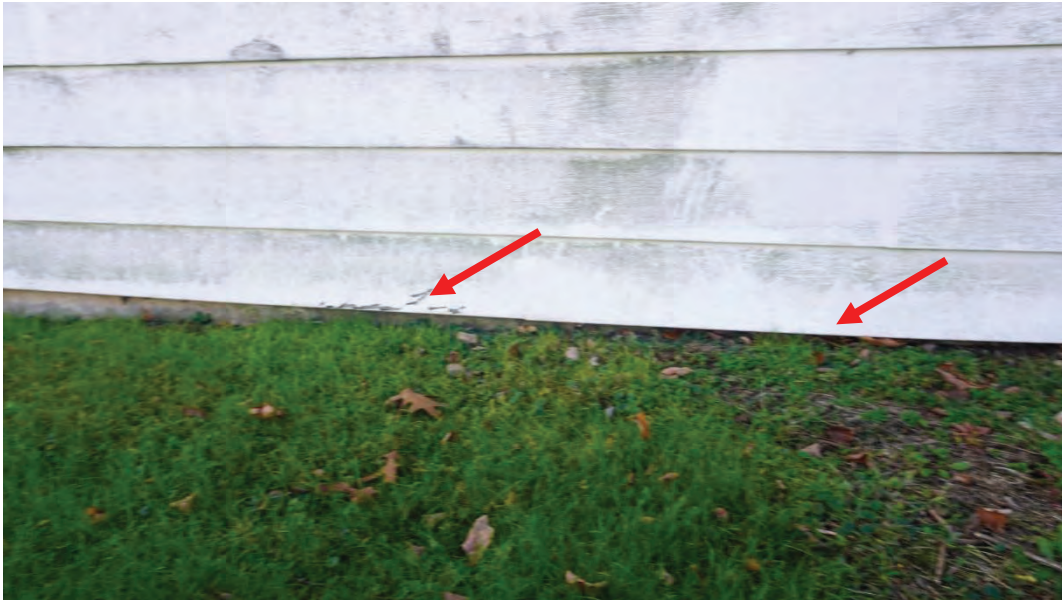
Photo #15: Foundation along front façade of original structure is low and at same level as grading. Water can infiltrate above foundation wall and rot out wood sill beam that runs along top of foundation.

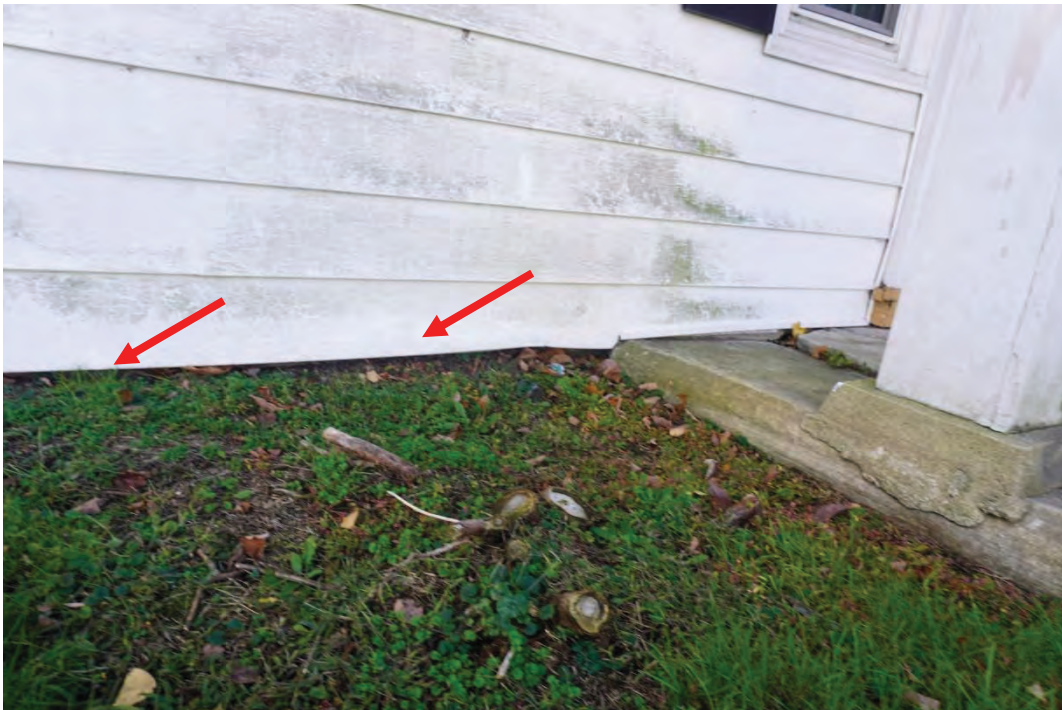
Photo #16: Foundation along front façade of original structure is low and at same level as grading. Water can infiltrate above foundation wall and rot out wood sill beam that runs along top of foundation.

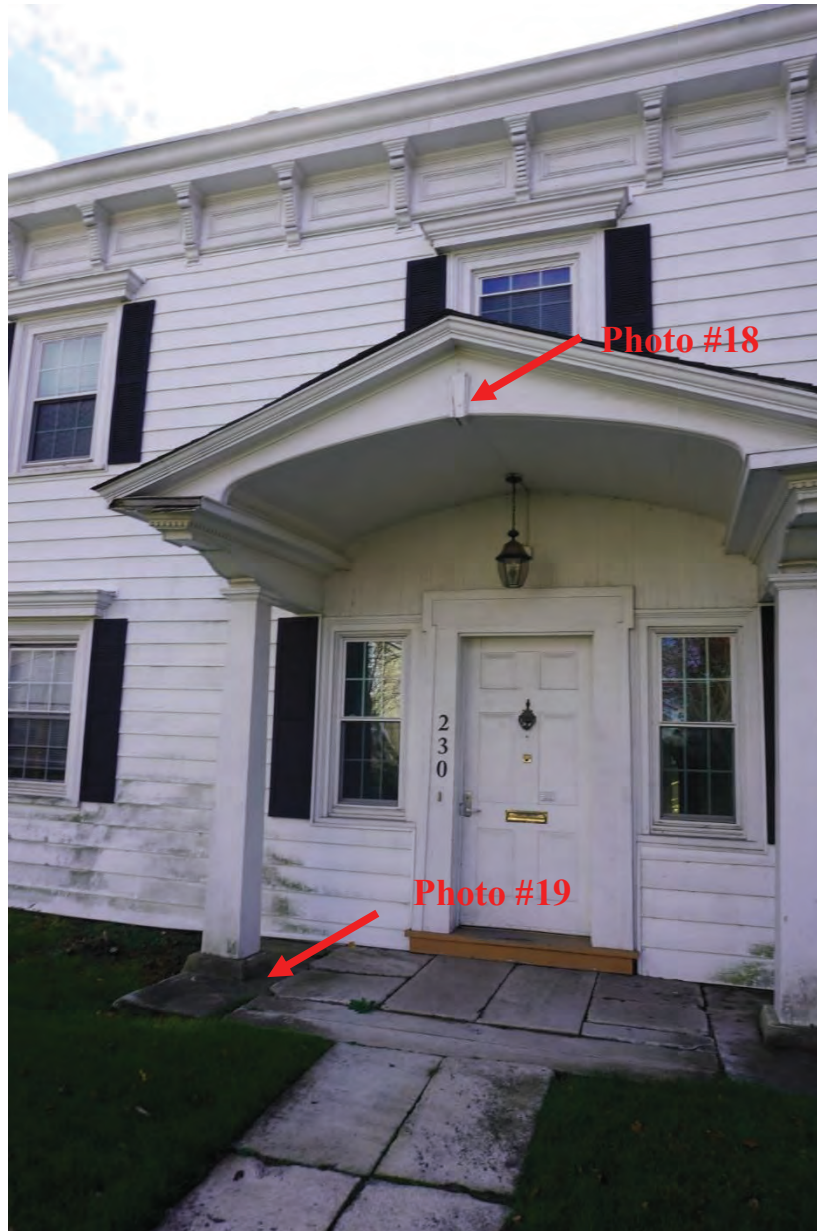
Photo #17: Base of column support for front portico showing signs of differential settlement.
Vertical crack running down middle of front portico.

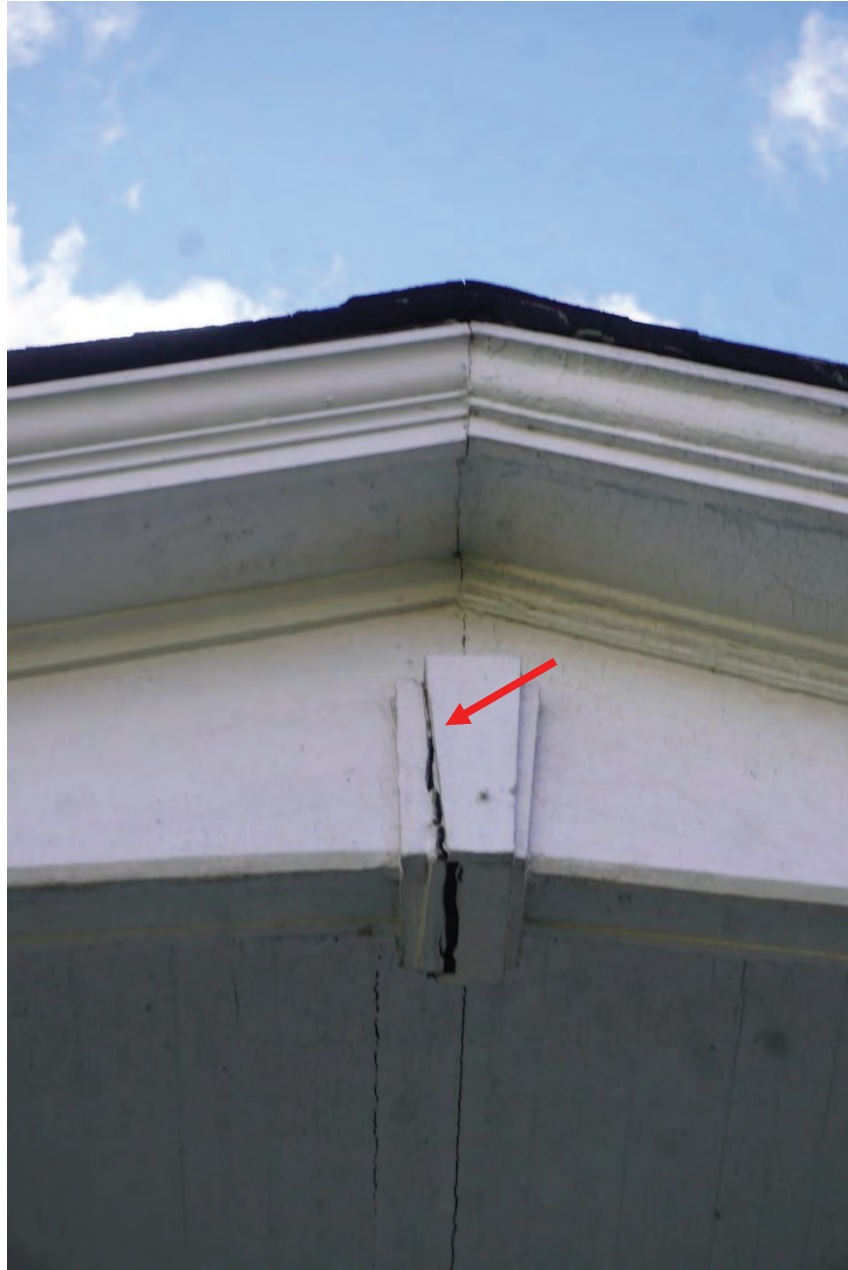
Photo #18: Vertical crack running down middle of front portico.

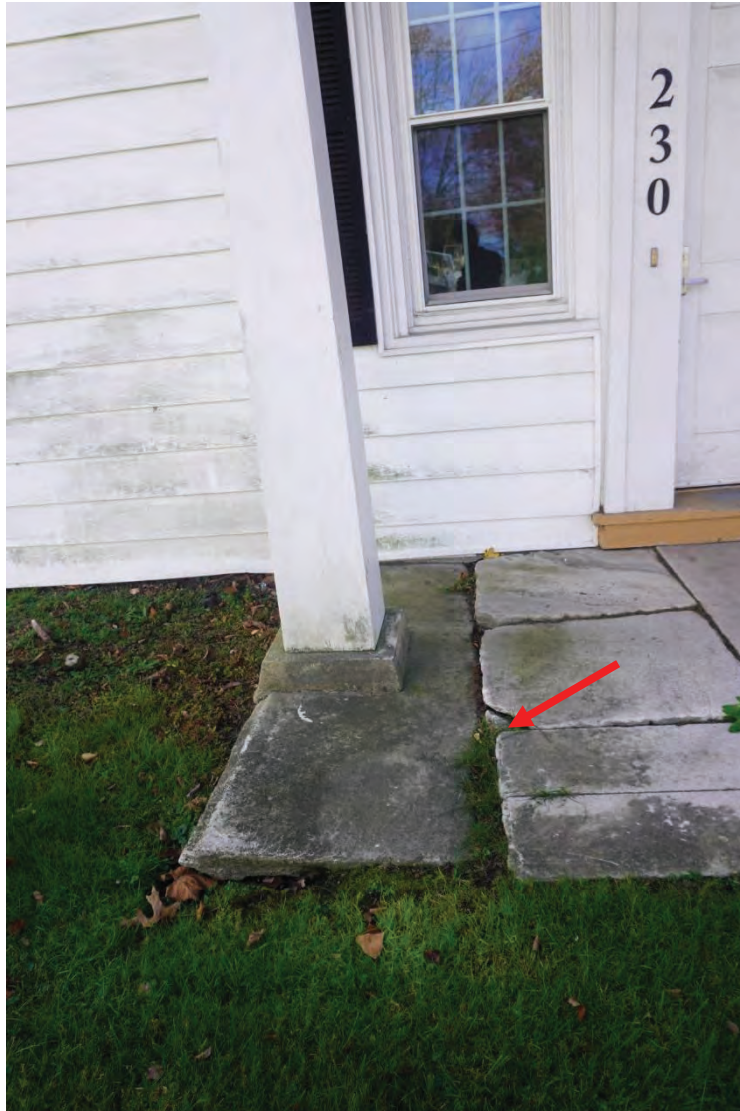
Photo #19: Base of column support for front portico showing signs of differential settlement.

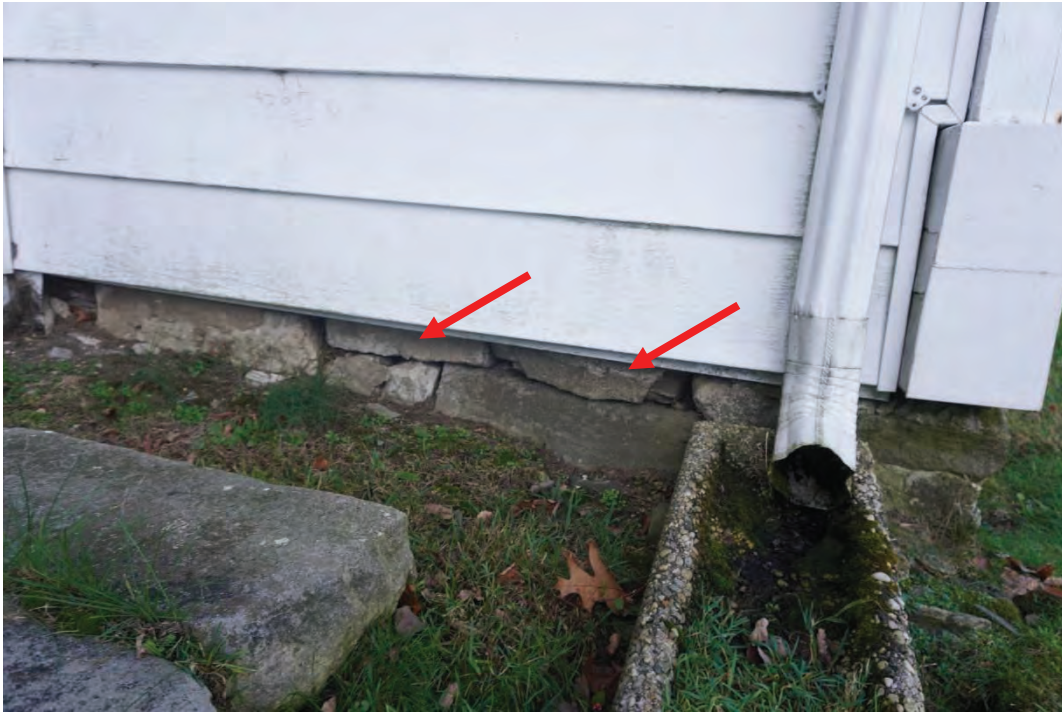
Photo #20: Exposed exterior side of rumble foundation deteriorating. No mortar between stones.

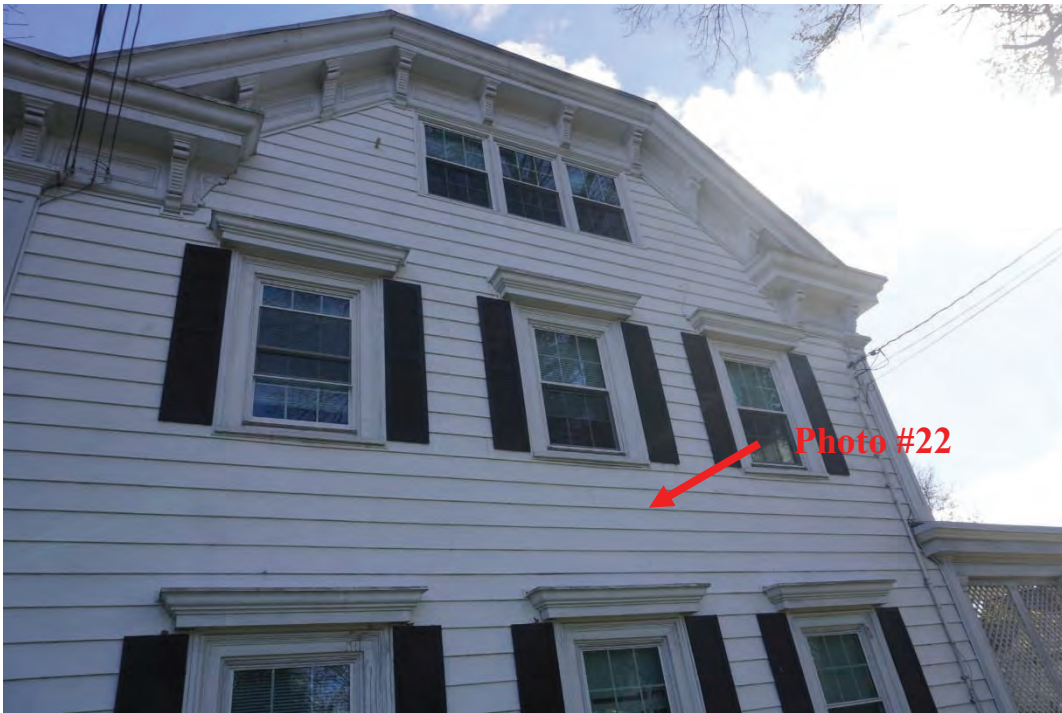
Photo #21: Bulge noticed between first and second floors, west façade of home. Cause unknown. Further investigation required.

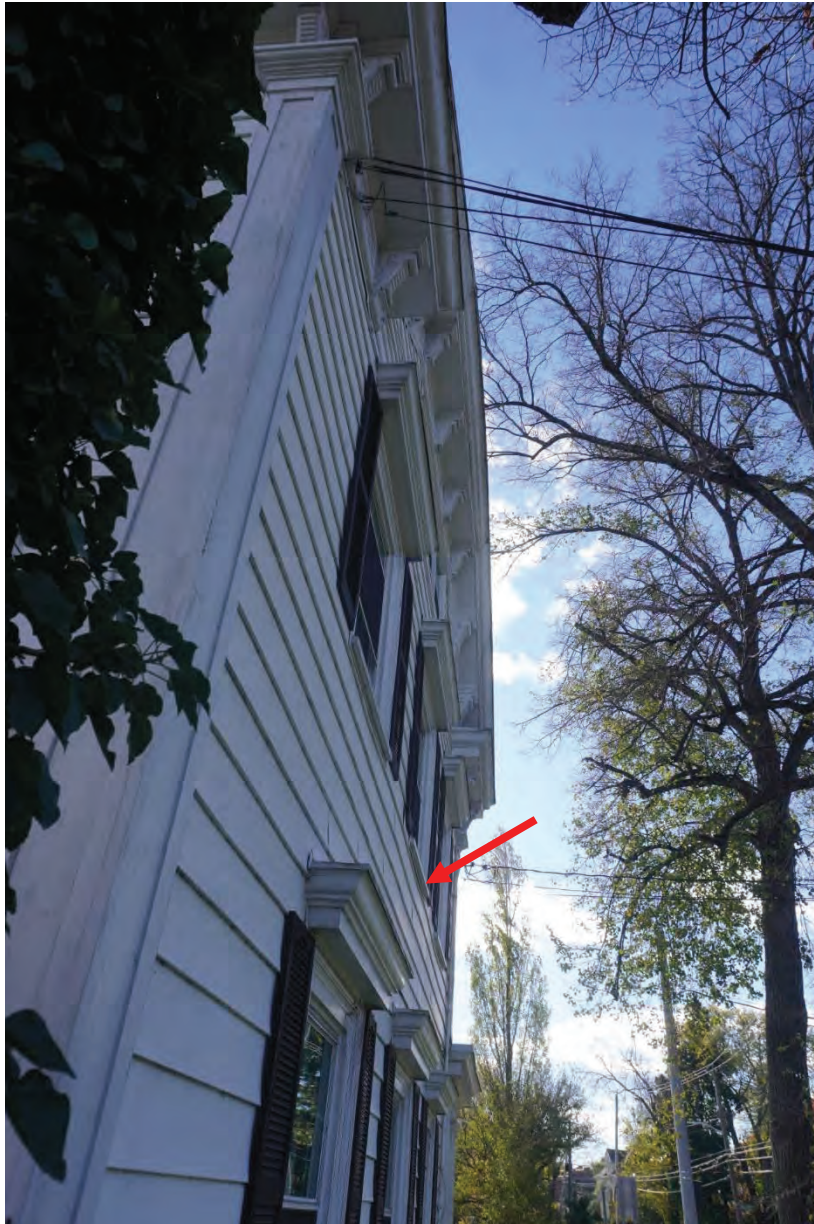
Photo #22: Bulge noticed between first and second floors, west façade of home. Cause unknown. Further investigation required.

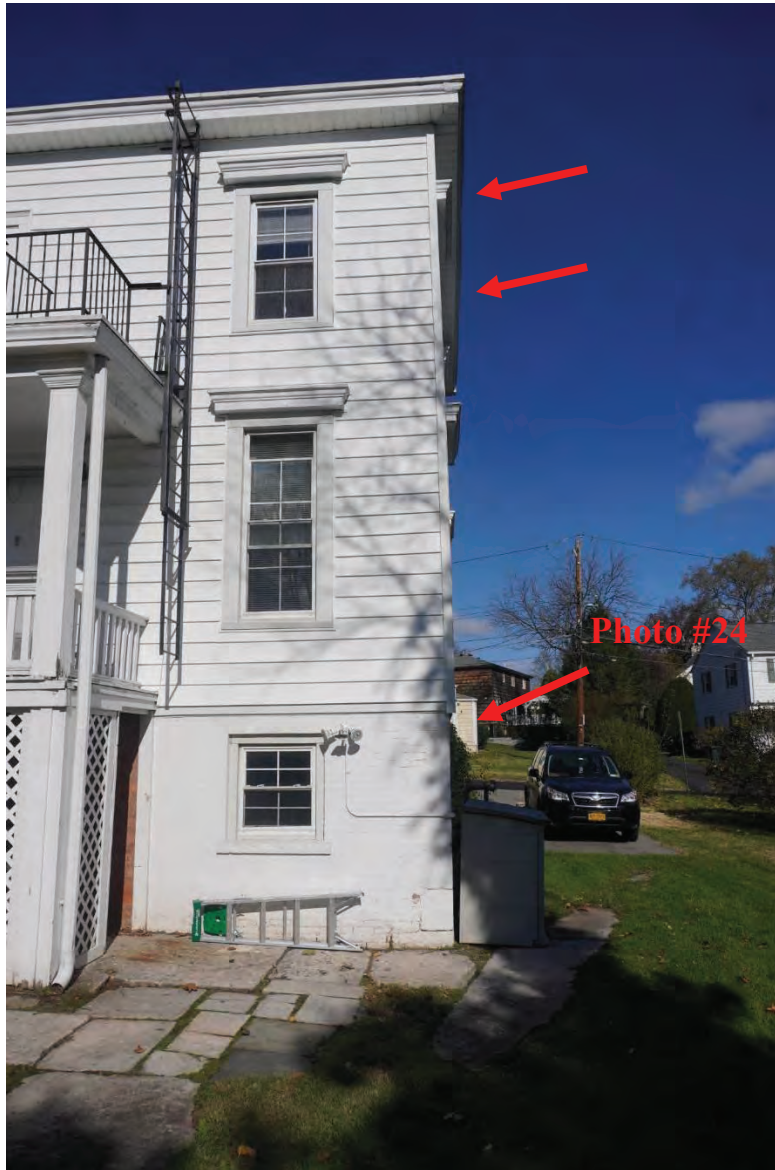
Photo #23: Southeast corner of structure showing signs of inwards movement towards the top. Cause unknown. Further investigation required.

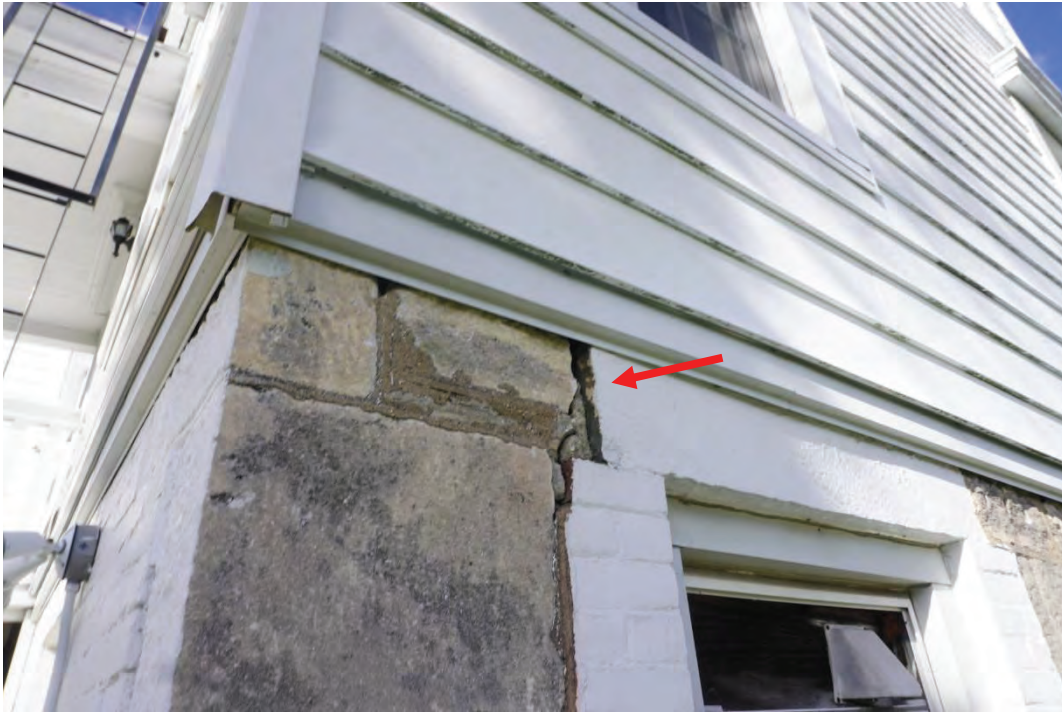
Photo #24: Vertical crack ground level stonework east façade, southeast corner of structure at addition.

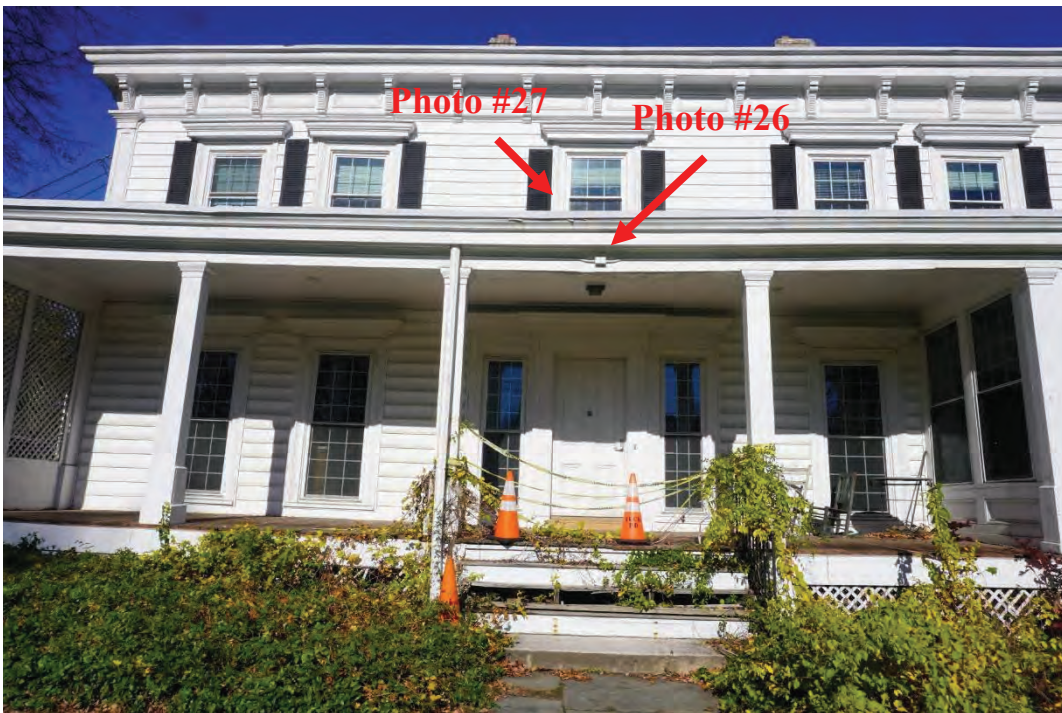
Photo #25: Rear porch roof deflecting over stairs causing water to pool and leaf build up.

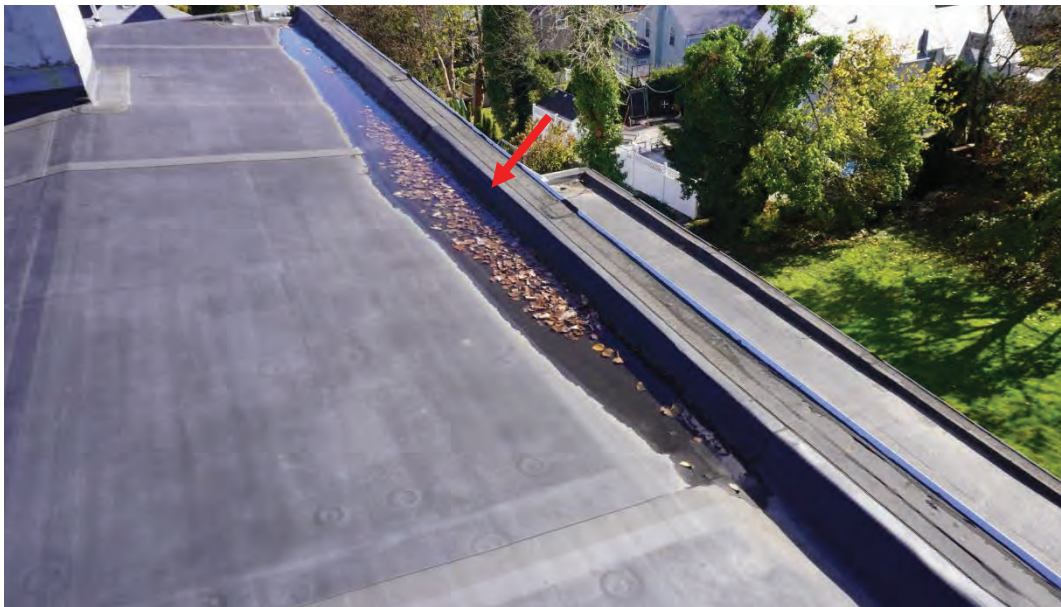
Photo #29: Roof structure has deflected causing water to pool. Roofing membrane observed to be fairly new.

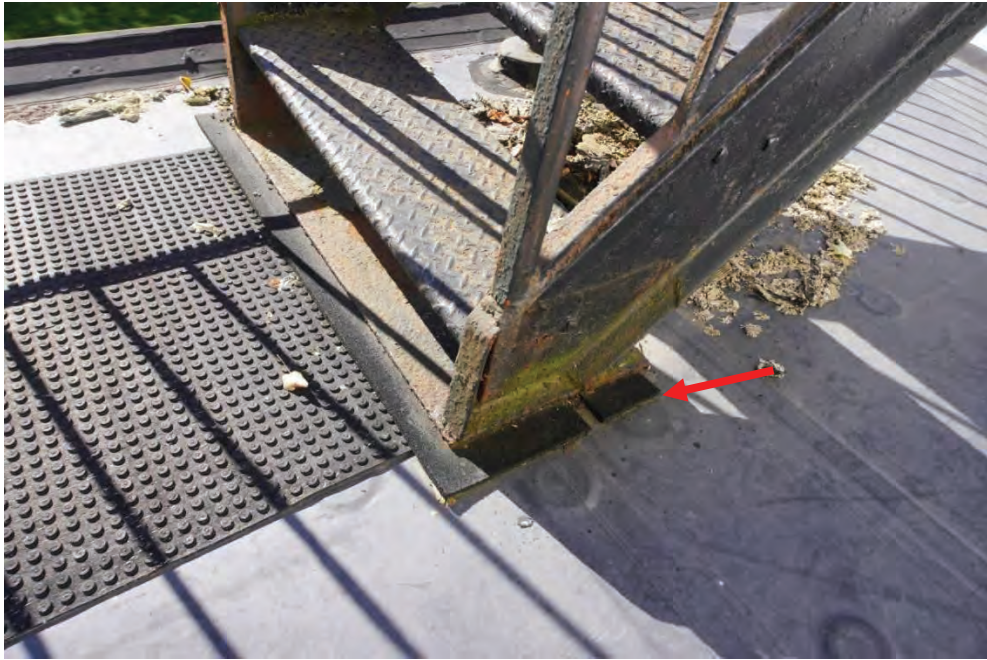
Photo #30: Exterior metal stair egress just sitting on roofing membrane and not attached to structure.

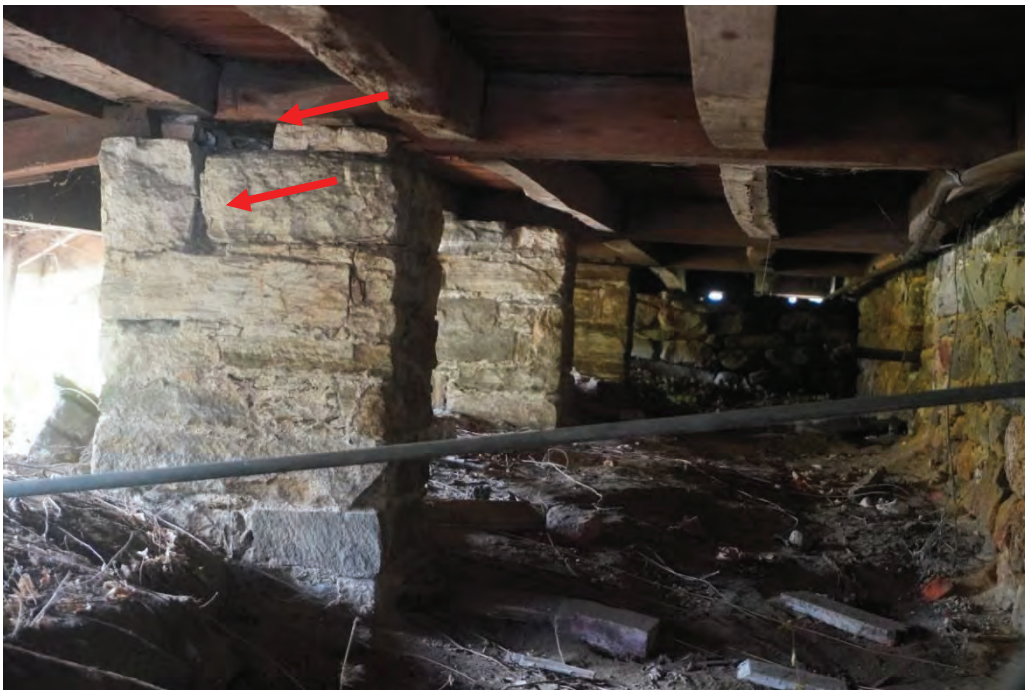
Photo #31: Rear porch sitting on stone pillars that are showing signs of deterioration.

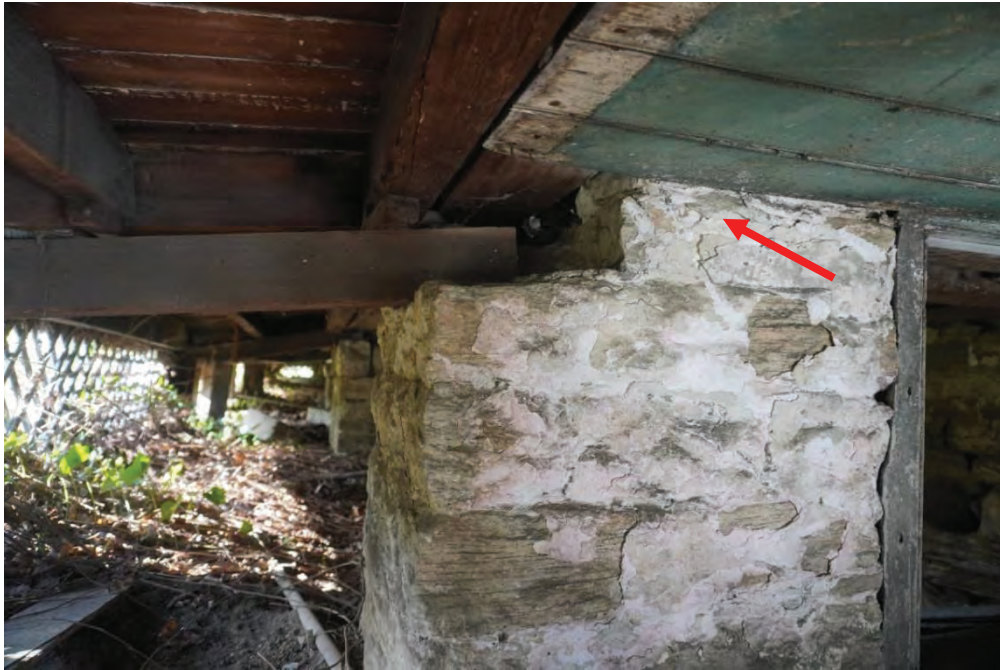
Photo #32: Rear porch sitting on stone pillars that are showing signs of deterioration.
