March 15, 2023

Via FedEx & Email (mmccann@tuckahoe-ny.com)

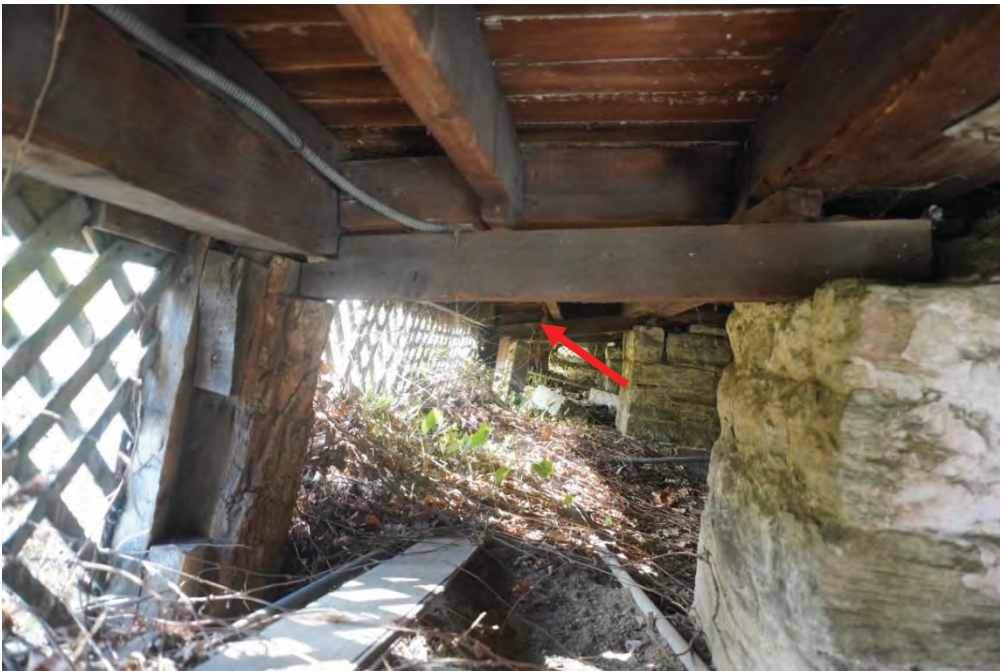
Photo #33: Rear porch was extended to be made wider at some unknown time in the past.

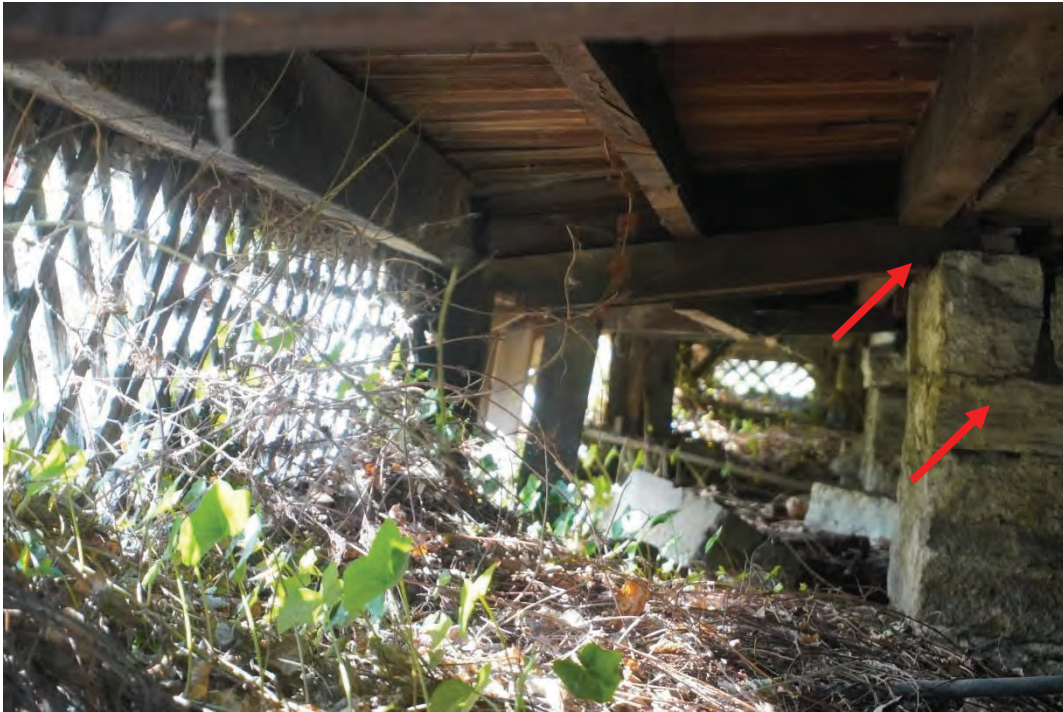
Photo #34: Rear porch sitting on stone pillars that are showing signs of deterioration.

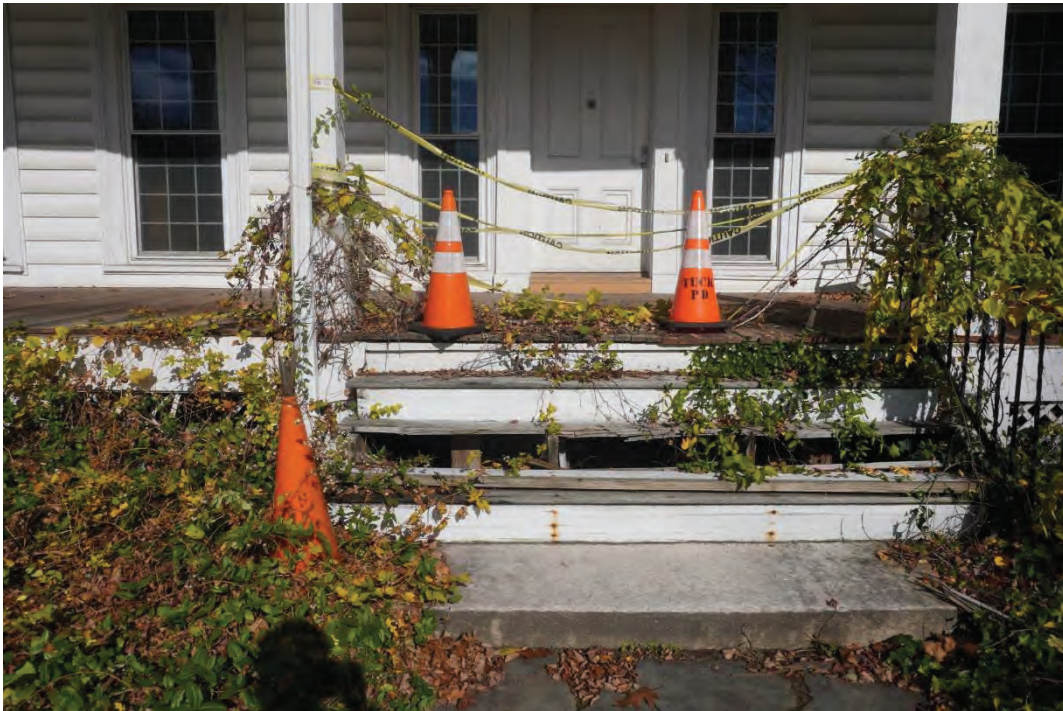
Photo #35: Rear porch stairs deteriorated. No longer usable. Unsafe condition.

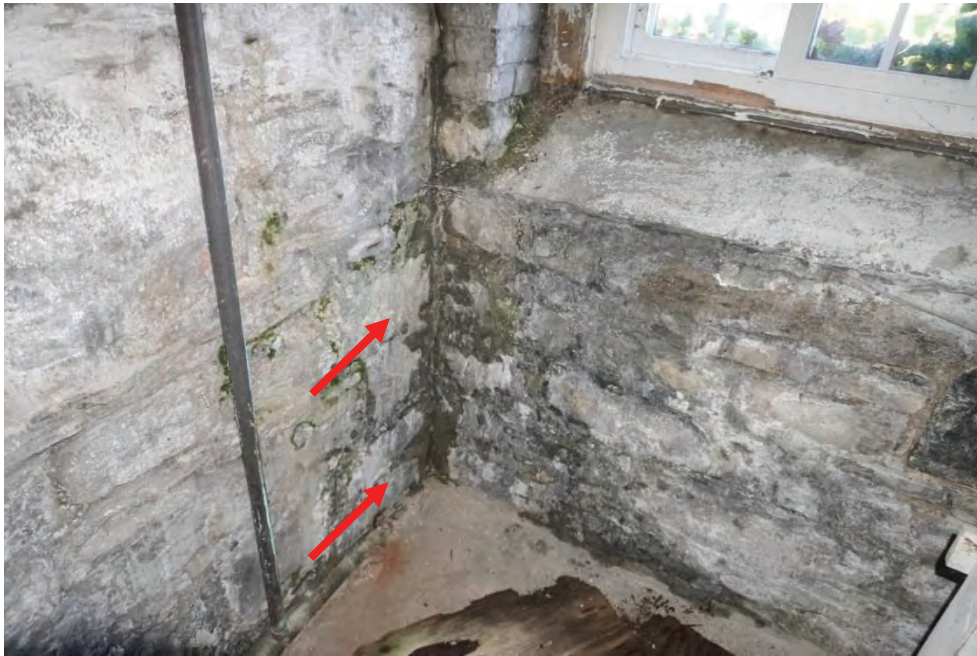
Photo #36: Water intrusion foundation wall, northeast corner of home at extension.

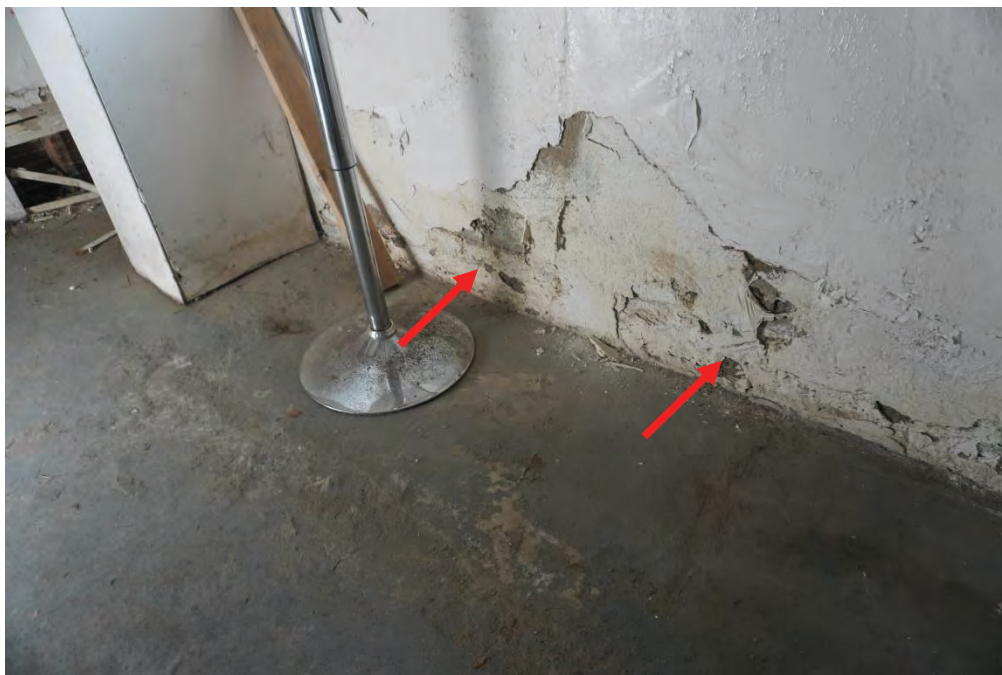
Photo #37: Water intrusion foundation, south wall of home at extension.

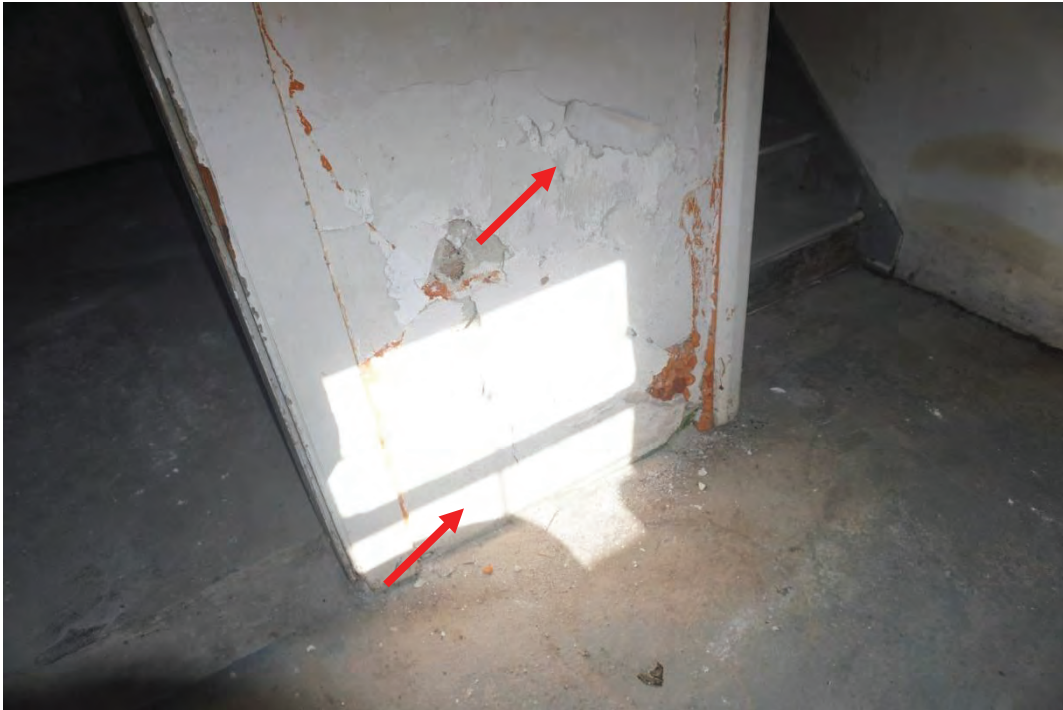
Photo #38: Mold formation and deteriorating damp plaster interior walls at cellar level due to water wicking up through cellar floor.

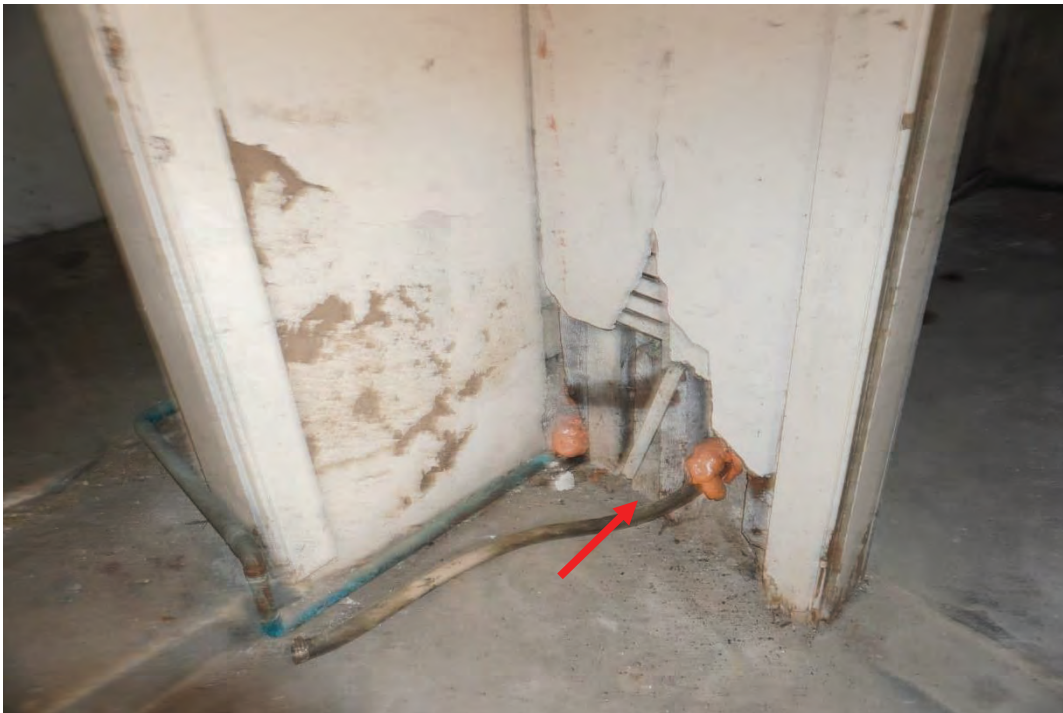
Photo #39: Mold formation and deteriorating damp plaster interior walls at cellar level due to water wicking up through cellar floor.

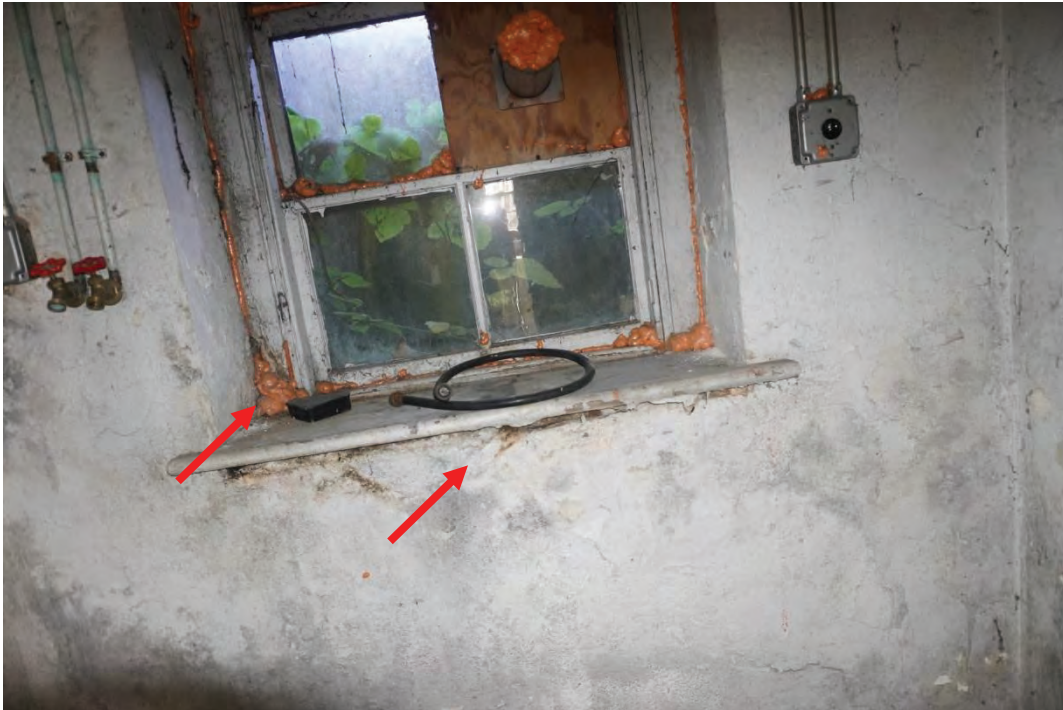
Photo #40: Water infiltration around cellar window, north façade of home at window well.

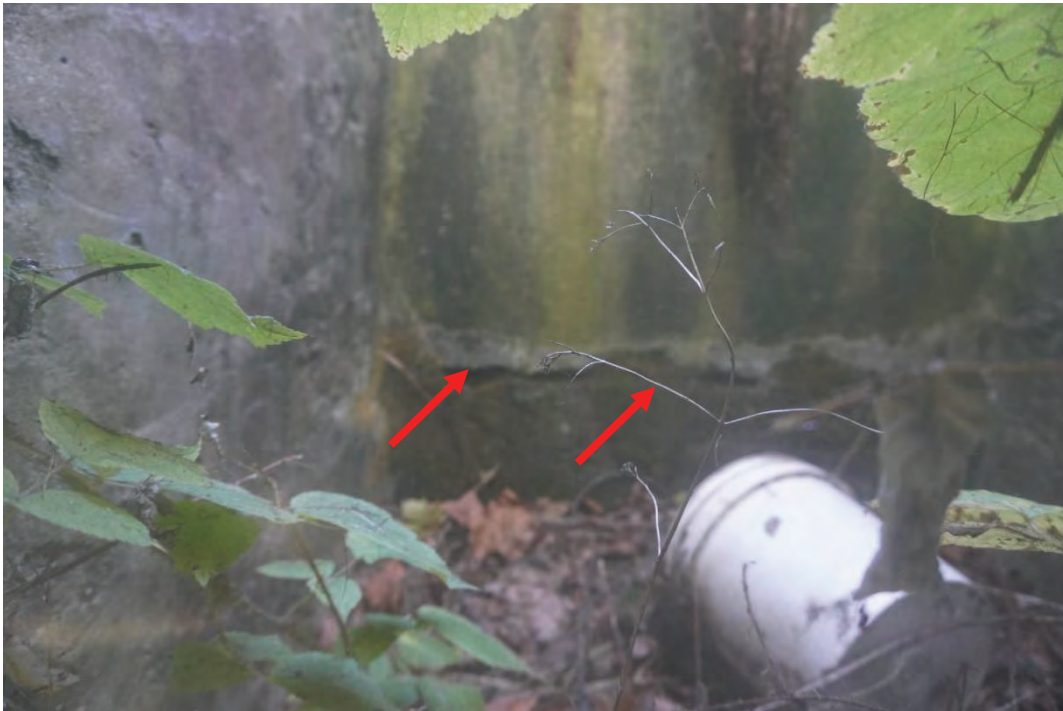
Photo #41: Horizontal crack has formed in concrete window well, north façade.

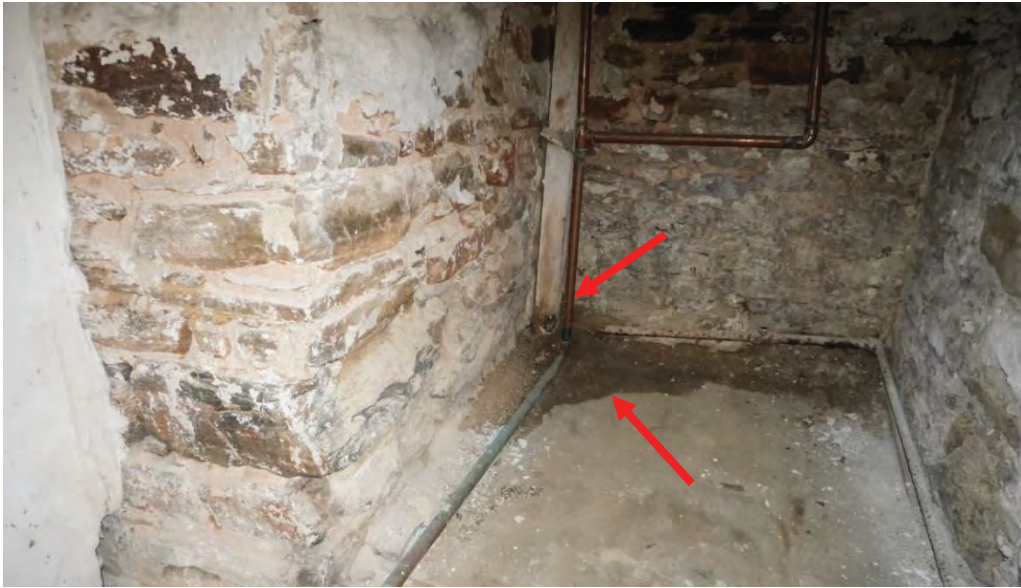
Photo #42: Water infiltration at base of inner, original foundation wall. Water is rotting base of wood support post. Crawlspace that spans the front side of the home is located on the other side of this wall.

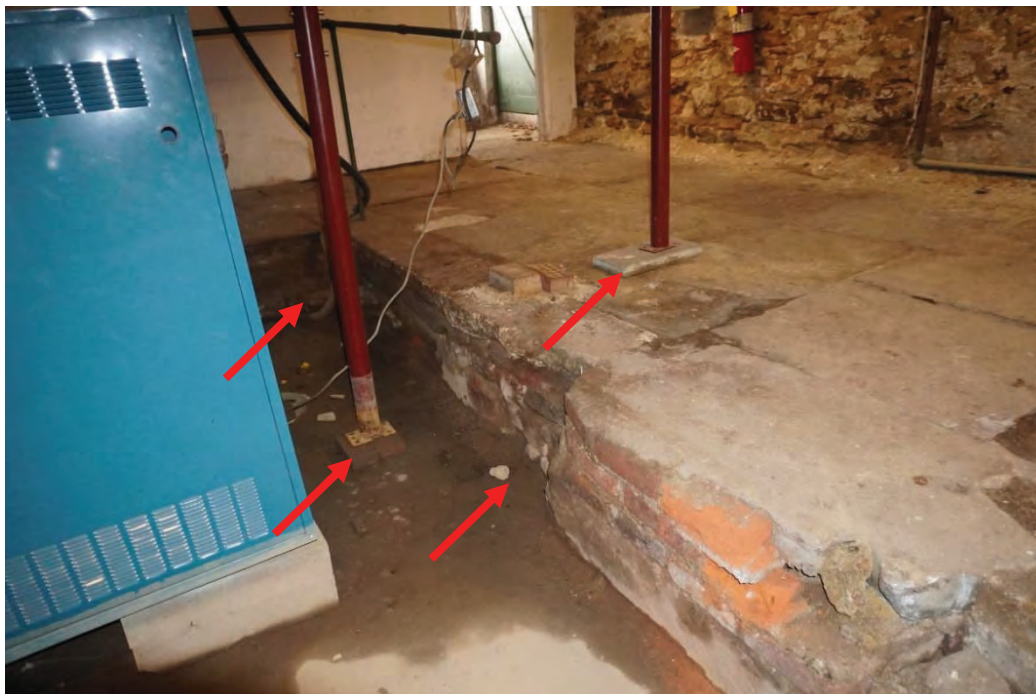
Photo #43: Water infiltration through foundation floor around perimeter of boiler pit. Concrete footings were never poured beneath temporary support columns that were added to prop up both failing girders in the cellar.

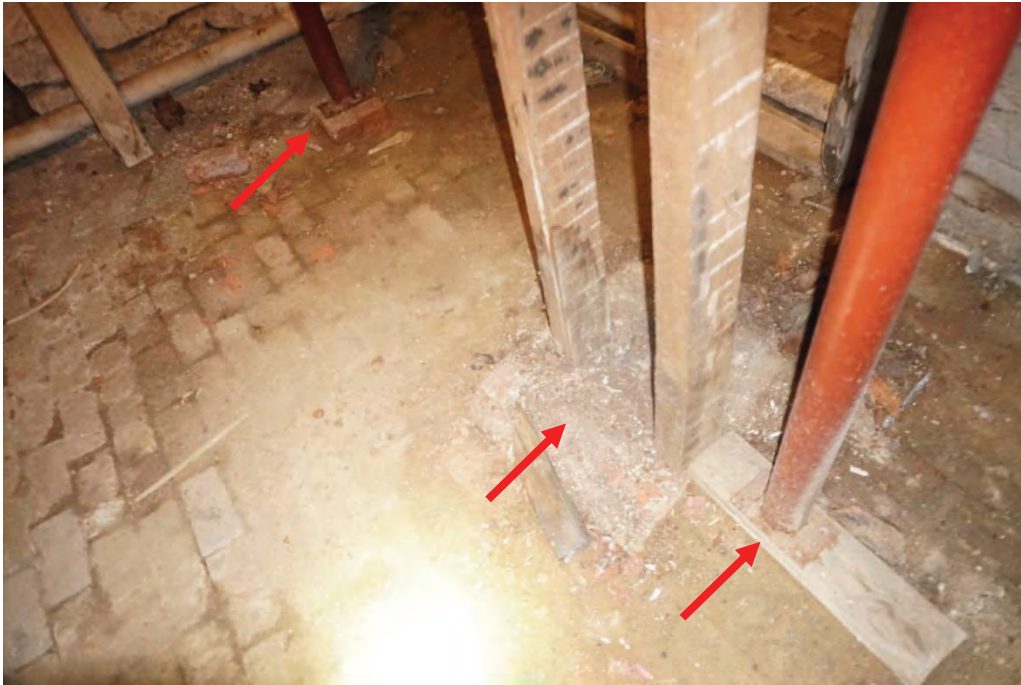
Photo #44: Concrete footings were never poured beneath temporary support columns that were added to prop of both failing girders in the cellar.

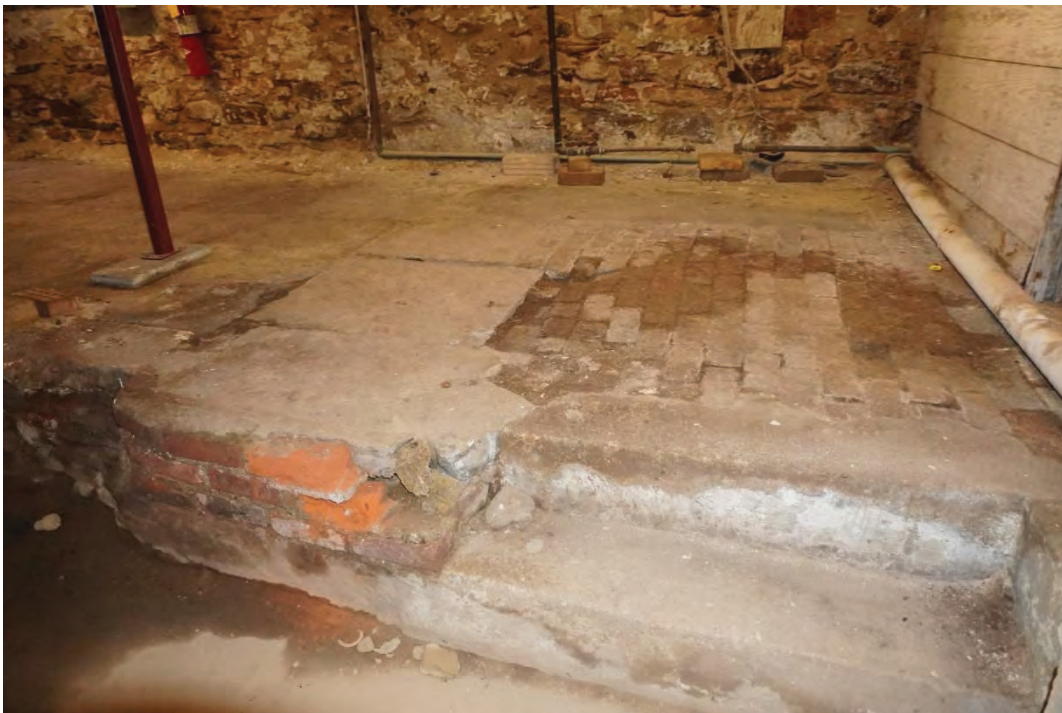
Photo #45: Cellar floor observed to be composed of bricks with a cement stucco layer that is deteriorating.

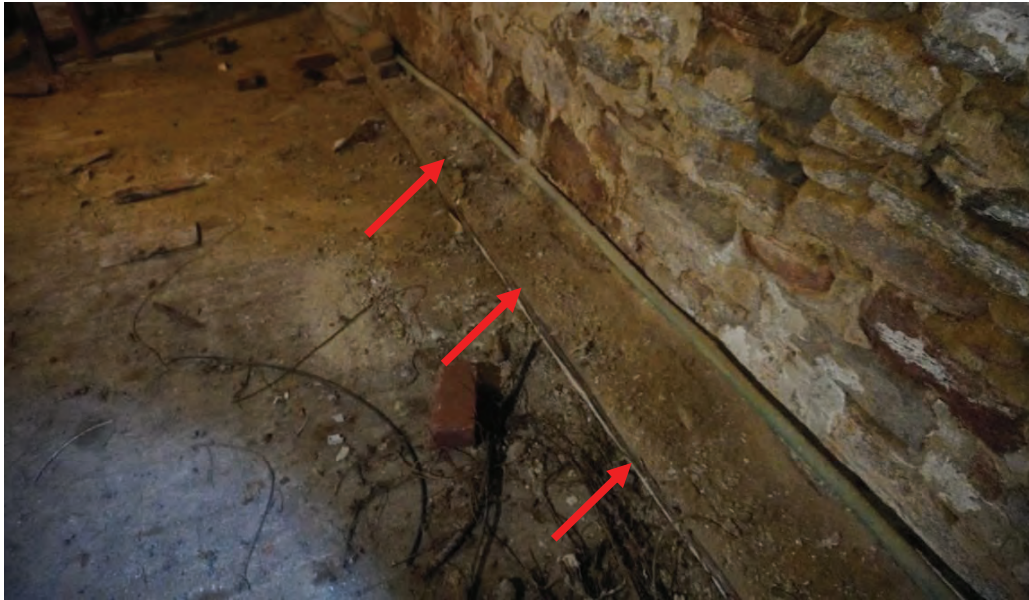
Photo #46: Water infiltrating through foundation is bringing in soil through spaces between dry laid rubble stone walls. Soil piling along inside of foundation walls.

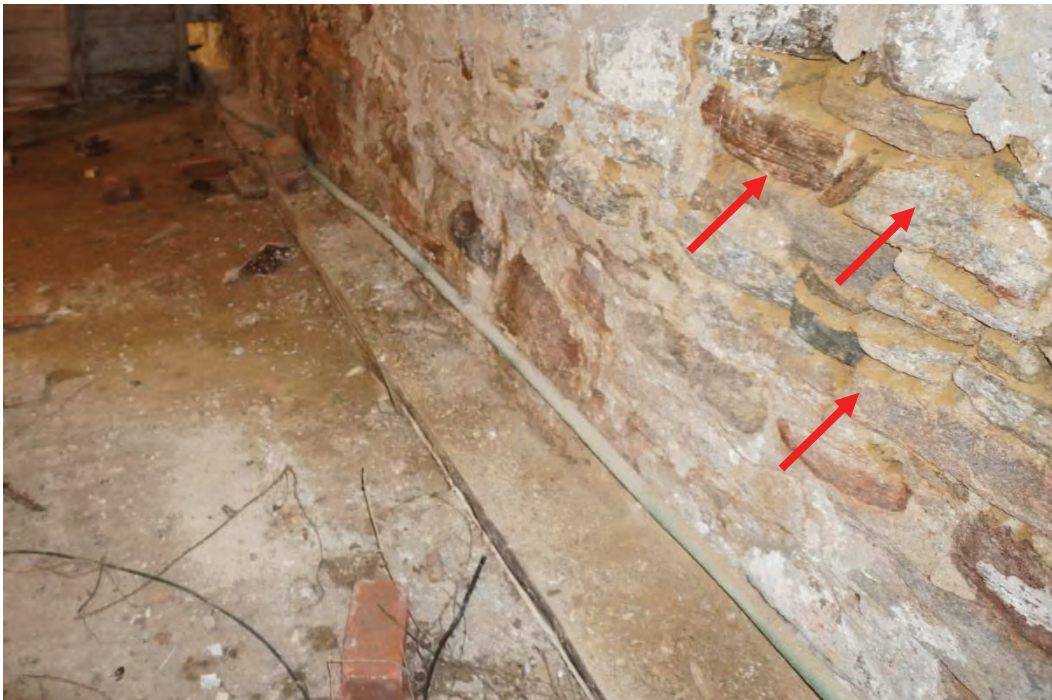
Photo #47: Water infiltrating through foundation is bringing in soil through spaces between dry laid rubble stone walls. Soil piling along inside of foundation walls.

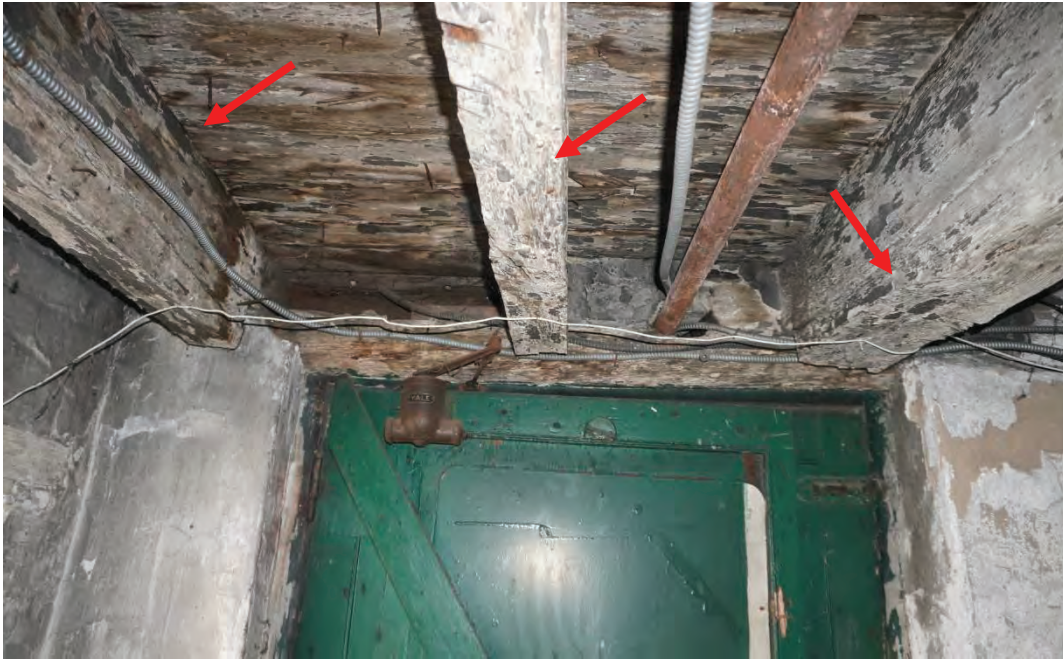
Photo #48: Two 10x3 beams spaced 16 inches apart on left are spanning 19 feet. The reason 6"x9-1/4" beam on right is sized larger than other joists is unclear. It is uncommon for such a large member to be sitting on a door header.

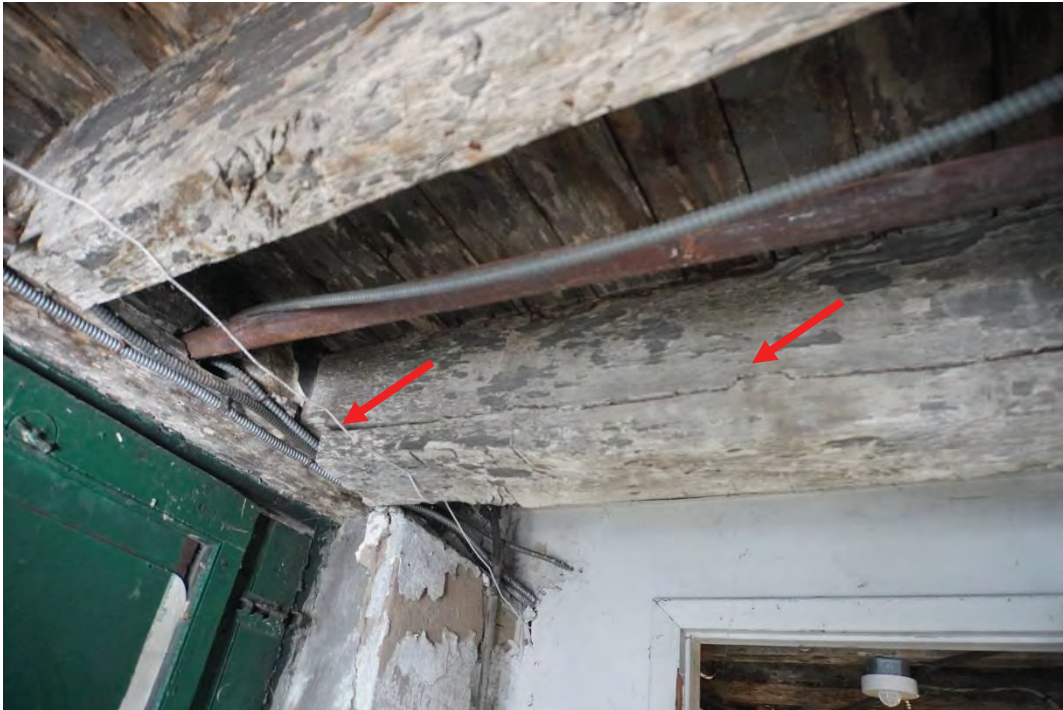
Photo #50: Horizontal crack from shear stress resonating down entire member from notch at end of beam.

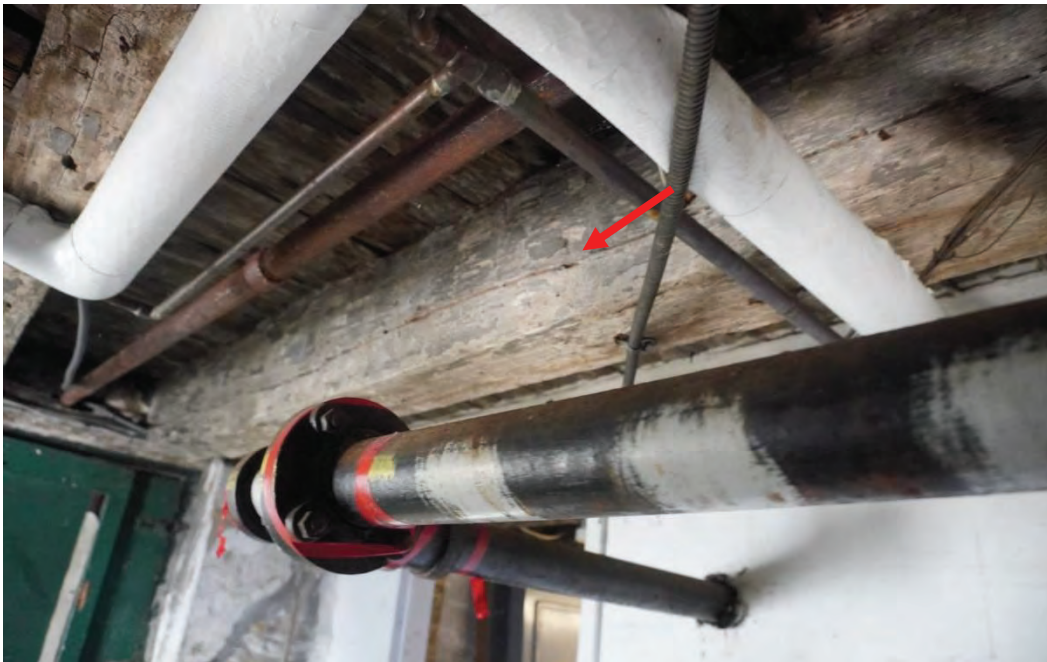
Photo #51: Horizontal crack from shear stress resonating down entire member from notch at end of beam.

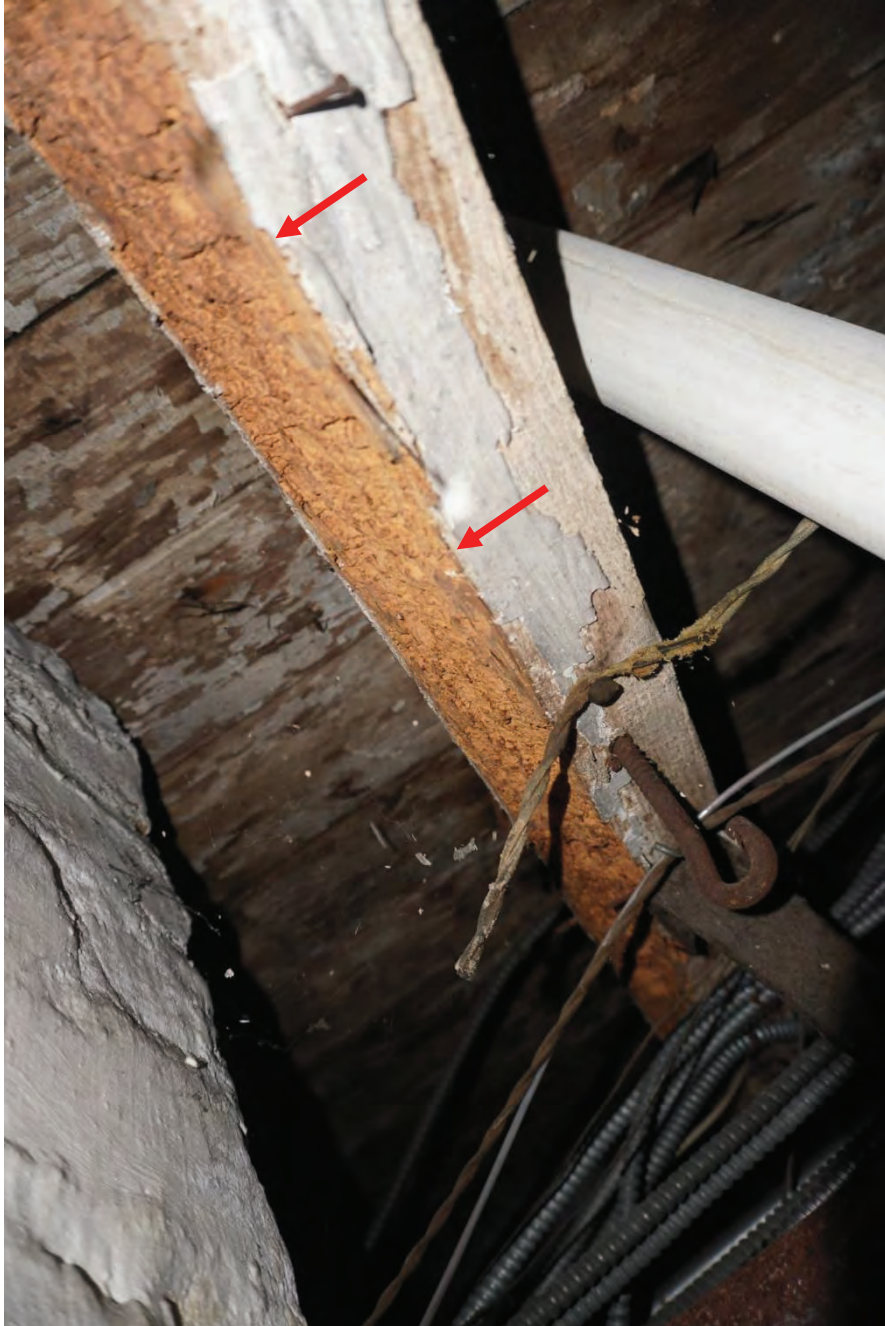
Photo #52: Wood joist observed to have a large extent of termite damage.

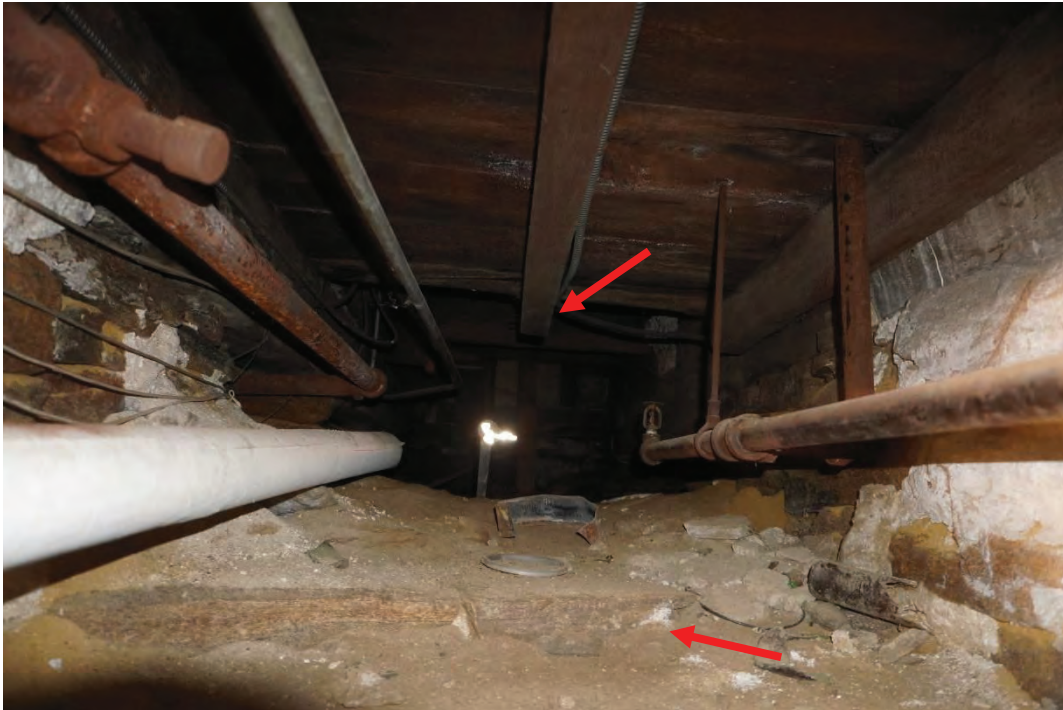
Photo #53: Joists connections in crawlspace observed to be coming apart. Piping was run into crawlspace through what potentially was an old window in original foundation wall.

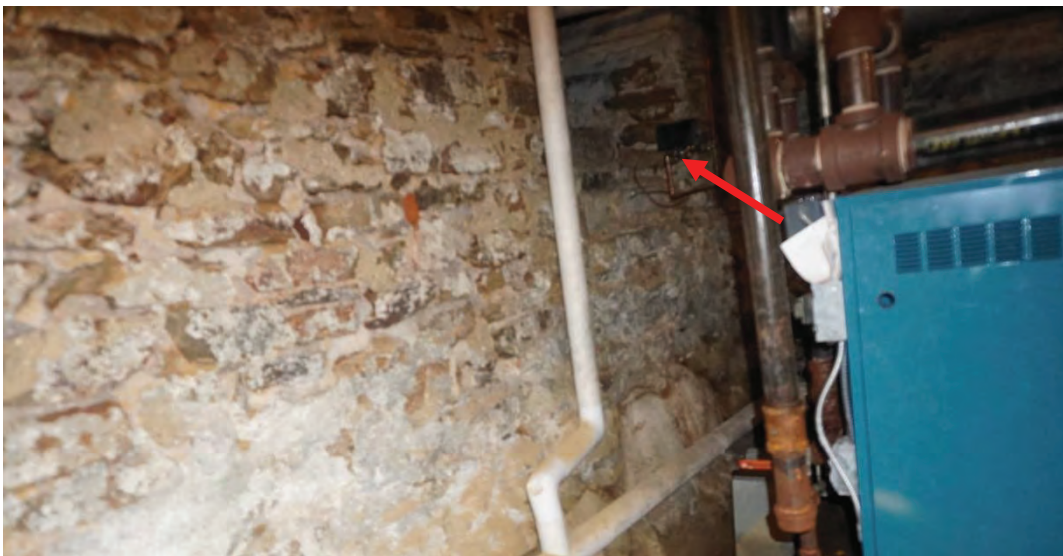
Photo #54: Piping was run into crawlspace through what potentially was an old window in original foundation wall.

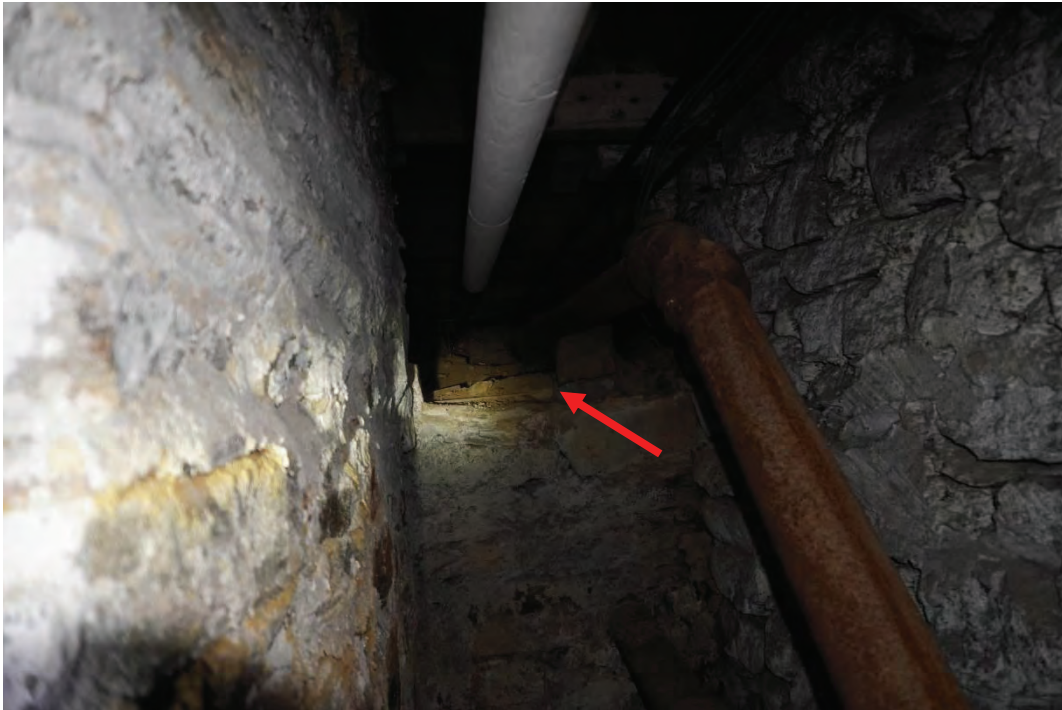
Photo #55: Piping was run into crawlspace through what potentially was an old window (second location) in original foundation wall.

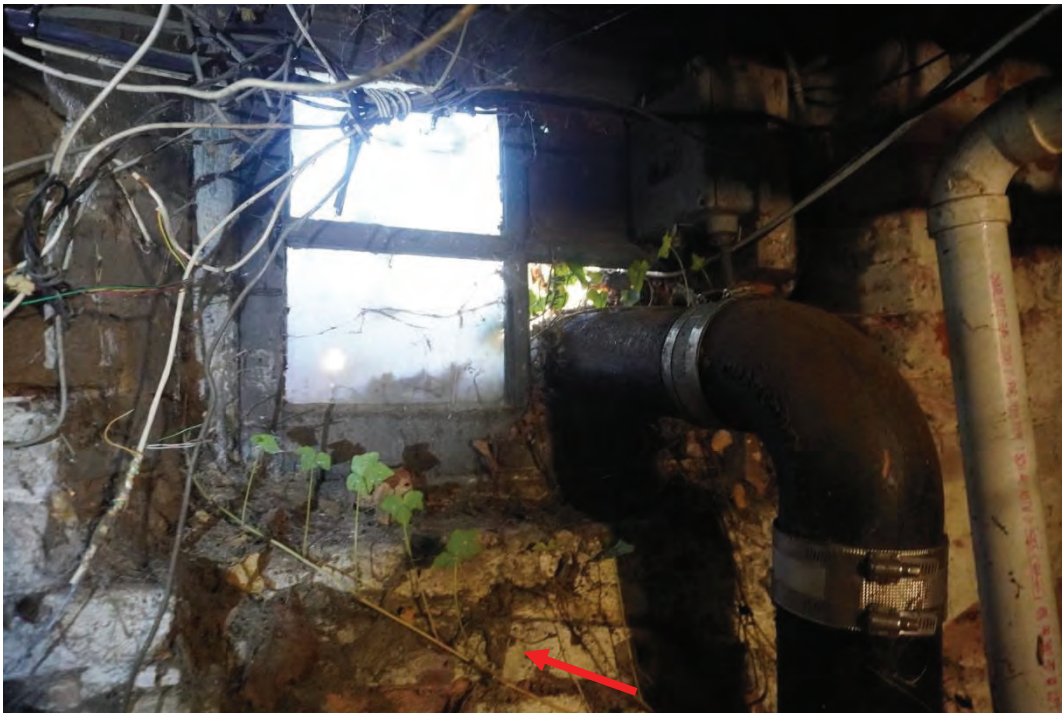
Photo #56: Dirt and soil infiltrating around window in cellar at west foundation wall.

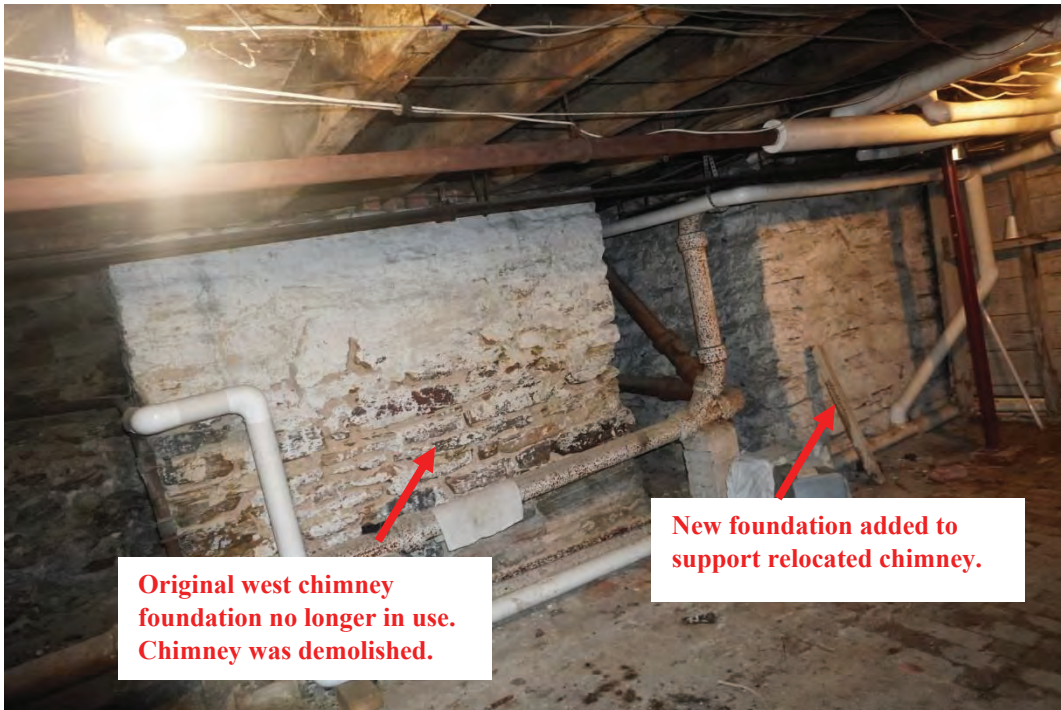
**Original west chimney
foundation no longer in use.
Chimney was demolished.**

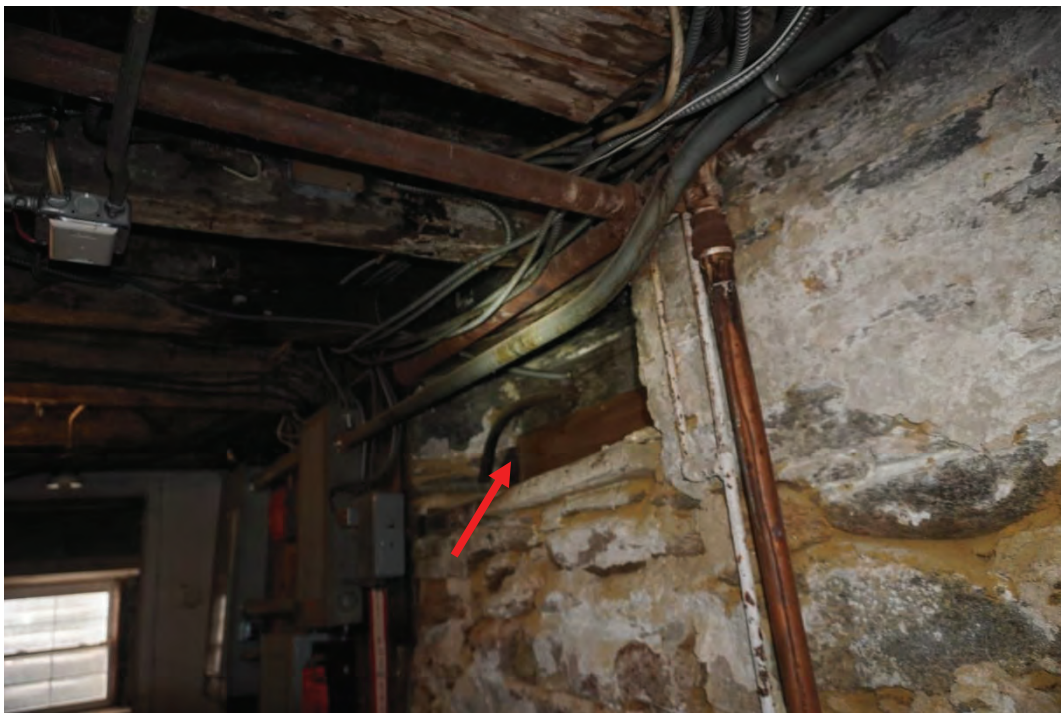
Photo #58: Cellar window at boiler room south foundation wall has been covered up when porch was added to the rear of the home.

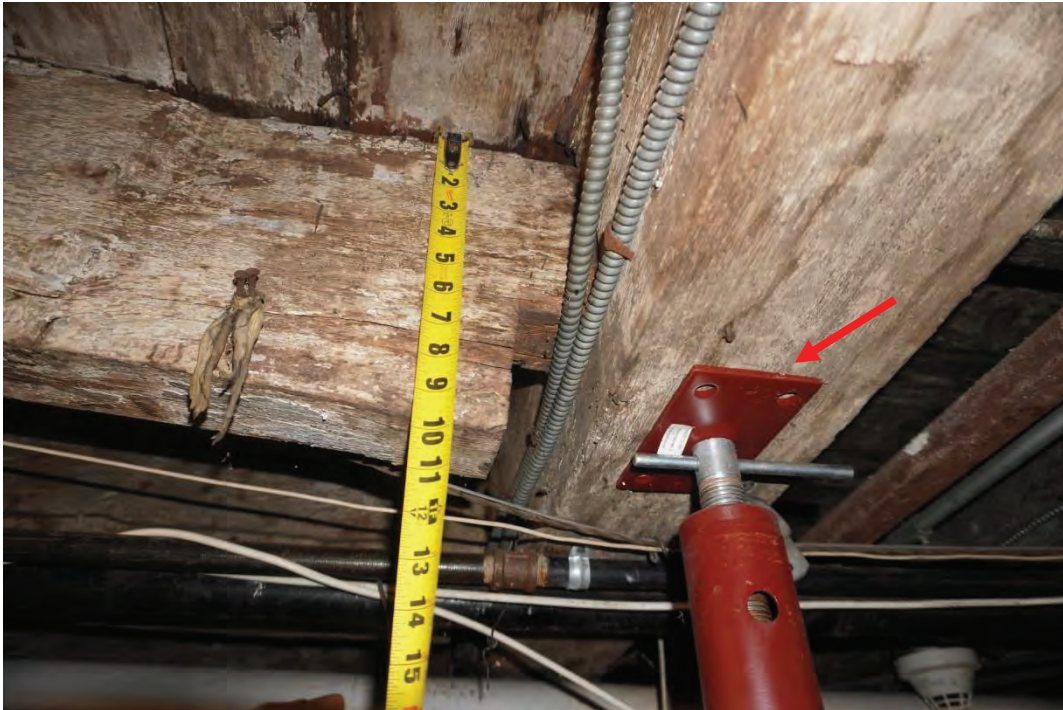
Photo #59: Temporary support column being used to hold failing 9-1/2"x9-1/4" girder in boiler room. Column not mechanically attached to girder above and does not have a proper footing.

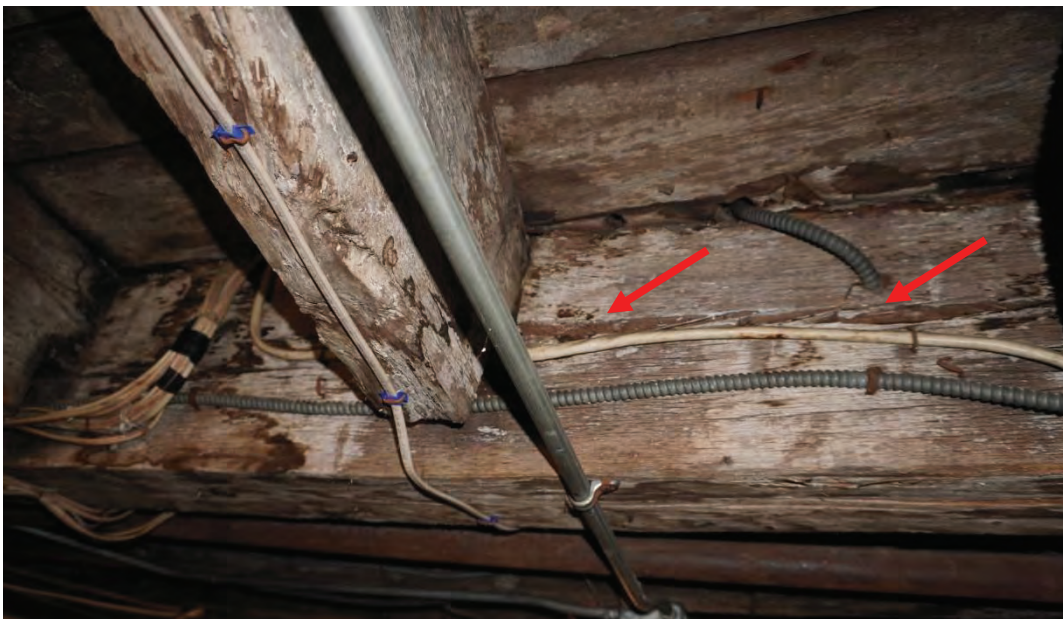
Photo #60: Large horizontal crack in 9-1/2"x9-1/4" girder in boiler radiating from mortise-and-tenon joint connections.

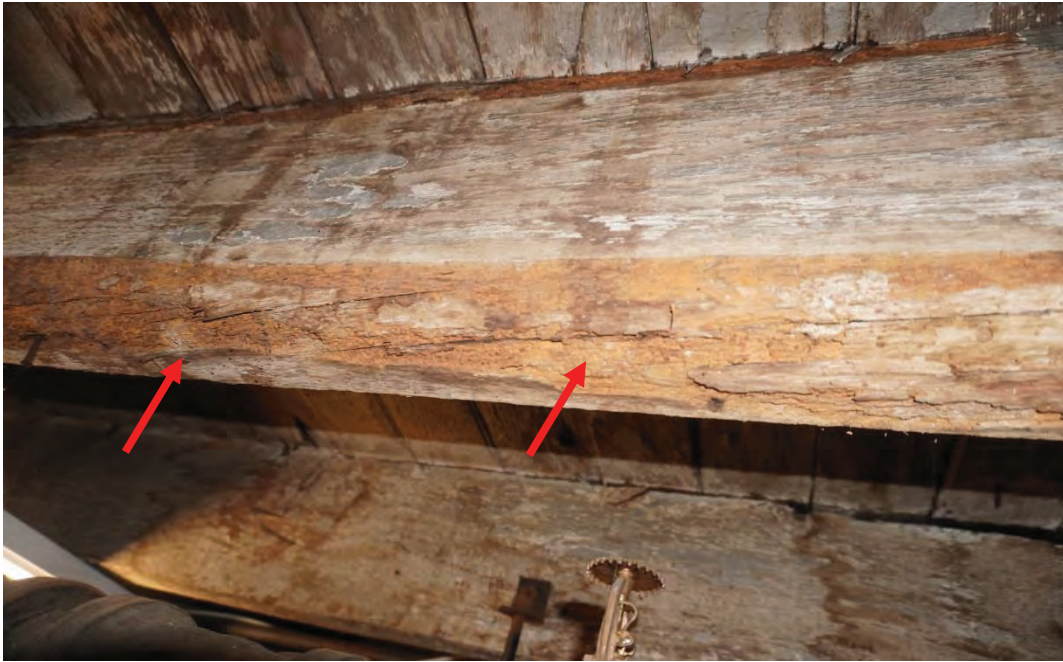
Photo #61: Wood joist observed to have a large extent of termite damage.

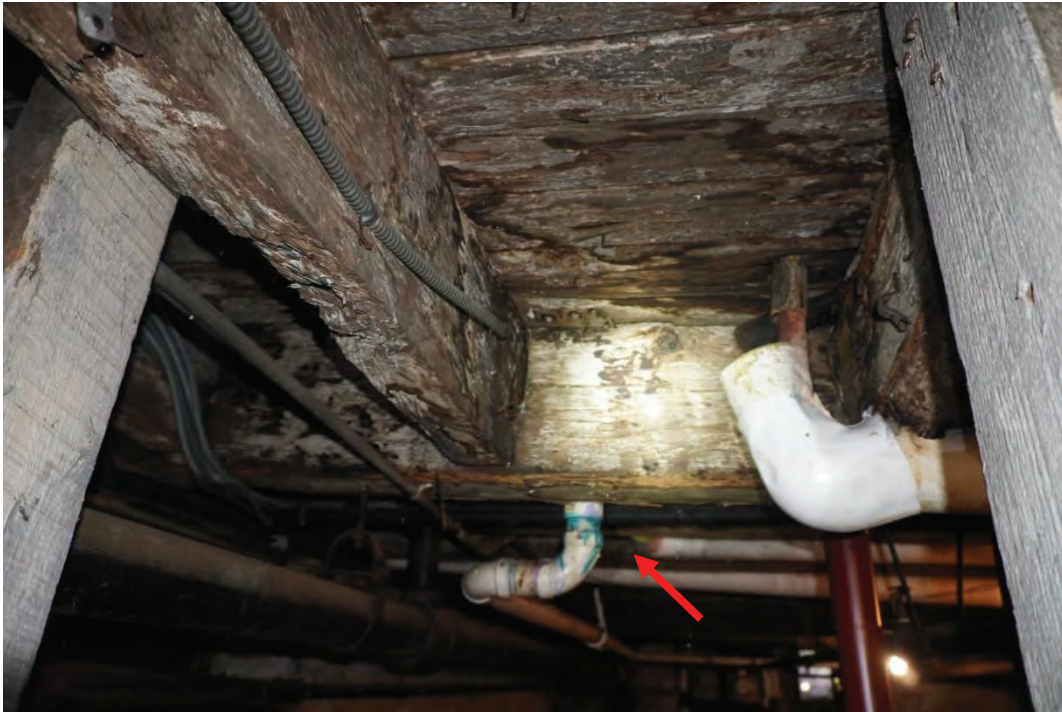
Photo #63: Plumbing pipe drilled directly through main girder in the vertical direction, west end of cellar.

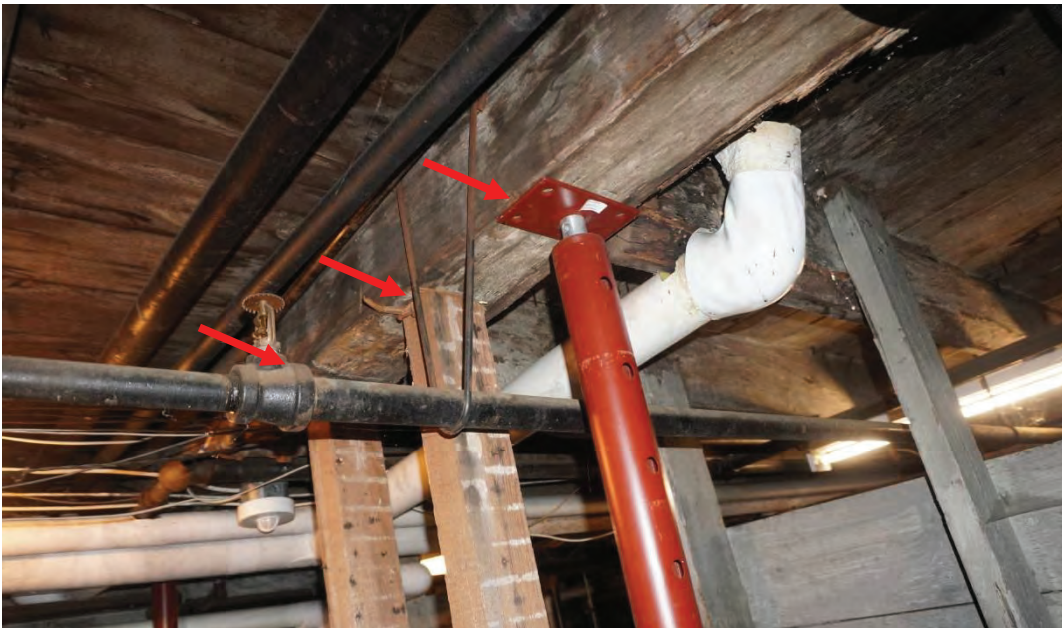
Photo #64: Temporary support columns being used to hold failing 6-3/4"x10-1/2" girder in place west end of cellar. Columns are not mechanically attached to girder above and do not have proper footings.
