March 15, 2023

Via FedEx & Email (mmccann@tuckahoe-ny.com)

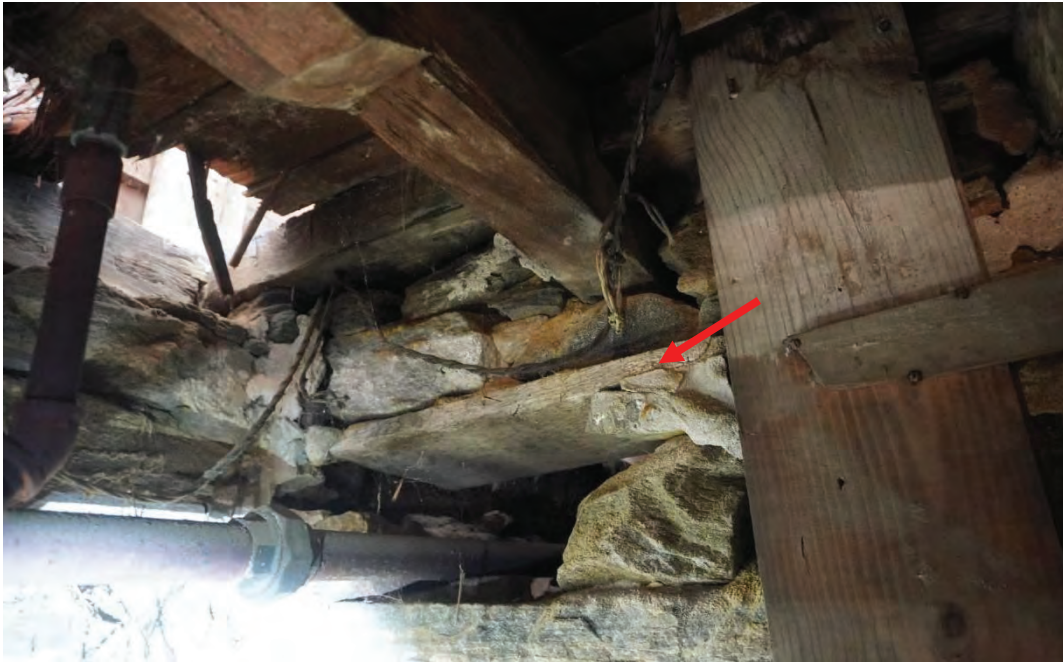
Photo #65: Joist with inadequate support resting on foundation wall that is deteriorated and that has been damaged to make a pipe penetration into crawlspace.

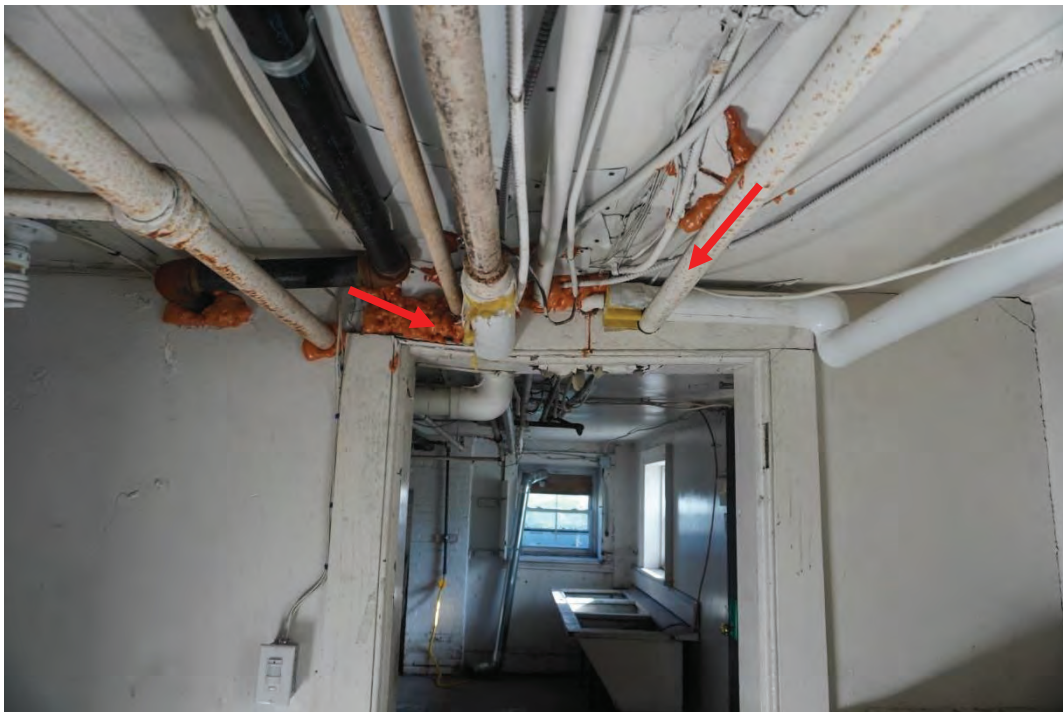
Photo #66: Multiple penetrations have been made through a door header that is observed to be failing. There is a wall on the first-floor level directly above this header.

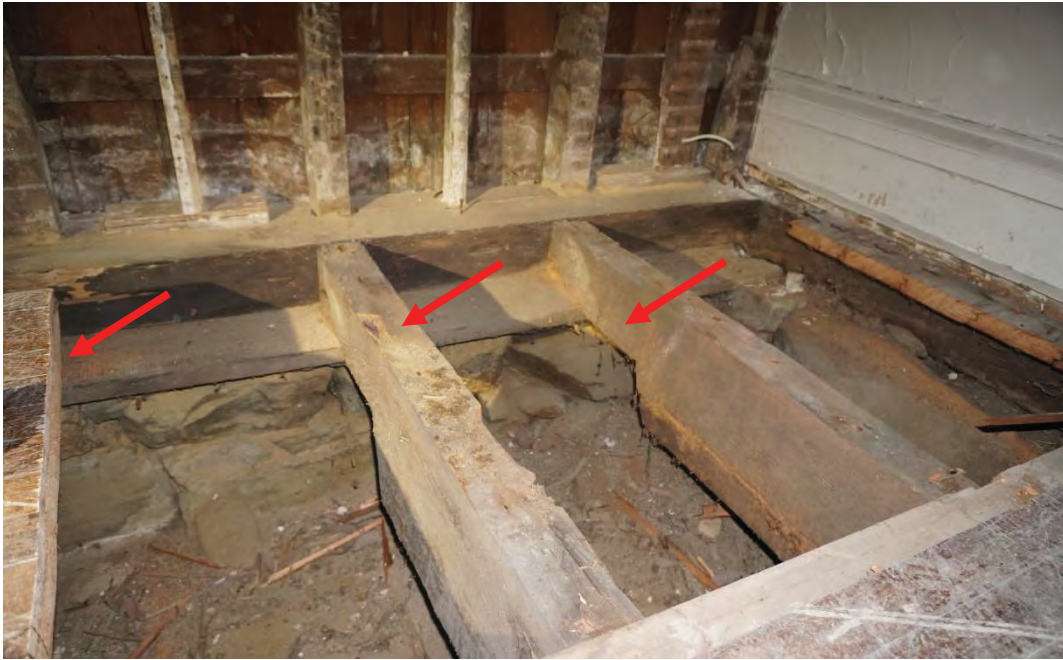
Photo #67: Joists spanning crawlspace sit on a thin sill plate which is not a standard timber framing technique. Typically, wood joists would be notched into the sill beam with use of a mortise and tenon connections (Probe #1).

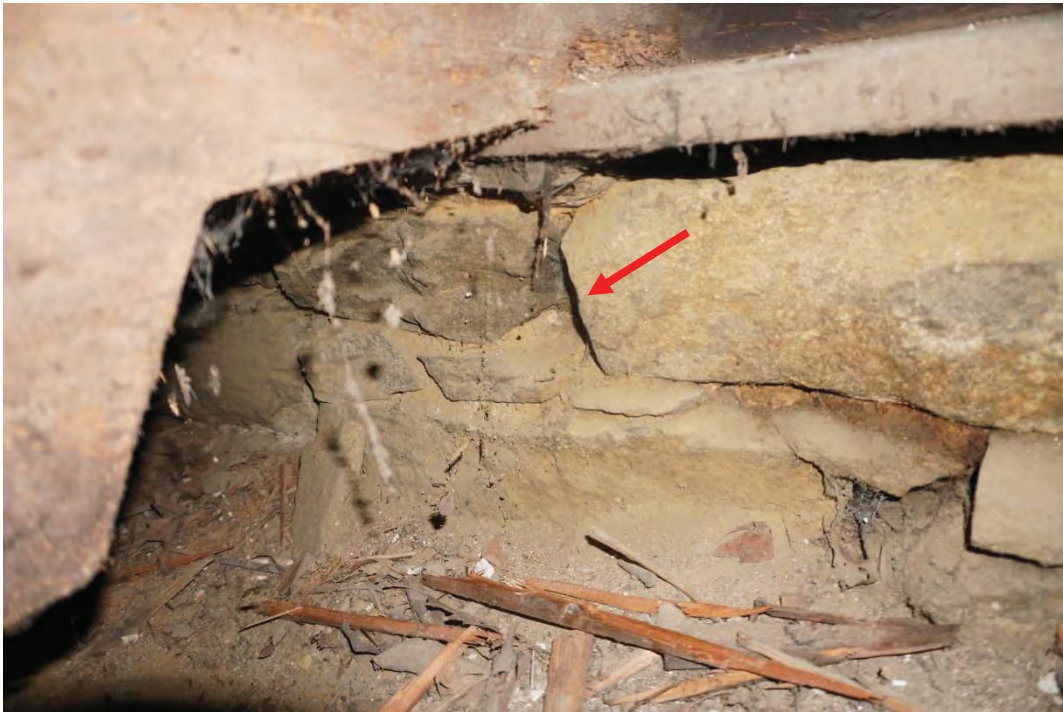
Photo #68: Thin sill plate, joists spanning crawlspace are sitting on, is being supported by a rubble stone foundation wall that is coming apart (Probe #1).

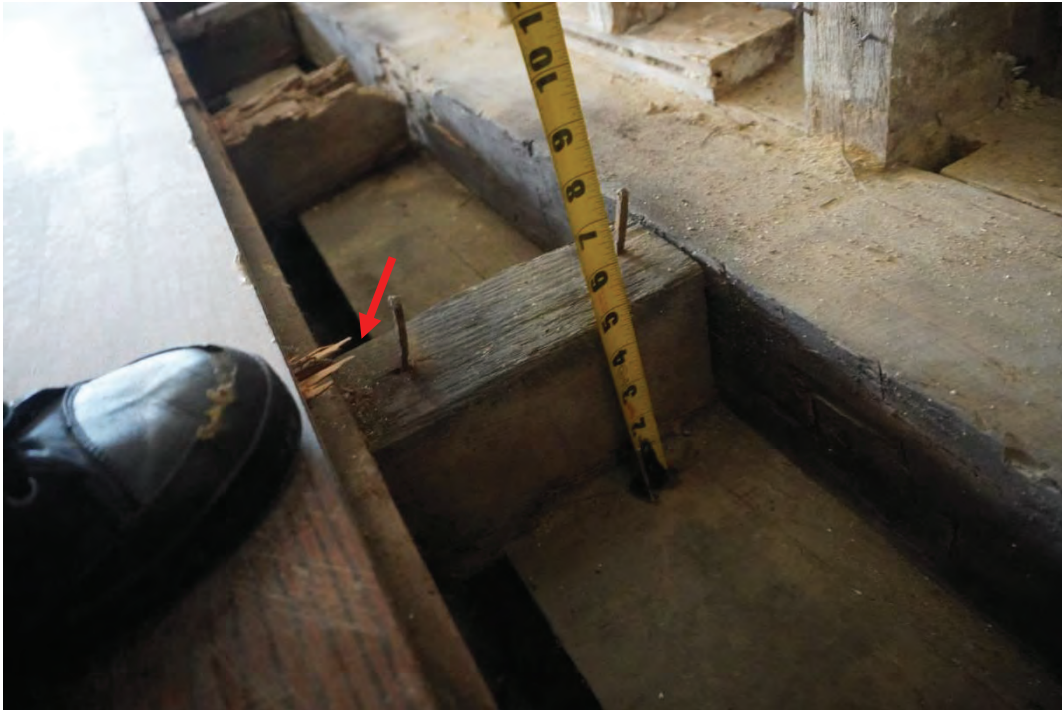
Photo #69: Original floorboards above crawlspace have been removed. New wood flooring directly attached to joists. Crawl space joists sitting on an improperly supported sill plate.

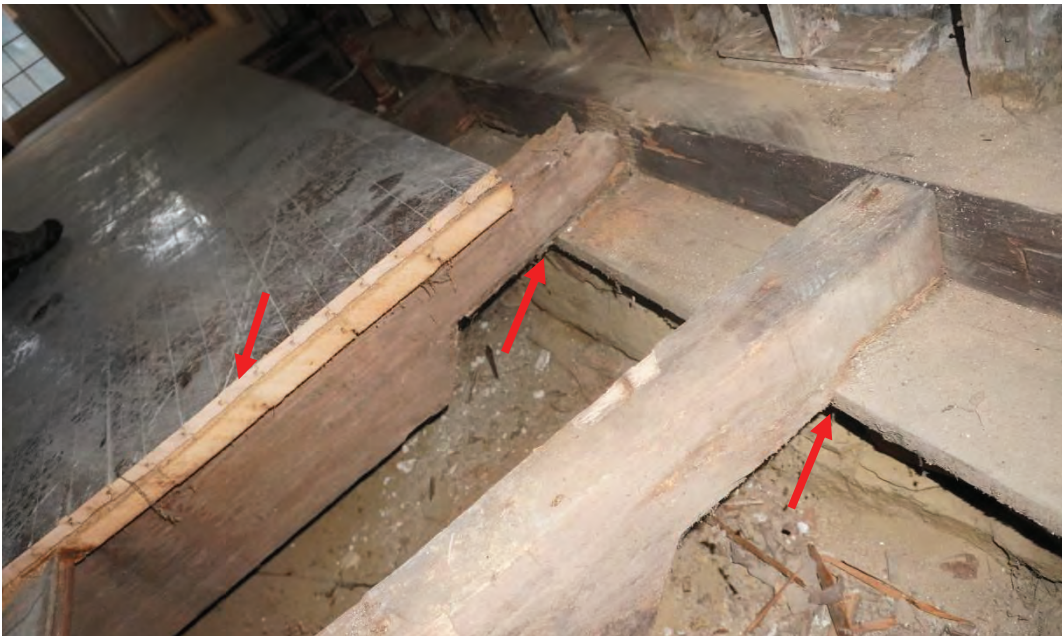
Photo #70: Original floorboards above crawlspace have been removed. New wood flooring directly attached to joists. Crawl space joists sitting on an improperly supported sill plate (Probe#1).

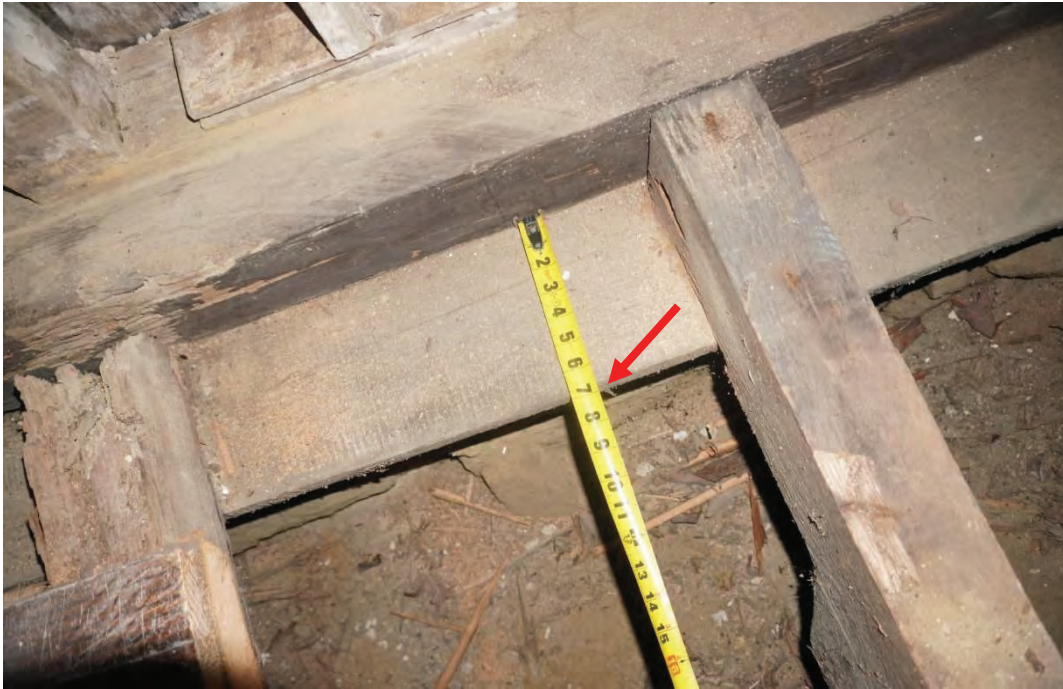
Photo #71: Crawl space joists sit on a 7-inch sill plate that is only bearing 3 inches onto deteriorating foundation wall below. Sill plate has a four-inch unsupported overhang (Probe #1).

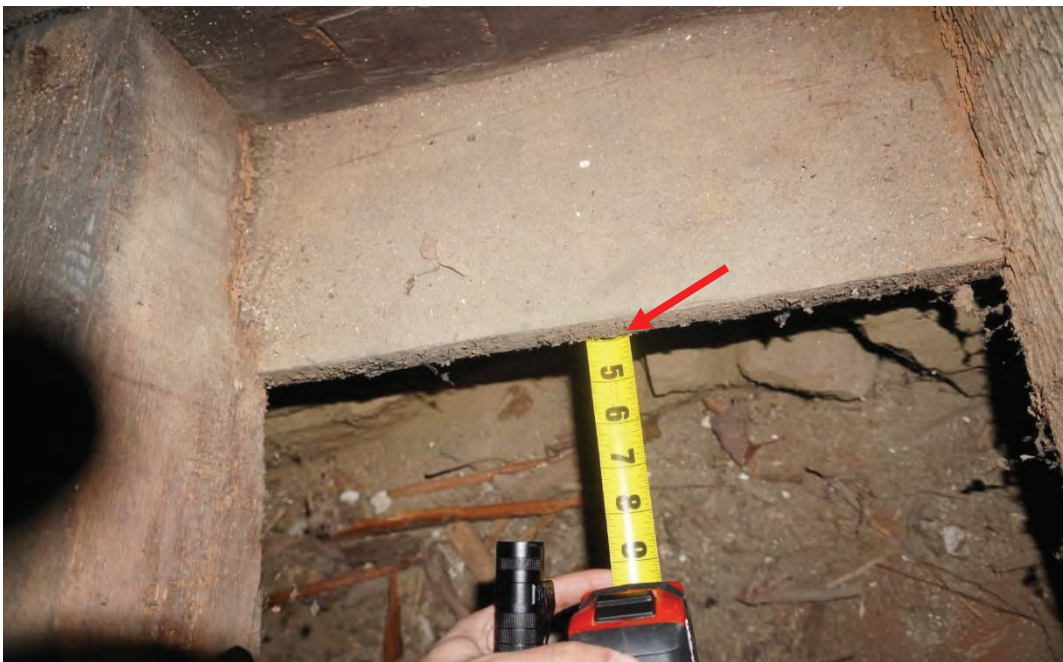
Photo #72: Crawl space joists sit on a 7-inch sill plate that is only bearing 3 inches onto deteriorating foundation wall below. Sill plate has a four-inch unsupported overhang (Probe #1).

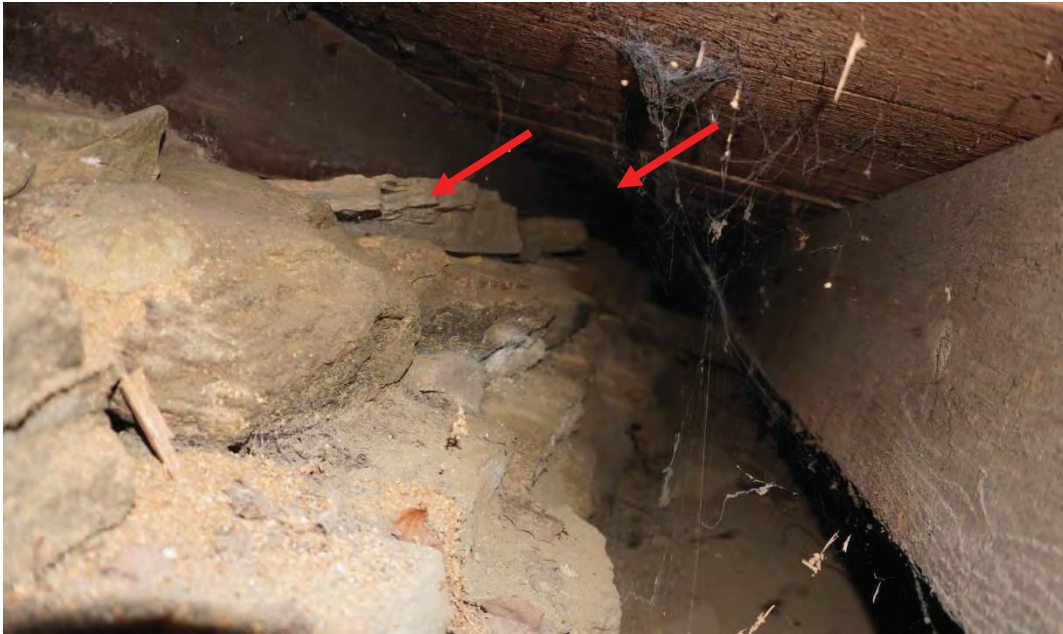
Photo #73: Exterior foundation along north side of home below sill beam is deteriorating and observed to have displaced. (Probe #1)

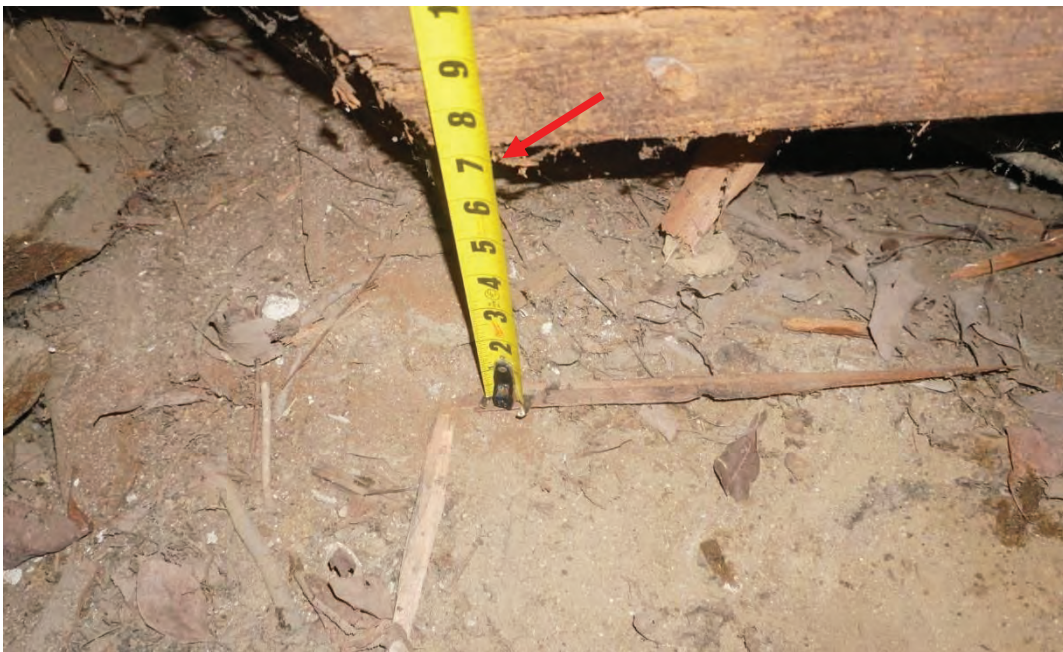
Photo #74: Wood joists in crawlspace are sitting 7 inches above exposed dirt beneath crawlspace. Crawlspace is inaccessible. Crawlspace foundation most likely does not extend below the frost line (Probe #1). Further investigation required.

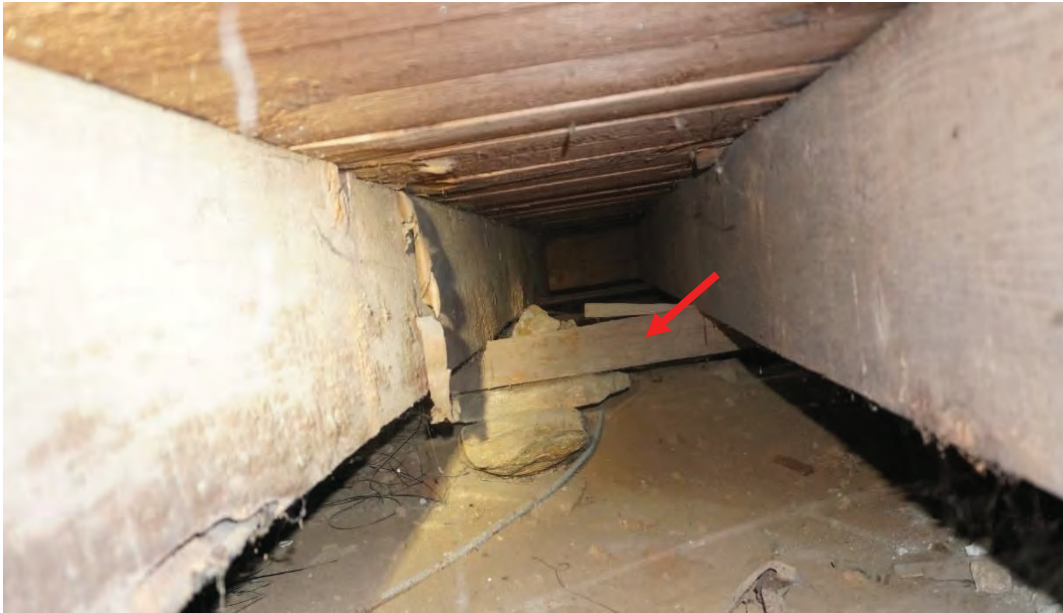
Photo #75: Wood joists spanning crawl space are being inadequately supported at midspans by wood members that are balanced above unstable pieces of stone (Probe #1).

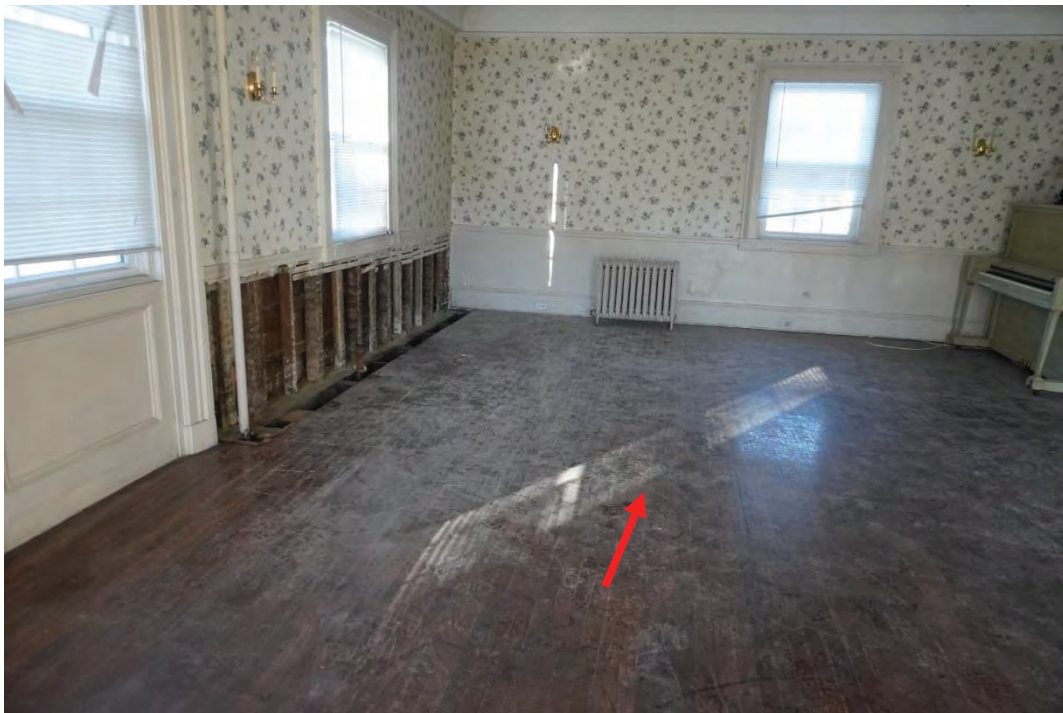
Photo #76: Location of west chimney that was relocated at some point in the past. Foundation still in place and can be observed in cellar below.

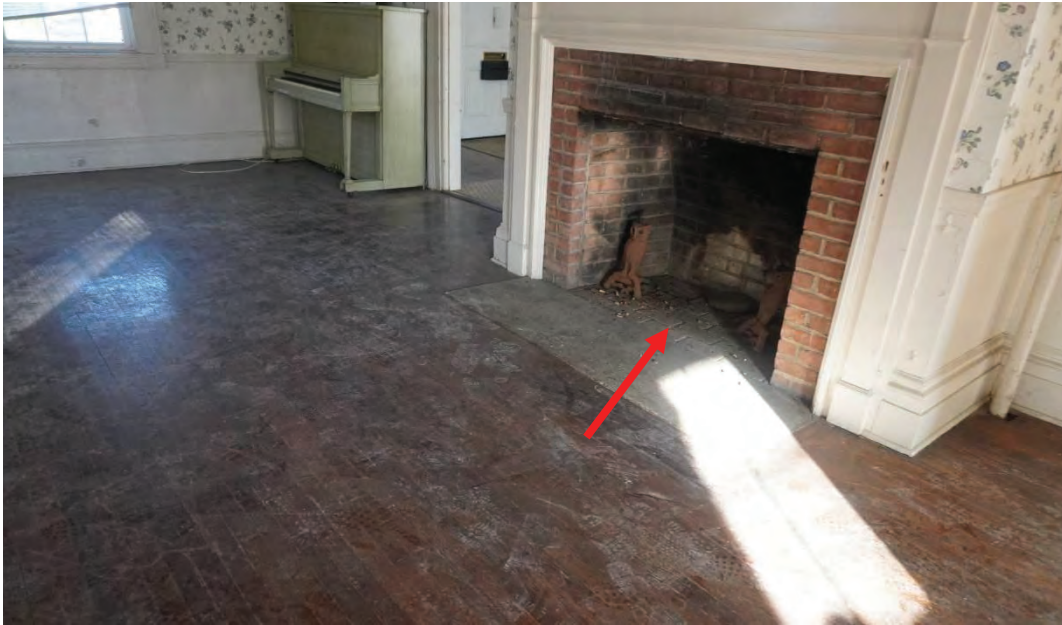
Photo #77: Chimney was added to this location at some unknown point in the past. Presumably when the original west chimney was demoed.
