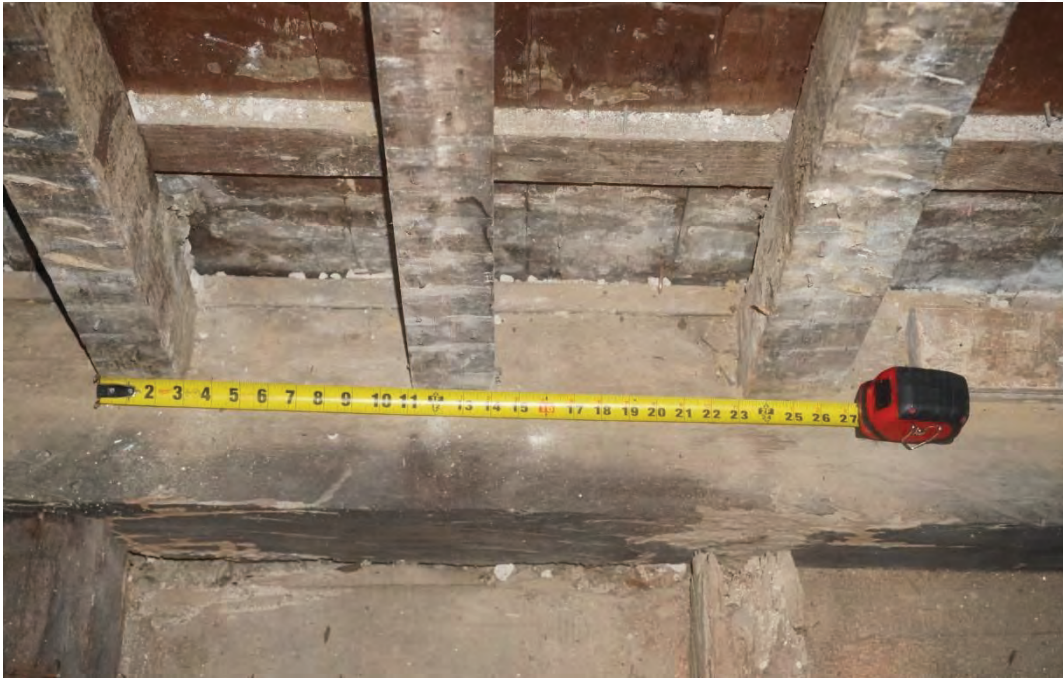
Photo #79: Vertical exterior framing members spaced at approximately 10 to 11 inches apart along west façade sitting on sill beam (Probe #1).

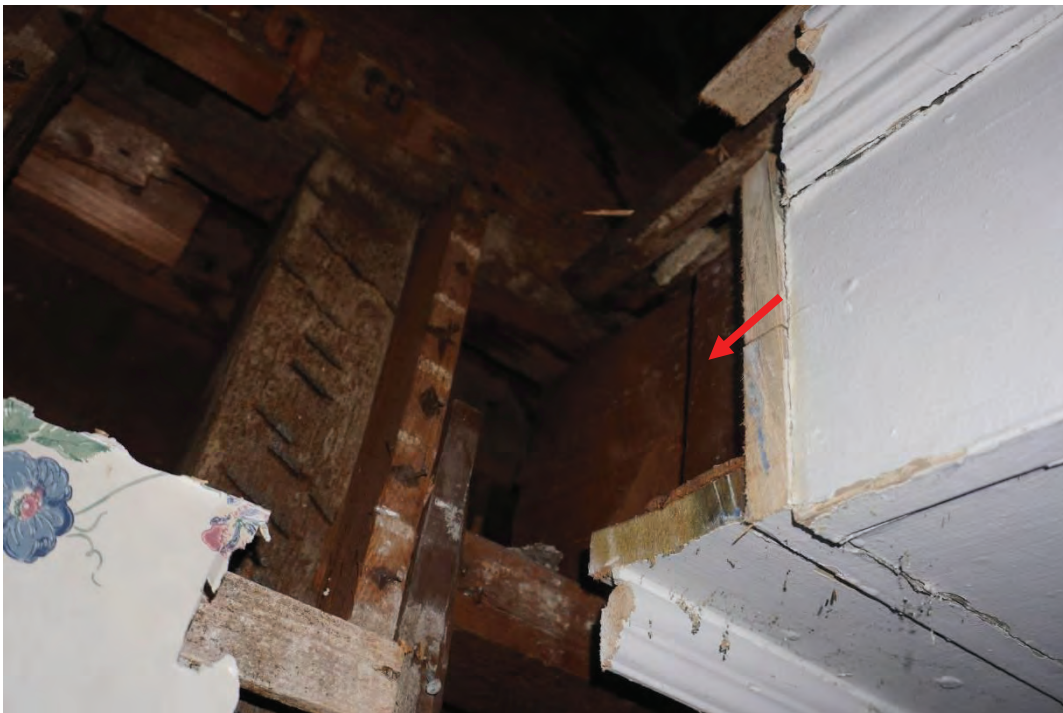
Photo #80: Large beam observed in ceiling soffit spanning east to west. Beam is acting as a midspan support for floor joists above that span north to south (Probe #2).

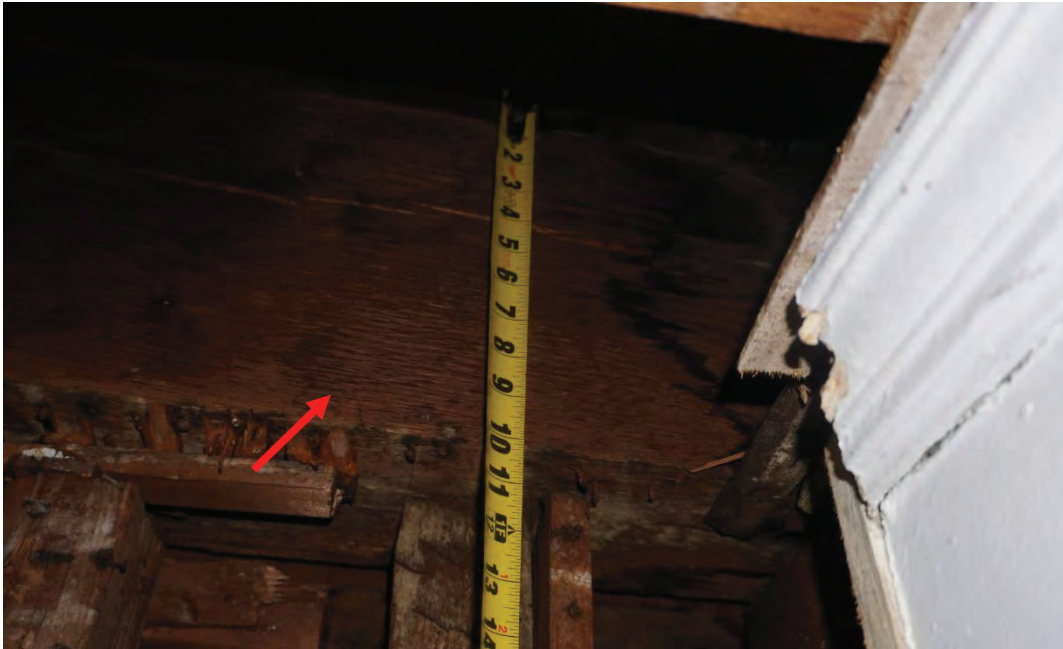
Photo #81: 10x7 Exterior spandrel beam running north to south 1st floor ceiling level along west exterior wall. (Probe #2)

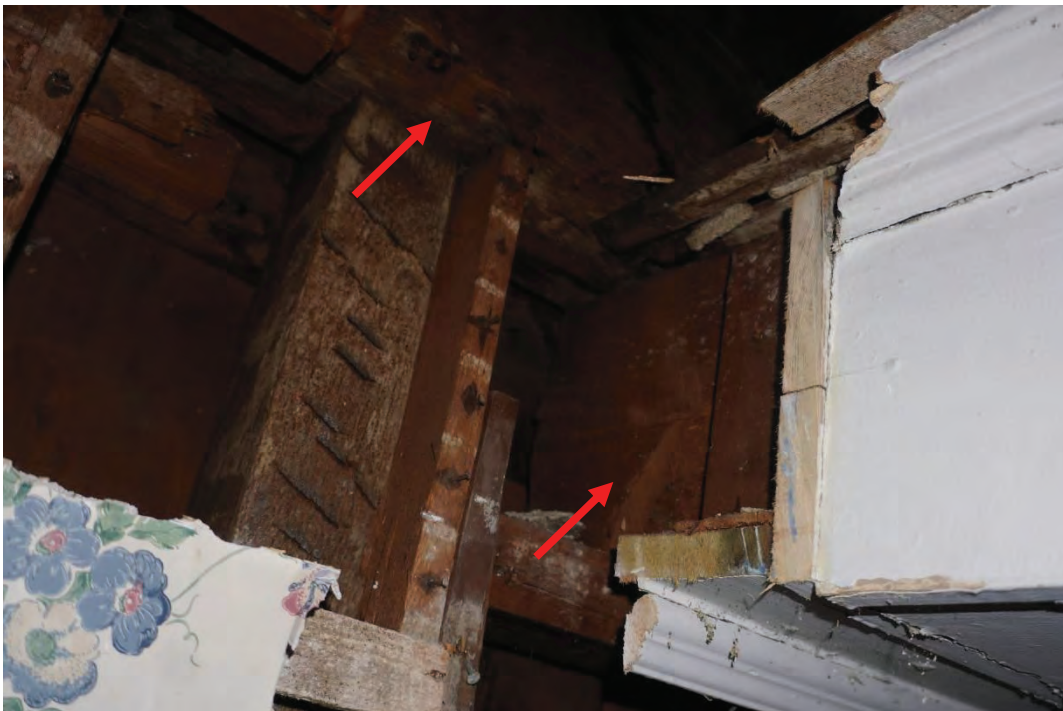
Photo #82: Ceiling soffit contains a support beam that runs east to west below the spandrel beam. Beam running east to west supports joists above at midspan. This is an atypical configuration that was most likely a modification and not part of the original timber framing design (Probe #2).

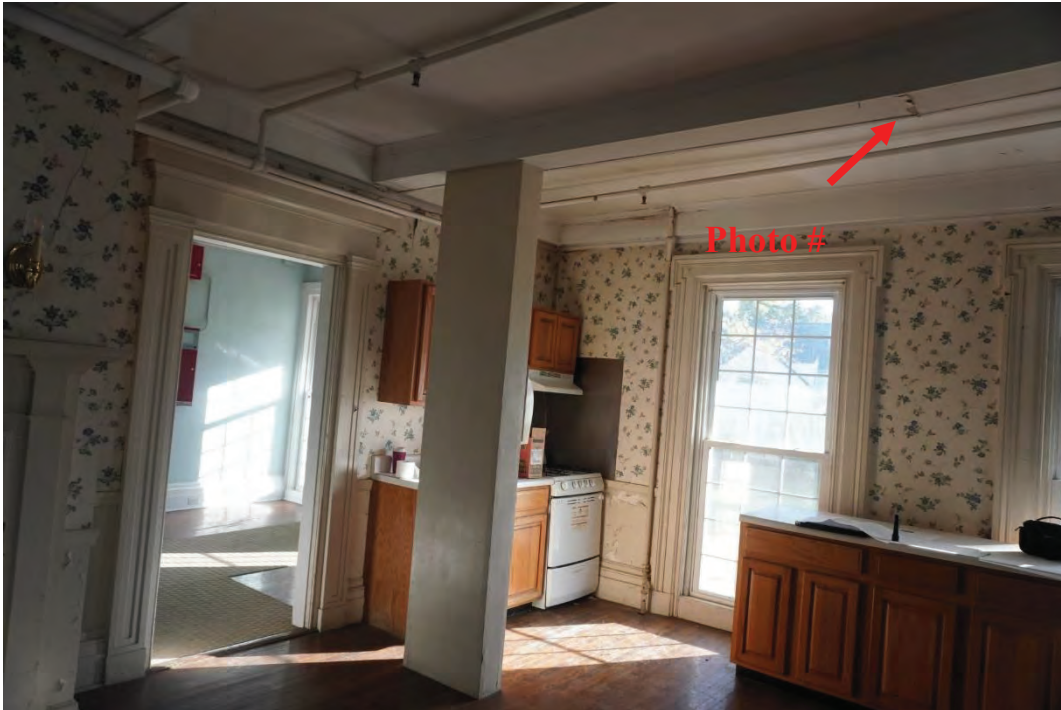
Photo #83: Soffit was opened up to further investigate crack. When soffit at this location was opened up it was empty inside and apparently was just there for aesthetic purposes (Probe #3).

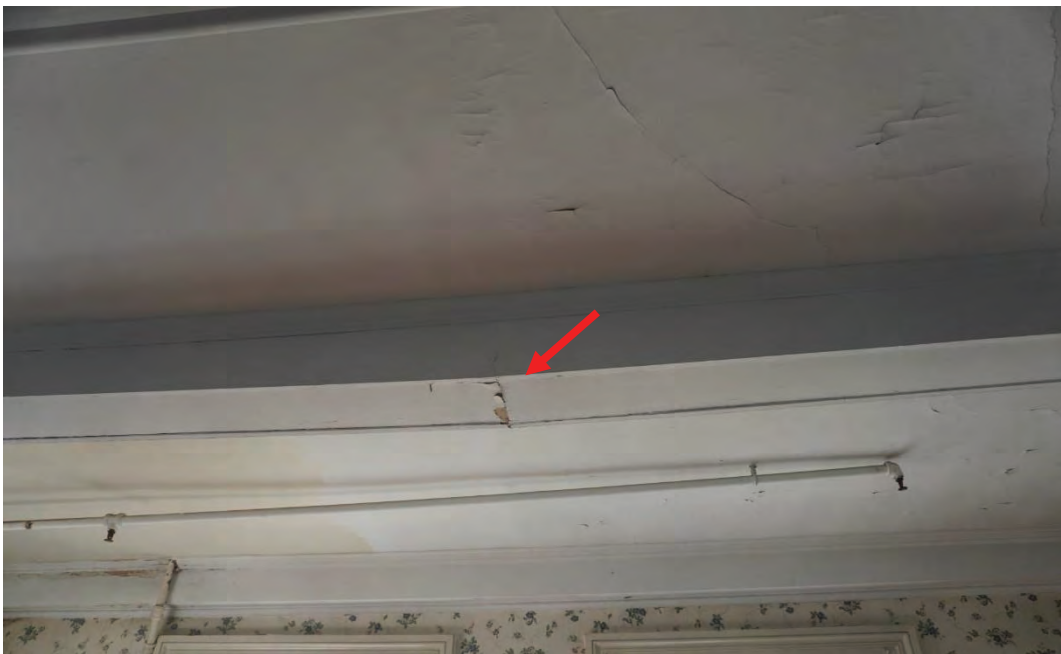
Photo #84: Soffit was opened up to further investigate crack. When soffit at this location was opened up it was empty inside and was just apparently there for aesthetic purposes (Probe #3).

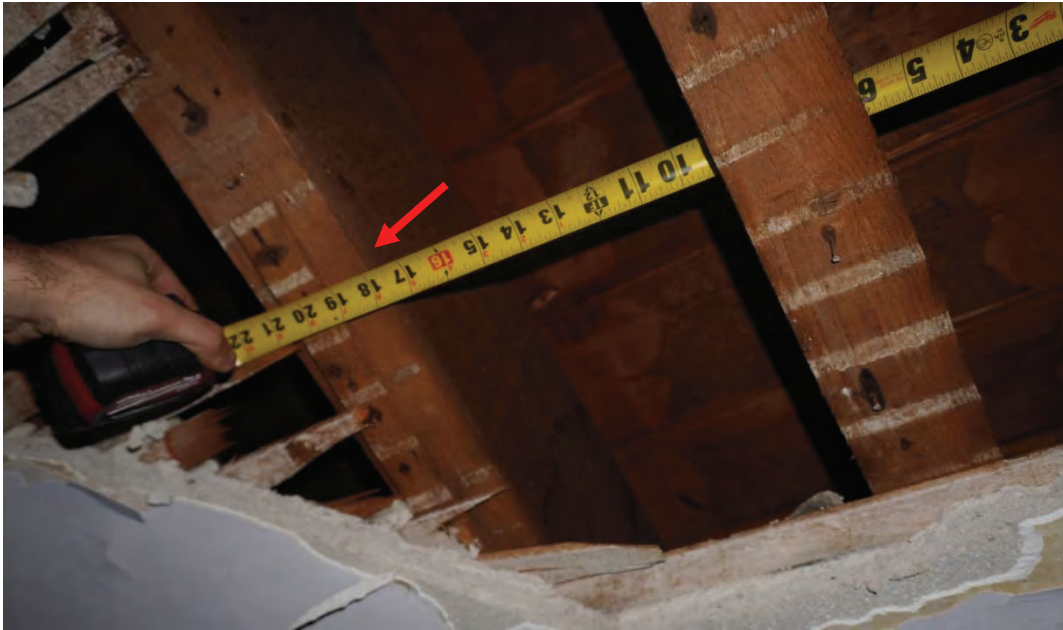
Photo #85: Joists above faux soffit are running north to south and are spaced at 18” inches apart. All other floor joists observed in the original structure above the ground level are running perpendicular to these joists (Probe #3). Further investigation required.

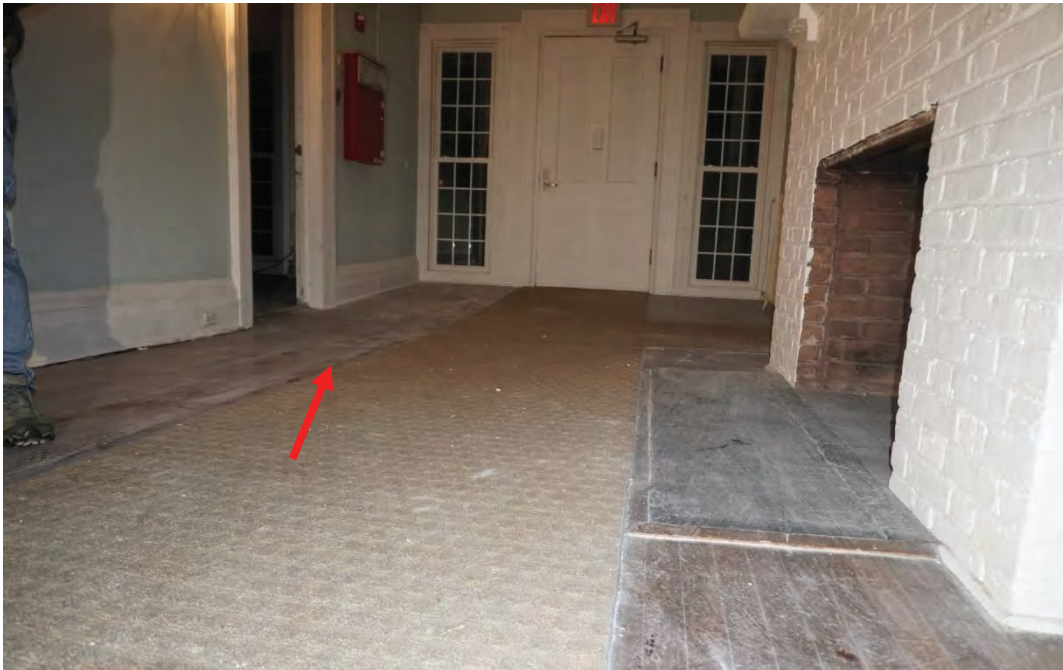
Photo #86: Large floor depression adjacent to load bearing wall 1st floor. This area is directly above girder that is failing in the boiler area and being propped up with temporary columns. Staircase to go up to the second floor was originally located somewhere in this room.

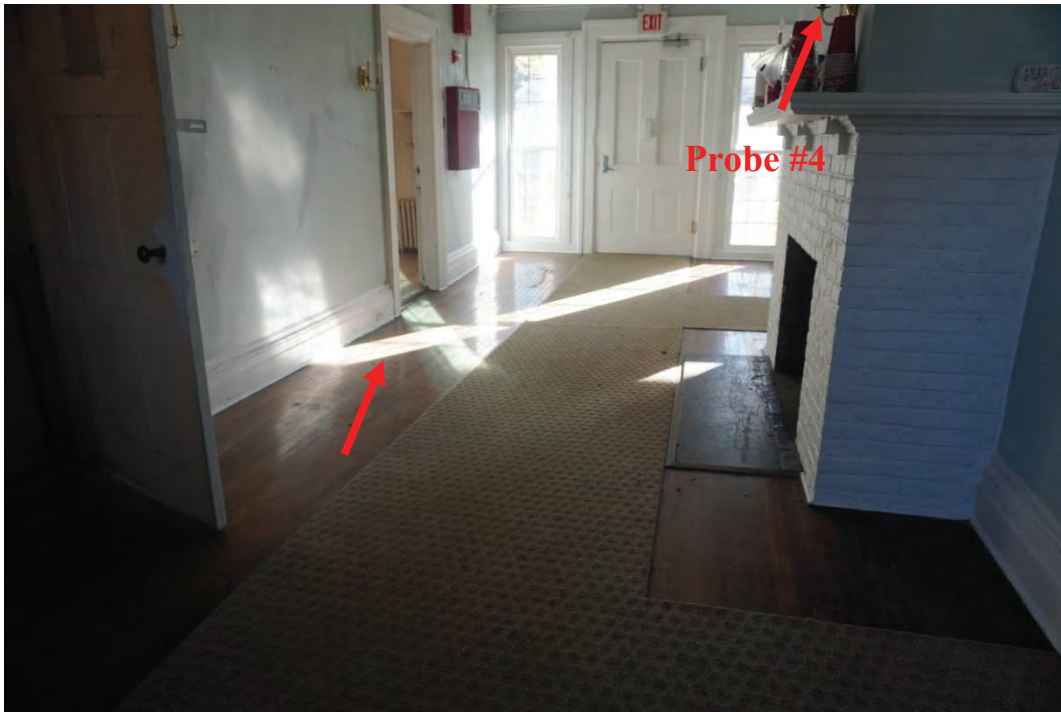
Photo #87: Large floor depression adjacent to load bearing wall 1st floor. This area is directly above girder that is failing in the boiler area and being propped up with temporary columns. Staircase to go up to the second floor was originally located somewhere in this room.

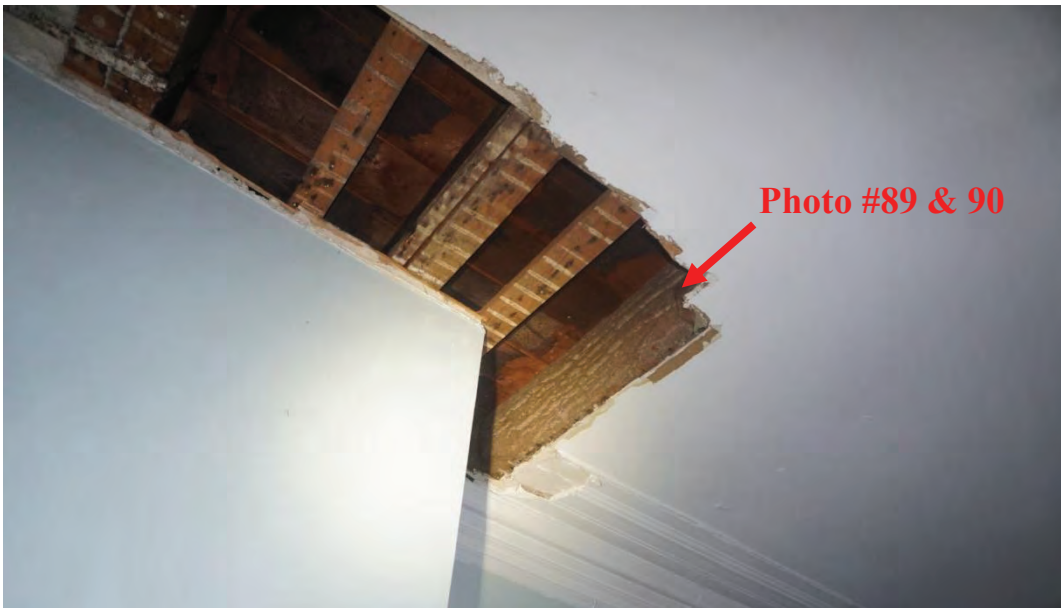
Photo #88: Ceiling joist that was never fully scored into a square framing member and still has bark exterior (Probe #4).

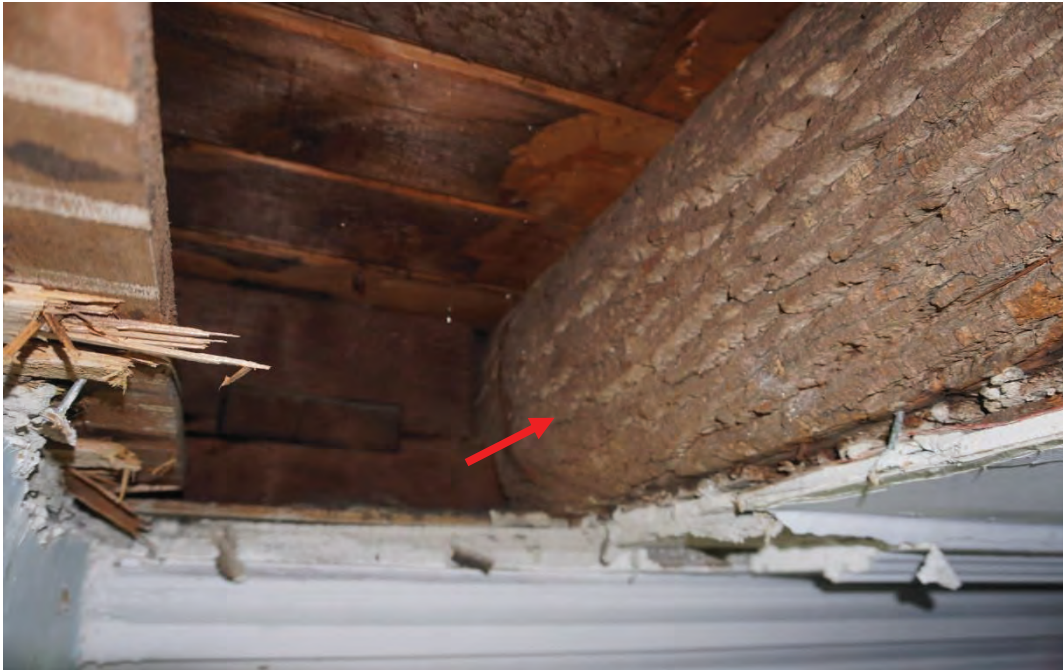
Photo #89: Ceiling joist that was never fully scored into a square framing member and still has bark exterior (Probe #4).

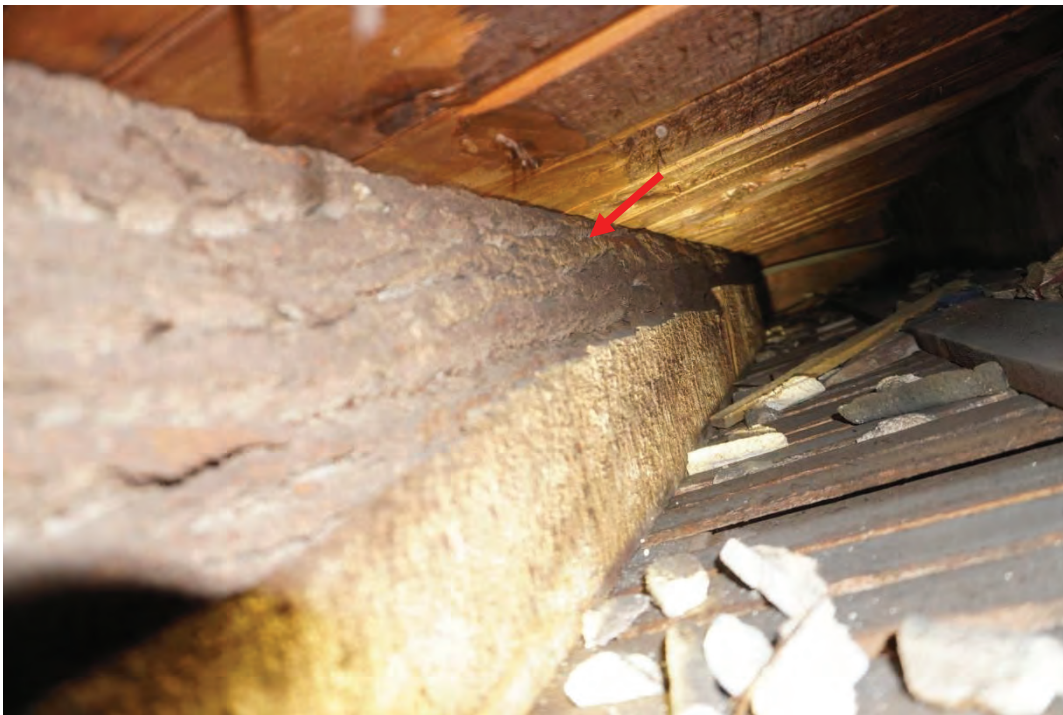
Photo #90: Ceiling joist that was never fully scored into a square framing member and still has bark exterior (Probe #4).

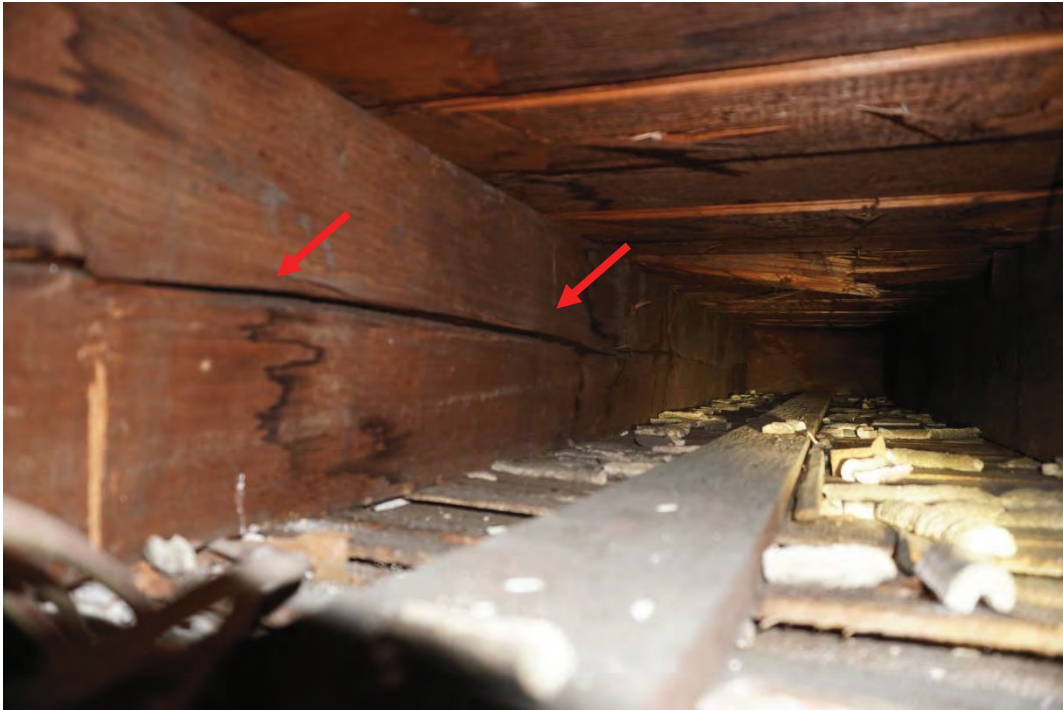
Photo #91: Large shrinkage crack that runs entire floor joist (Probe #4).

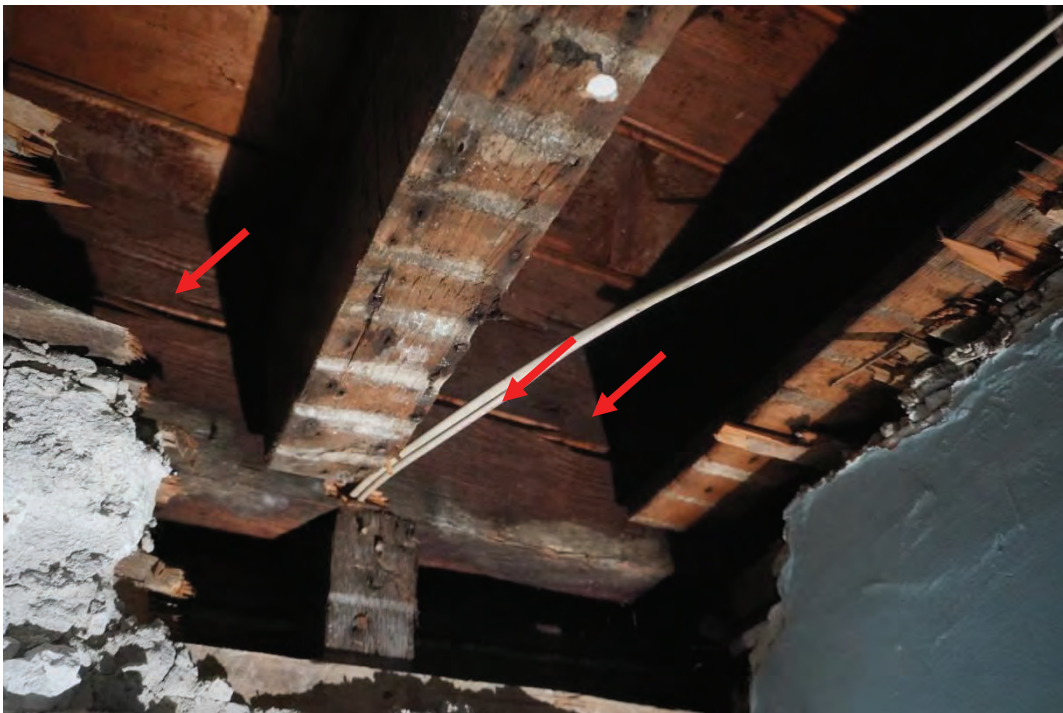
Photo #92: Interior girder running north to south is splitting along the mortise and tenon joint connections (Probe #4).

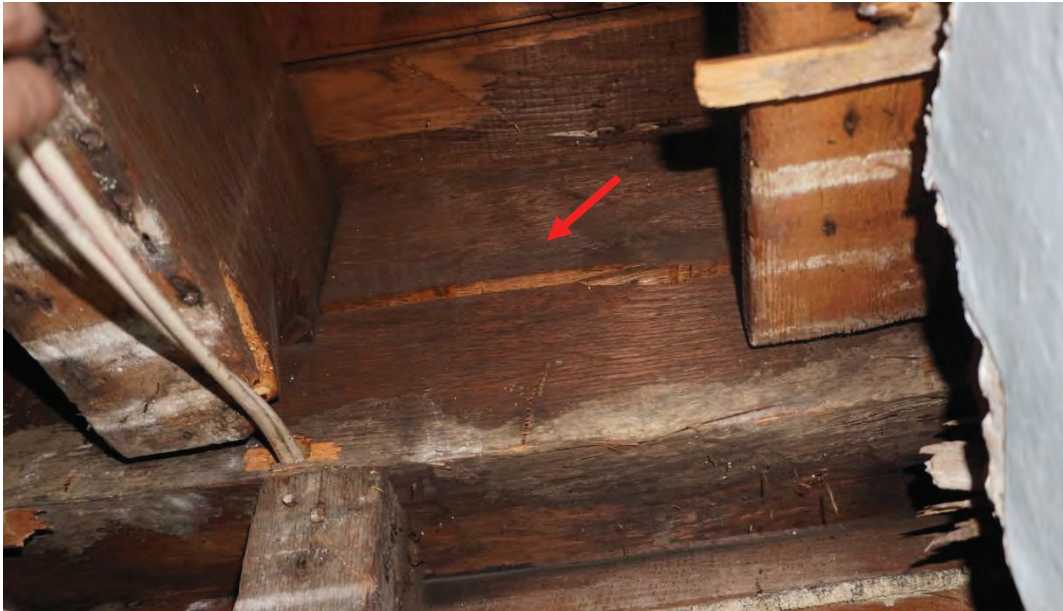
Photo #93: Interior girder running north to south is splitting along the mortise and tenon joint connections (Probe #4).

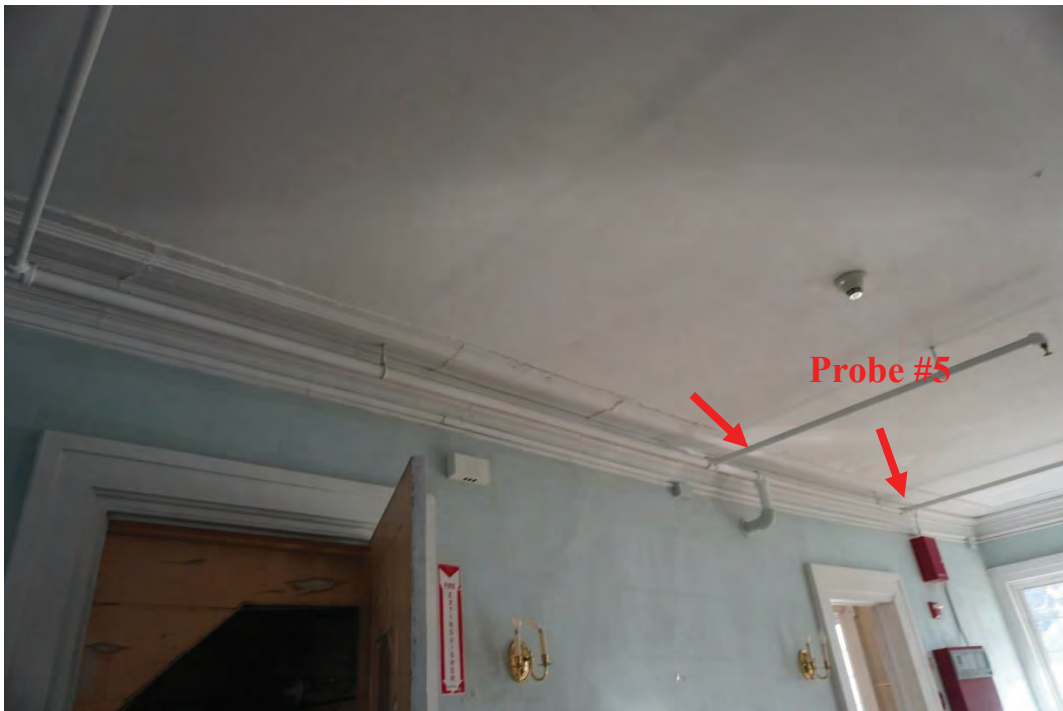
Photo #94: Wall containing girder beam showing signs of deflection. This girder is directly above girder that is failing in the boiler room area and is being propped up with temporary columns (Probe #5).

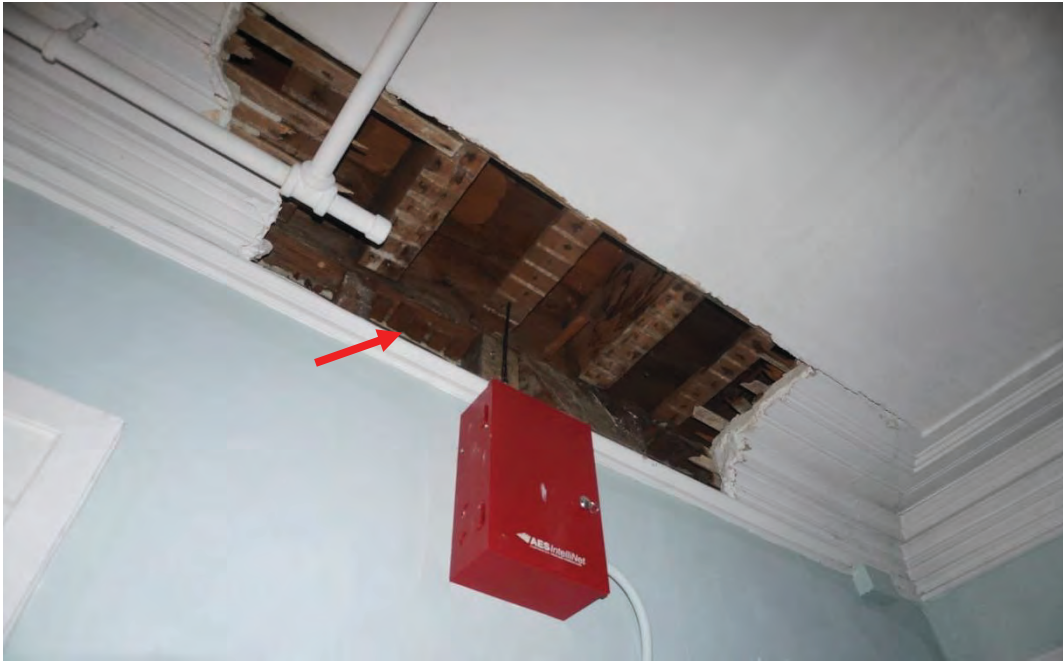
Photo #95: Interior girder that is showing signs of deflection. Girder is directly above girder that is failing in the boiler room area and is being propped up with temporary columns (Probe #5).

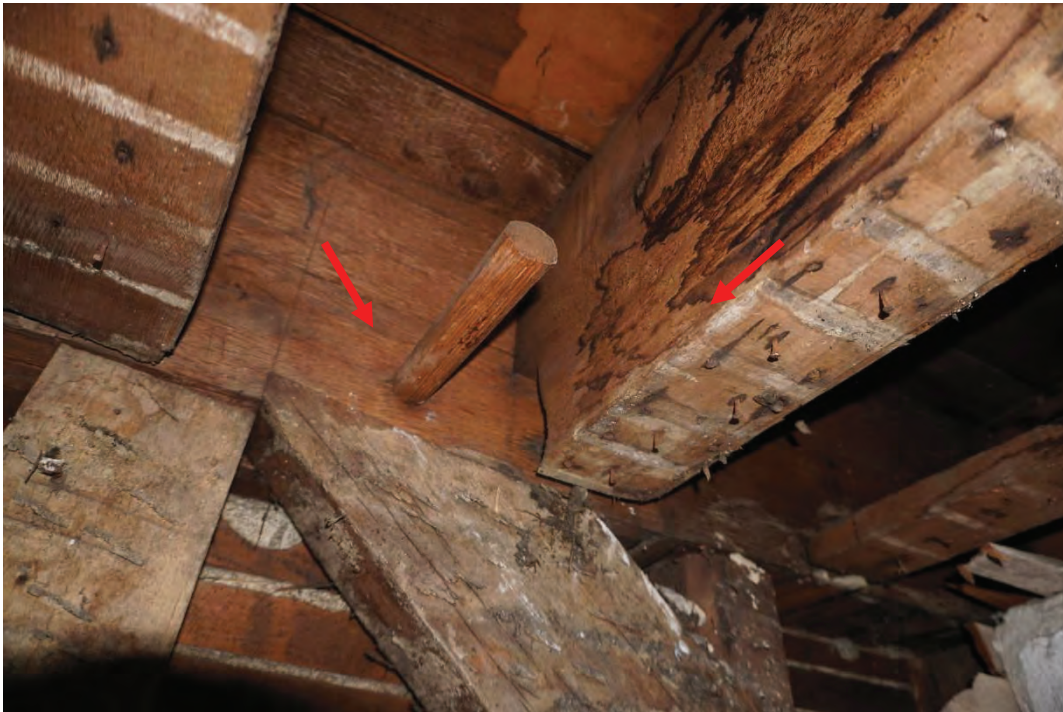
Photo #96: Mortise and tenon connection between a bracing member and interior girder being held in place with a wooden peg. (Probe #5)

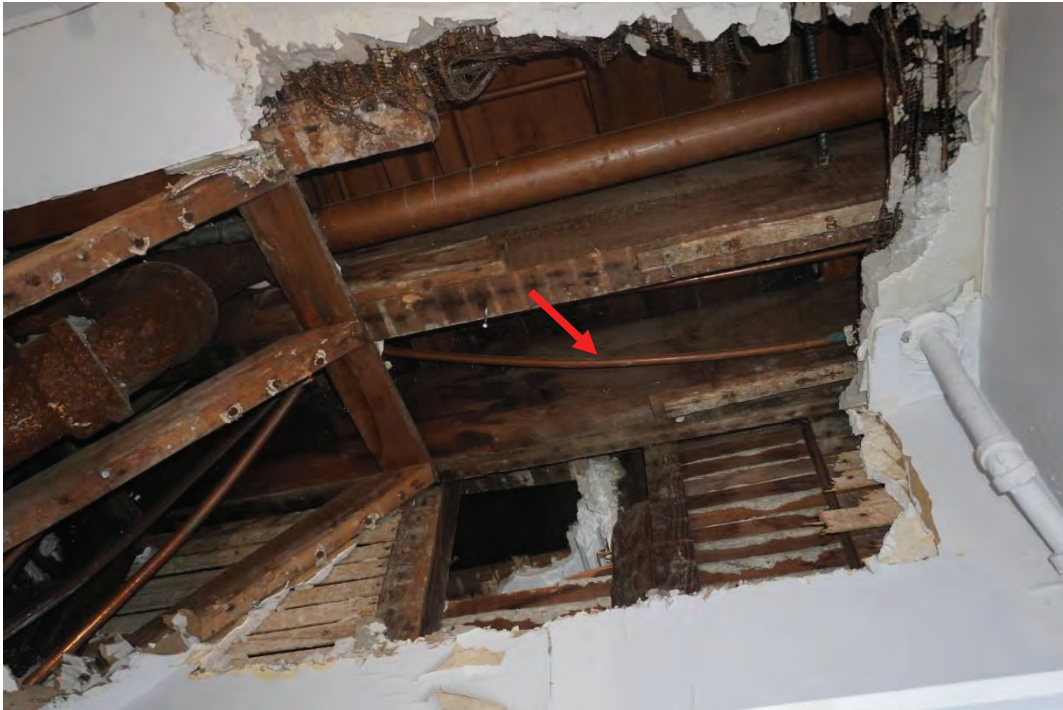
Photo #97: Girder beam that runs north to south in wall that use to be the exterior wall of the original structure (Probe #6).

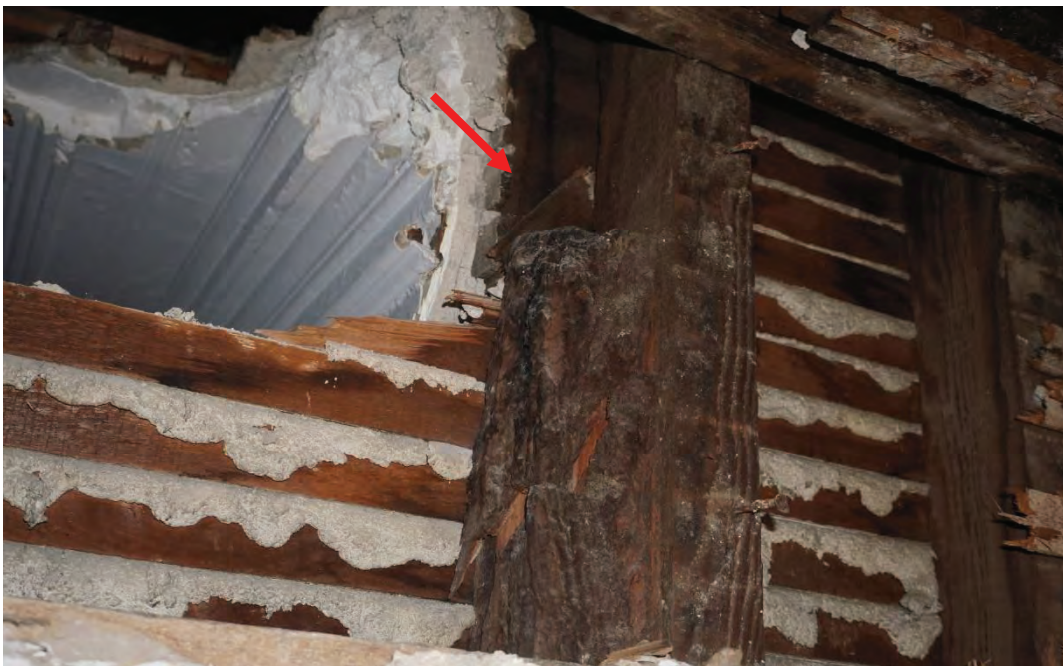
Photo #98: Old exterior wall vertical member that was never scored down into a square (Probe #6).

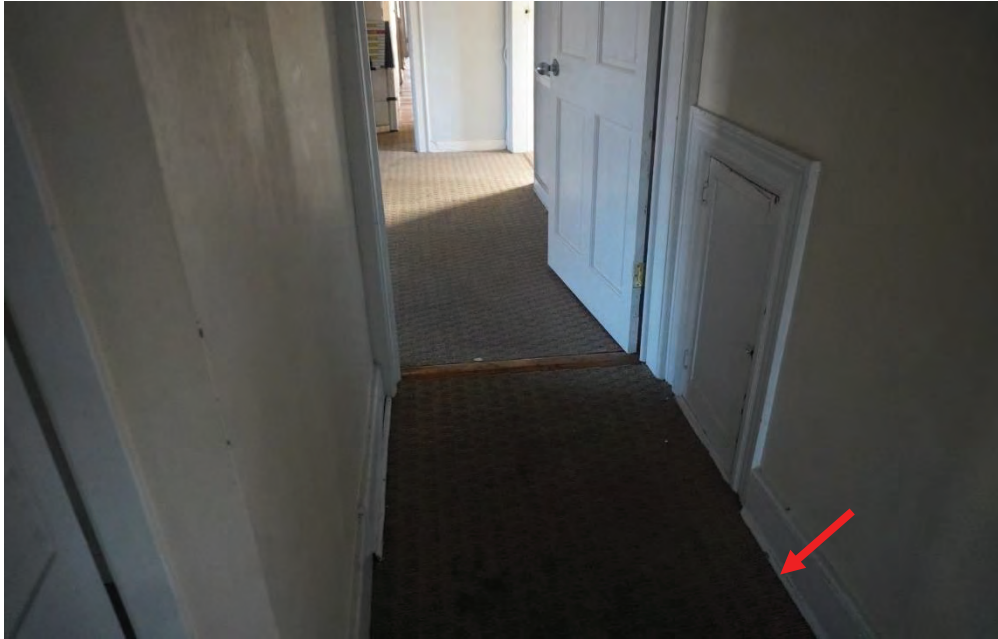
Photo #99: Depression in second floor hallway. Most likely due to weight of walls and bathroom added in this area. Further investigation would be required to figure out exact cause.

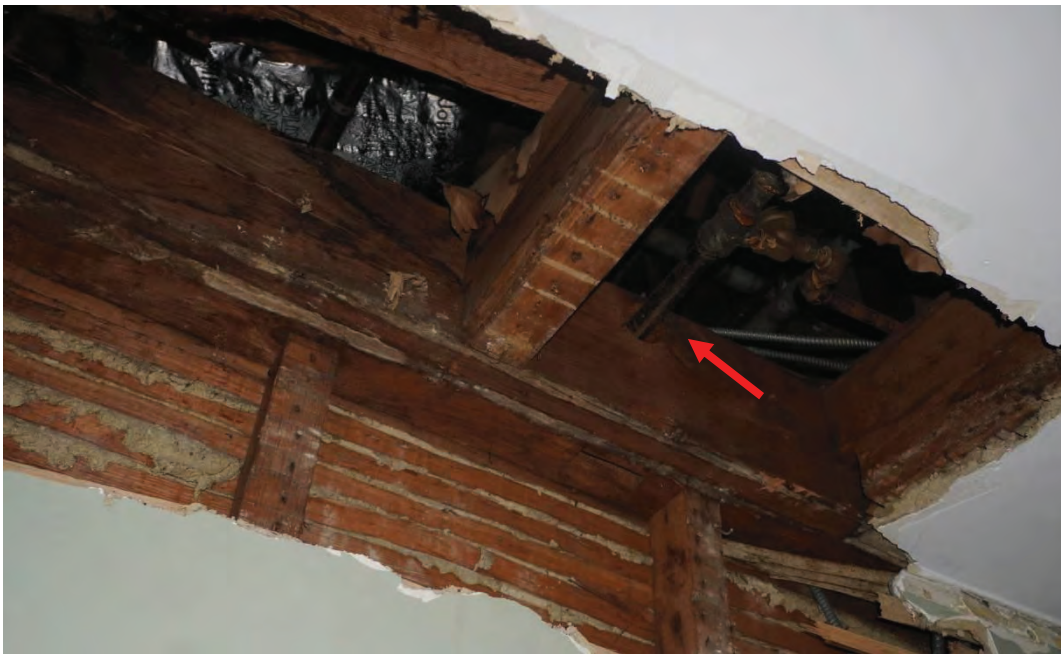
Photo #100: Floor joists supporting attic above observed at second floor level are oriented east to west. Large hole drilled through girder for pipe penetration (Probe #7).

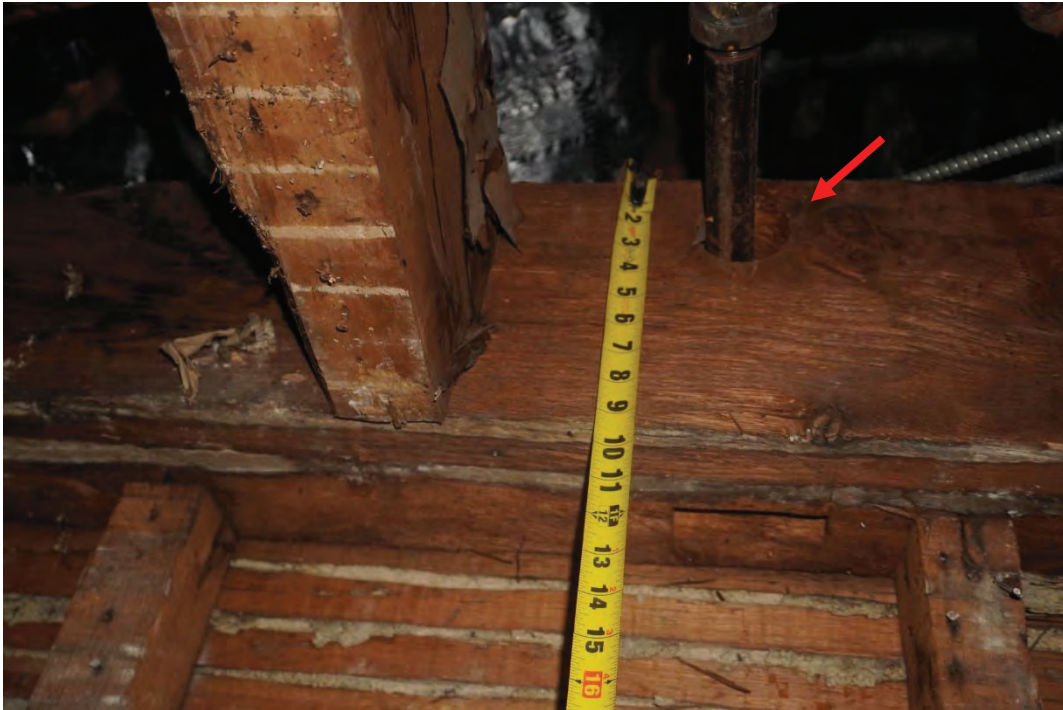
Photo #101: Floor joists supporting attic above observed at second floor level are oriented east to west. Large hold drilled through girder for pipe penetration (Probe #7).

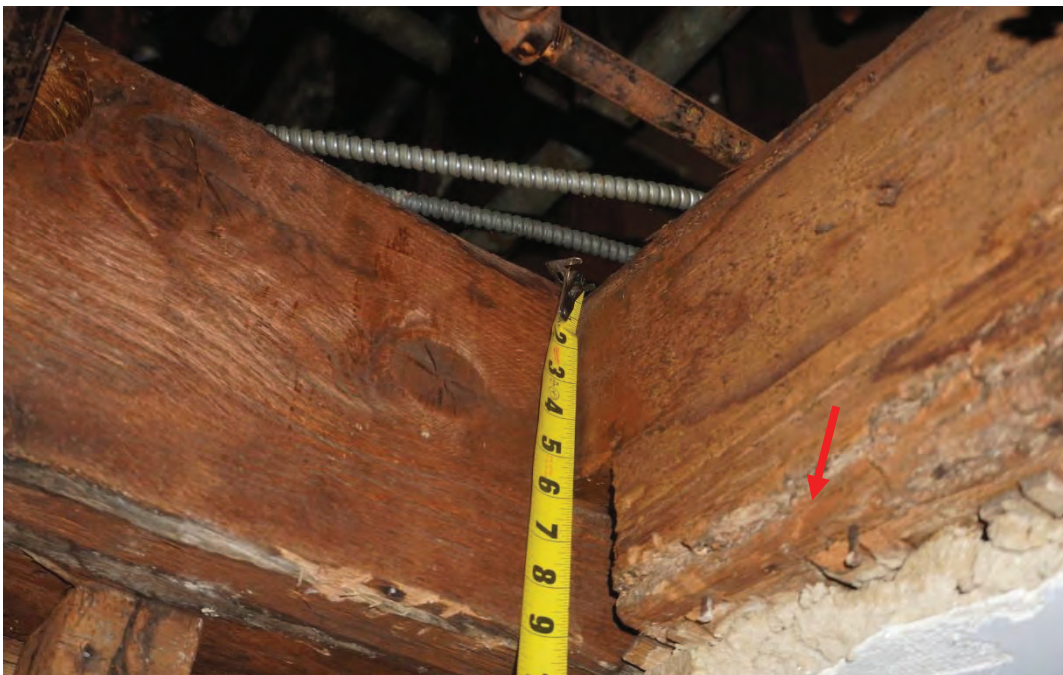
Photo #102: Past termite damage was observed in floor joist supporting attic level (Probe #7).

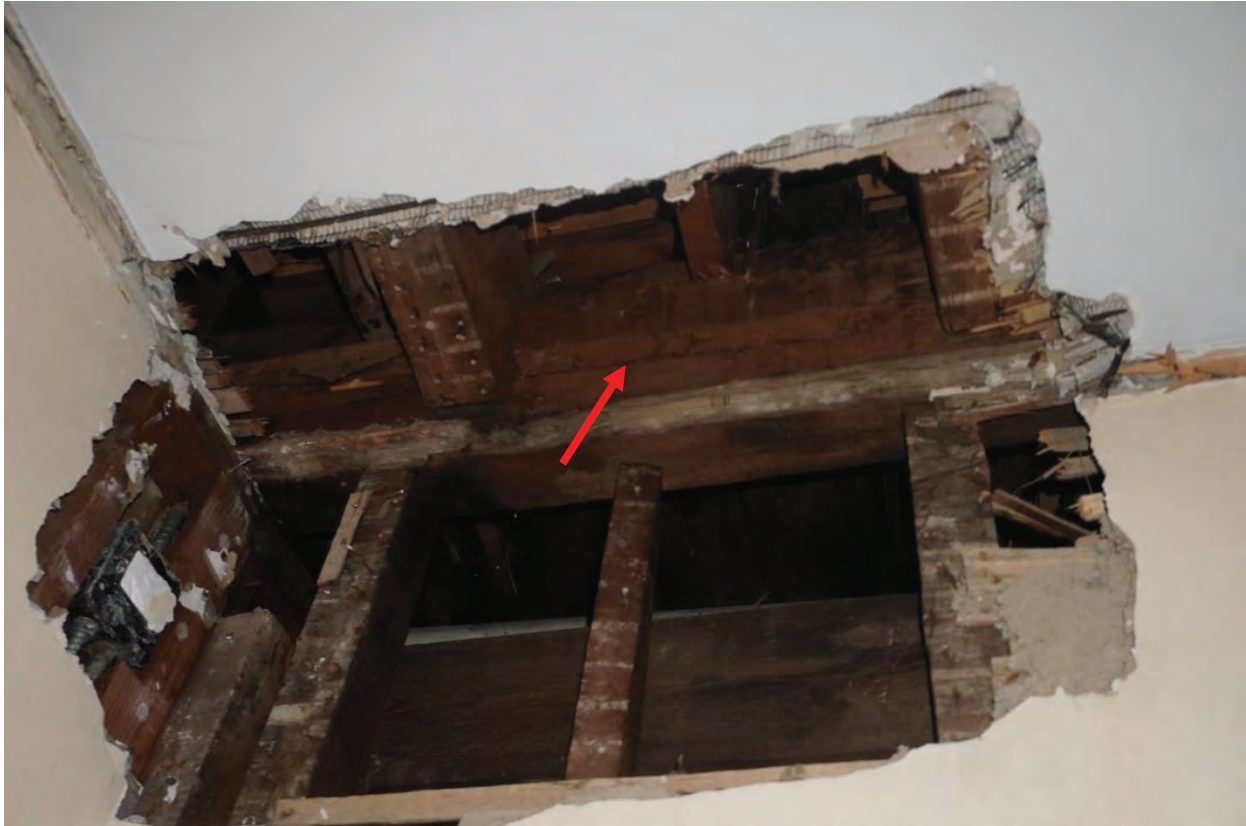
Photo #103: New joists running east to west have been installed at higher level than original joists and are resting on a 2x4 wood ledges that have been nailed to girder to support attic floor above. It is unclear why these joists were installed. Most likely to add additional space for piping below showers and toilets in attic. Further investigation required. Original joists left in place and still supporting ceiling below (Probe #8).

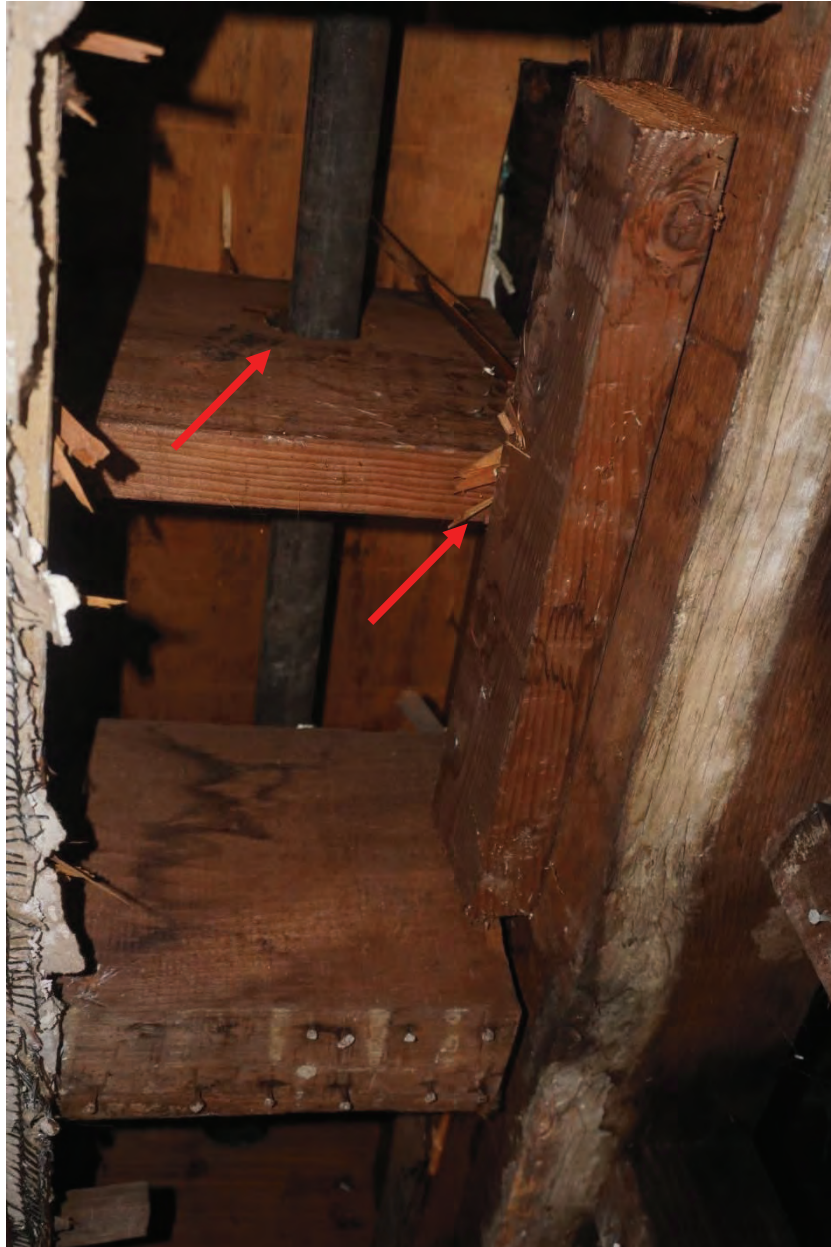
Photo #104: New joists running east to west have been installed at higher level than original joists and are resting on a 2x4 wood ledges that have been nailed to girder to support attic floor above. It is unclear why these joists were installed. Further investigation required to figure out why this was done. Original joists left in place and still supporting ceiling below. Multiple joists supporting attic floor above have holes drilled above their neutral axis at the joists ends where shear force is the highest (Probe #8).

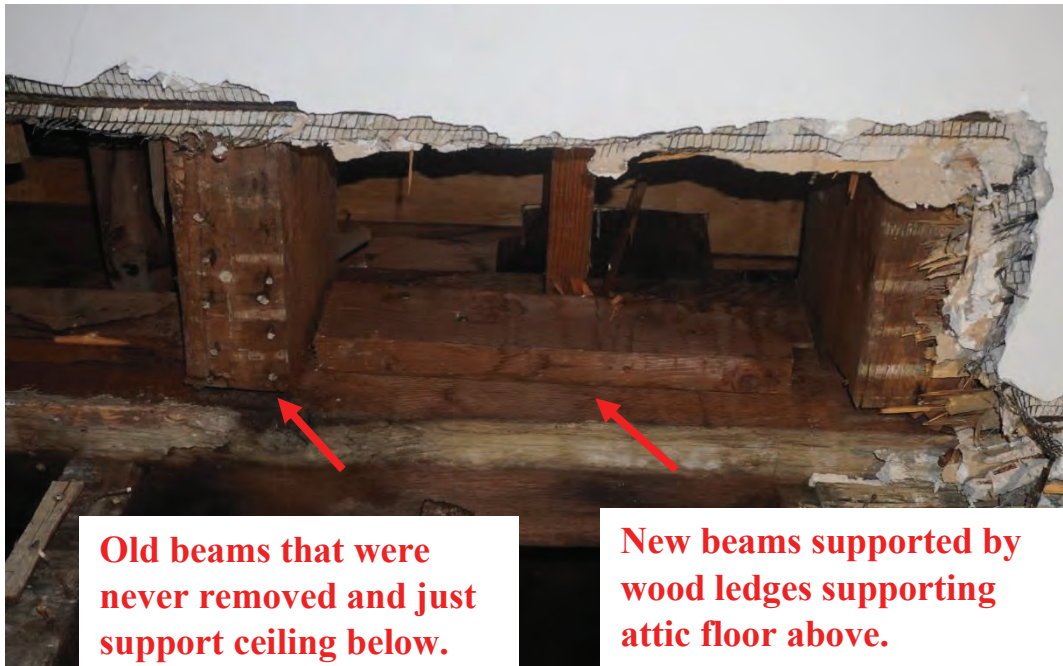
Photo #105: New joists running east to west have been installed at higher level than original joists and are resting on a wood ledge 2x4s that have been nailed to girder to support attic floor above (Probe #8).

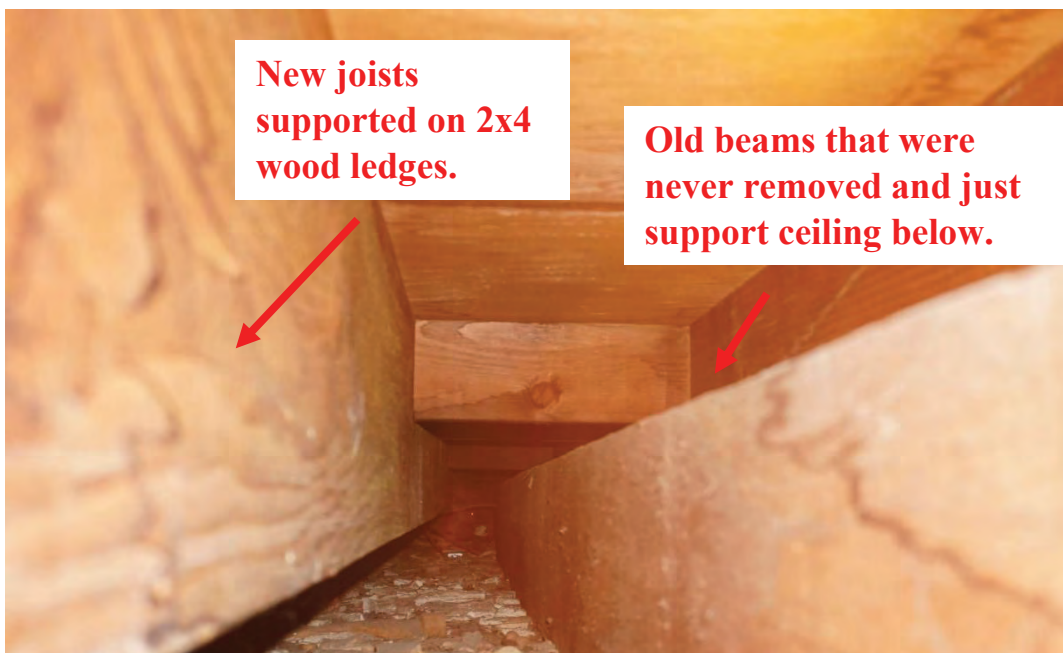
Photo #106: New joists running east to west have been installed at higher level than original joists and are resting on a wood ledge 2x4s that have been nailed to girder to support attic floor above (Probe #8). (Probe #8)

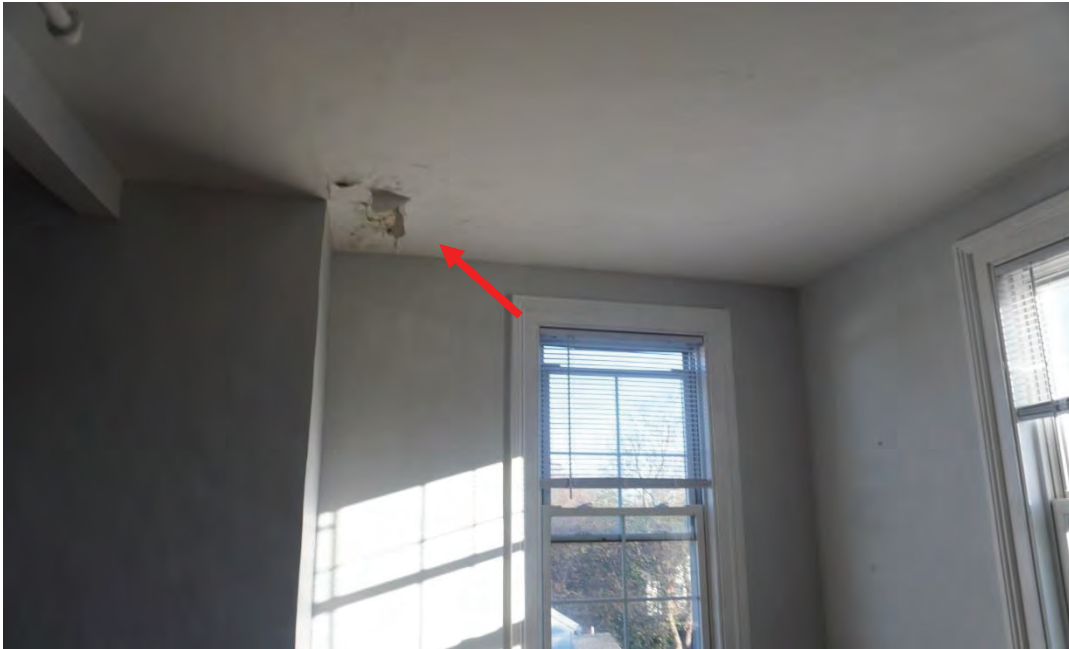
Photo #107: Water damage adjacent to east exterior wall of addition. Cause unknown, further investigation required.
