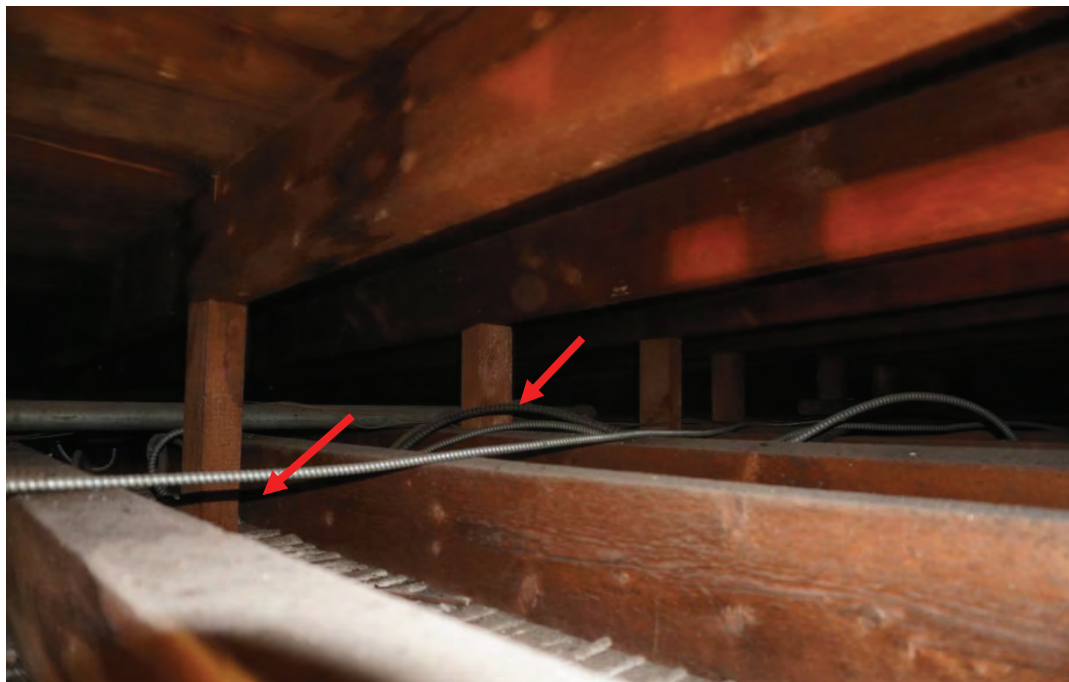
Photo #108: View facing northeast in roof void between 2nd floor ceiling joists and roof joists in the addition. Roof joists do not align with ceiling joists and are being supported at midspan with blocking that is resting right onto plaster ceiling (Probe #9).

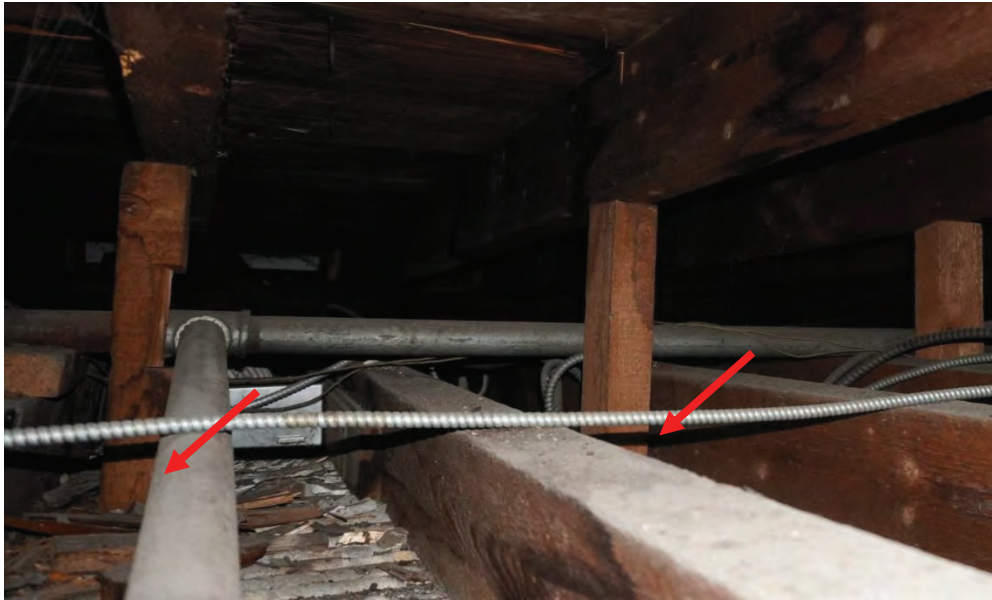
Photo #109: View facing northeast in roof void between 2nd floor ceiling joists and roof joists in the addition. Roof joists do not align with ceiling joists and are being supported at midspan with blocking that is resting right onto plaster ceiling (Probe #9).

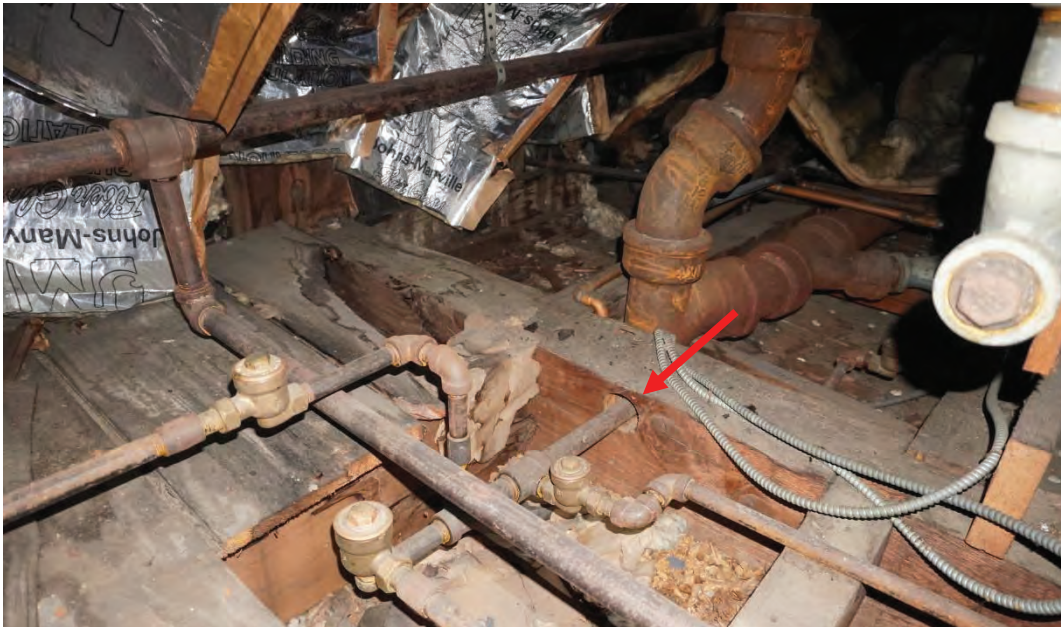
Photo #110: Pipe penetration drilled through girder drilled above its neutral axis. Observed in unfinished attic area, north side of original structure.

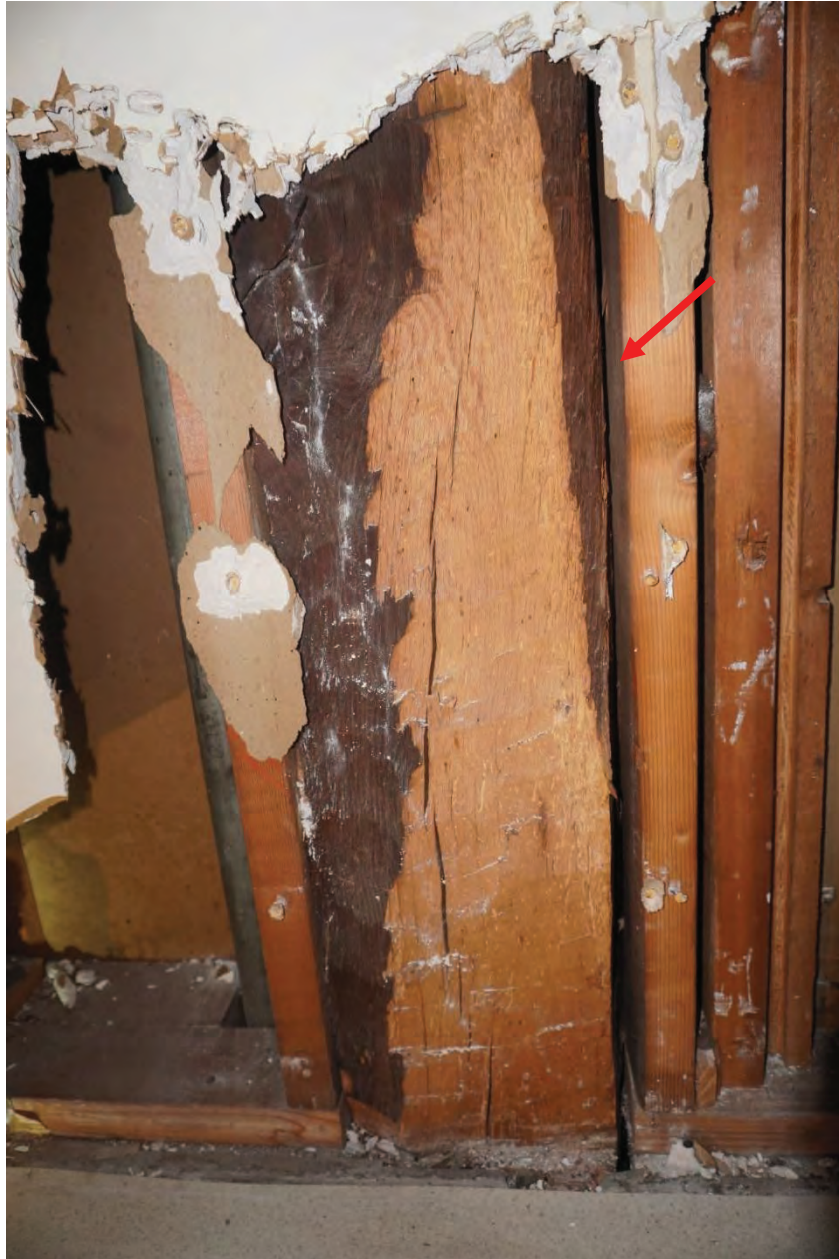
Photo #111: Post in attic space has moved out of place. Mortise and tenon joint that was connecting post to girder below has failed allowing member to rotate (Probe #10).

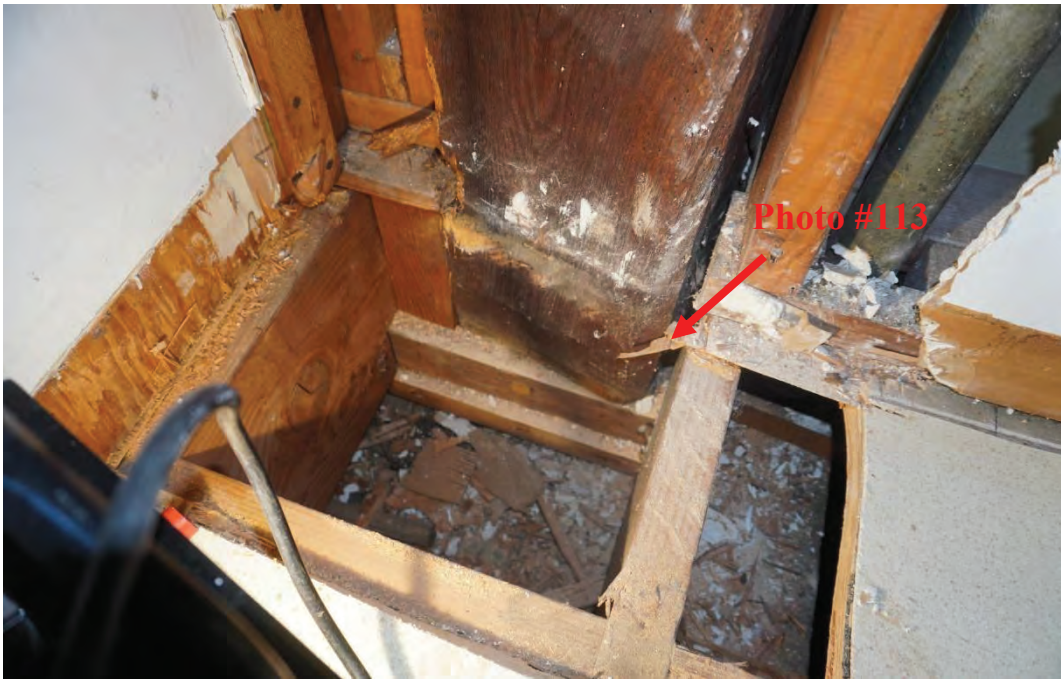
Photo #112: Post in attic space has moved out of place. Mortise and tenon joint that was connecting post to girder below has failed allowing member to rotate (Probe #11).

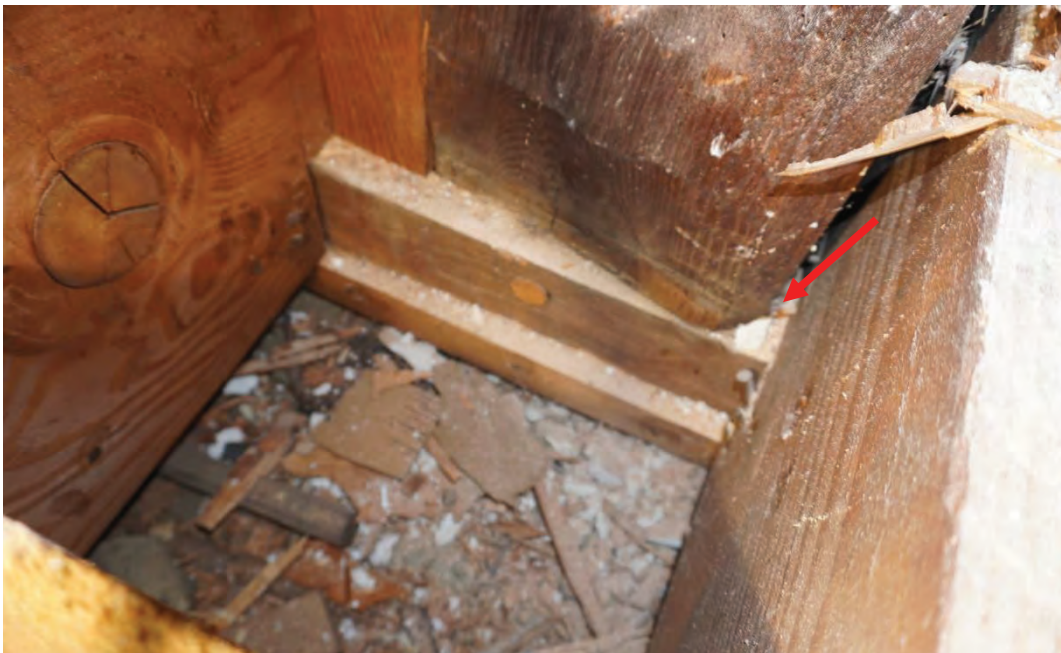
Photo #113: Post in attic space has moved out of place. Mortise and tenon joint that was connecting post to girder below has failed allowing member to rotate (Probe #11).

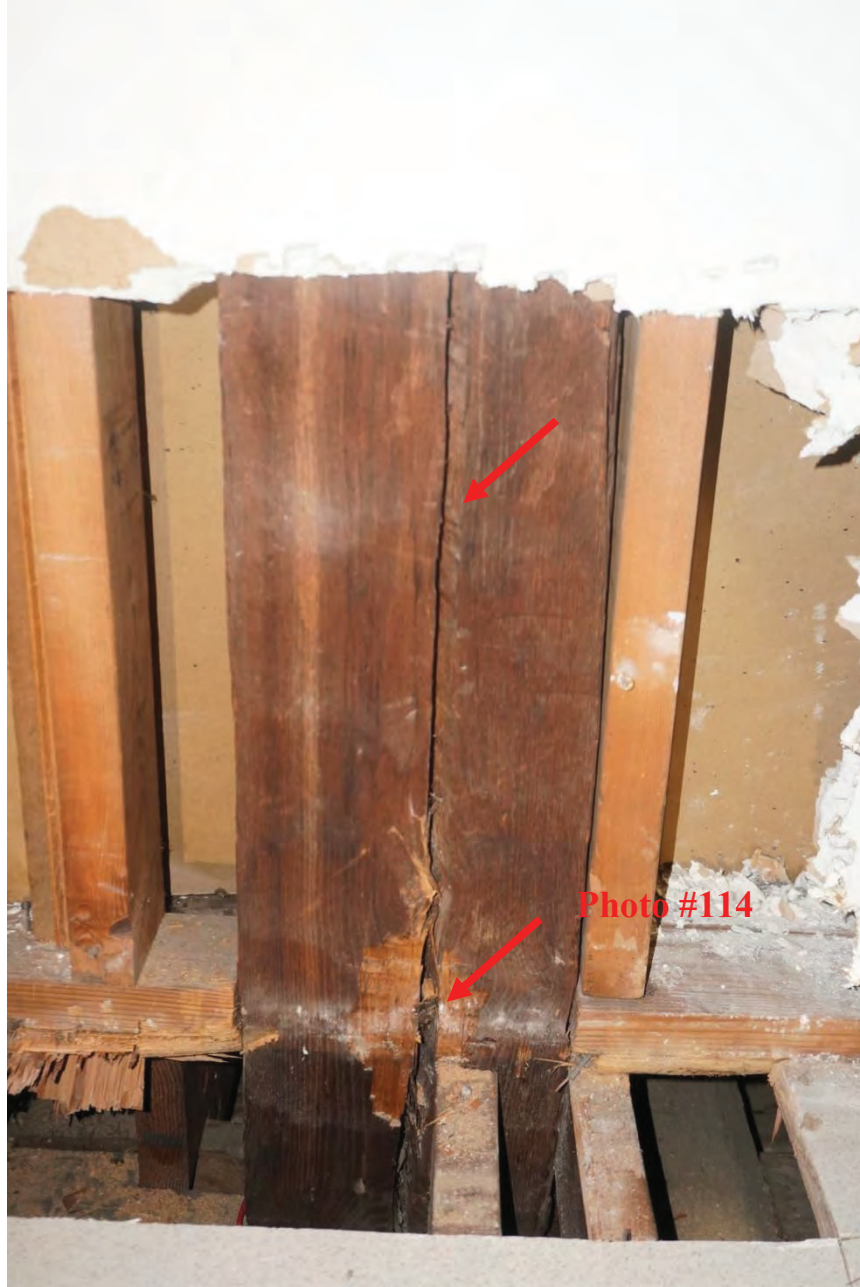
Photo #114: Vertical crack that has opened more towards the bottom observed, attic post
Unclear why this has occurred. Further investigation required (Probe #12).

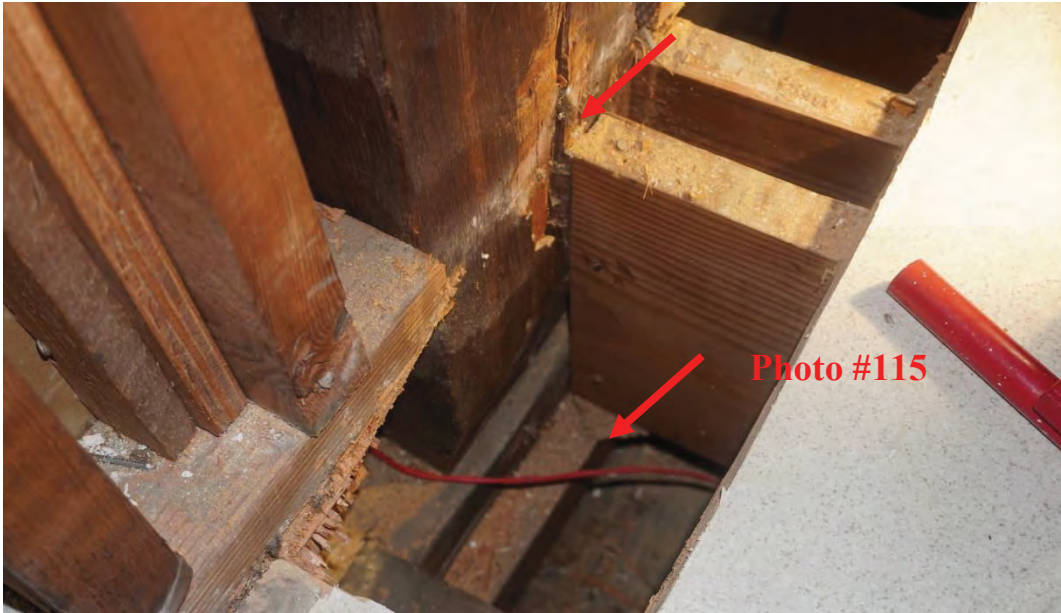
Photo #115: Vertical crack that has opened more towards the bottom observed, attic post. Unclear why this has occurred. Further investigation required. New wood joists have been installed going east to west bearing on wood ledge that has been nailed into girder. It is unclear why this was done. Further investigation required (Probe #12).

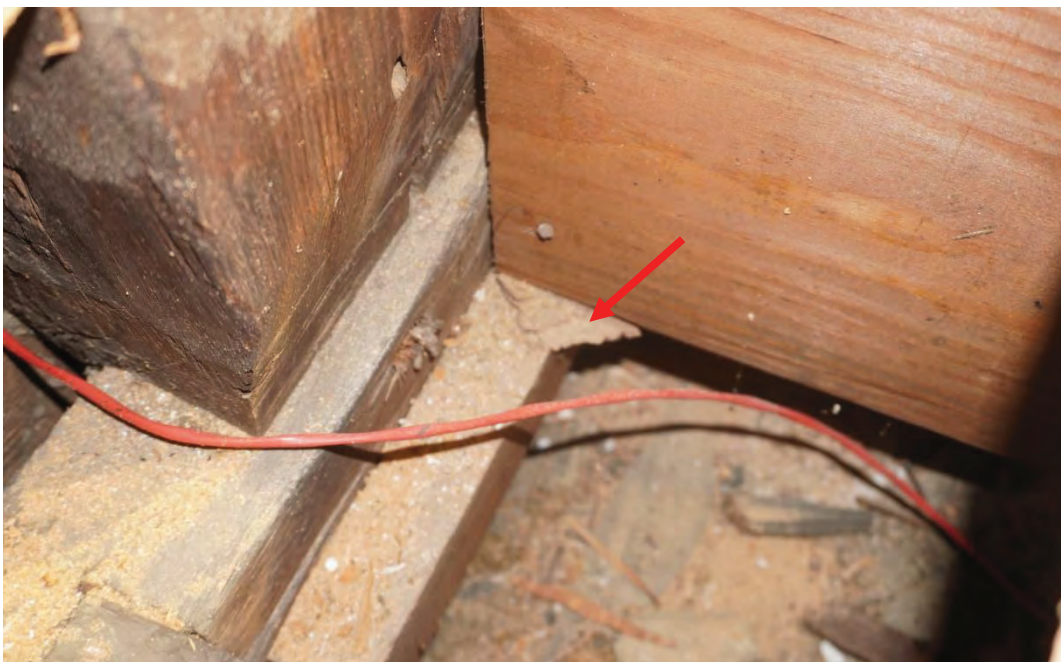
Photo #116: New wood joists have been installed going east to west bearing on wood ledge that has been nailed into girder. It is unclear why this was done. Further investigation required (Probe #12).

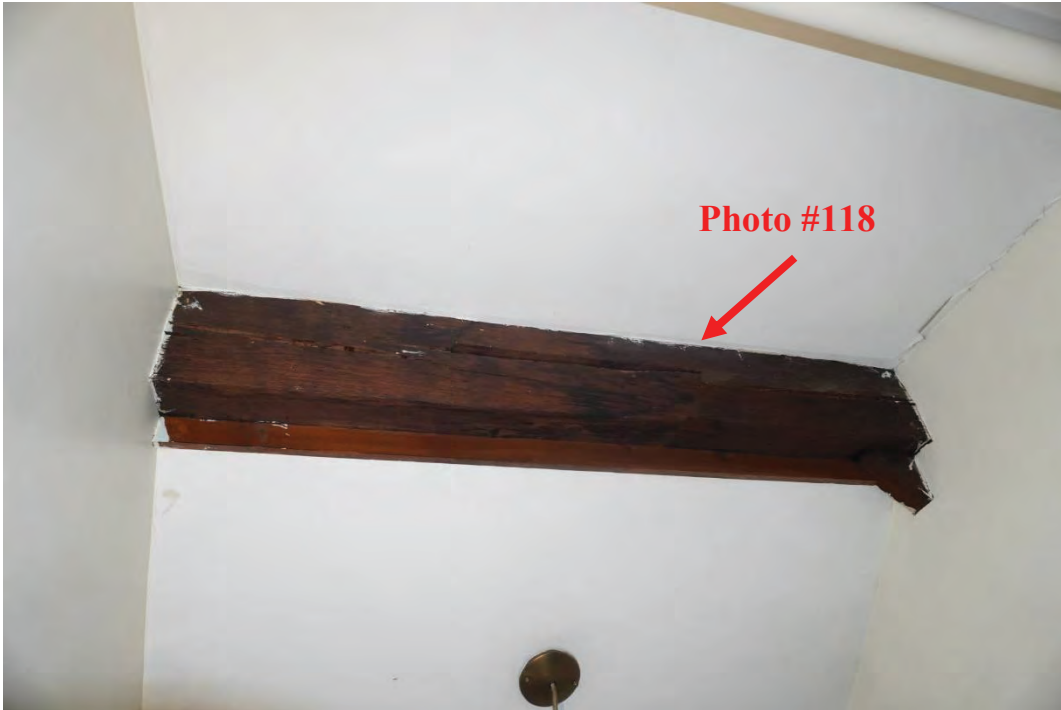
Photo #117: Roof support beam observed to be coming apart.

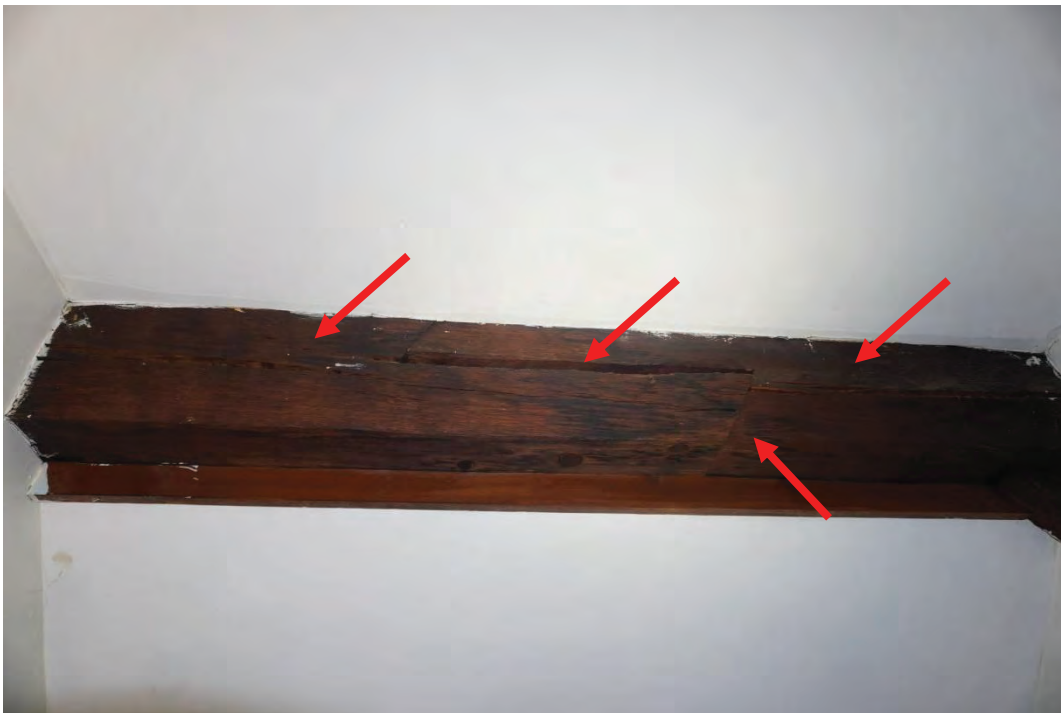
Photo #118: Roof support beam observed to be coming apart.

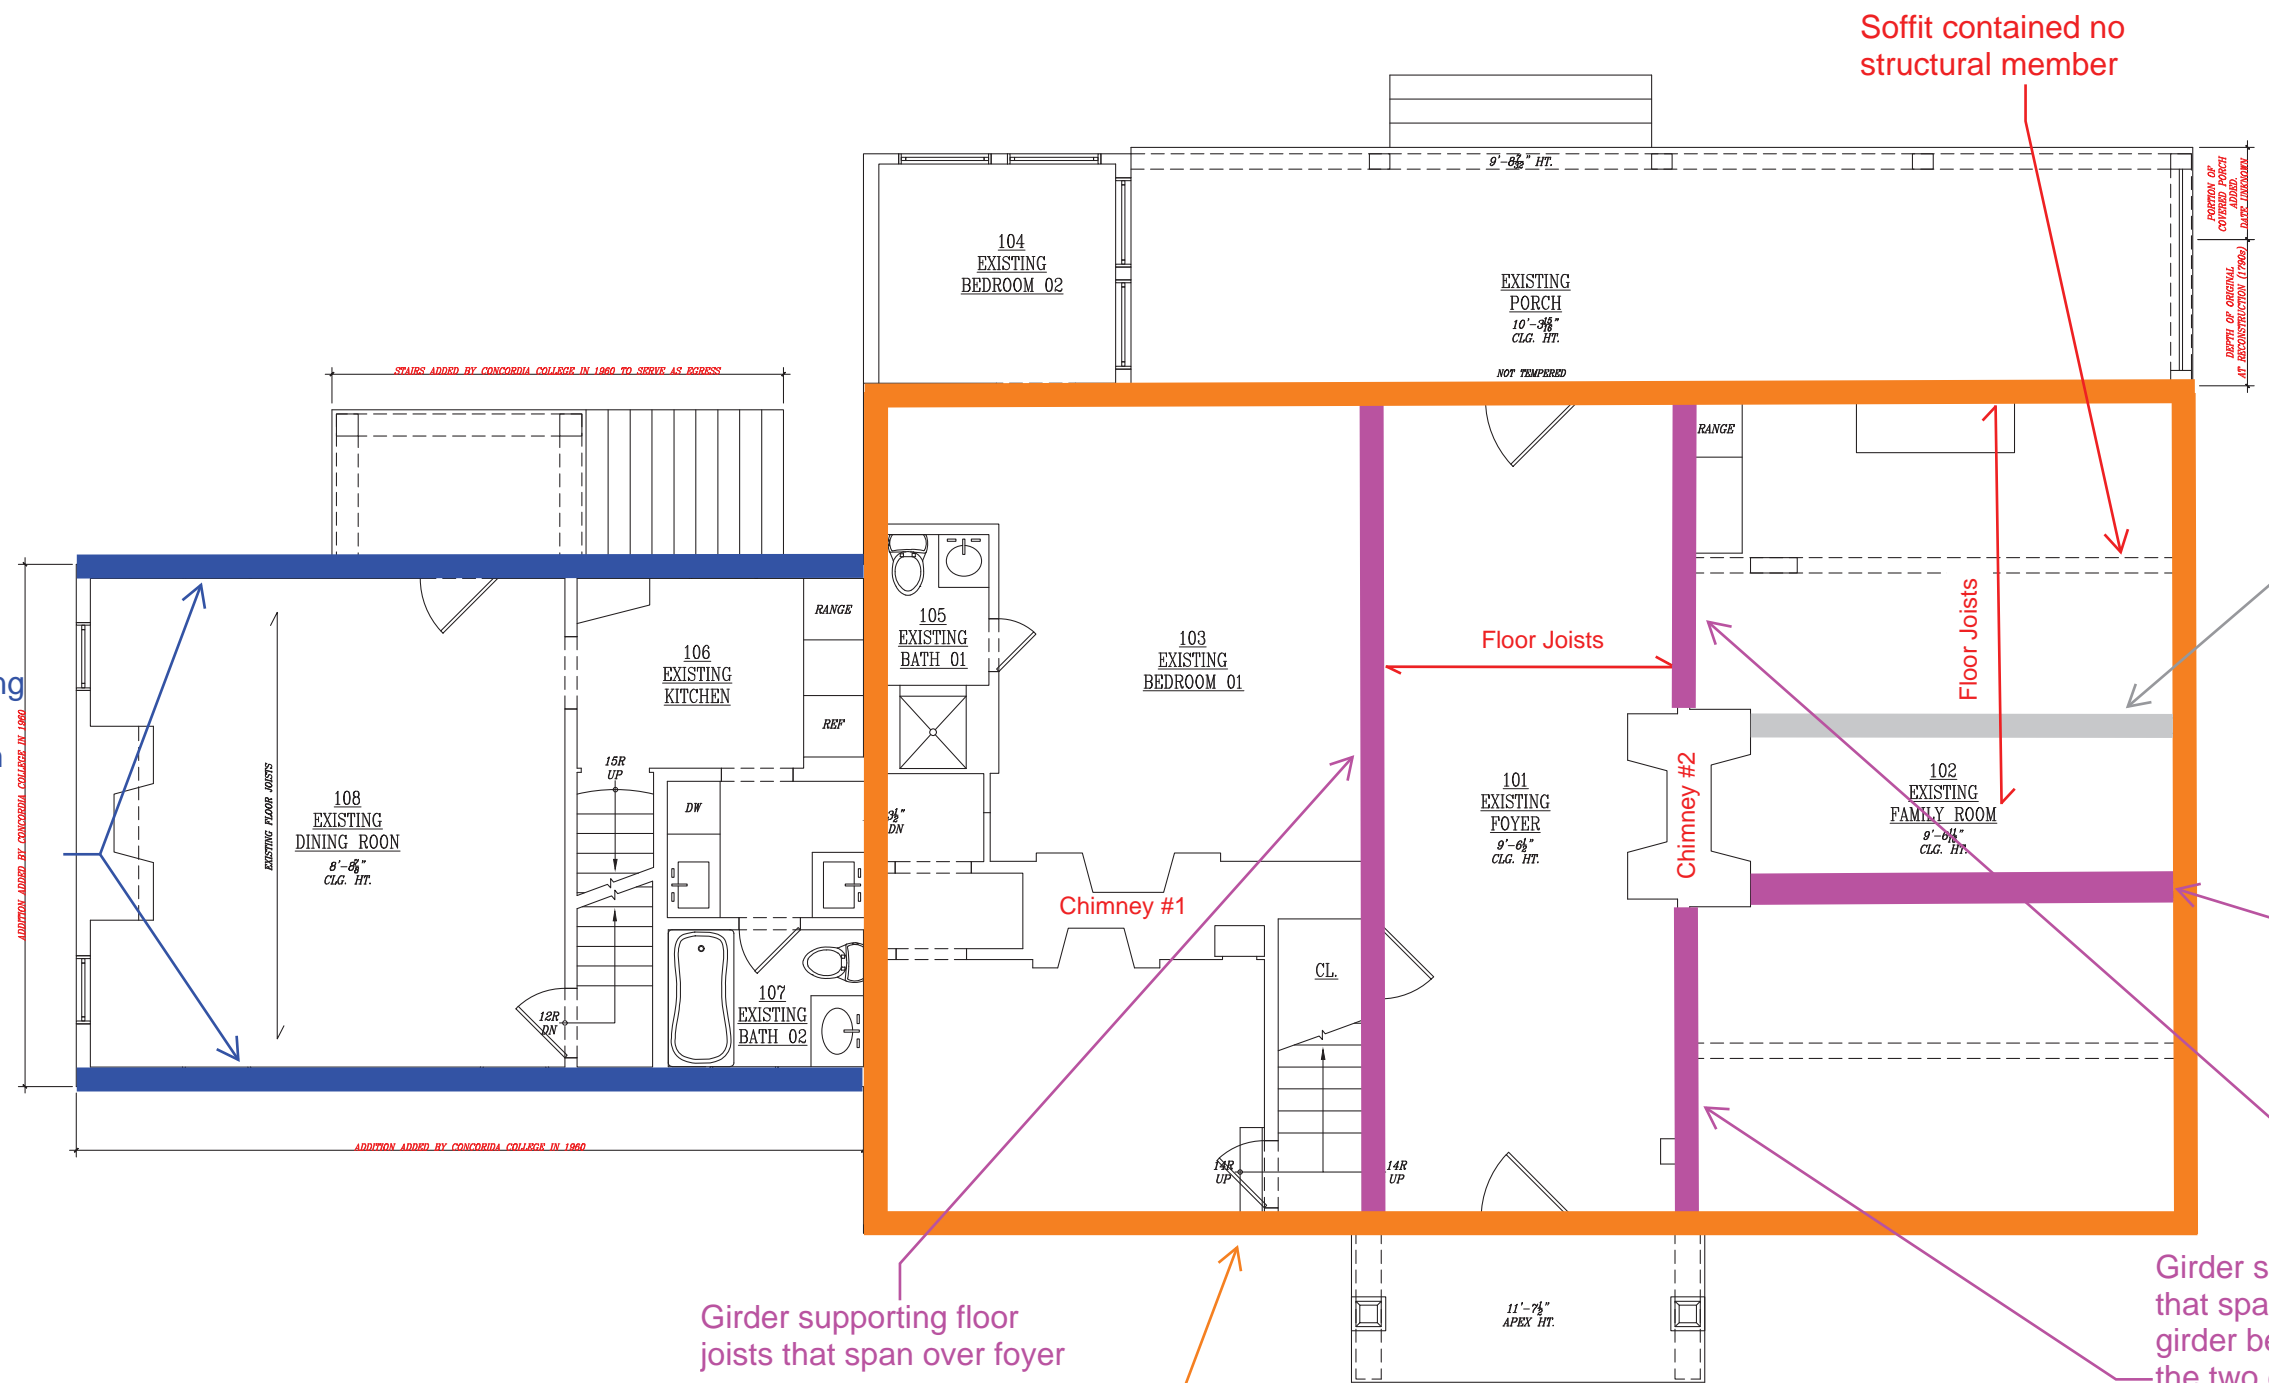
1st Floor (2nd Floor Framing)

Soffit contains large wooden member running below floor joists. Wood member is below ceiling level and is acting as additional support for floor joists. This is not a standard timber framing layout. Was a modification made after, potentially when the chimney was moved.

Girder supporting floor joists that span over foyer. Original girder beam spanned between the two exterior facades and was modified when chimney #2 was added to the home.
