**Re: *Biggest Fish Westchester LLC*
§11A-9 Economic Hardship Request (Certificate of Appropriateness)
*230 White Plains Road - Section 31. Block 3 Lot 13 ("Property")***

Property Location:	230 White Plains Road Tuckahoe, NY 10707
Inspection Dates:	Initial Inspection: 9/23/22 In Depth Inspection: 11/14/22 Probe Inspection: 12/13/22
Report Date:	1/28/23
Report By:	Peter Panagopoulos, P.E. <i>Principal</i> Pantec Engineering
Appendices:	Appendix A – Photos Appendix B – Probe Locations Appendix C – Structural Layout Appendix D – Deficiency Location Diagram Appendix E - Two Inner Chimney Georgia Colonial Layout

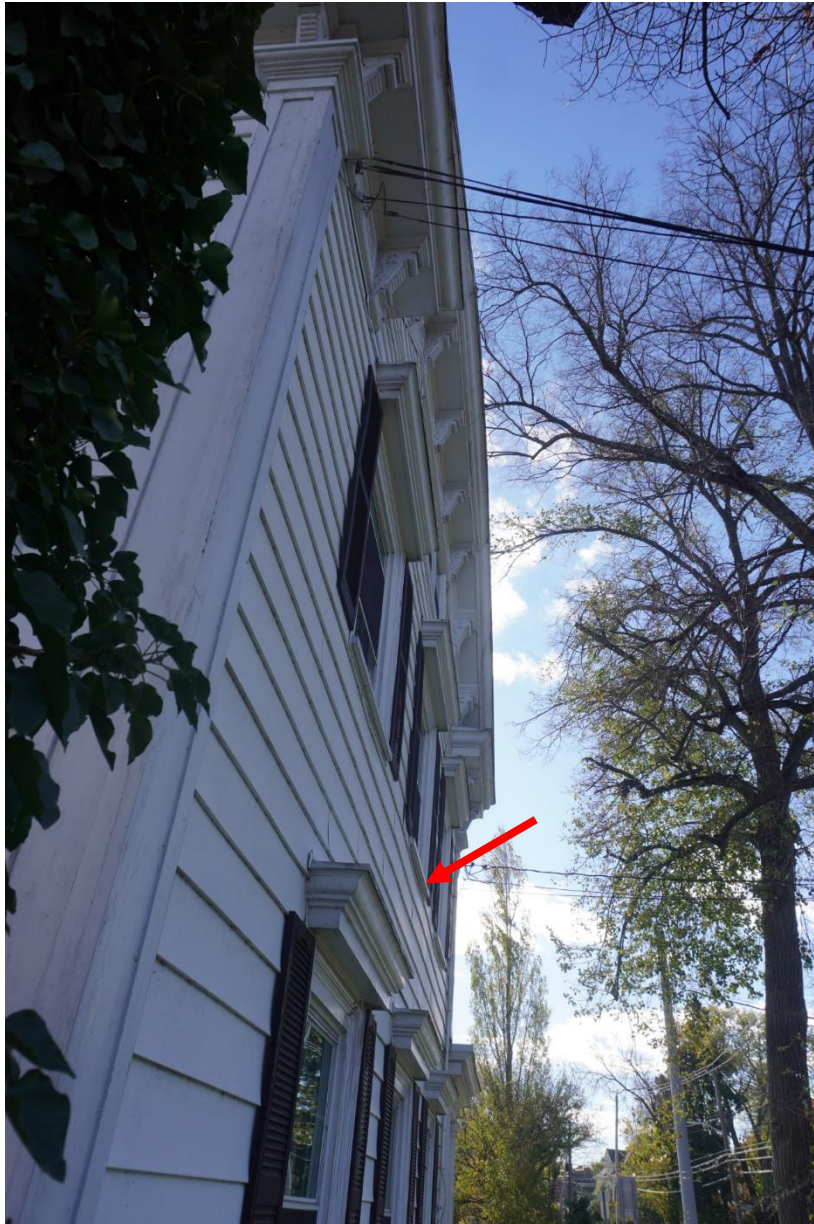
Photo #21: Bulge noticed between first and second floors, west façade of home. Cause unknown. Further investigation required.

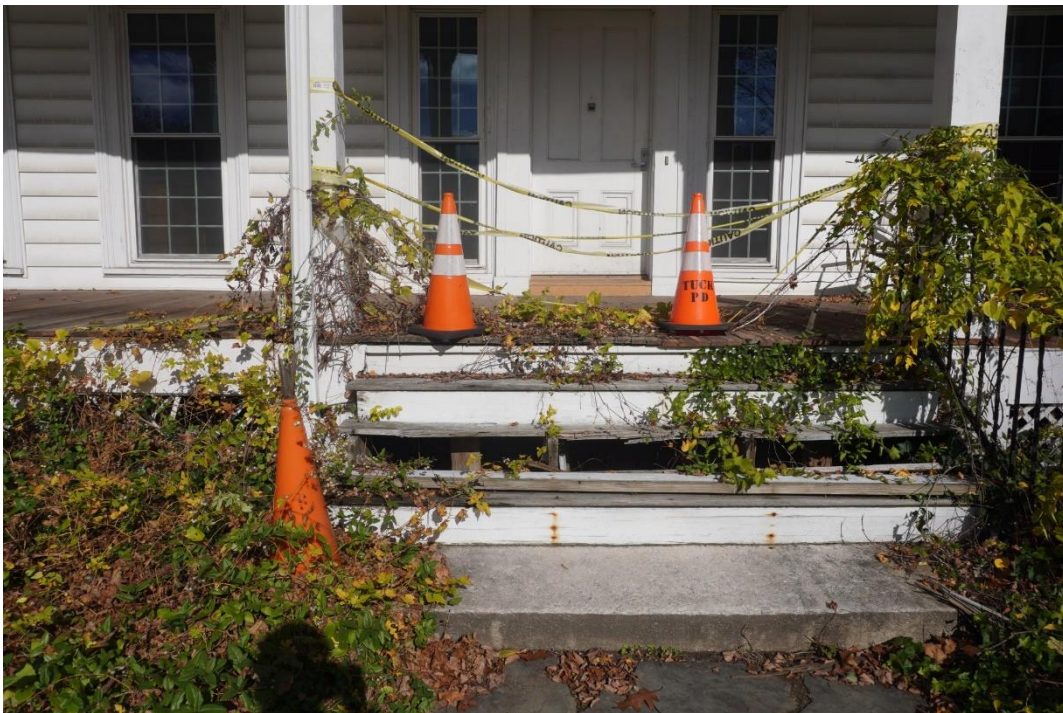
Photo #34: Rear porch sitting on stone pillars that are showing signs of deterioration.

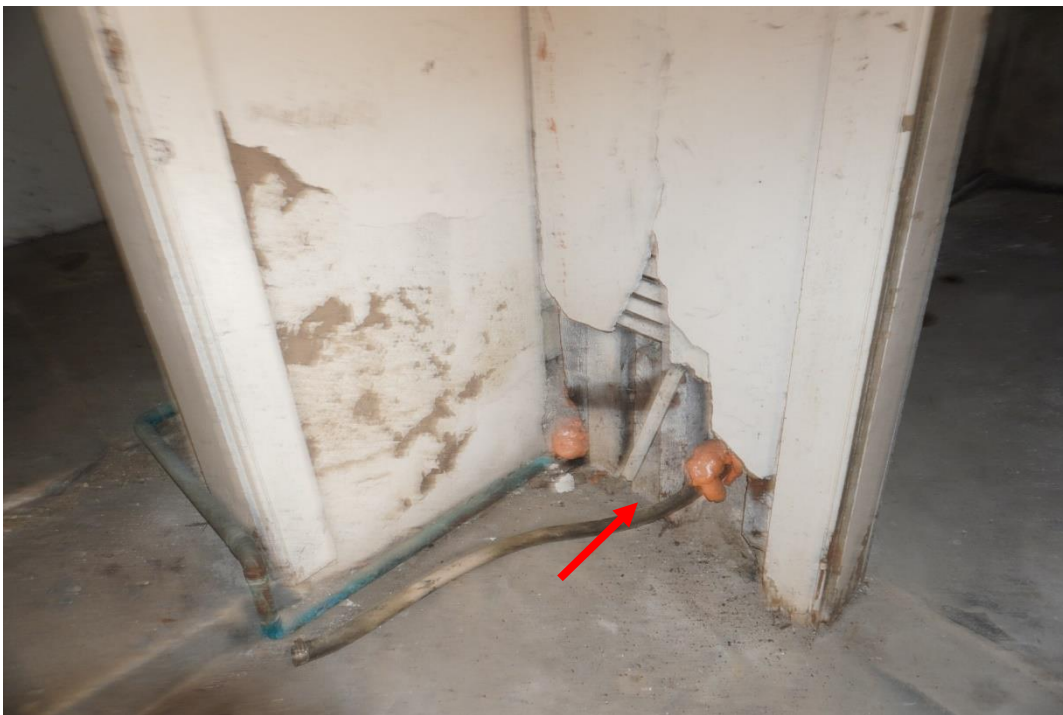
Photo #38: Mold formation and deteriorating damp plaster interior walls at cellar level due to water wicking up through cellar floor.

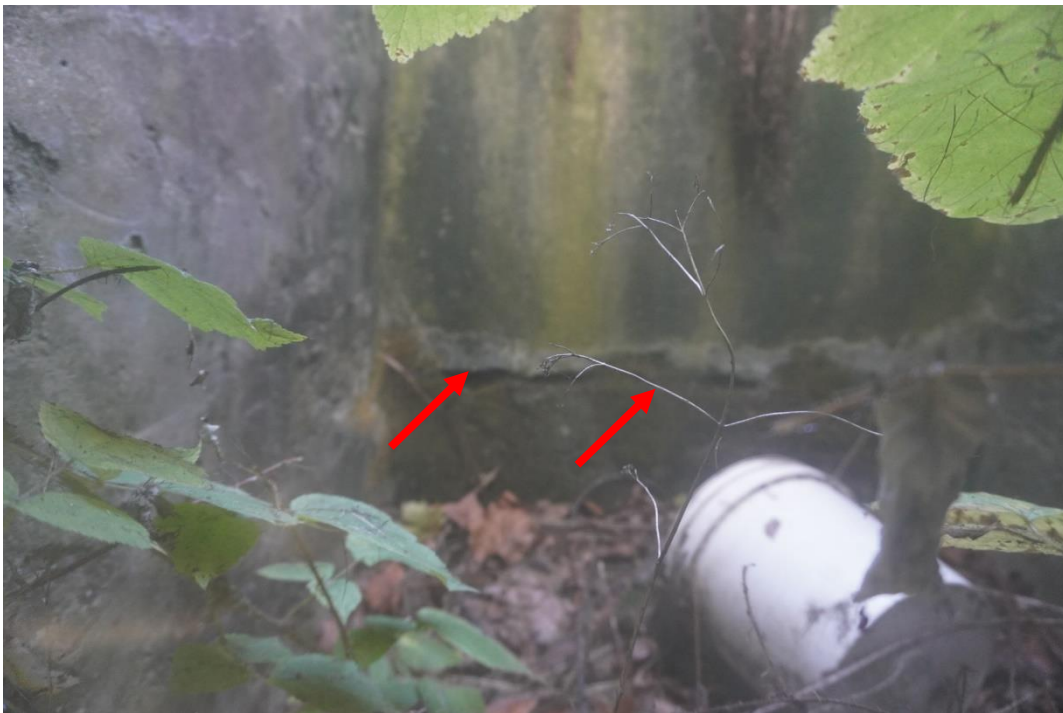
Photo #40: Water infiltration around cellar window, north façade of home at window well.

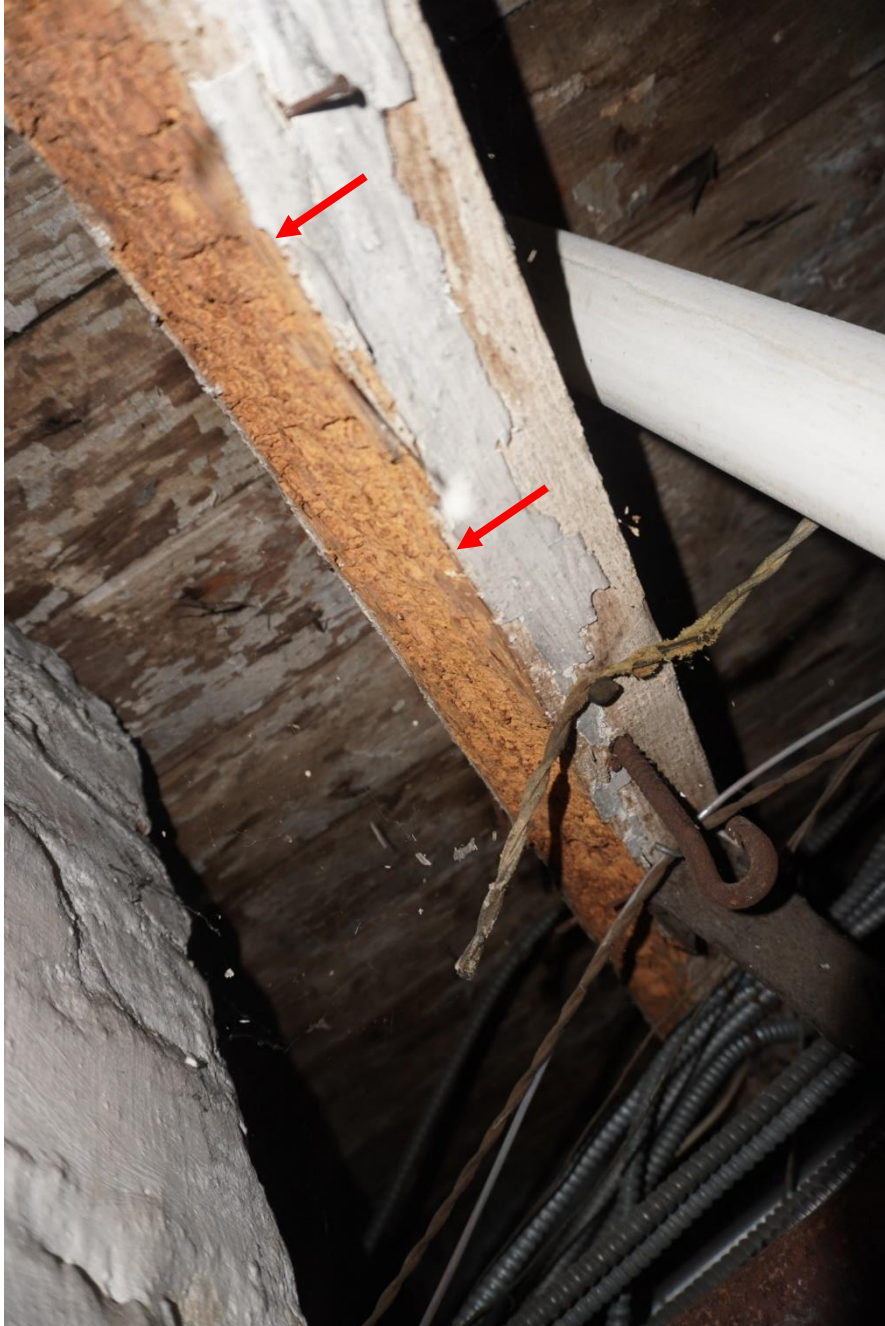
Photo #51: Horizontal crack from shear stress resonating down entire member from notch at end of beam.

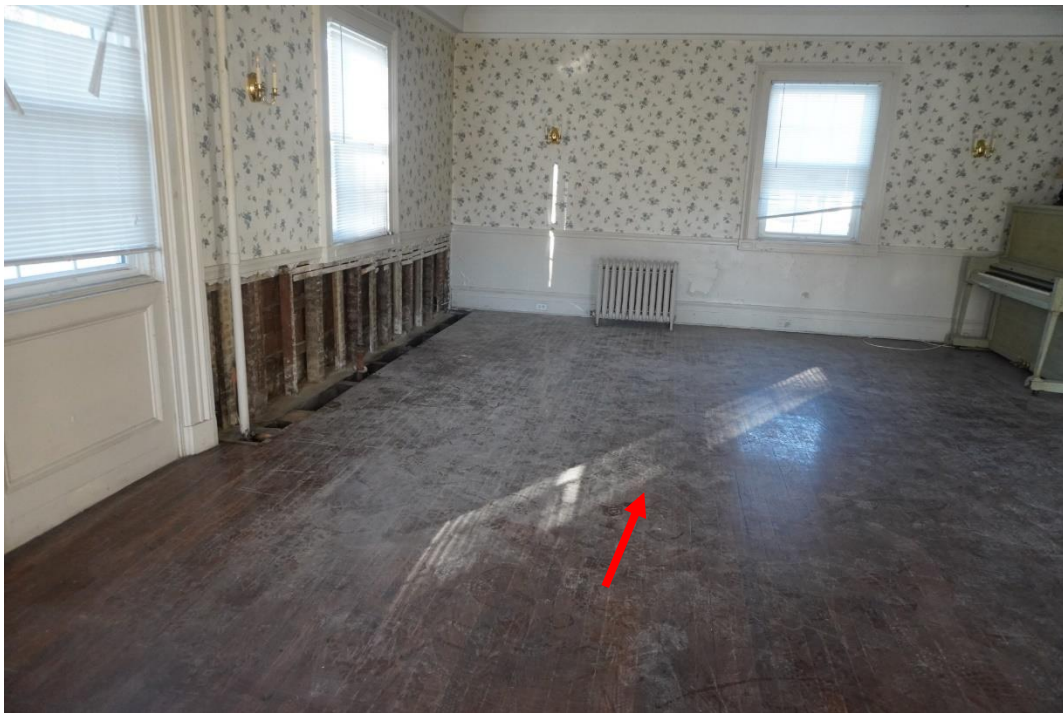
Photo #76: Location of west chimney that was relocated at some point in the past. Foundation still in place and can be observed in cellar below.

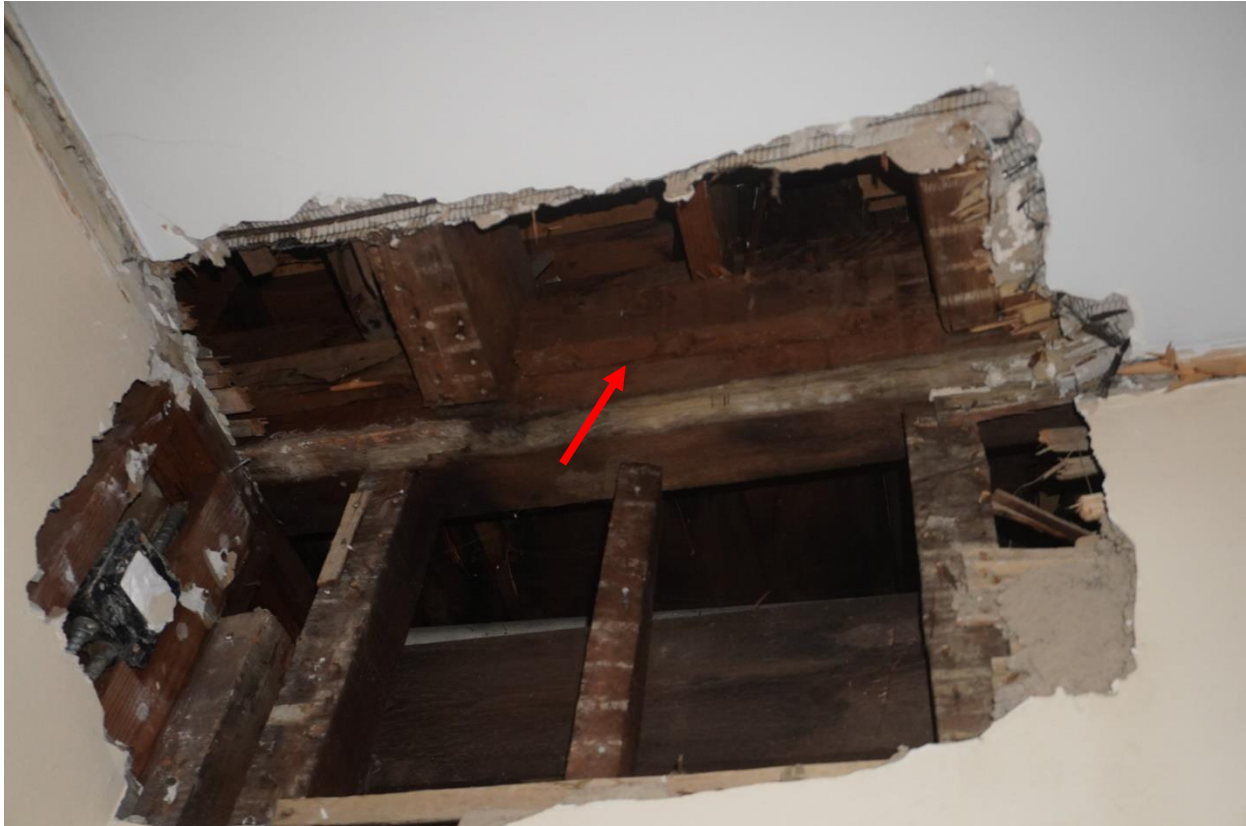
Photo #102: Past termite damage was observed in floor joist supporting attic level (Probe #7).

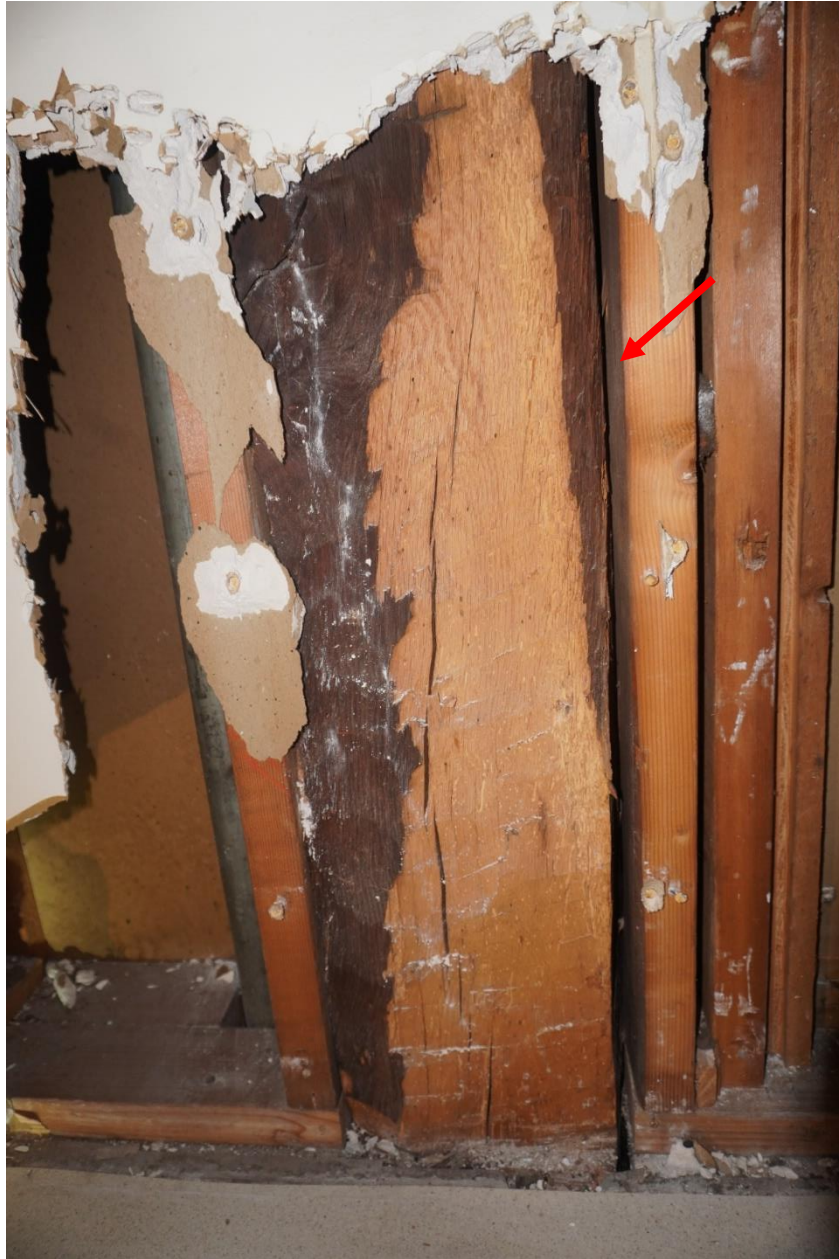
Photo #110: Pipe penetration drilled through girder drilled above its neutral axis. Observed in unfinished attic area, north side of original structure.

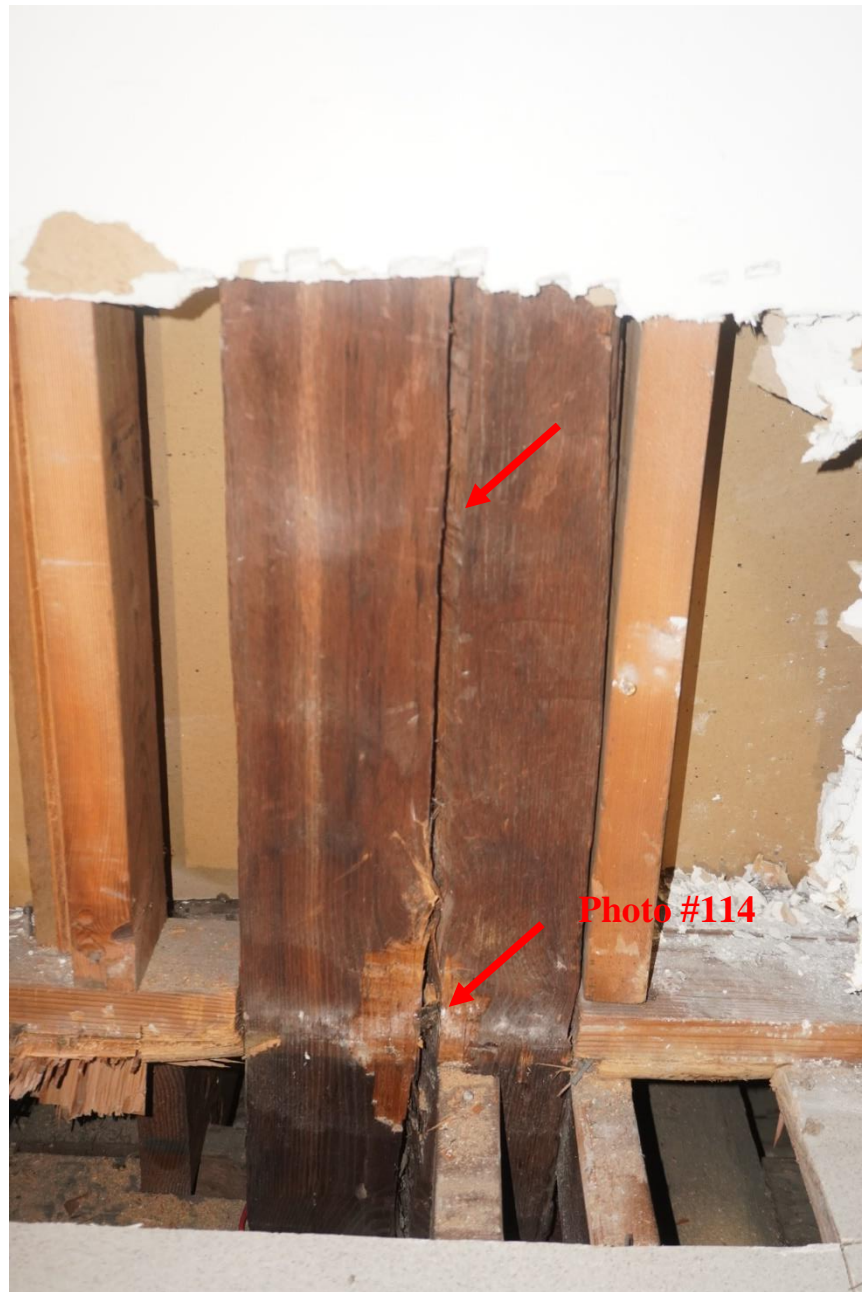
Photo #113: Post in attic space has moved out of place. Mortise and tenon joint that was connecting post to girder below has failed allowing member to rotate (Probe #11).

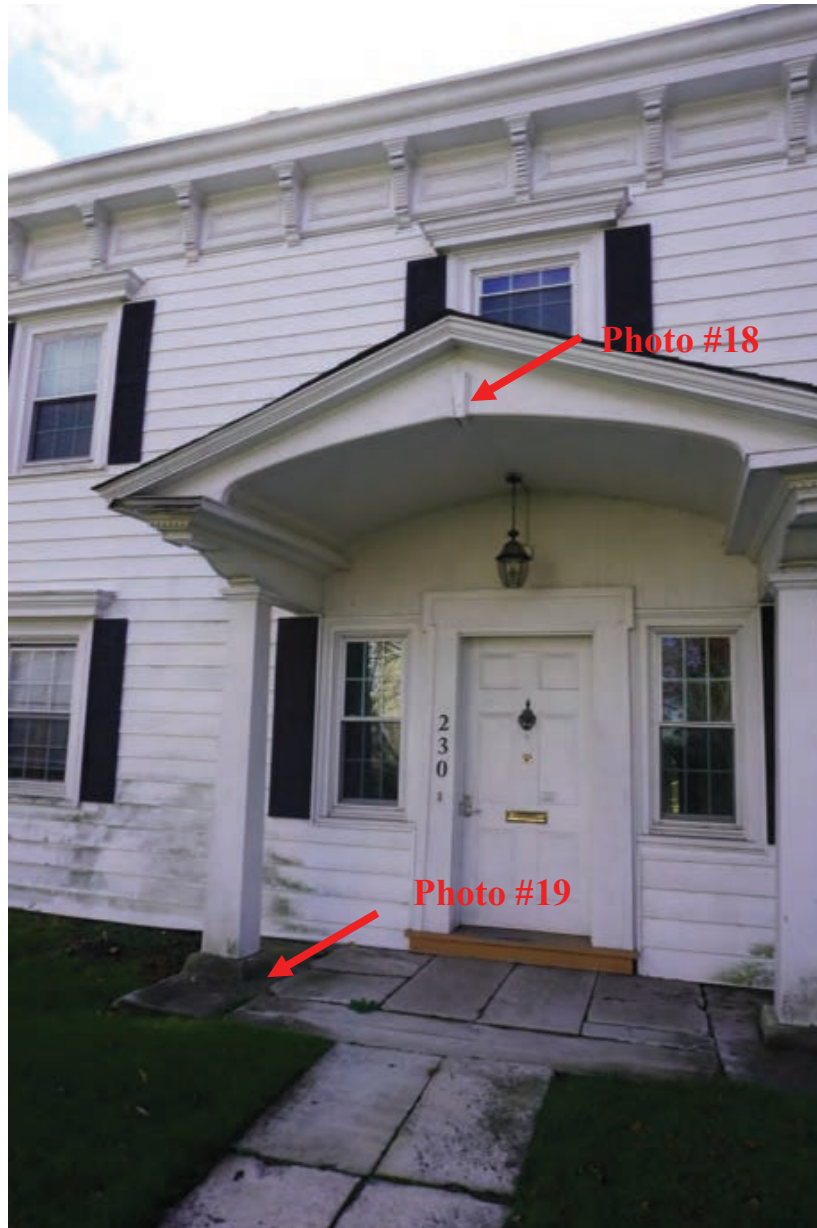
easily regraded
-- if it does
infiltrate

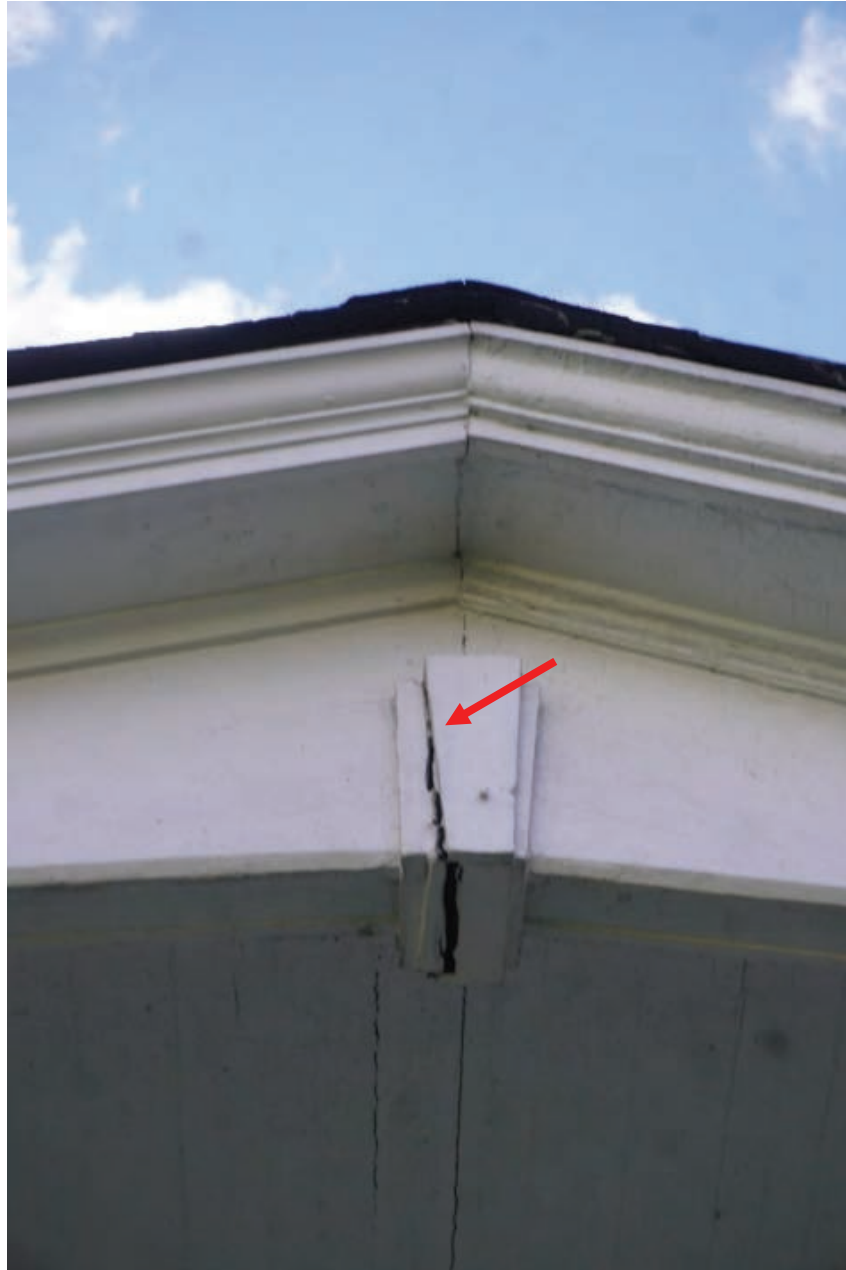
Photo #17: Base of column support for front portico showing signs of differential settlement.
Vertical crack running down middle of front portico.

straining again! shrinkage &
expansion but not remotely more
than a normal exterior repair issue

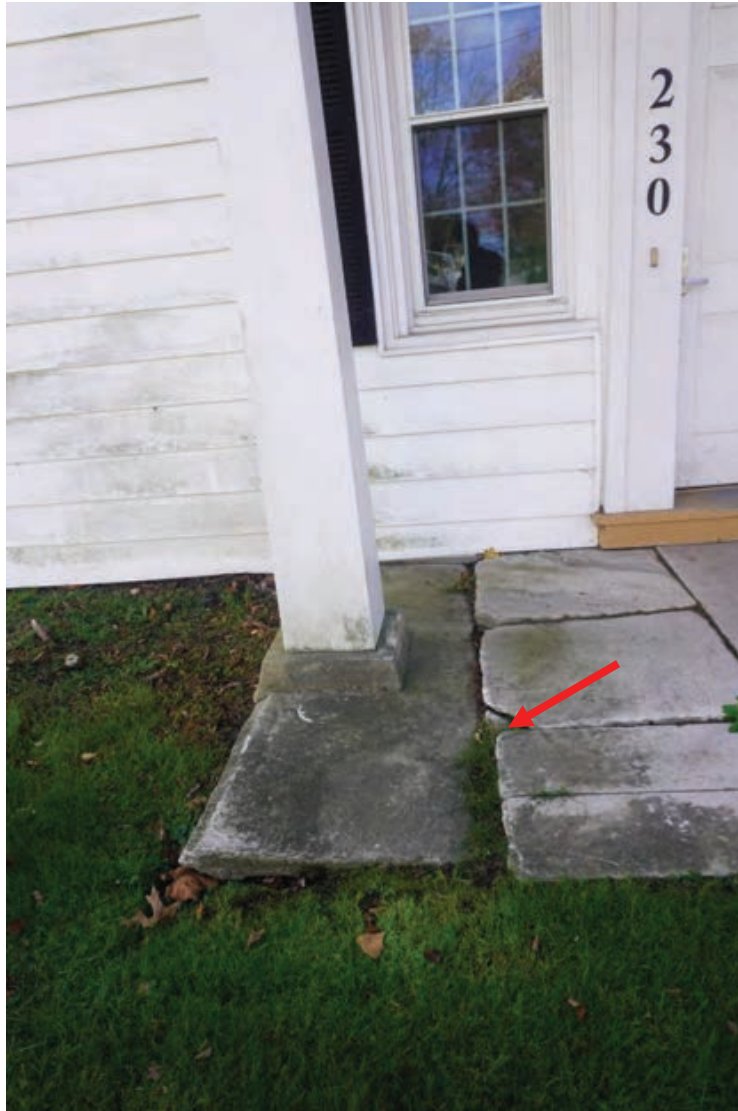
Photo #18: Vertical crack running down middle of front portico.
shrinkage & expansion but not remotely more than a normal
exterior repair issue

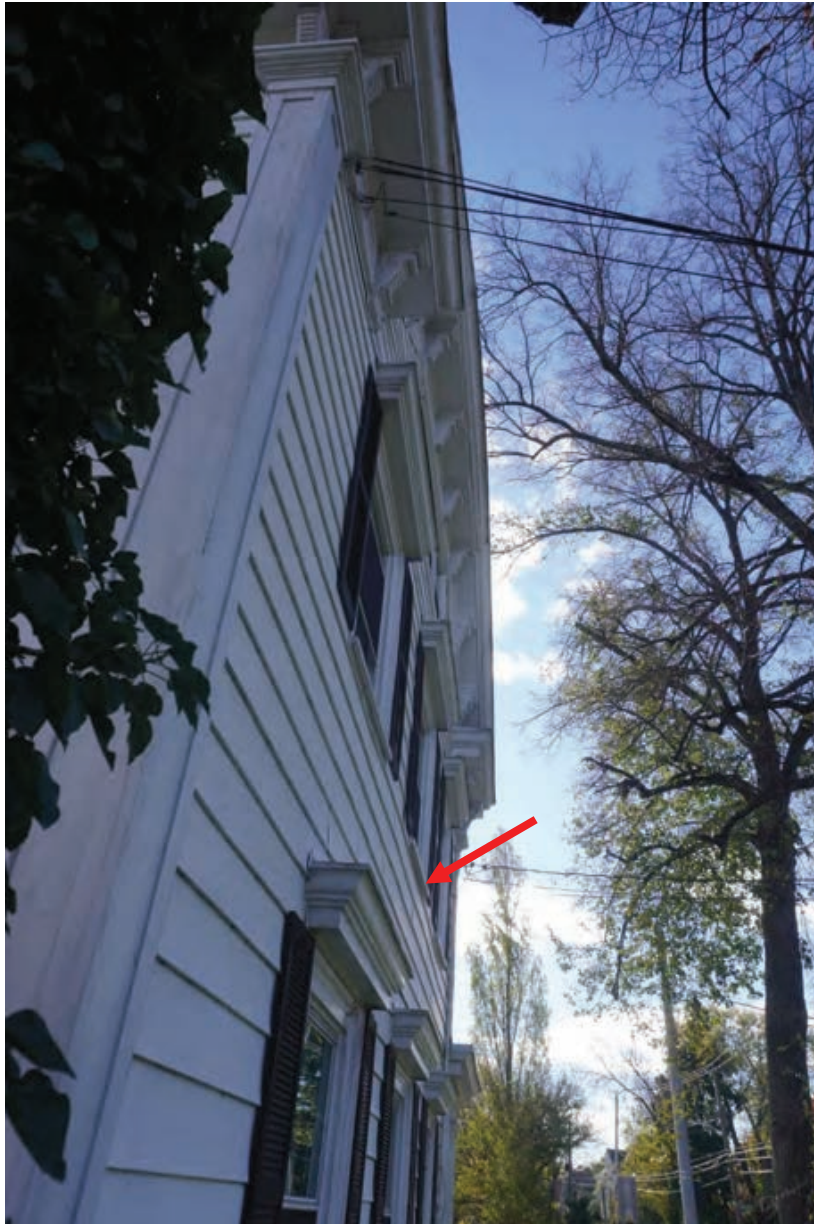
remember: vinyl siding does expand and contract
overall building appears quite plumb and true

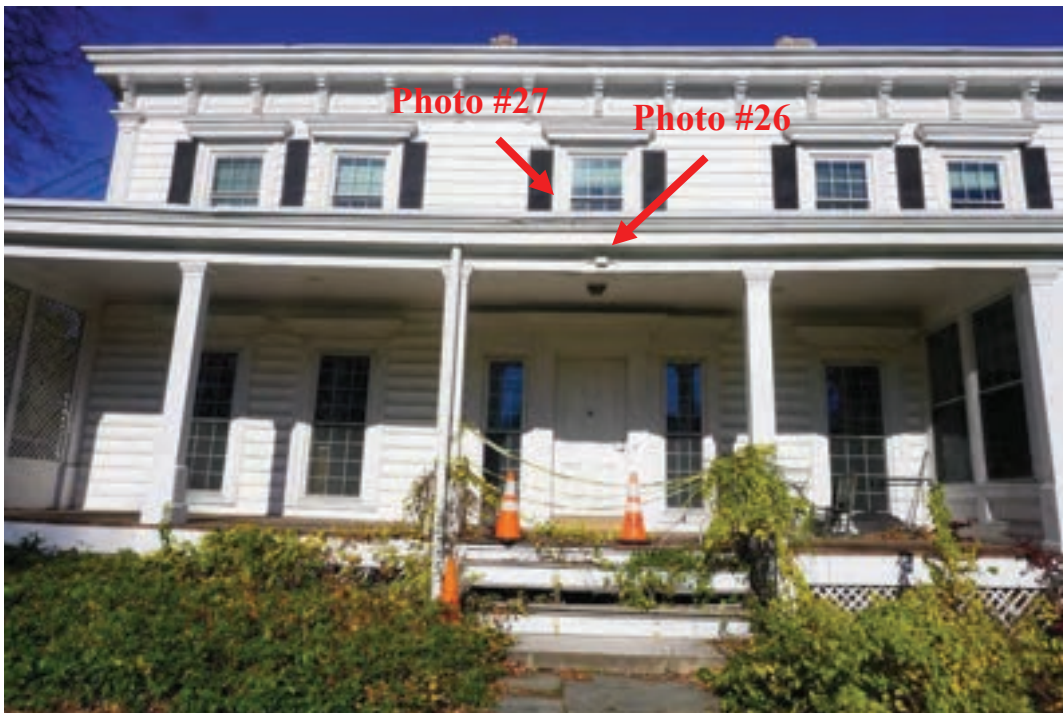
no other signs of movement apparent; apply crack gauge & monitor; this is a standard kind of condition we encounter; & is just an occasion for analysis before a standard repair with a soft or hard joint to prevent water entry

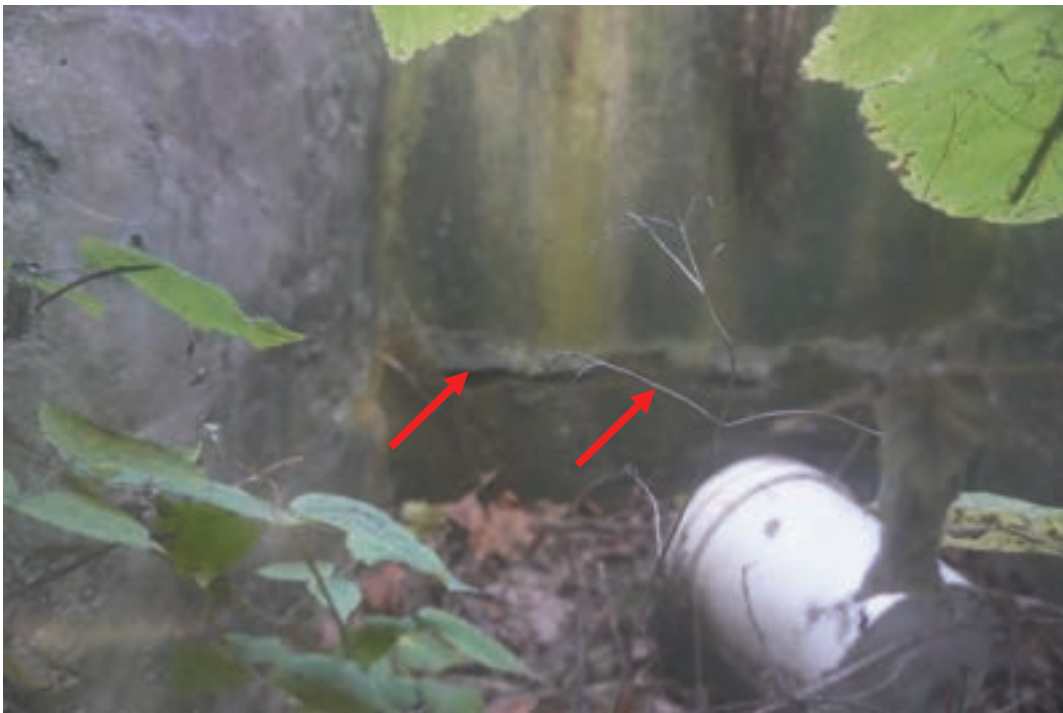
Photo #40: Water infiltration around cellar window, north façade of home at window well.
maintain exterior; clear window well of organics

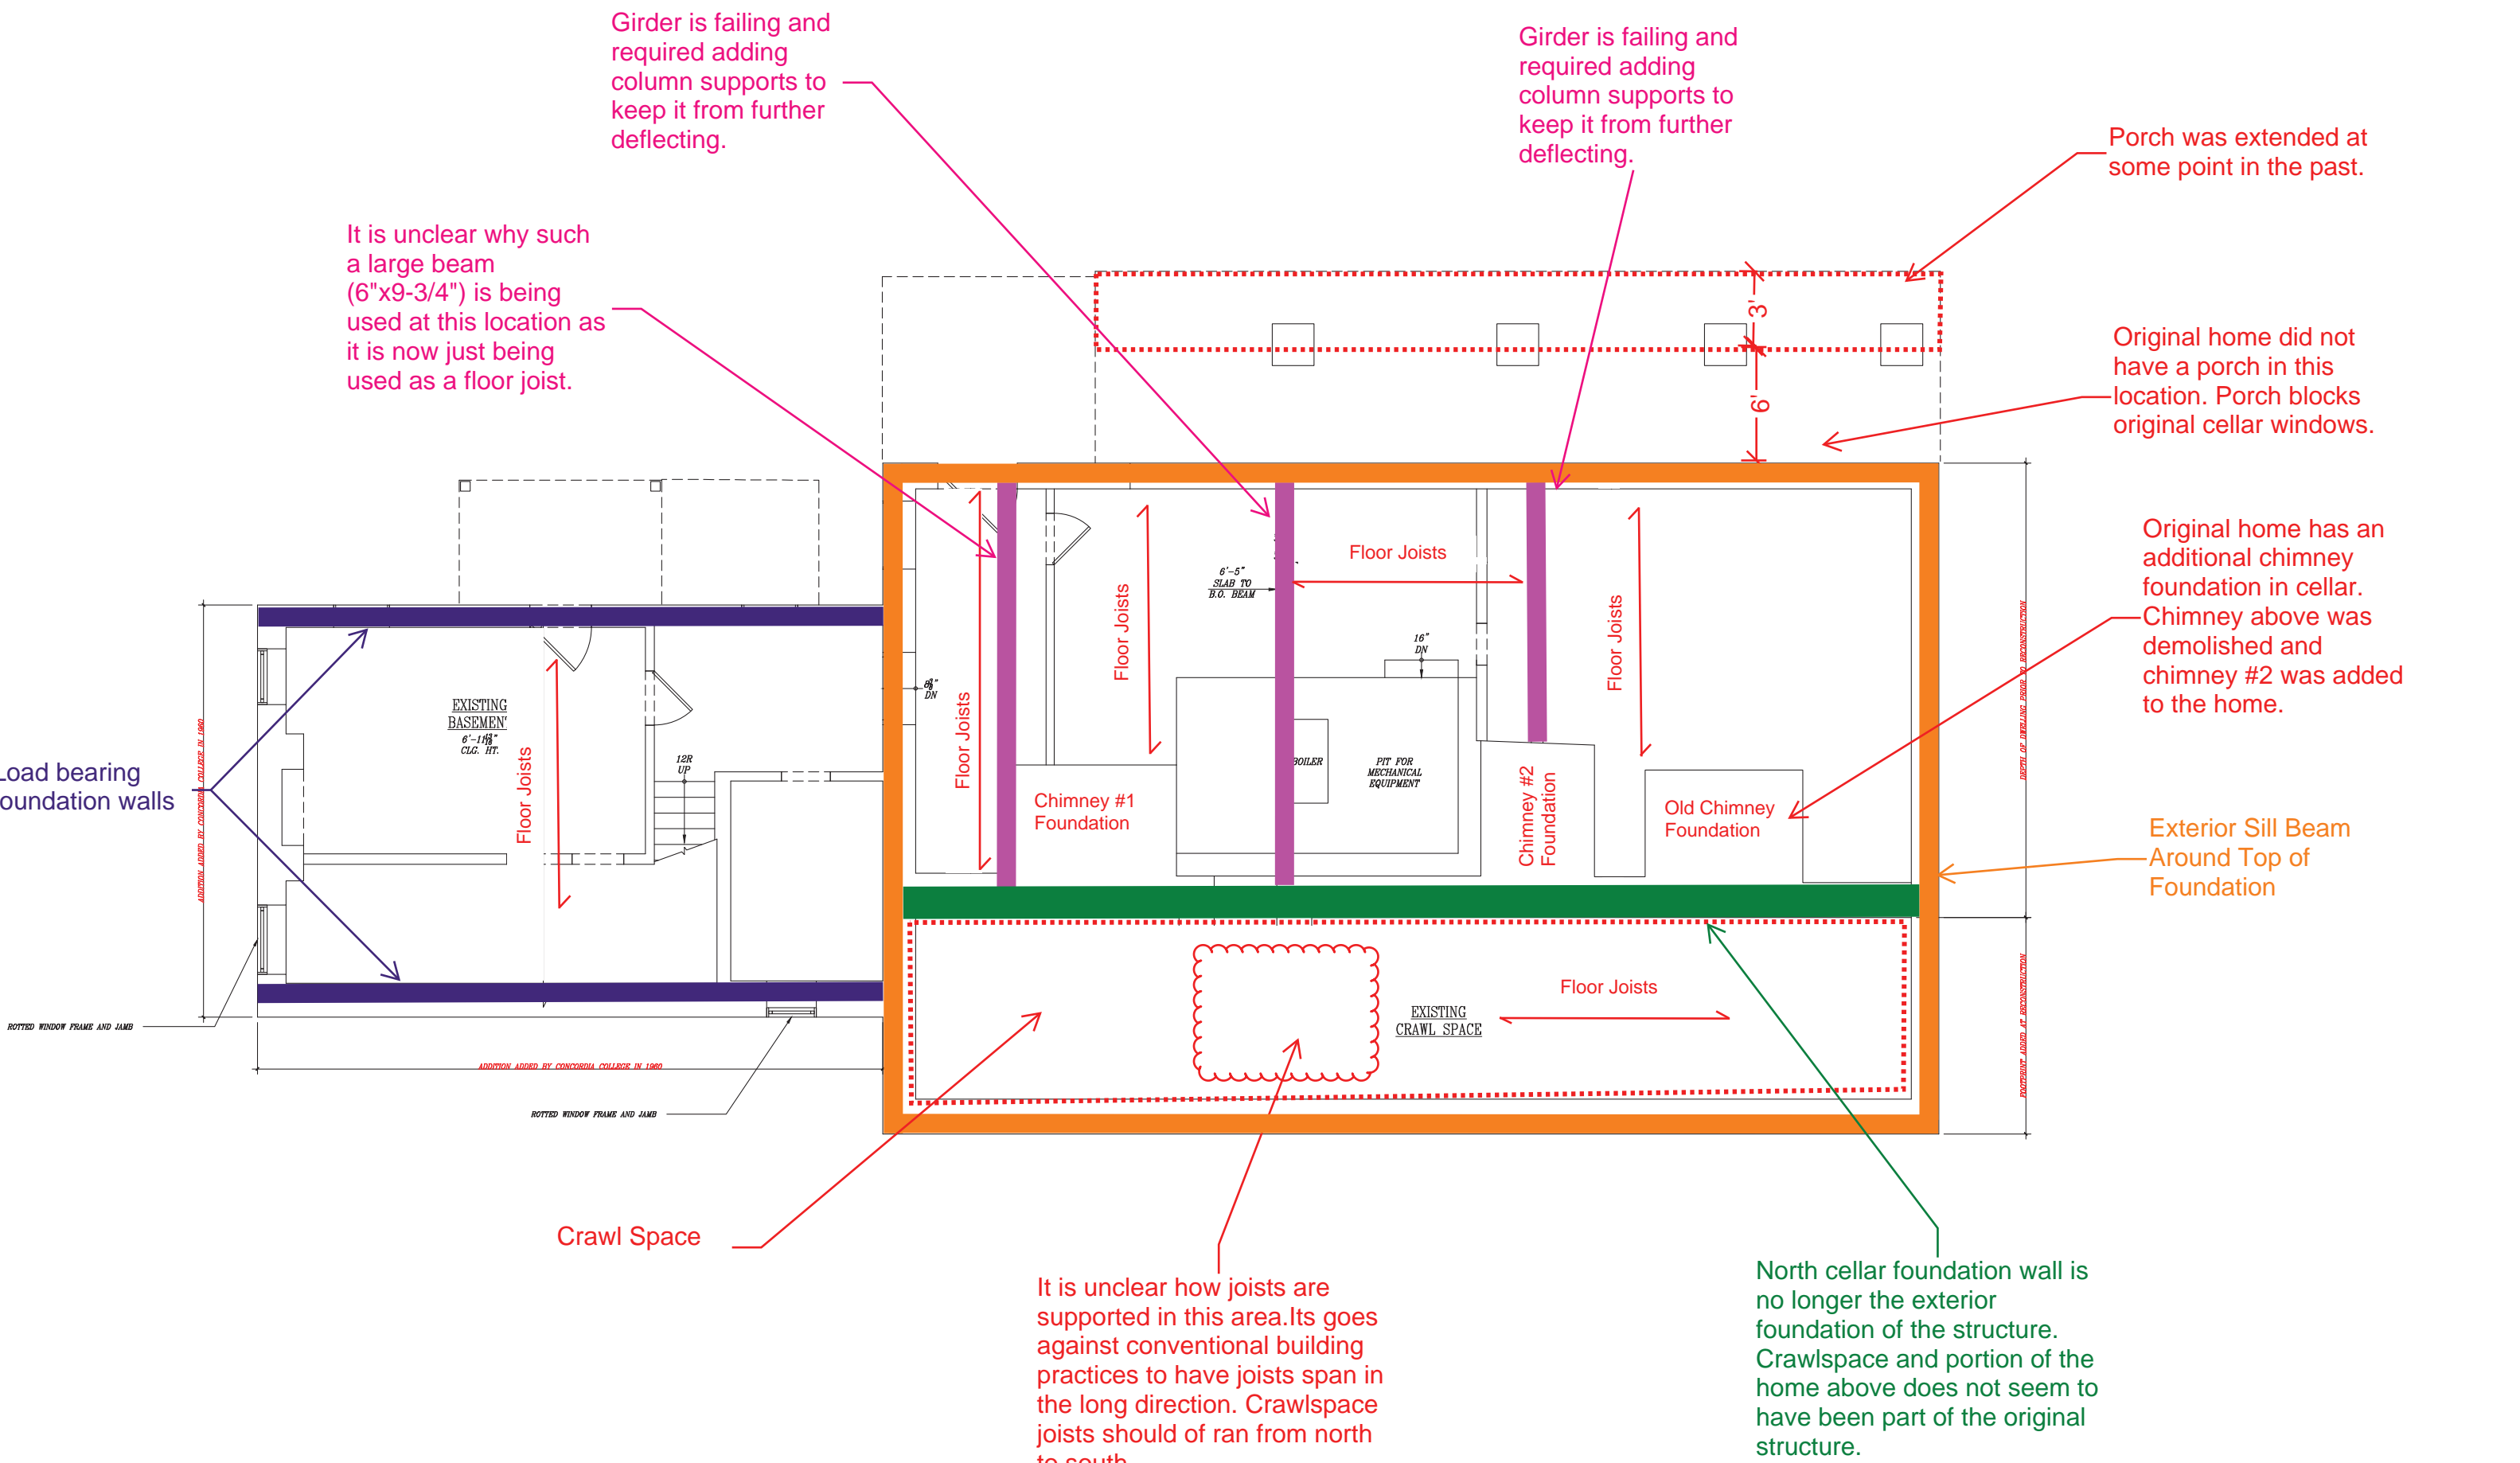
Girder is failing and required adding column supports to keep it from further deflecting.
