Marble Quarry Landfill Site

Draft Remedial Action Work Plan

April 14, 2016

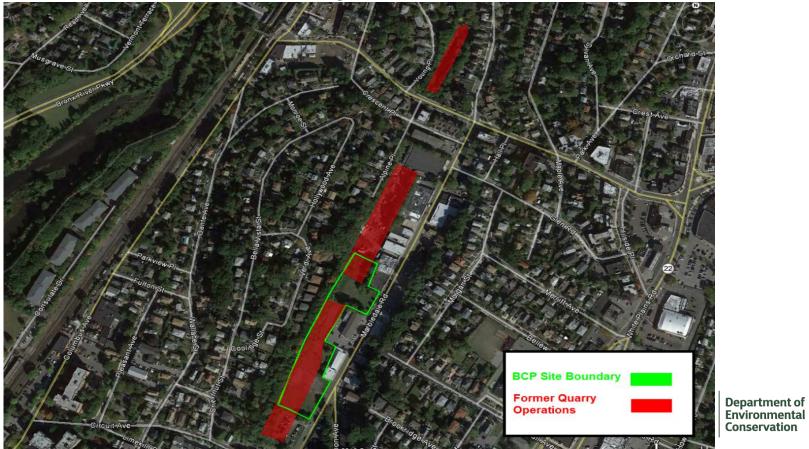
Former Marble Quarry/Landfill Limits

- Located in the Village of Tuckahoe
- Vacant 3.5 acre lot, made of 2 tax parcels
- Residential Verdi Avenue to the west, commercial properties to the north, Marbledale Road and commercial properties to the east, and to the south a large parking area
- The current site zoning is commercial

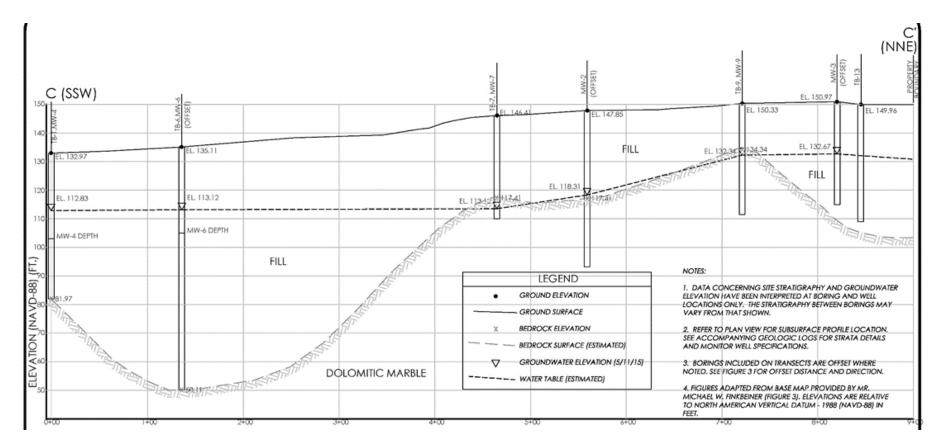
Site Cross section S/SW to N/NE

- 0-6 feet of sand fill material
- Below sand fill from 3-150 feet is a marble unit composed of dolomite marble
- Two marble pits are found on-site which were mined to a depth of approximately 100 feet below ground surface
- The two pits are filled with mix industrial wastes and comprise most of the site

- Two pits separated by marble bedrock rise and portions of the pits' sidewalls are within the site boundaries.
- Fractured bedrock units below the marble layer. The site is surrounded by shallow bedrock outcrops.
- Pits act as pools and fill with rain and runoff water.
- Groundwater pools release to bedrock and flows downgradient to south/southwest.
- Regional groundwater flow is to the south-southwest toward Bronx River.

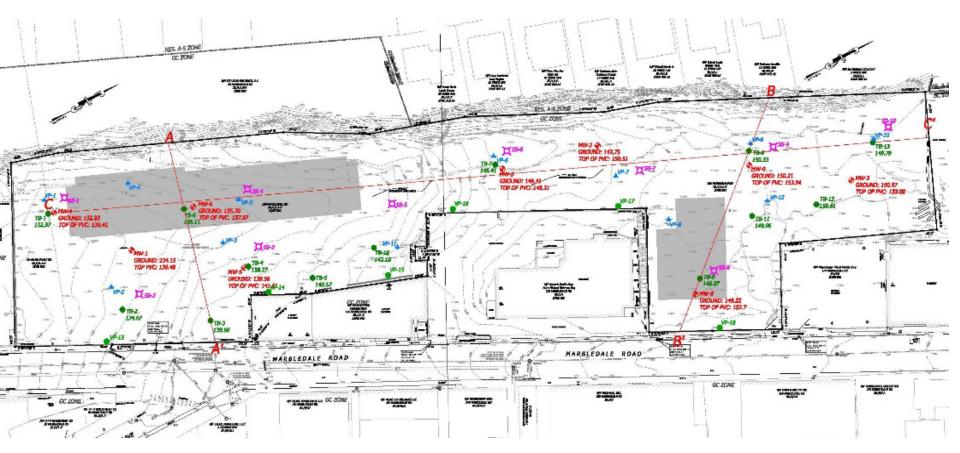
Sampling Locations

- Thirteen (13) soil borings;
- Collection and analysis of twenty-five (25) subsurface soil samples;
- Collection of analysis of ten (10) surface soil samples
- Installation of six (6) groundwater wells and groundwater sampling of nine (9) groundwater wells; and
- Installation and sampling of eighteen (18) soil vapor probes.

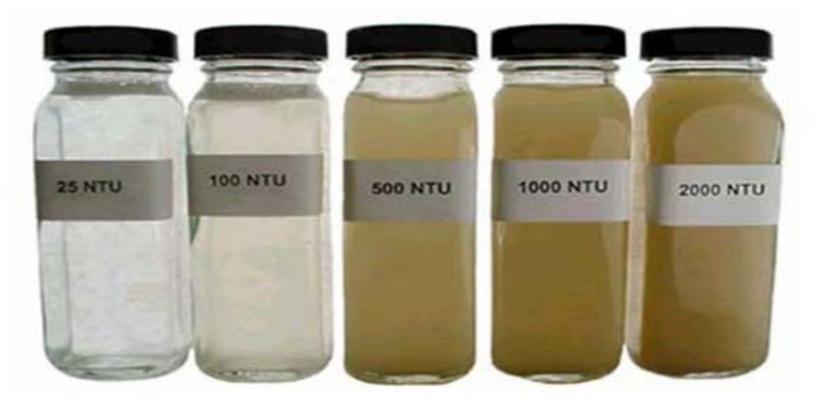
Turbid vs Non-Turbid

- Cloudiness or haziness of a fluid caused by large amounts of suspended particles
- DEC seeks to collect groundwater samples free of turbidity
- Samples with high turbidity readings can alter groundwater results as the particles are included with groundwater

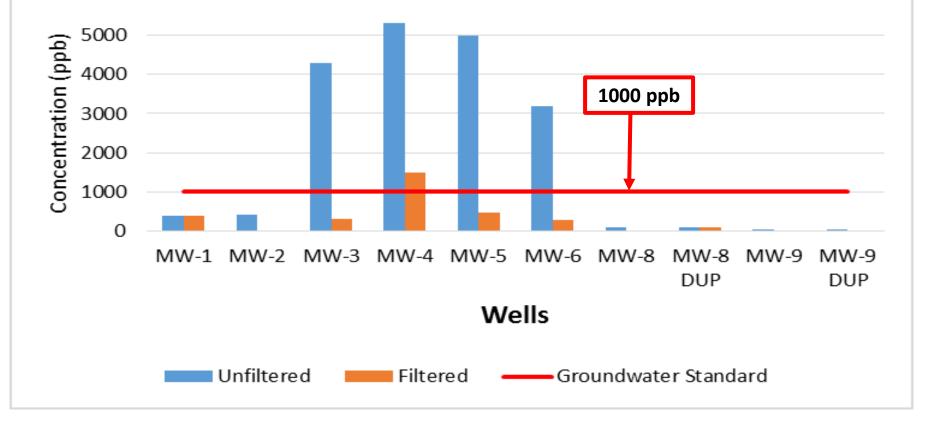
Barium Groundwater Unfiltered vs Filtered

Metals	GW Standard	Min. Concentration	Max. Concentration	Detections	Exceed GW Standard
Arsenic	25	5.6	10	5 of 10	0 of 10
Barium	1000	91	1500	10 of 10	1 of 10
Cadmium	5	0.53	0.53	1 of 10	0 of 10
Chromium	50	1.7	4.8	5 of 10	0 of 10
Cobalt	5	1	4.9	8 of 10	0 of 10
Copper	200	2	3.6	2 of 10	0 of 10
Iron	300	300	21400	10 of 10	10 of 10
Lead	25	6.4	13	4 of 10	0 of 10
Manganese	300	230	1100	10 of 10	9 of 10
Nickel	100	1.7	11	10 of 10	0 of 10
Sodium	20,000	37400	1040000	10 of 10	10 of 10
Zinc	2,000	1.6	82	9 of 10	0 of 10

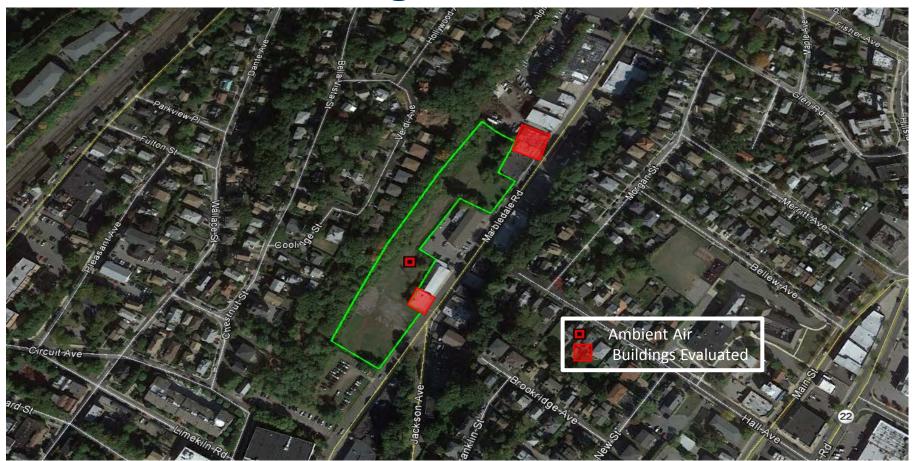
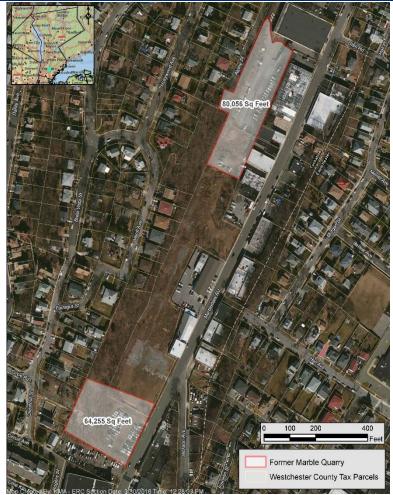
Off-Site SVI Investigation

- Site includes 40, 117, & 225 Marbledale Road
- Remainder of the quarry pits outside the BCP site
- Site is roughly 3.1 acres in size

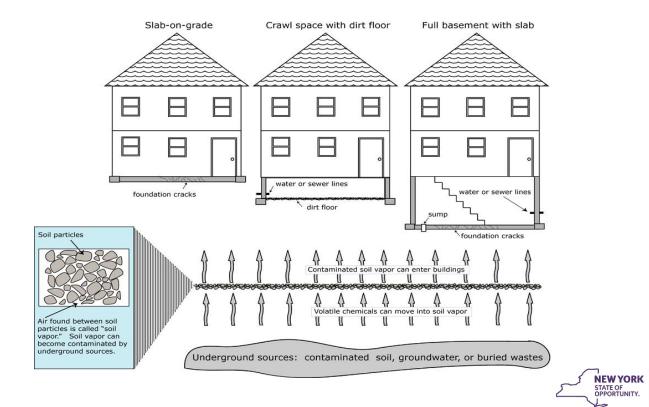
How can Indoor Air be Impacted?

- There are no buildings on the site; inhalation of site-related contaminants via soil vapor intrusion (SVI) does not represent a current concern.
- The potential for indoor air impacts via SVI in proposed on-site buildings will be addressed by the use of vapor barriers and the operation of active sub-slab depressurization systems.
- The potential for SVI is being evaluated in offsite structures.
