**Former Marble Quarry Landfill
109 Marbledale Road
Tuckahoe, New York**

NYSDEC Brownfield Cleanup Program #C360143

Community Meeting # 12

June 28, 2017

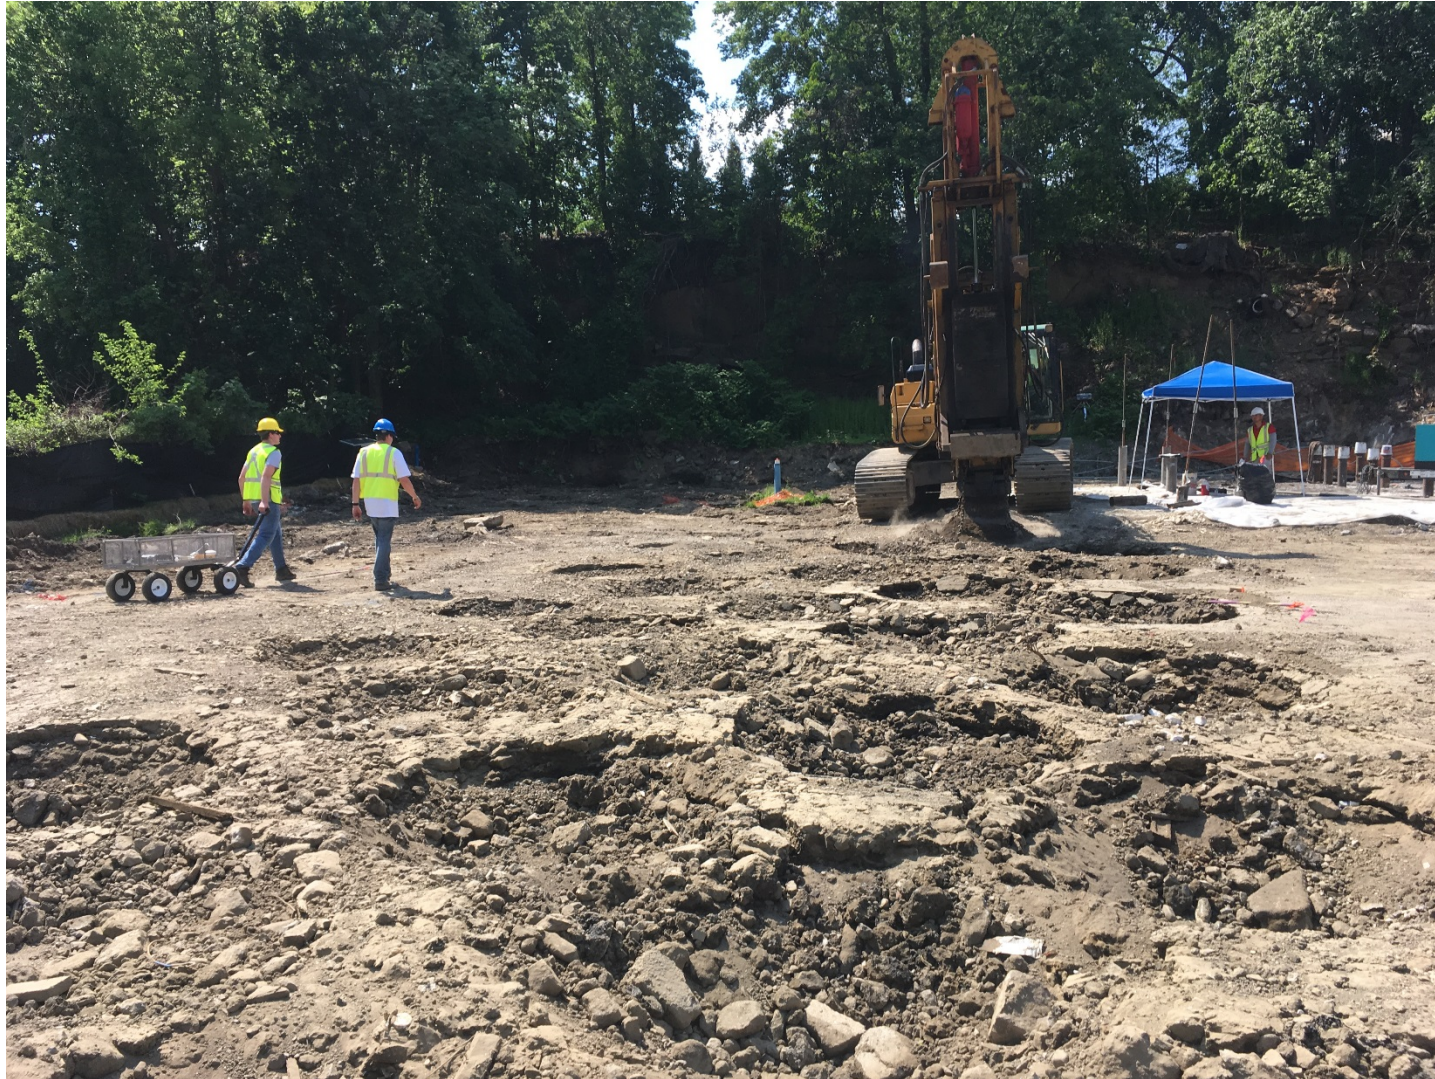
RIC (Rapid Impact Compaction)

- GeoStructures, Inc. completed RIC work on June 8, 2017.
- RIC only occurred between the hours of 8:00 AM and 5:30 PM on weekdays.
- CAMP stations were used to monitor the site during all RIC work.
- Vapor monitoring of the designated vapor wells was preformed during all RIC work.

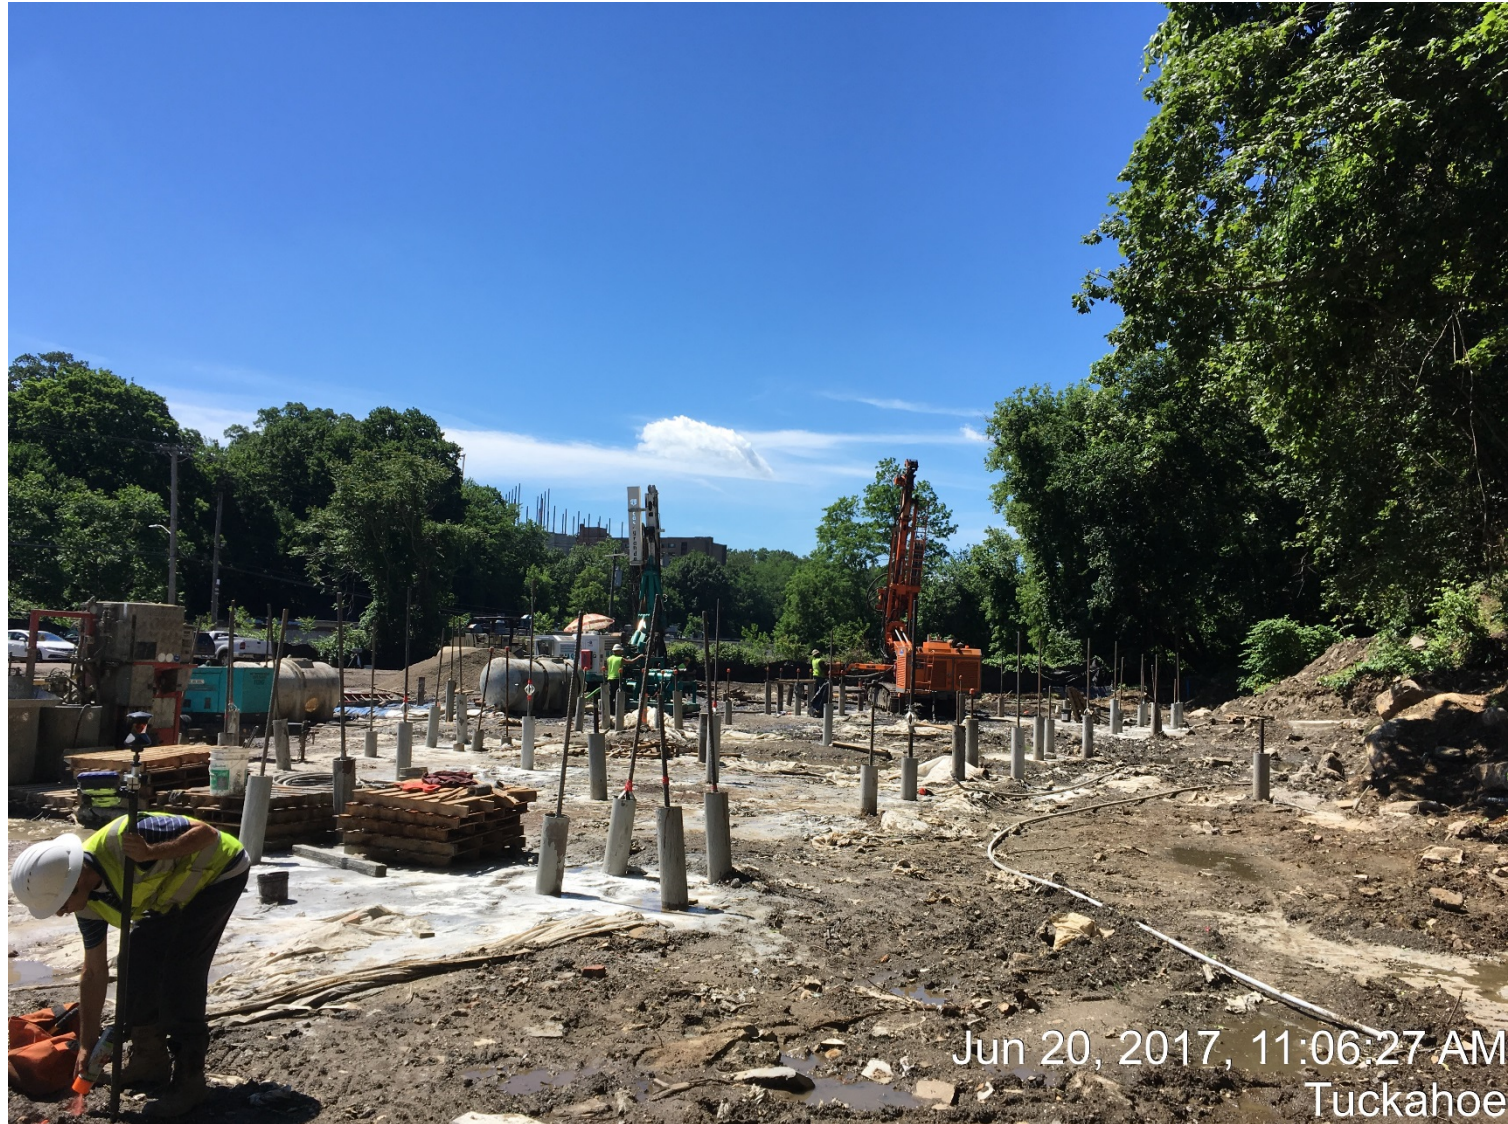
Pile Drilling

- EBC (Environmental Bulkheading Corp.) has continued pile drilling using two drill rigs and the mud rotary drilling method. Drilling occurs between the hours of 7:00 AM and 7:00 PM on weekdays and some Saturdays.
- As of this week pile work is 75% complete.
- CAMP stations are used to monitor the site during all pile drilling work.
- Vapor monitoring of the designated vapor wells is being preformed during all pile drilling work.

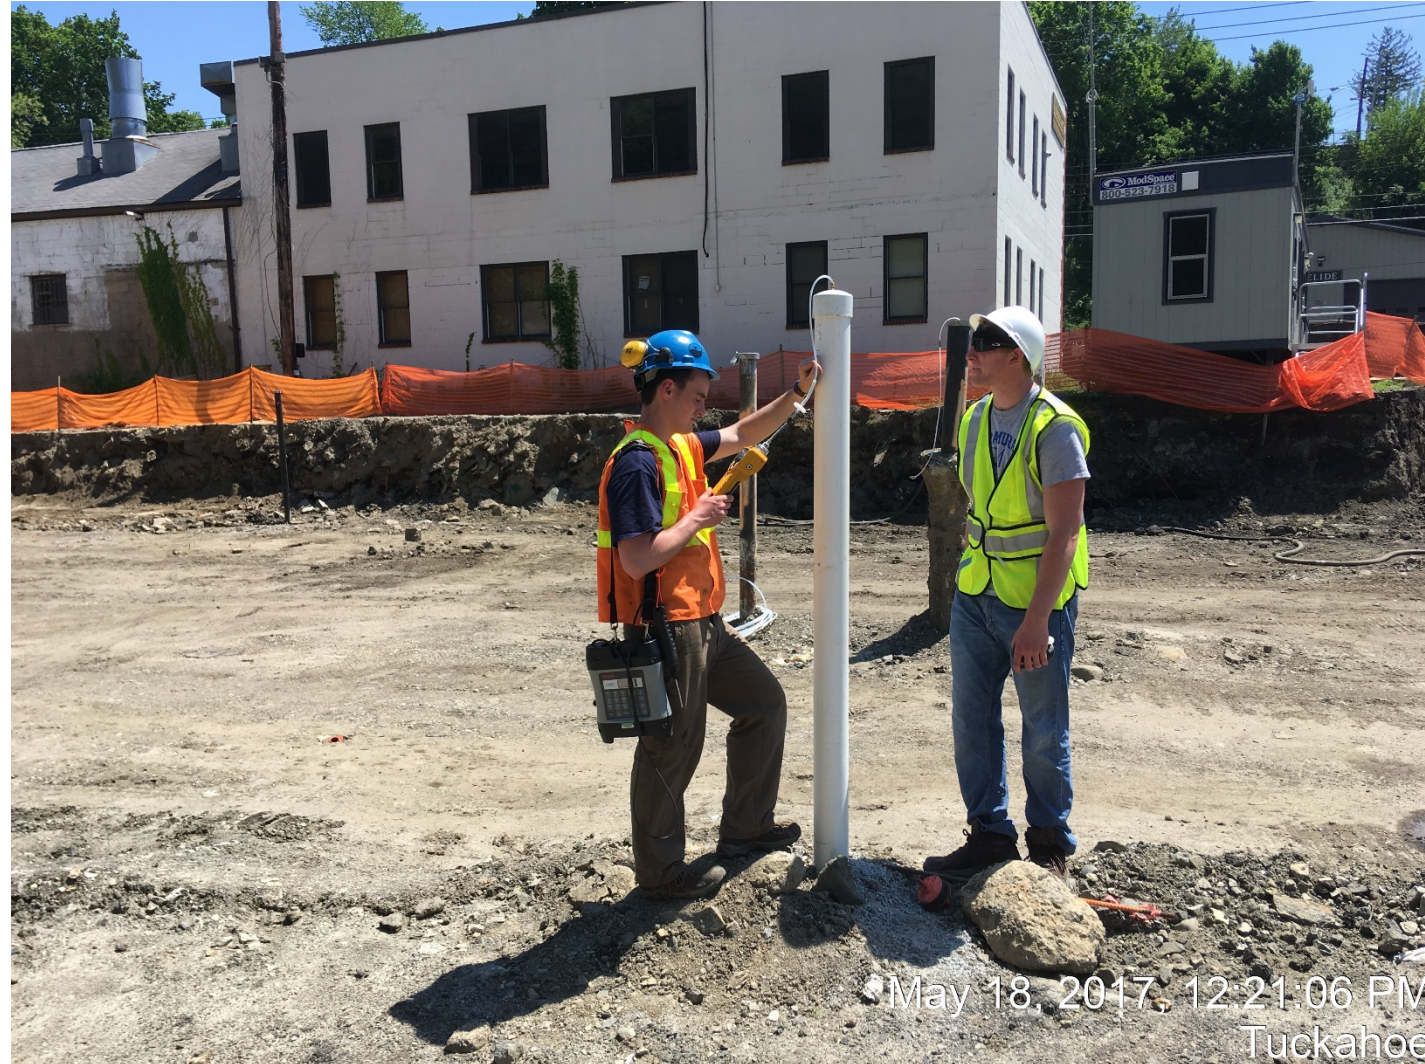
Vapor Well Monitoring

- HES, HDR, and NYSDEC agreed upon which vapor wells and monitoring wells should be monitored for vapors using a PID, FID, and Four Gas meter during all RIC and pile work.
- HES monitored vapor levels in all agreed-upon wells in the localized area of RIC and pile work each day. Vapor monitoring is performed at the selected vapor wells a minimum of once every three hours while work continues.
- Three to four rounds of vapor monitoring occurred each day, depending on how long contractors worked on each given day.
- All results were shared with the NYSDEC and HDR on a daily basis for review and discussion.

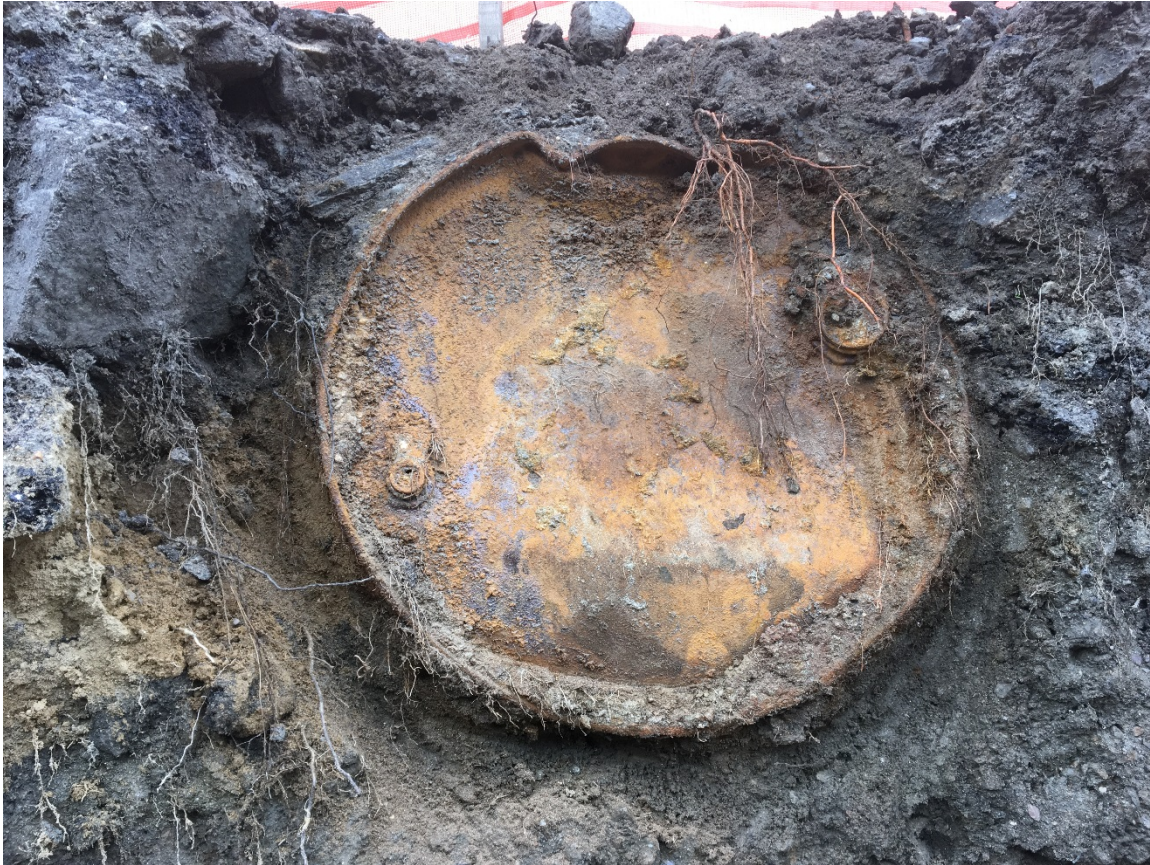
Uncovered Drum

- During excavation one steel drum (<55-gallons) was uncovered.
 - Drum was empty.
 - Field screening of surrounding soils and inside of drum did not result in elevated readings.

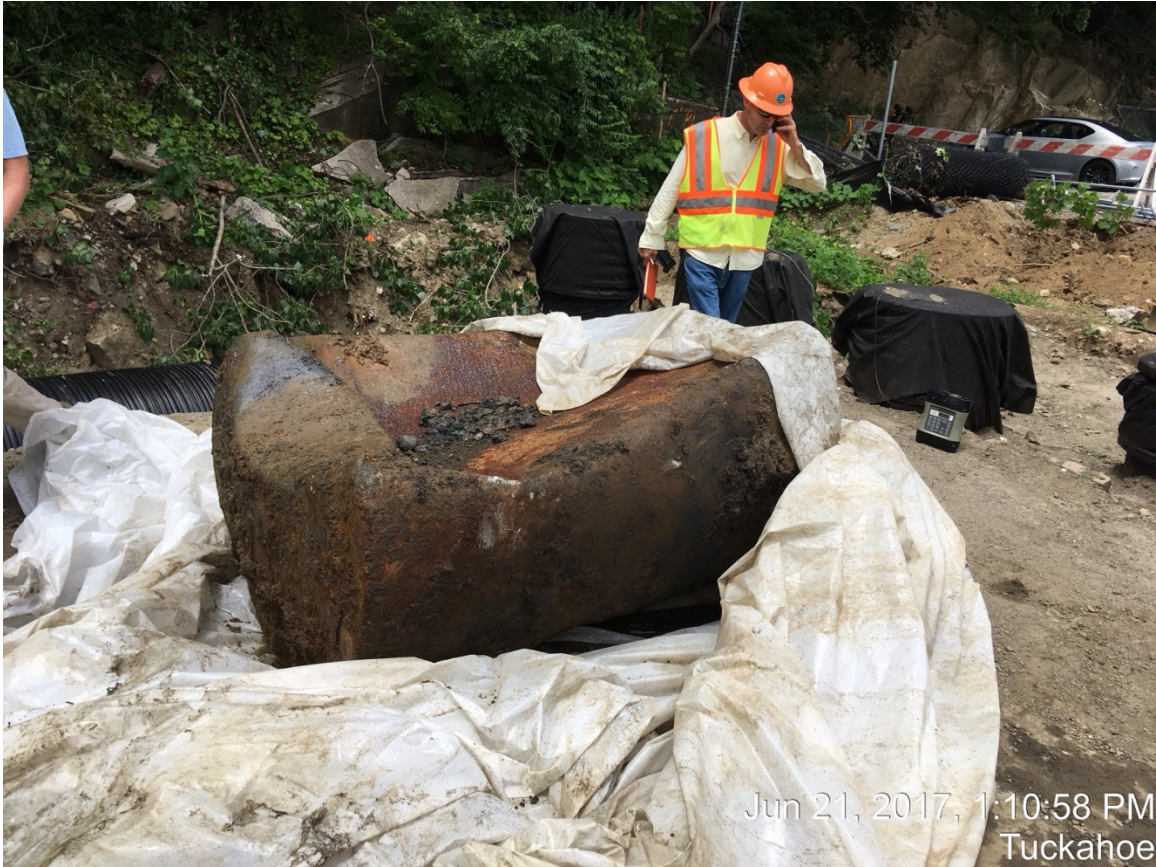
Uncovered UST

- During excavation of northern most retention basin system, one < 550-gallon steel UST was encountered and removed.
 - UST is staged adjacent to the excavation pending sampling results of its contents.
 - Surrounding soil was screened and stockpiled for disposal.
 - Excavation end-point samples were collected. Results are pending.
