**Former Marble Quarry Landfill
109 Marbledale Road
Tuckahoe, New York**

NYSDEC Brownfield Cleanup Program #C360143

Community Meeting # 13

October 11, 2017

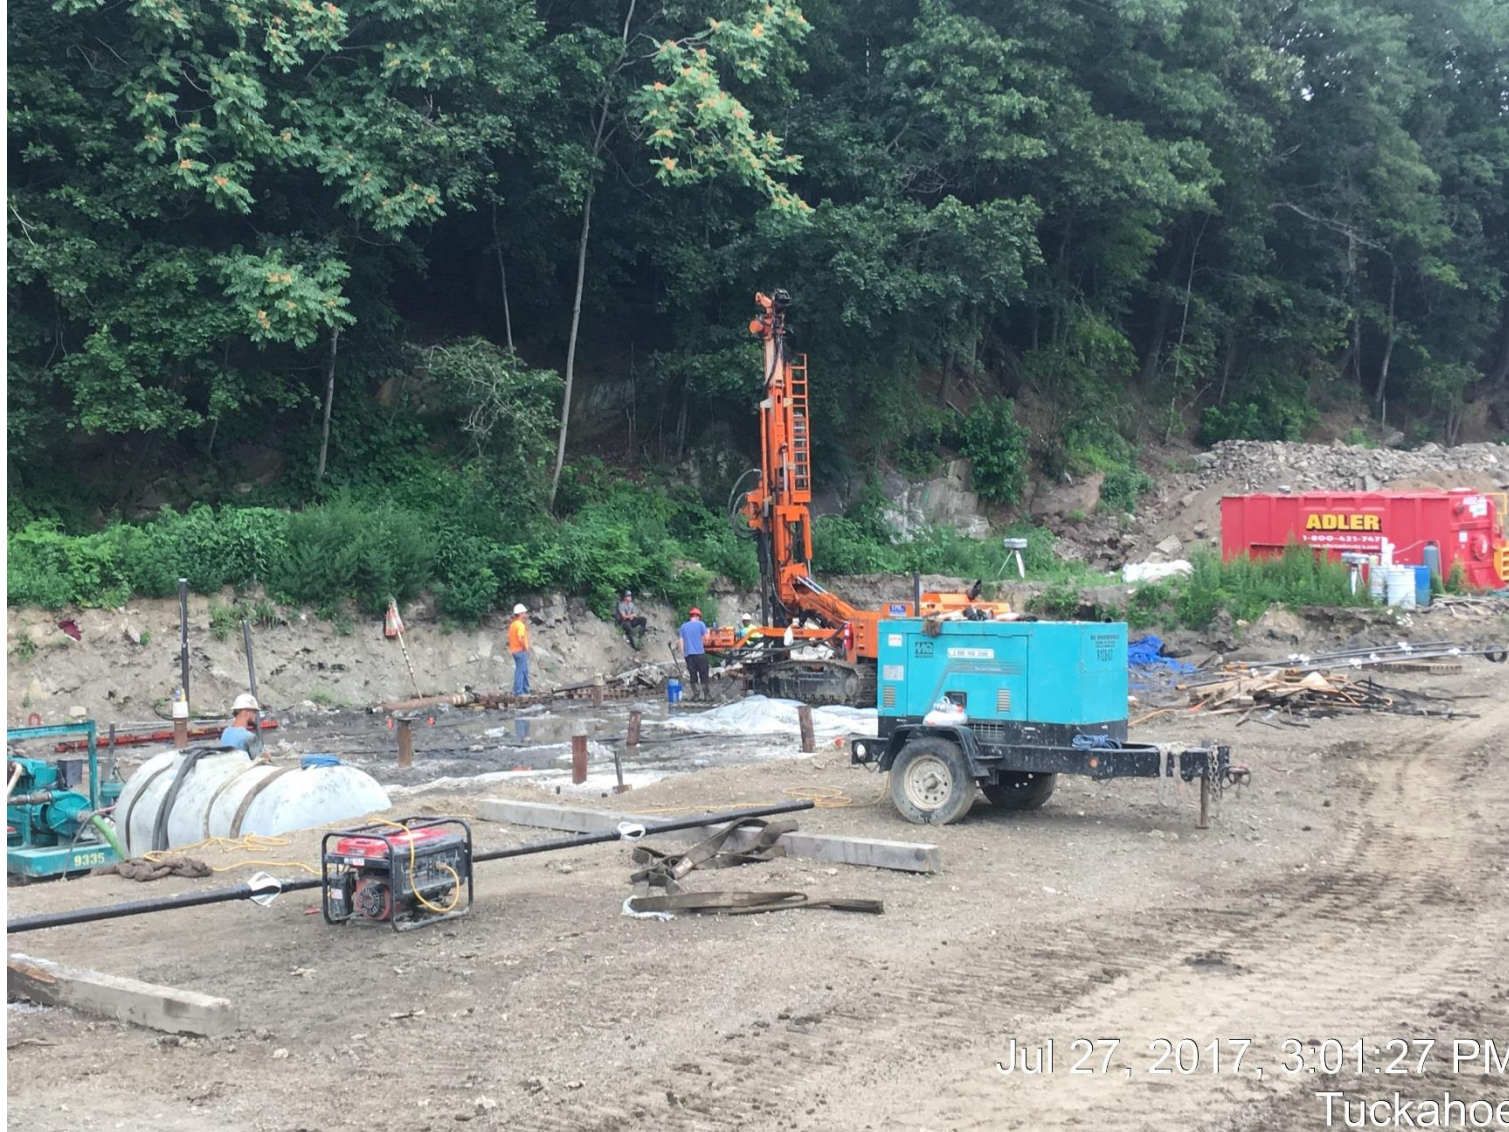
Pile Drilling

- EBC (Environmental Bulkheading Corp.) continued pile drilling using two drill rigs and the mud rotary drilling method. The final hotel pad pile was drilled on August 22, 2017.
- CAMP stations were used to monitor the site during all pile drilling work.
- Vapor monitoring of the designated vapor wells was performed during all pile drilling work.

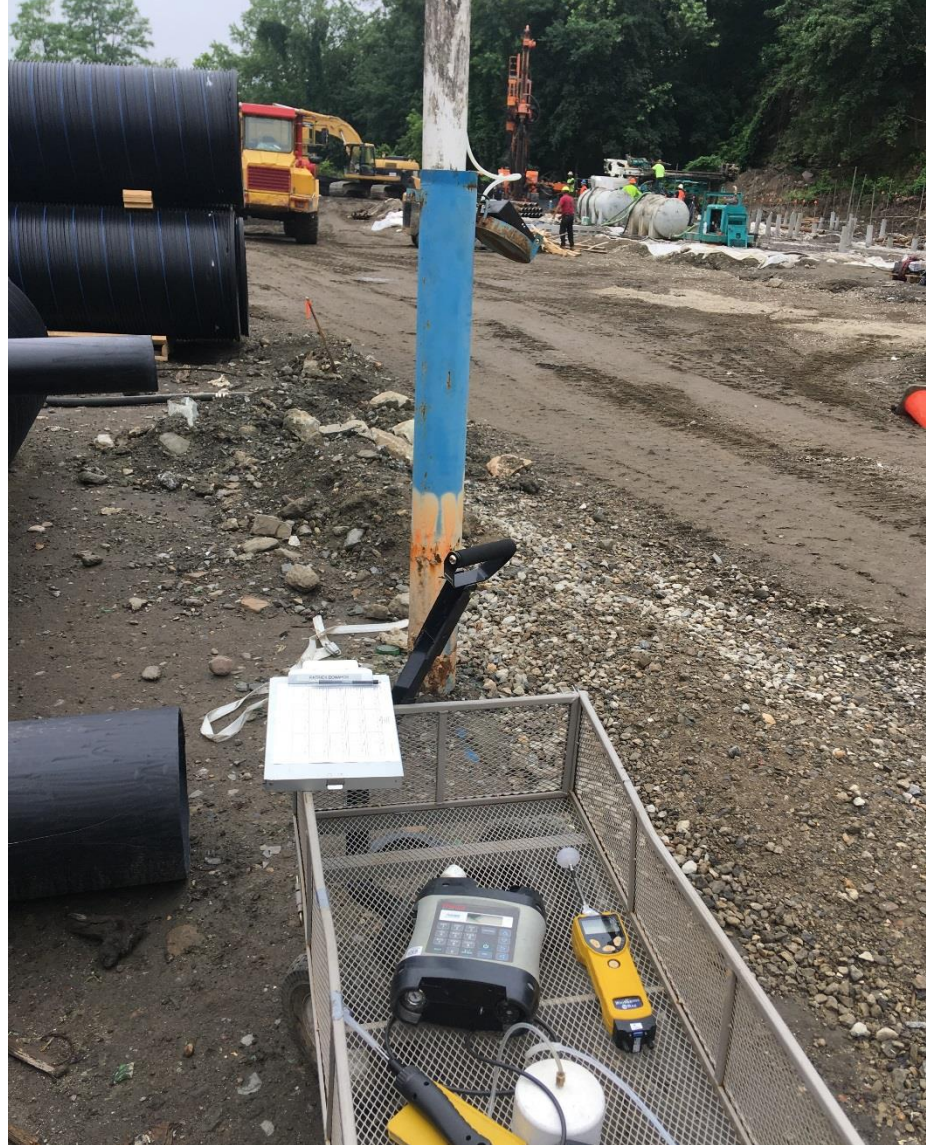
Vapor Well Monitoring

- HES, HDR, and NYSDEC agreed upon which vapor wells and monitoring wells should be monitored for vapors using a PID, FID, and Four Gas meter during pile work.
- HES monitored vapor levels in all agreed-upon wells in the localized area of the pile work each day. Vapor monitoring was performed at the selected vapor wells a minimum of once every three hours while work continued.
- Up to three rounds of vapor monitoring occurred each day, depending on how long contractors worked on each given day.
- All results were shared with the NYSDEC and HDR on a daily basis for review and discussion.

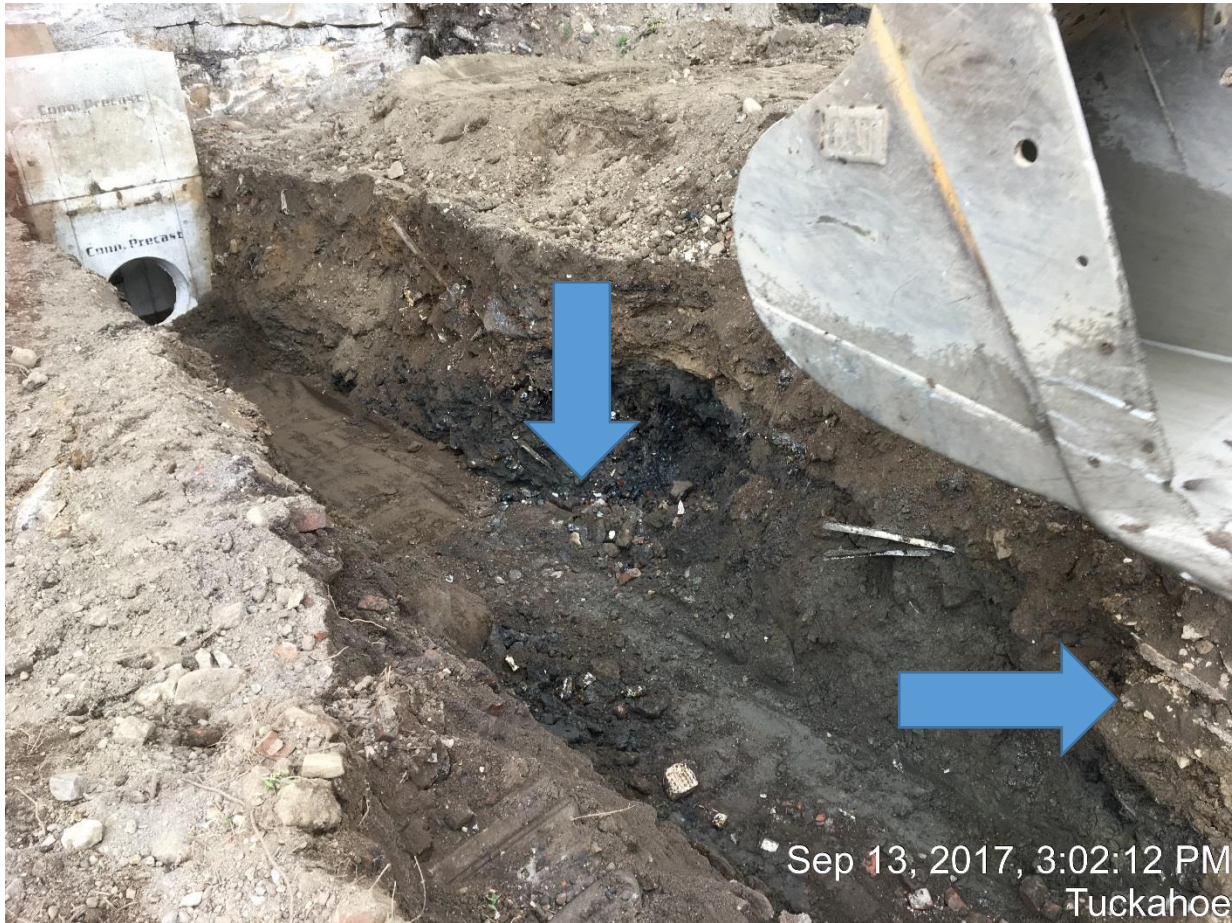
Uncovered Cosmetic Material and Revlon Products

- Additional cosmetic material, including Revlon products, was discovered during planned excavation for site drainage and sewer systems on July 20, July 31, August 1, August 14, September 13, October 3, and October 6, 2017.
- Material was stockpiled, sorted and placed in drums for off-site removal. Samples of canisters were sent to a certified laboratory for analysis.

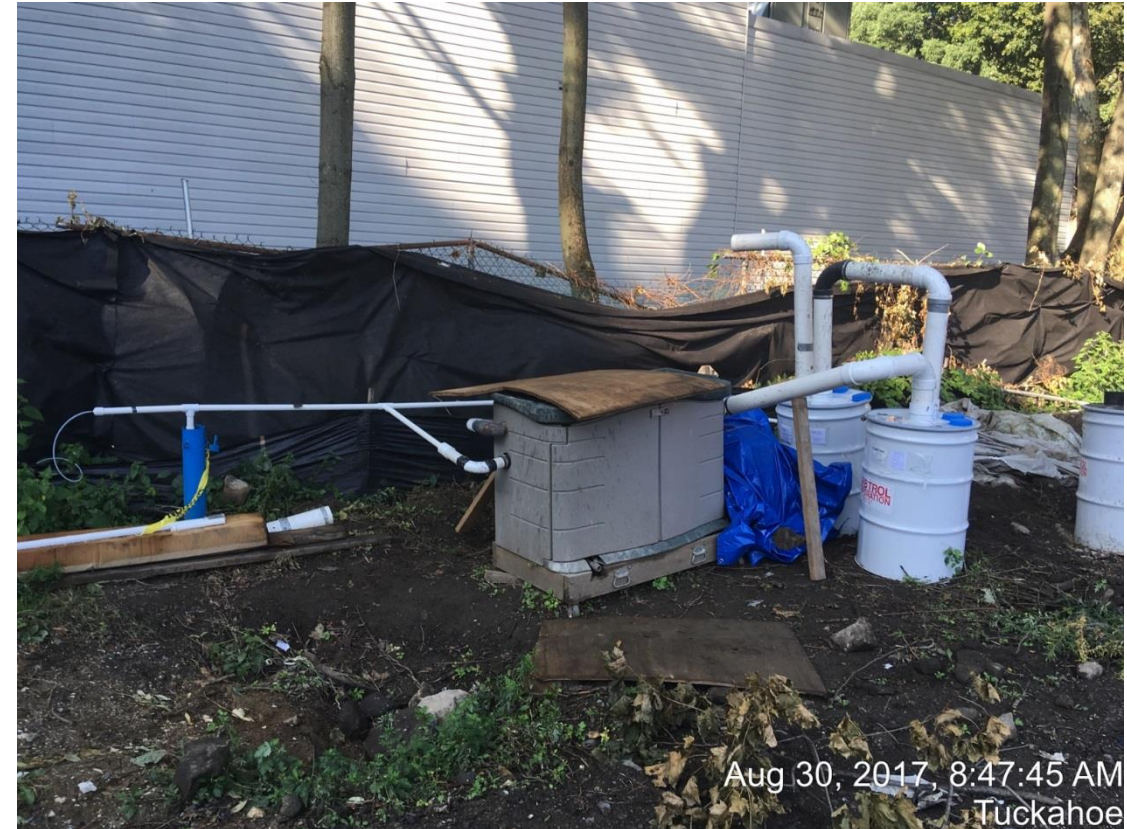
Temporary Soil Vapor Well Venting System

- A vapor venting system consisting of a generator, regenerative blower and carbon filtration drums was connected to 2 vapor wells and one vapor point in the vicinity of the restaurant pad.
- The system is in place for use during the possible future drilling of foundation piles in the restaurant pad.
- The system was operational for the purpose of collecting data for engineering purposes.

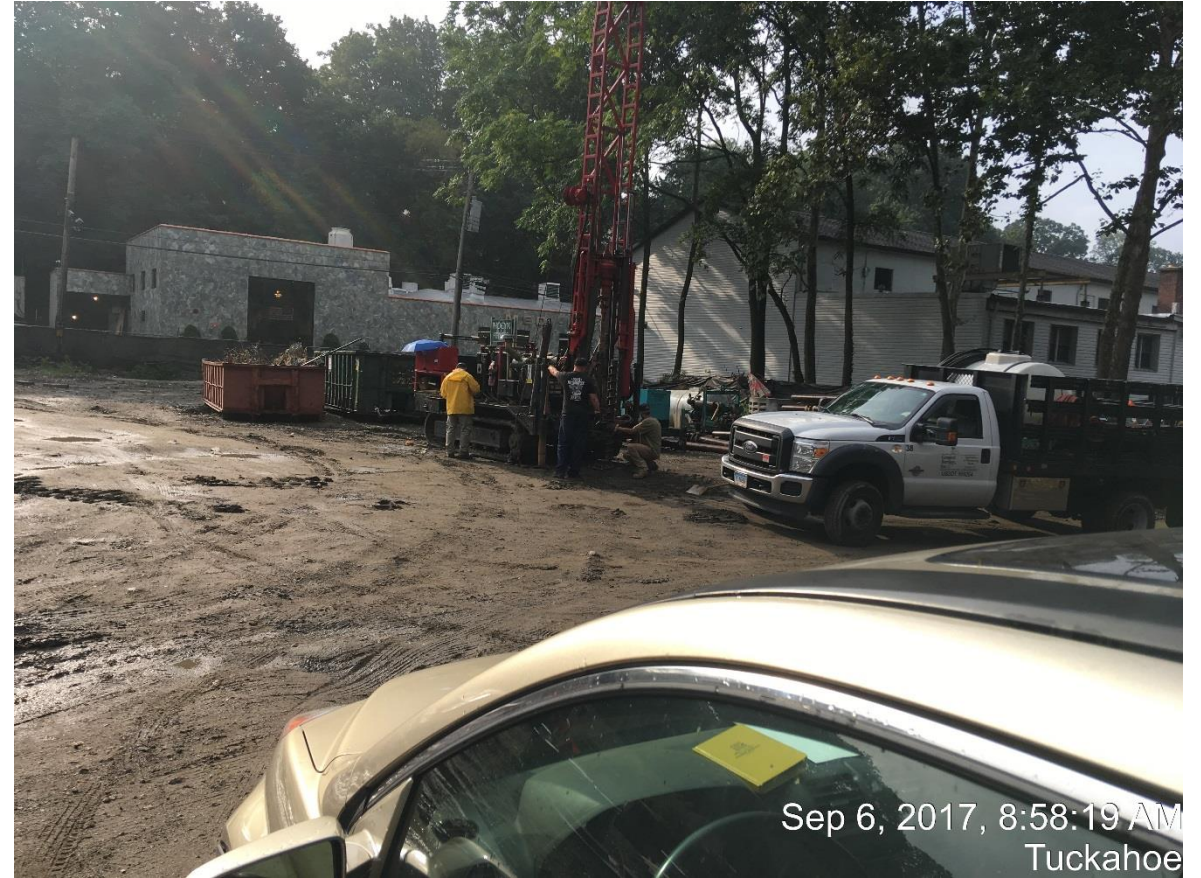
Restaurant Pad Test Borings

- General Borings, Inc. (GBI) installed two test borings in the restaurant pad for the purpose of collecting geophysical data on August 28, September 1, and September 6 of 2017.
- CAMP station monitoring, ambient air monitoring with a handheld PID, and operation of the soil vapor venting system occurred during the drilling of the test borings.

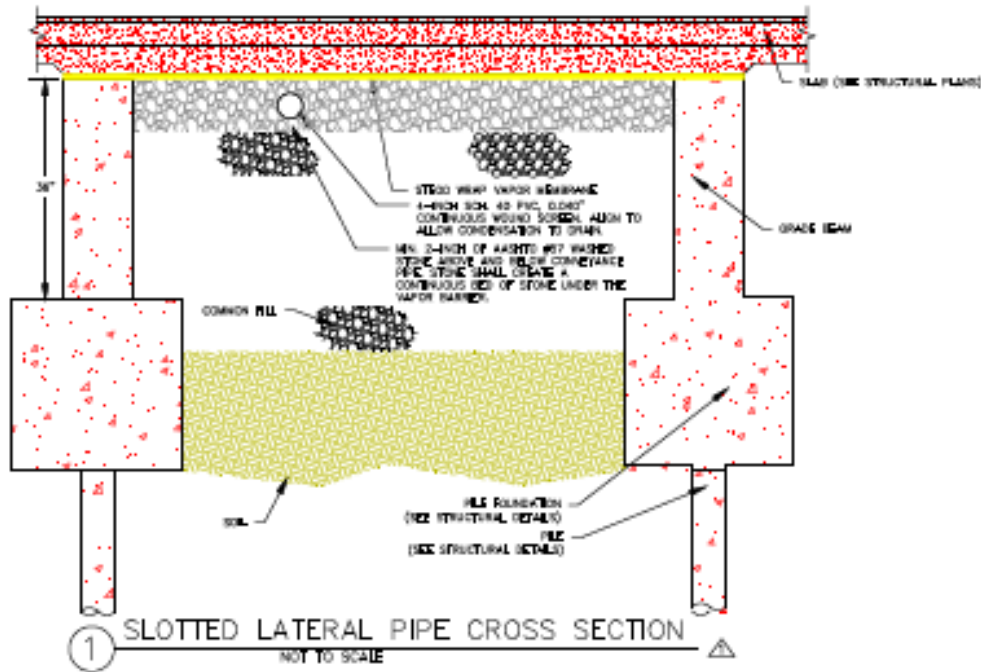
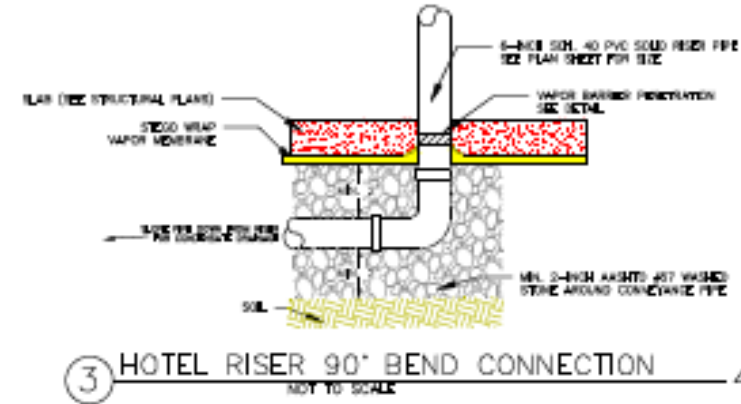
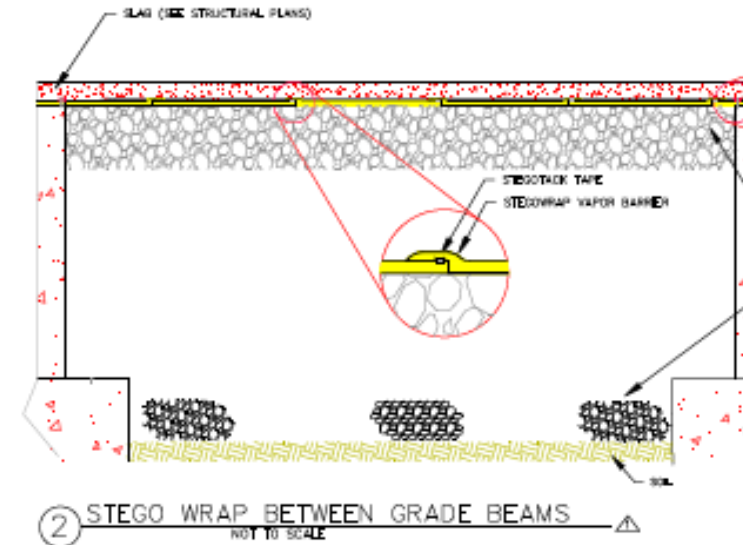
SSDS Design

NOTES:
ALL SLOTTED PIPE SHALL BE 4-INCH SCHEDULE 40 PVC BY JOHNSON SCREENS OR APPROVED EQUAL.

NOTES:
A CONTINUOUS STONE 2-INCH THICK BED OF 4-AGGREGATE 407 WASHED STONE SHALL BE BETWEEN
ALL PILE FOUNDATIONS UNDER SLAB. STONE BED SHALL BE COVERED WITH STEGOWRAP VAPOR
BARRIER OR APPROVED EQUAL. STEGOWRAP TAPE SHALL BE USED TO CONNECT SECTIONS OF
STEGOWRAP AND TO FOUNDATION FOOTING.
