NEW YORK STATE DEPARTMENT OF ENVIRONMENTAL CONSERVATION

Division of Environmental Remediation, Remedial Bureau C

Re: Radiation Screening
Former Marble Quarry Landfill
Site ID No. C360143
Tuckahoe, Westchester County

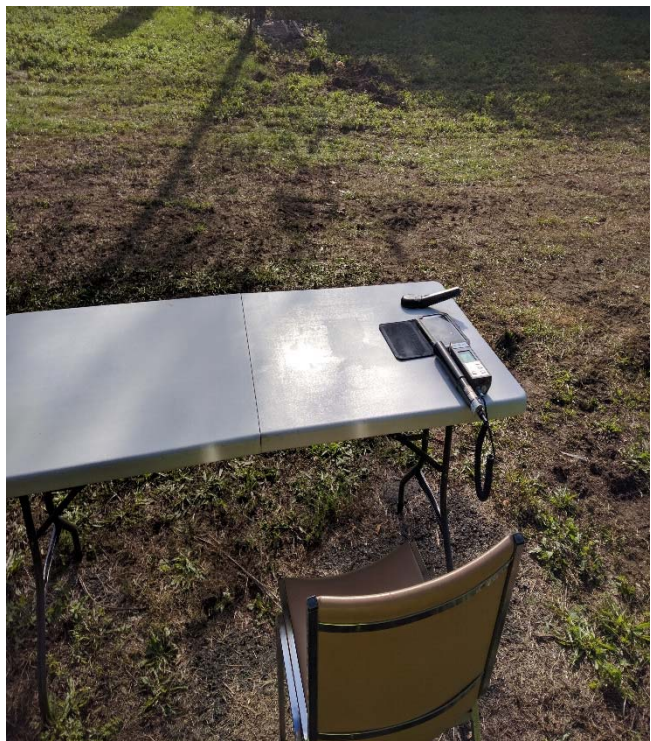
Sample Scanning Area

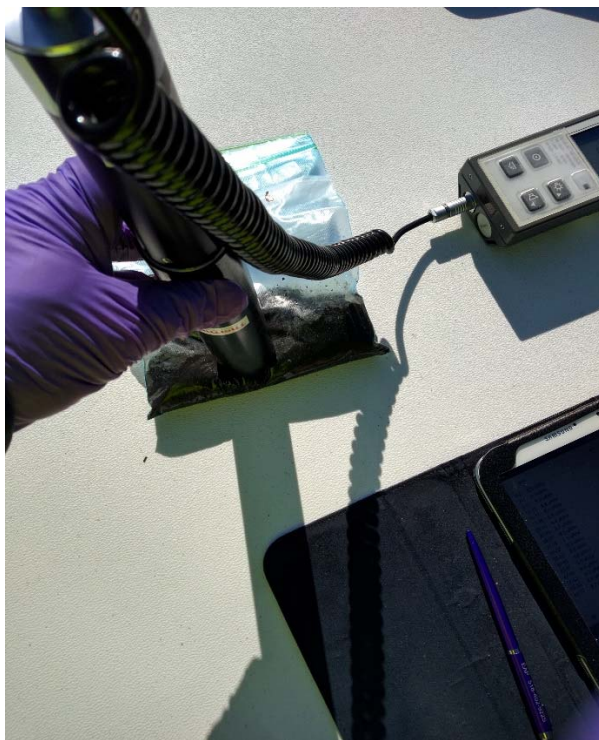
All bagged materials were scanned with both the 1x1 NaI probe for potential gamma emitting radionuclides and the G-M probe which has the ability to detect Alpha, Beta and Gamma emissions. Due to the moisture content of the materials, the Alpha scintillator probe was not utilized as Alpha particles are easily attenuated by excess moisture in materials.

Sample Scanned Using 1x1 NaI Probe
