**Re: *Biggest Fish Westchester LLC*
§11A-9 Economic Hardship Request (Certificate of Appropriateness)
*230 White Plains Road - Section 31. Block 3 Lot 13 ("Property")***

Property Location:	230 White Plains Road Tuckahoe, NY 10707
Inspection Dates:	Initial Inspection: 9/23/22 In Depth Inspection: 11/14/22 Probe Inspection: 12/13/22
Report Date:	1/28/23
Report By:	Peter Panagopoulos, P.E. <i>Principal</i> Pantec Engineering
Appendices:	Appendix A – Photos Appendix B – Probe Locations Appendix C – Structural Layout Appendix D – Deficiency Location Diagram Appendix E - Two Inner Chimney Georgia Colonial Layout

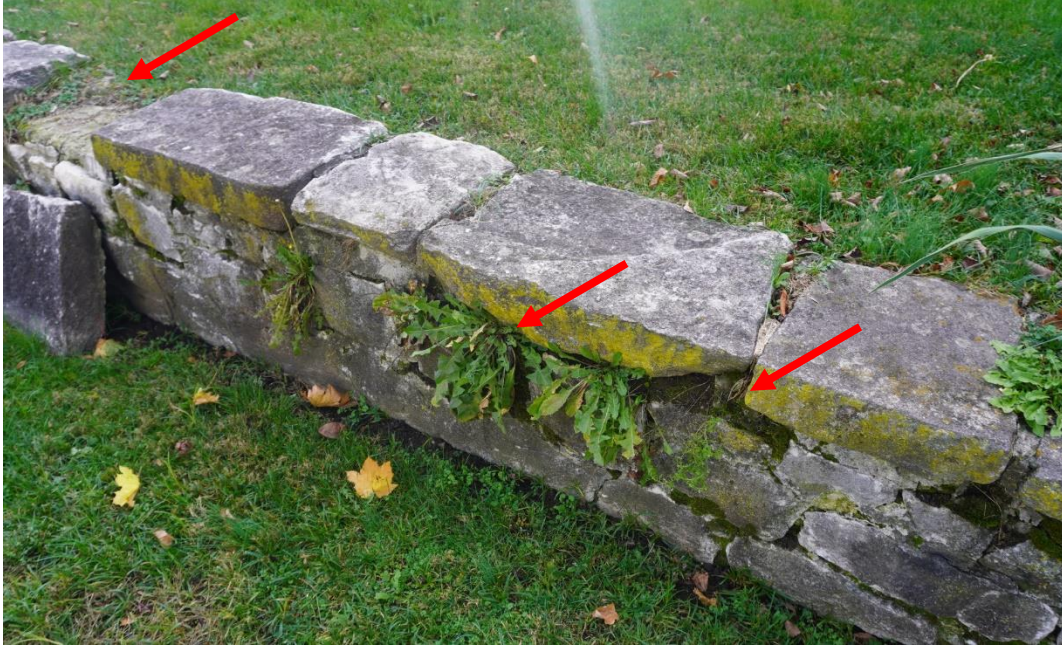
1. Retaining wall that runs from between front entrance and driveway is deteriorating throughout. Joints have filled with dirt. Multiple stone pieces no longer attached. Roots/ large weeds growing through joints of walls multiple locations. (Photo #1-3)
2. Retaining wall that runs between rear yard and adjacent sidewalk deteriorating throughout. Broken stones and joints between stones have filled with dirt/ organic growths. (Photo #11)

Photo #1: Retaining wall that runs from between front entrance and driveway is deteriorating throughout. Joints have filled with dirt. Multiple stone pieces no longer attached.

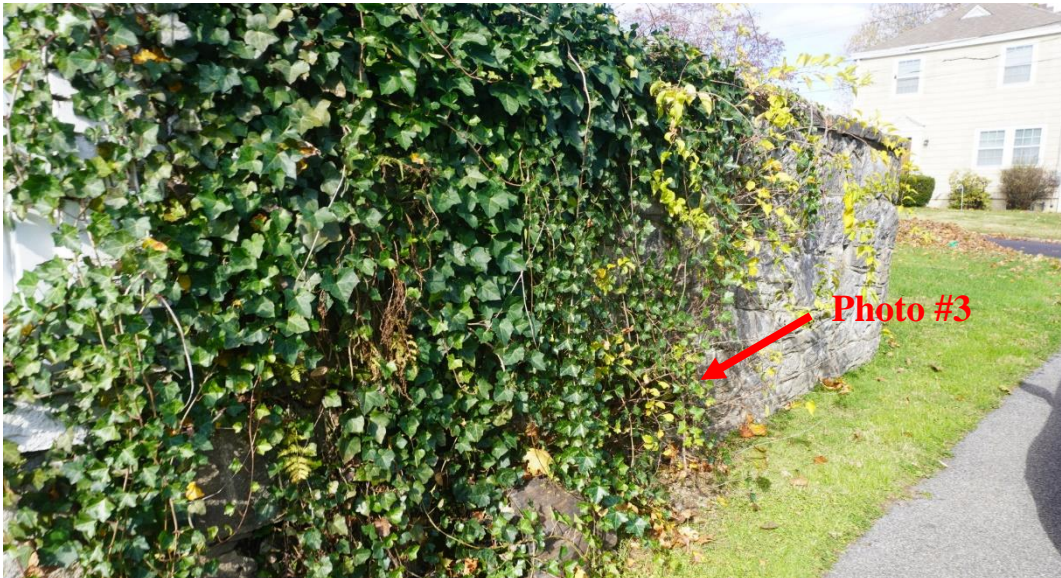
Photo #2: Retaining wall that runs from between front entrance and driveway is deteriorating throughout. Roots/ large weeds growing through joints of walls multiple locations.

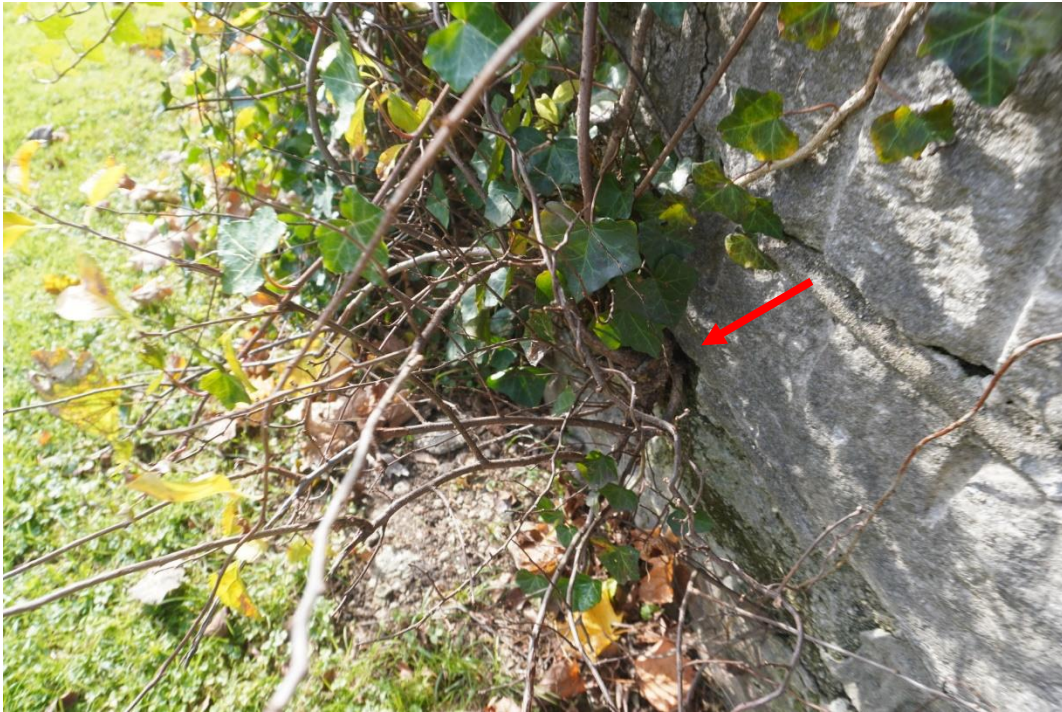
Photo #3: Retaining wall that runs from between front entrance and driveway is deteriorating throughout. Roots/ large weeds growing through joints of walls multiple locations.

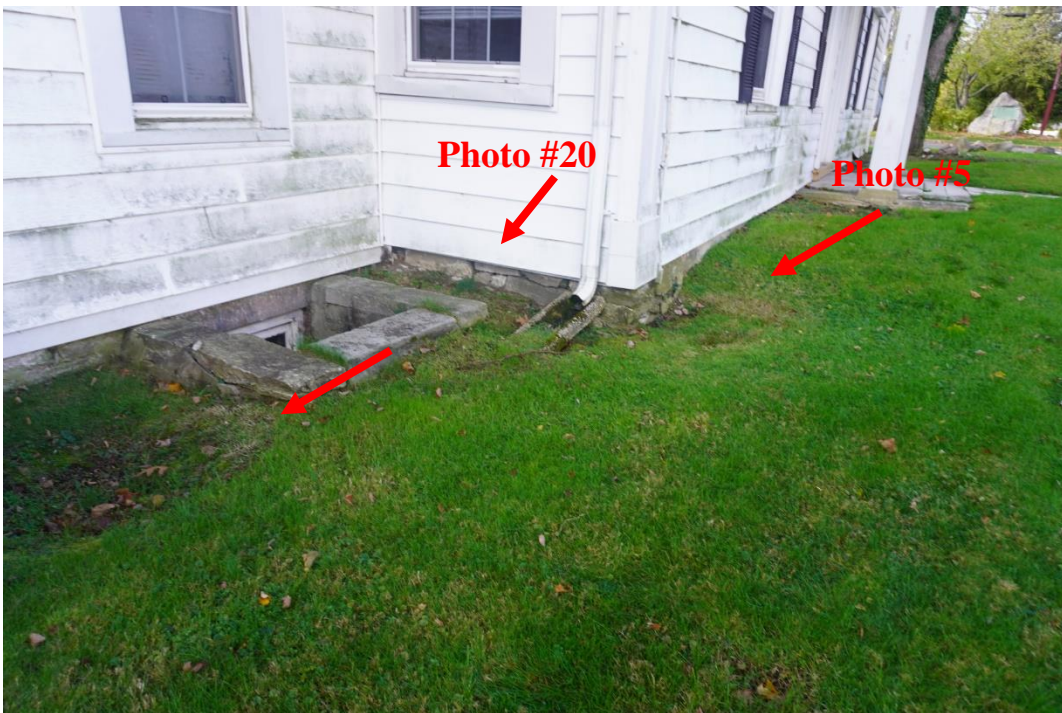
3. Negative grading front of home. Water pooling up against foundation wall and most likely infiltrating into crawlspace. Signs of foundation deterioration (Photo #4 - #6).
4. Stone slabs have settled/heaved creating multiple trip hazards, stone walkway rear yard (Photo #7).
5. Stone slabs have settled/ heaved creating multiple trip hazards, stone patio rear yard (Photo #8 - #10).

Photo #4: Negative grading front of home between entrance and northeast corner of original structure. Water pooling up against foundation wall and most likely infiltrating into crawlspace.

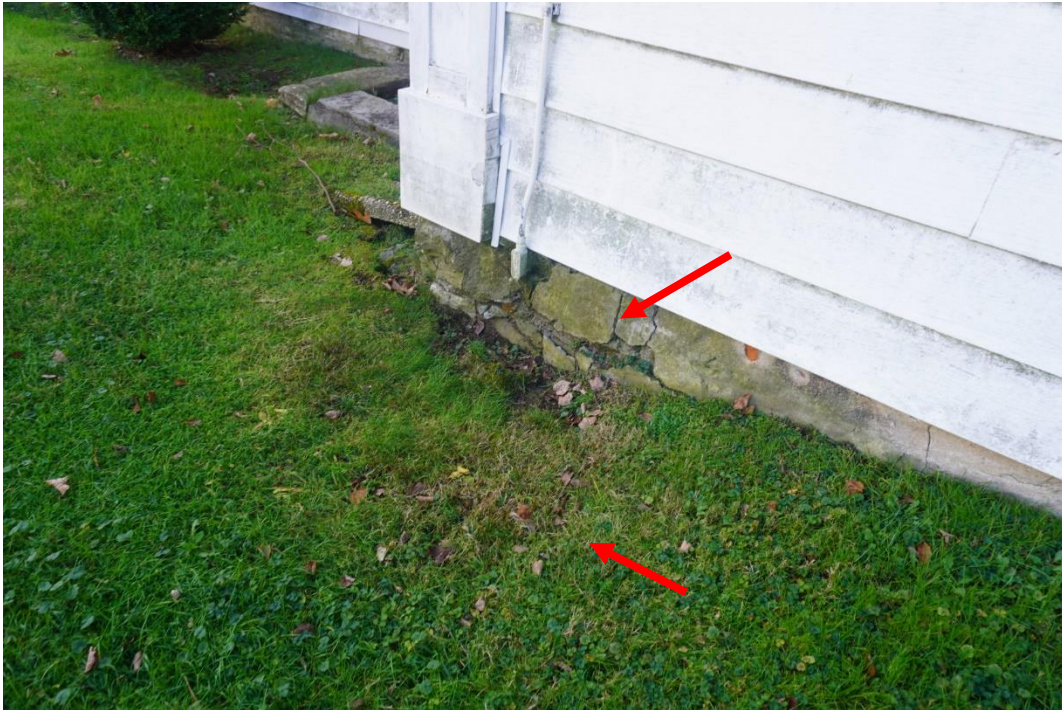
Photo #5: Negative grading front of home between entrance and northeast corner of home. Water pooling up against foundation wall and most likely infiltrating into crawlspace. Signs of foundation deterioration.

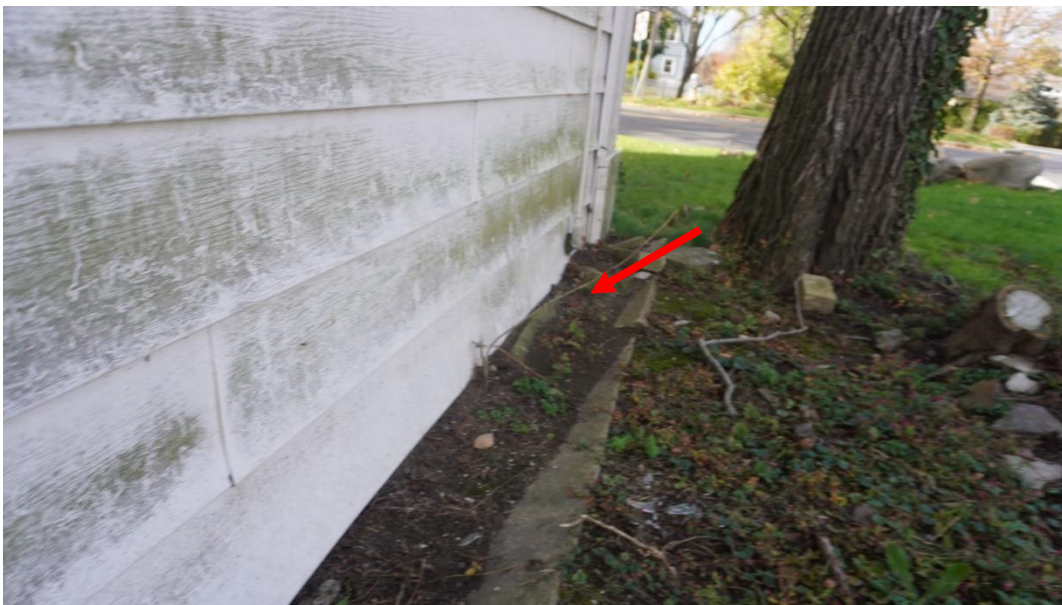
Photo #6: Negative grading front of home between entrance and northwest corner of home. Water pooling up against exterior foundation wall of crawlspace.

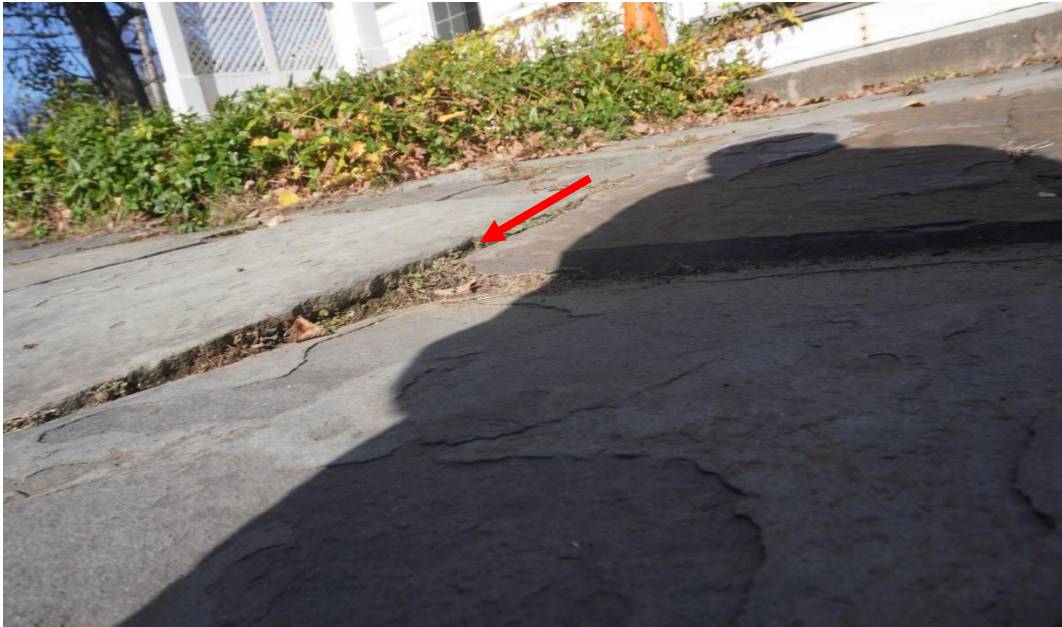
Photo #7: Stone slabs have settled/heaved creating multiple trip hazards, stone walkway rear yard.

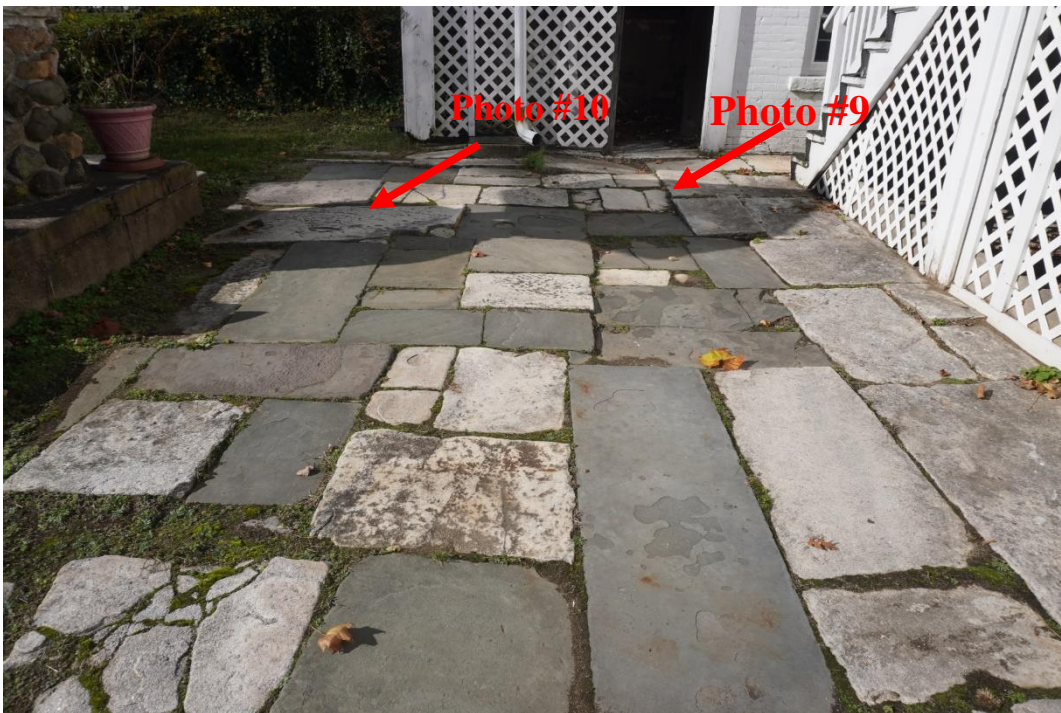
Photo #8: Stone slabs have settled/ heaved creating multiple trip hazards, stone patio rear yard.

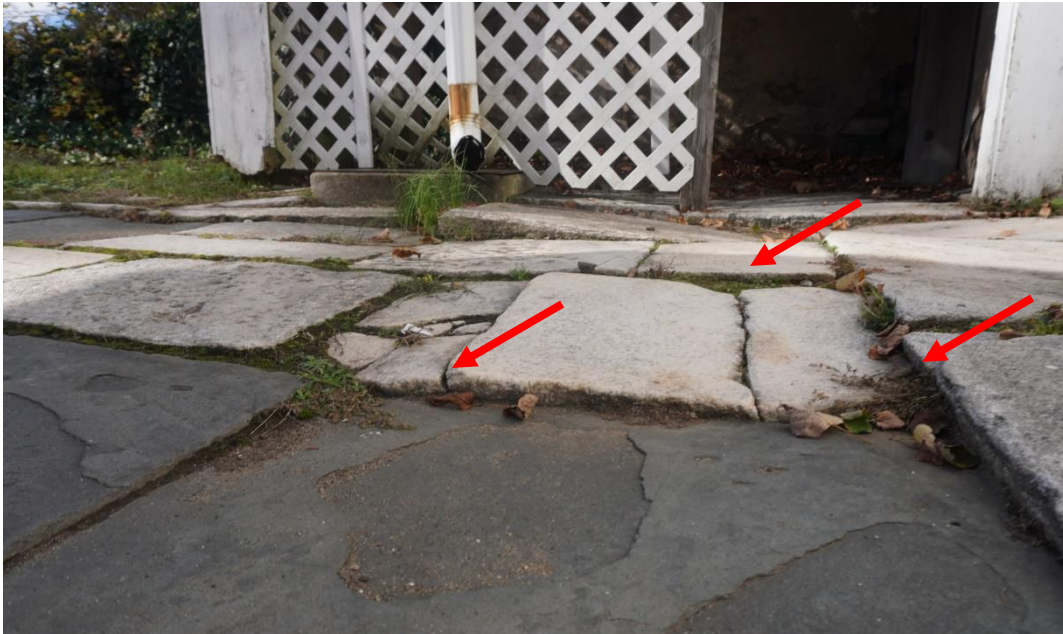
Photo #9: Stone slabs have settled/ heaved creating multiple trip hazards, stone patio rear yard.

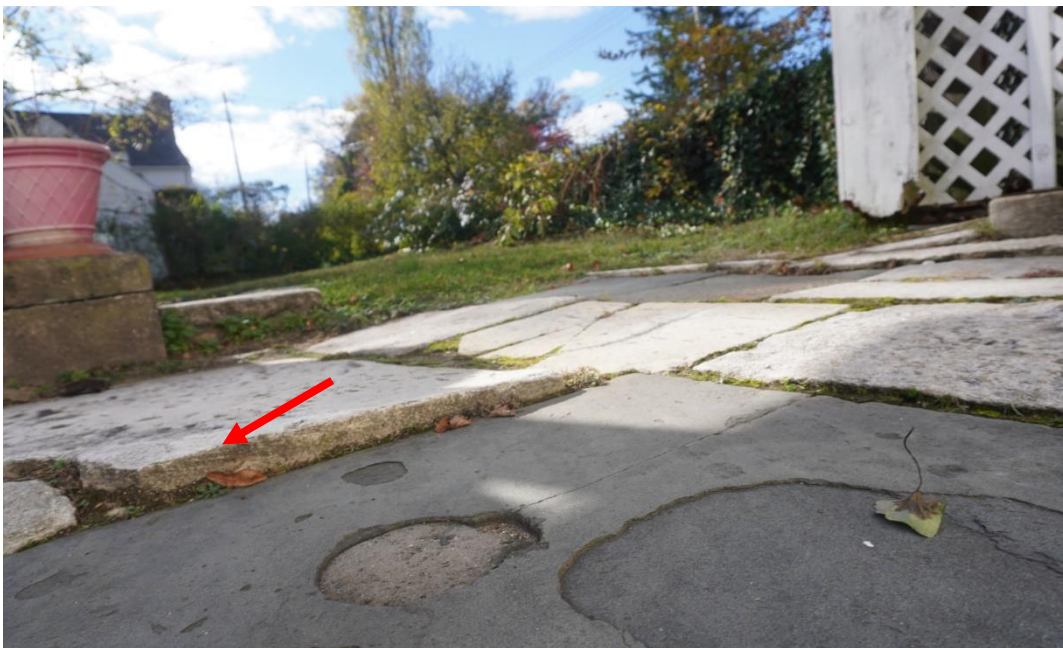
Photo #10: Stone slabs have settled/ heaved creating multiple trip hazards, stone patio rear yard.

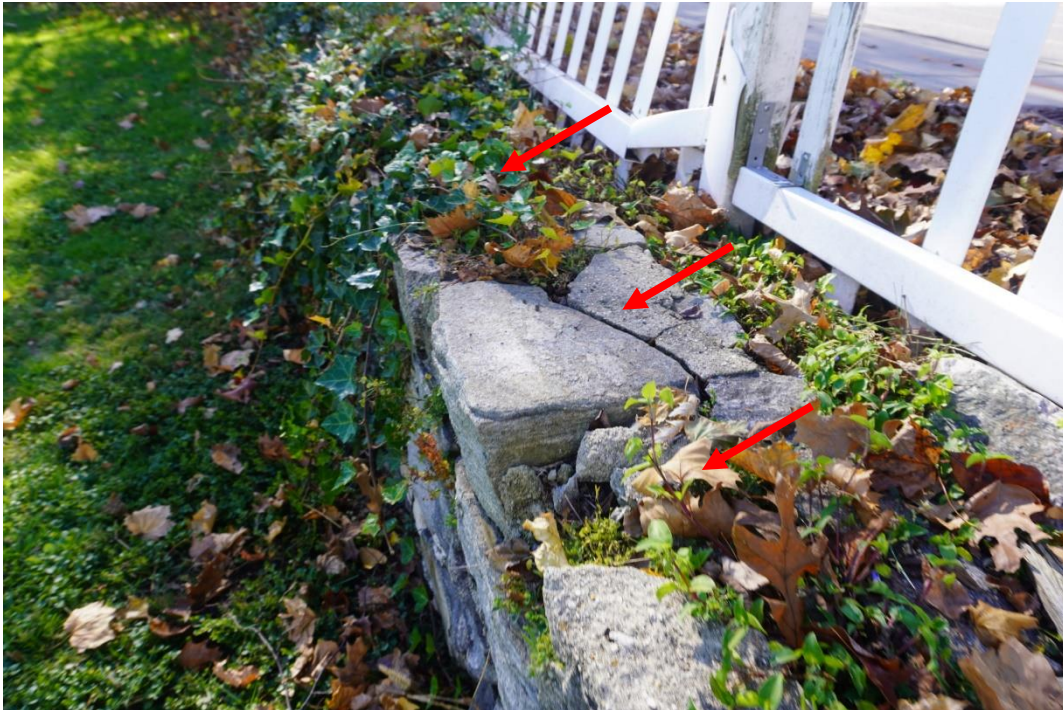
Photo #11: Retaining wall that runs between rear yard and adjacent sidewalk deteriorating throughout. Broken stones and joints between stones have filled with dirt/ organic growths.

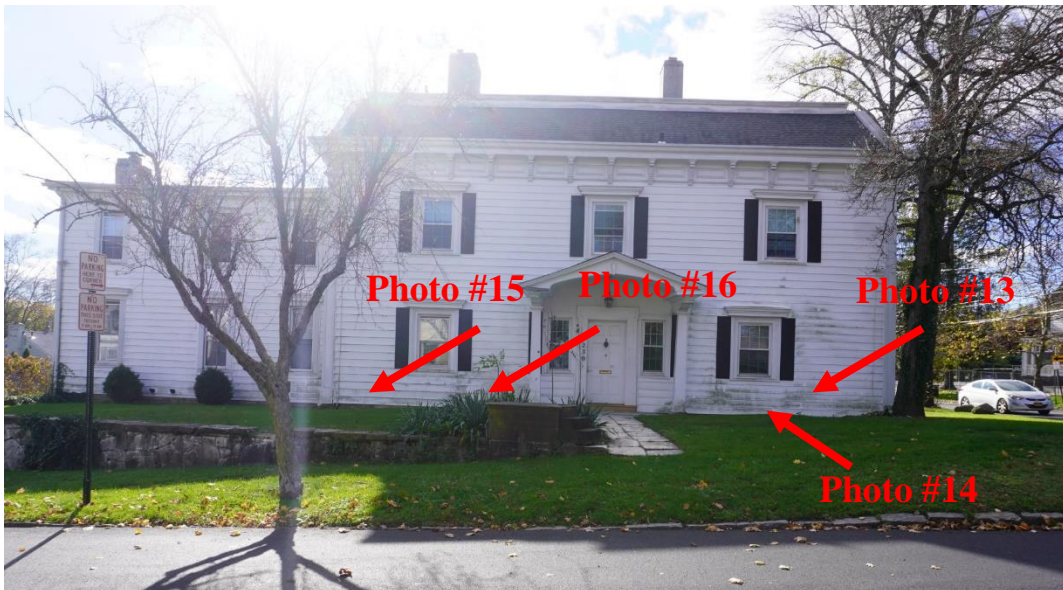
6. Foundation along front façade of original structure is low and at same level as grading. Water can infiltrate above foundation wall and rot out wood sill beam that runs along top of foundation (Photo #12, #13, #15, & #16).

Photo #12: Foundation along front façade of original structure is low and at same level as grading. Water can infiltrate above foundation wall and rot out wood sill beam that runs along top of foundation.

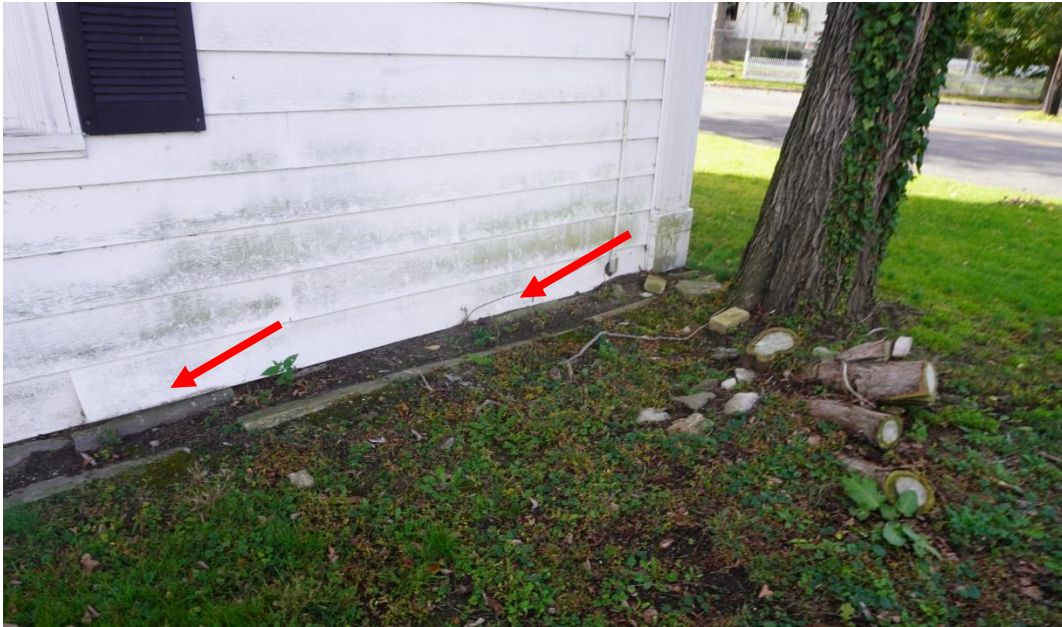
Photo #13: Foundation along front façade of original structure is low and at same level as grading. Water can infiltrate above foundation wall and rot out wood sill beam that runs along top of foundation.

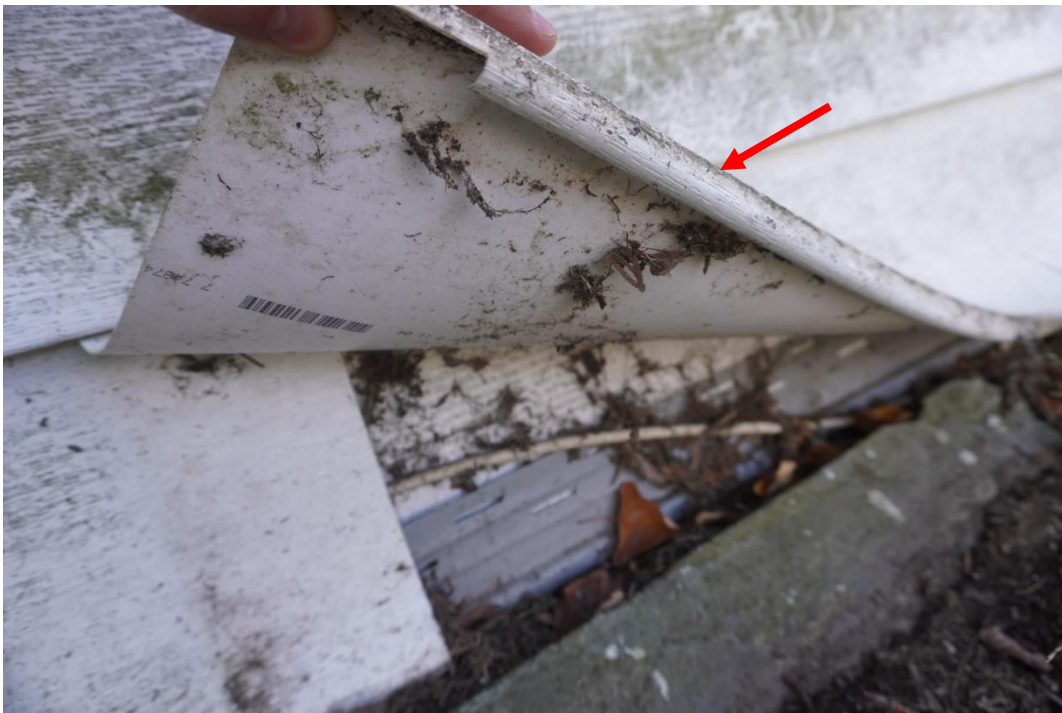
Photo #14: Exterior of building covered in vinyl siding which is not the homes original exterior building material.

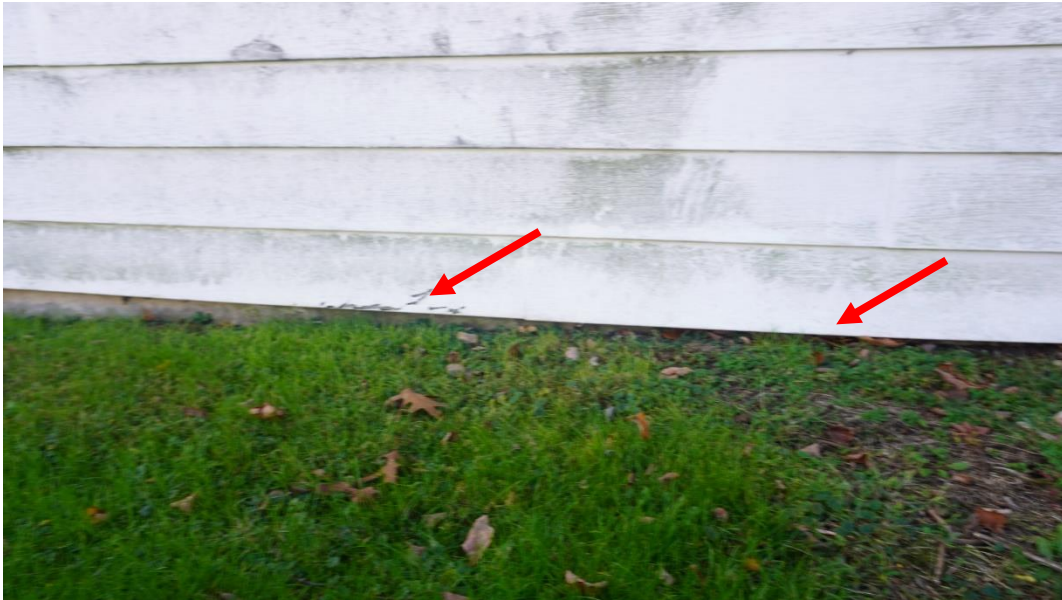
Photo #15: Foundation along front façade of original structure is low and at same level as grading. Water can infiltrate above foundation wall and rot out wood sill beam that runs along top of foundation.

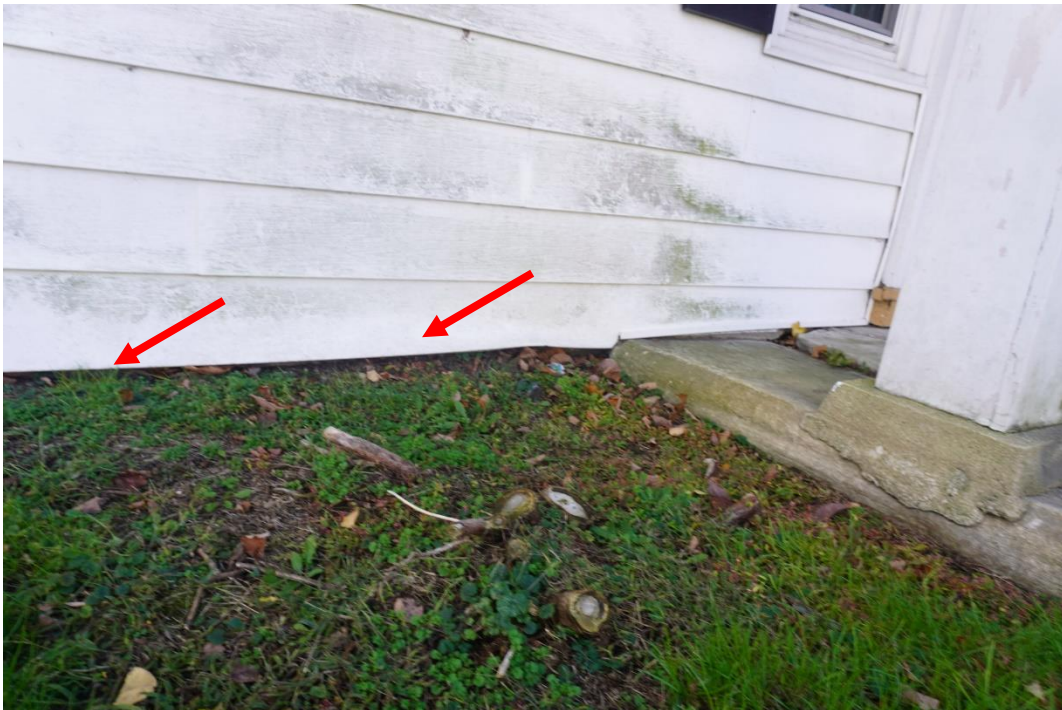
Photo #16: Foundation along front façade of original structure is low and at same level as grading. Water can infiltrate above foundation wall and rot out wood sill beam that runs along top of foundation.

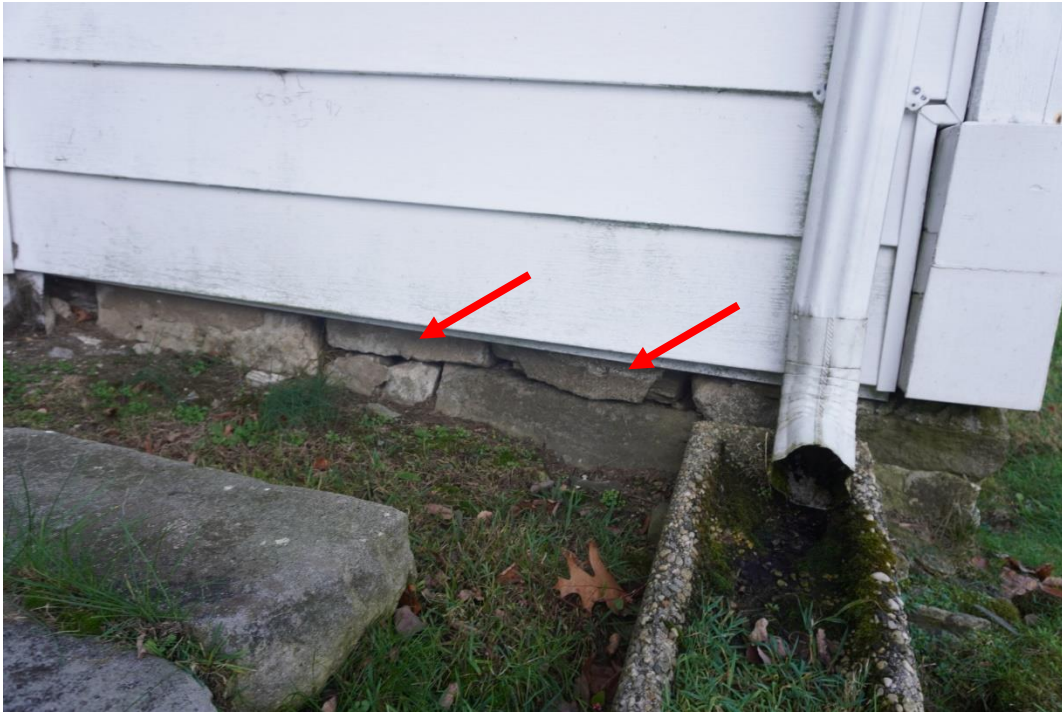
8. Exposed exterior side of rumble foundation deteriorating (Photo #20).
9. Bulge noticed between first and second floors, west façade of home. Cause unknown. Further investigation required (Photo #21 & #22).

Photo #20: Exposed exterior side of rumble foundation deteriorating. No mortar between stones.

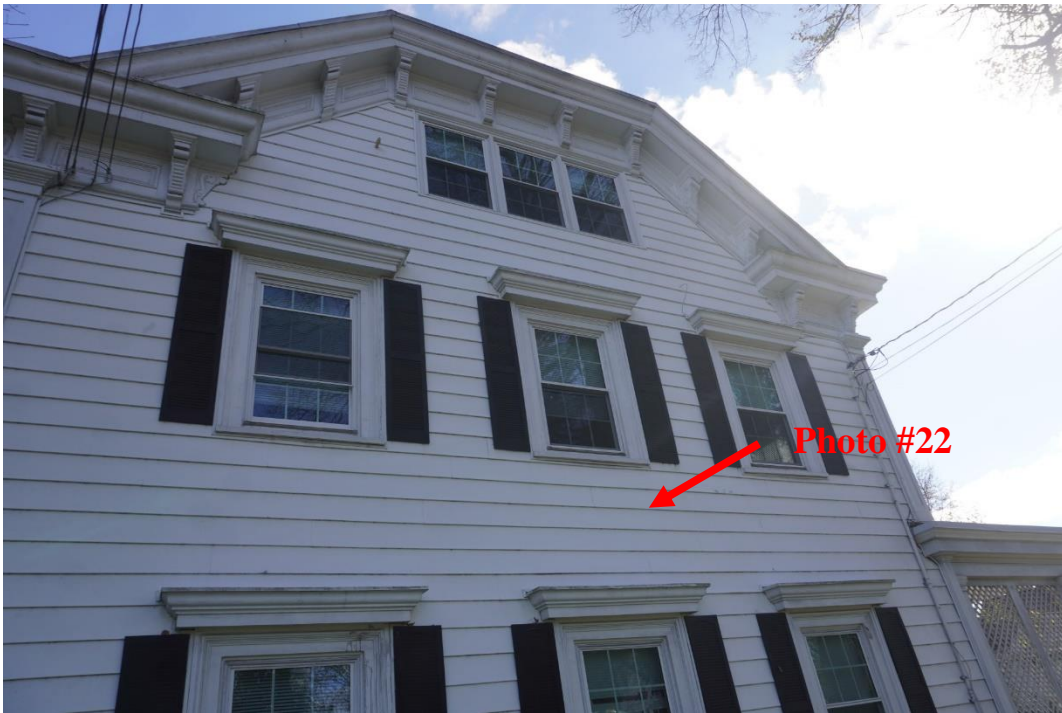
Photo #21: Bulge noticed between first and second floors, west façade of home. Cause unknown. Further investigation required.

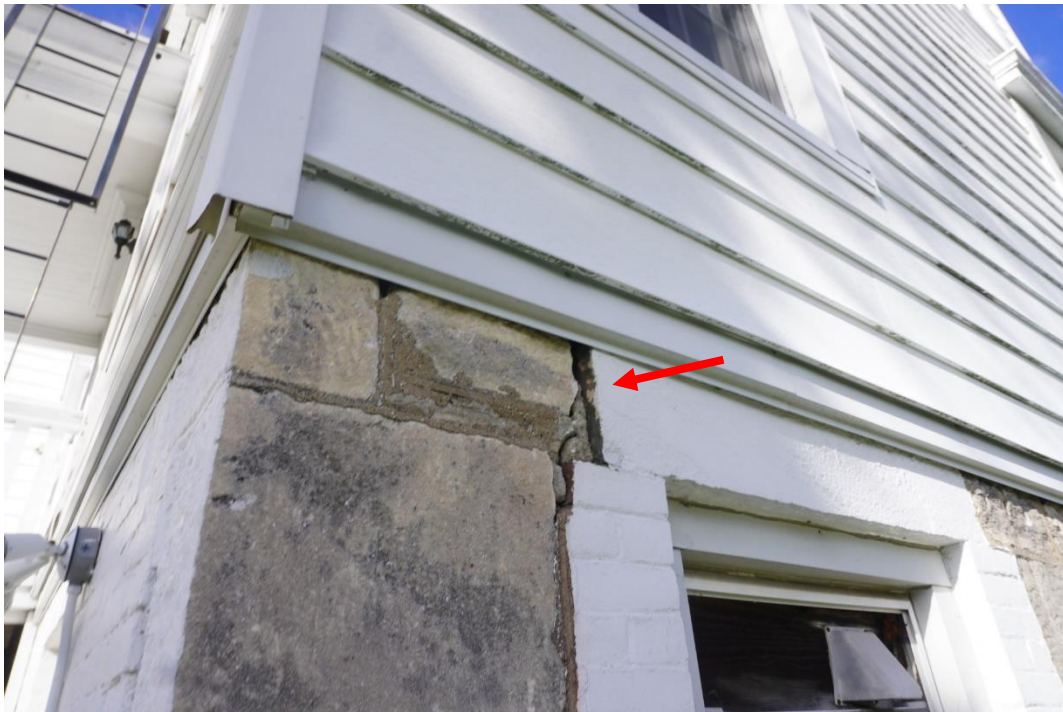
10. Southeast corner of structure showing signs of inwards movement towards the top. Cause unknown. Vertical crack ground level stonework. Further investigation required (Photo #23 & #24).

Photo #24: Vertical crack ground level stonework east façade, southeast corner of structure at addition.

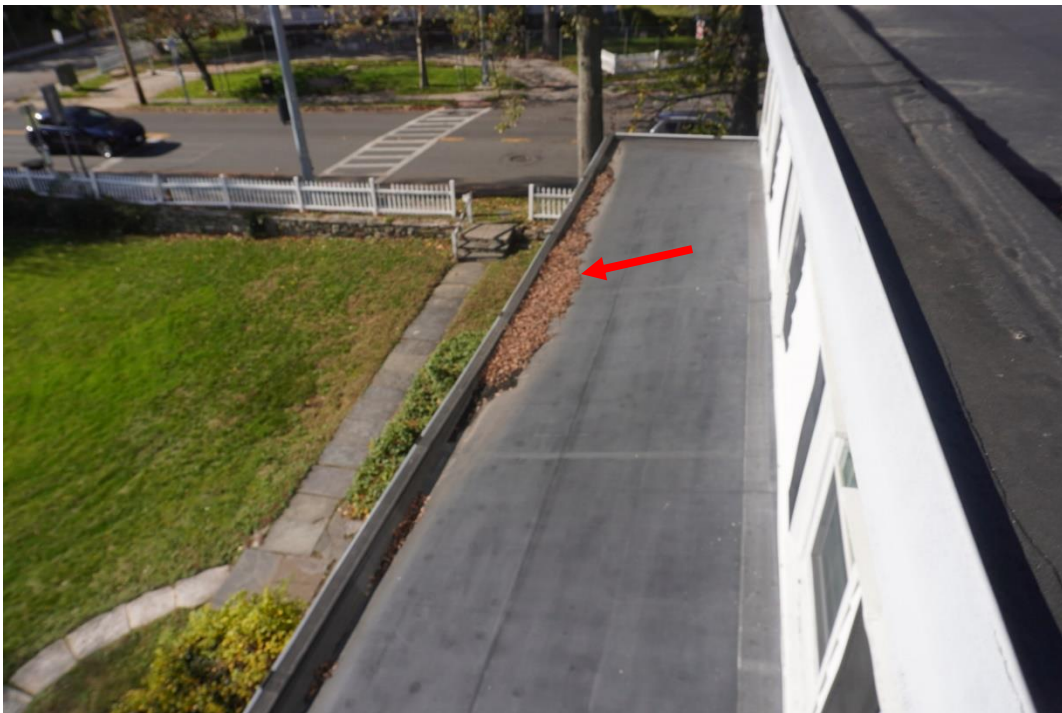
Photo #27: Rear porch roof deflecting over stairs causing water to pool and leaf build up.

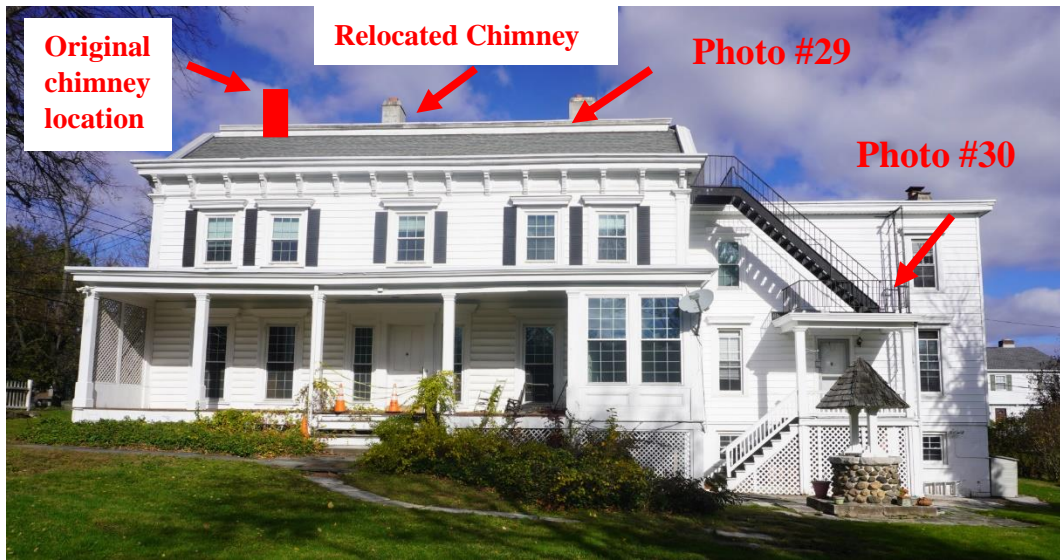
- f) Typically, the front of home had the double lines of windows on either side of the door. At 230 White Plains Road the front façade has only one line of windows on each side of the door and what is now the rear façade with the porch has two lines of windows on each side of the door. This means the rear of the home at 230 White Plains Rd was the original front of the home (Appendix E, Photo #12, and Photo #28). It is unclear at what point in time this change was made.

Photo #28: Rear south façade. Chimneys in colonial era Georgian style homes were symmetrically placed. Original chimney was demolished and relocated at some unknown point in the past. Typically, the front of home had the double sets of windows on either side of the door for this type of Georgian colonial. This means the façade that is now the front of the home that only has one window on each side of the door was most likely the old rear façade of the home.

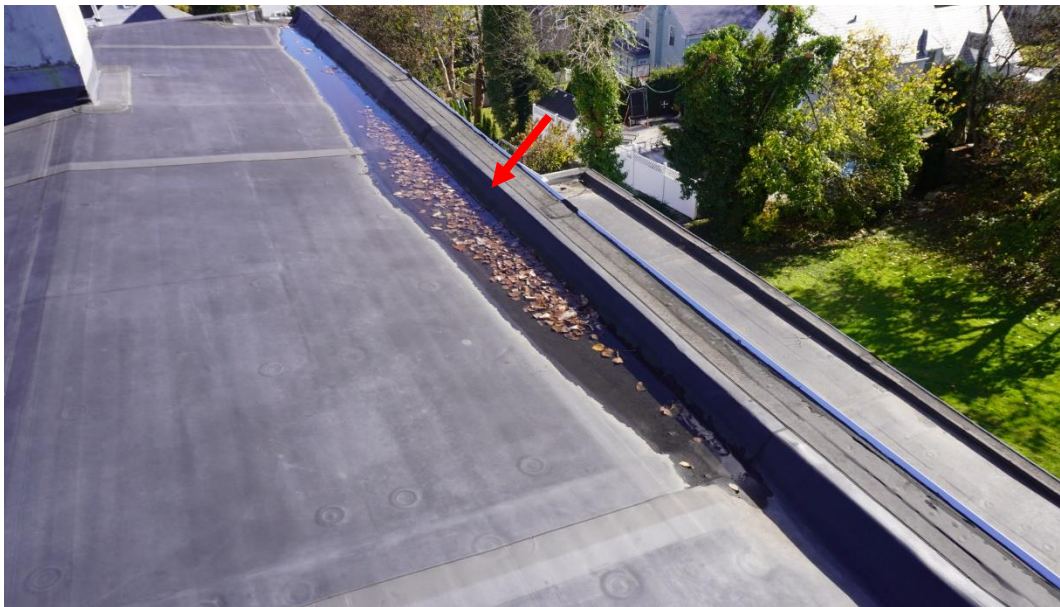
11. Roof structure has deflected causing water to pool. Roofing membrane observed to be fairly new (Photo #28 & #29).
12. Exterior metal stair egress just sitting on roofing membrane and not attached to structure (Photo #28 & #30).

Photo #29: Roof structure has deflected causing water to pool. Roofing membrane observed to be fairly new.

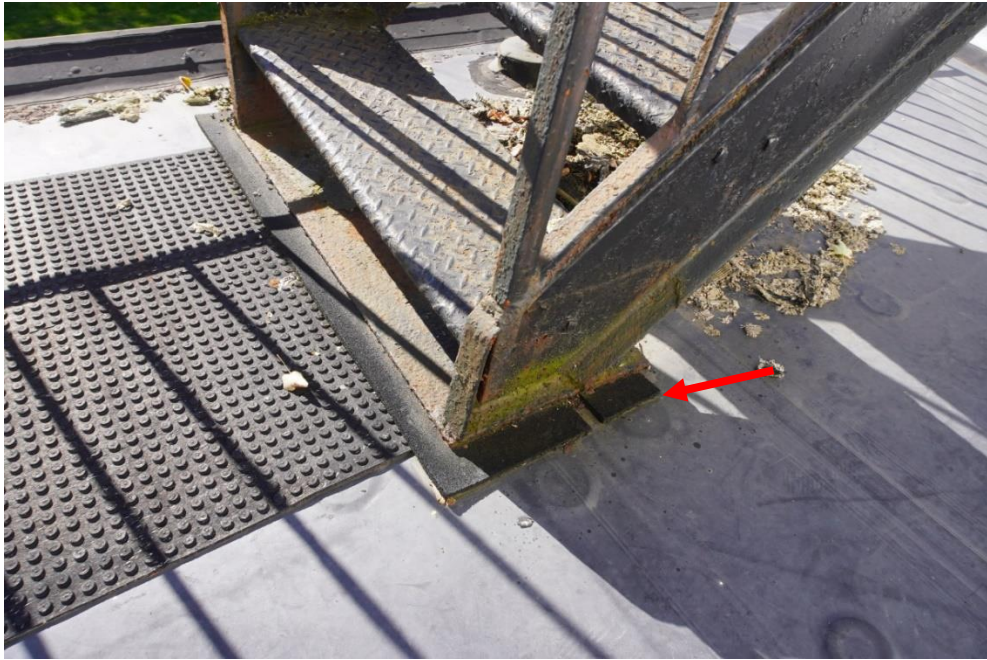
Photo #30: Exterior metal stair egress just sitting on roofing membrane and not attached to structure.

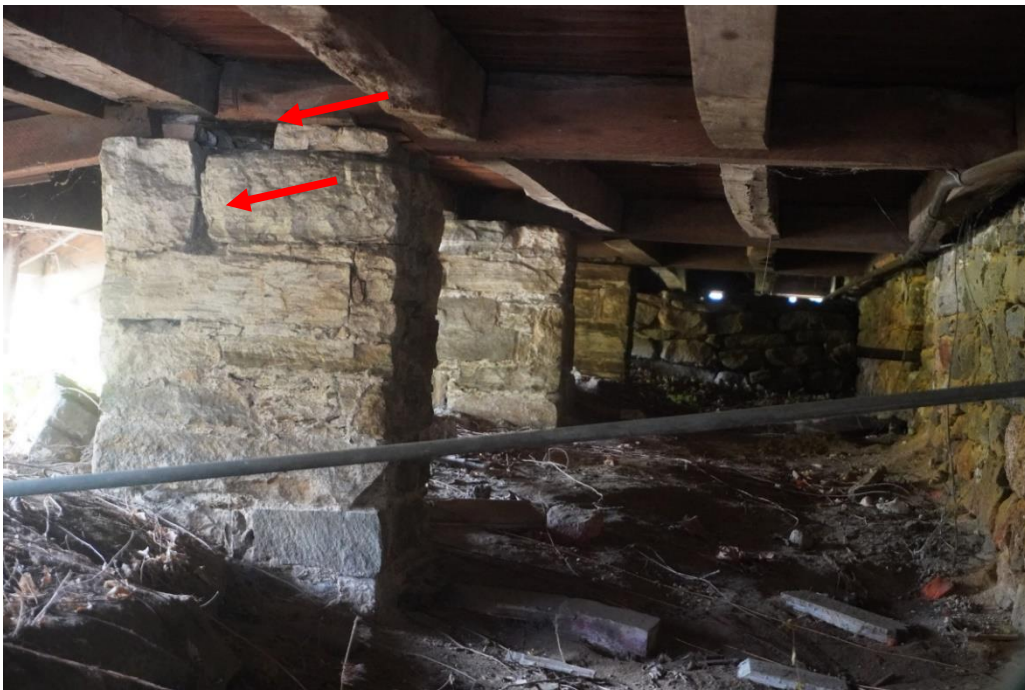
Photo #31: Rear porch sitting on stone pillars that are showing signs of deterioration.

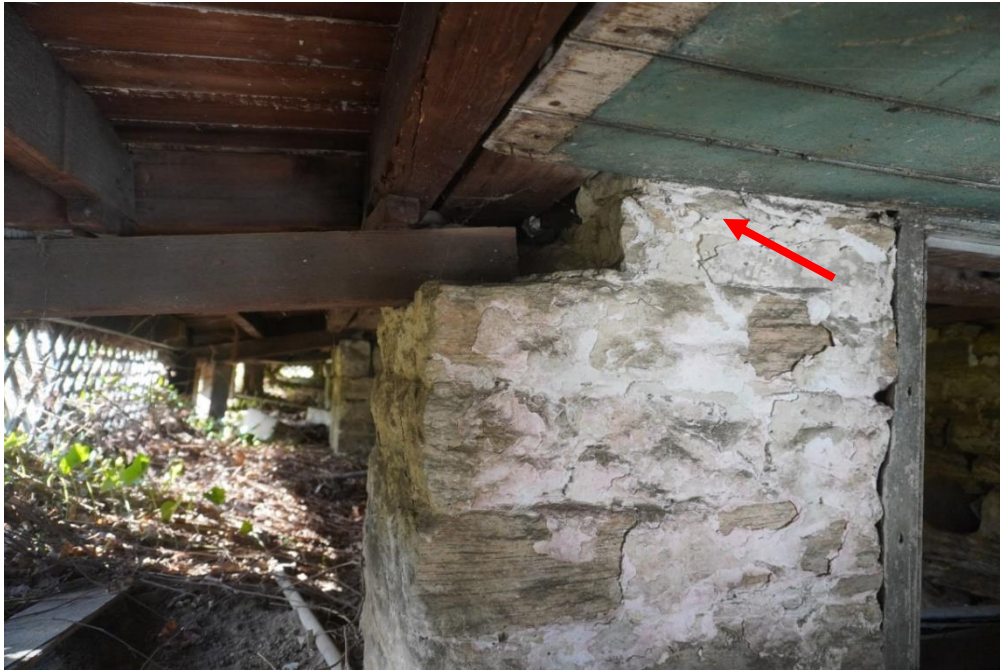
Photo #32: Rear porch sitting on stone pillars that are showing signs of deterioration.

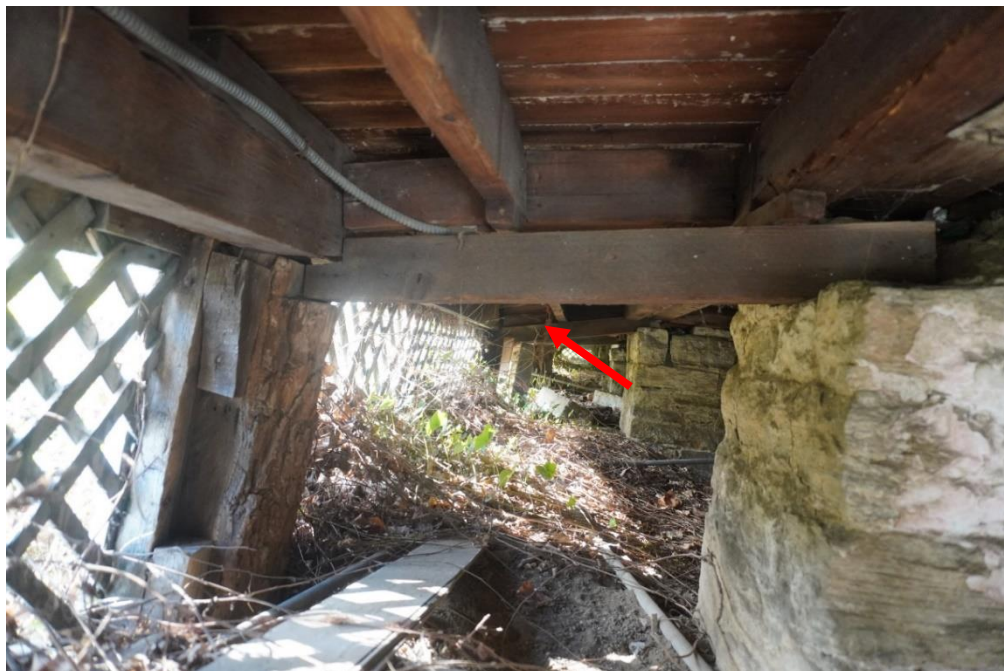
Photo #33: Rear porch was extended to be made wider at some unknown time in the past.

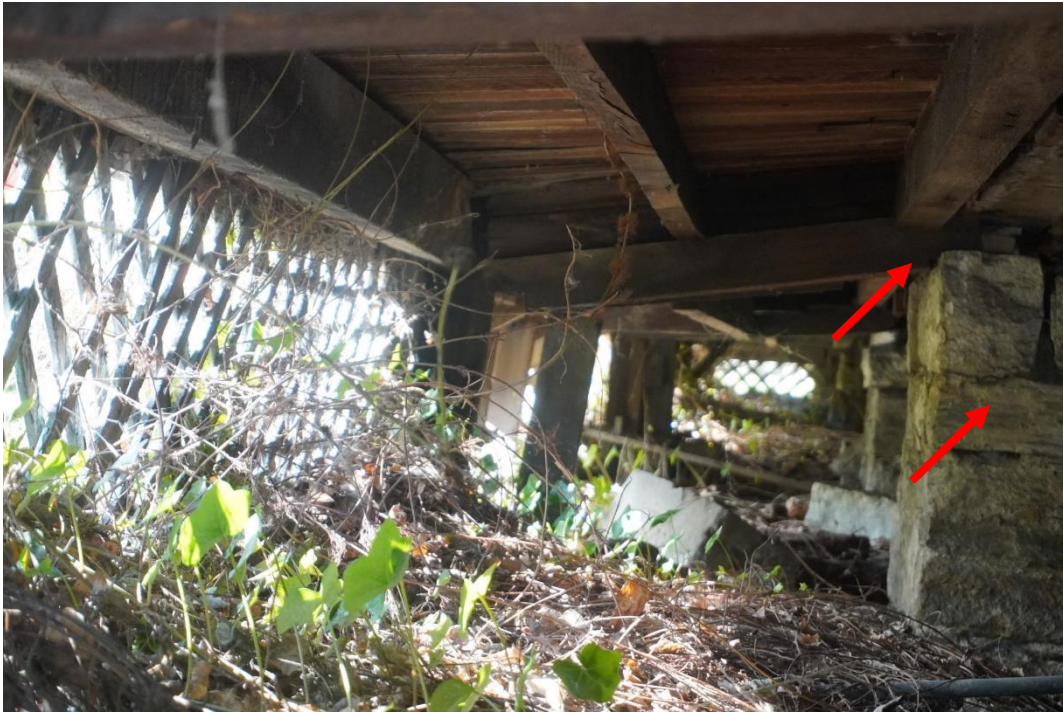
Photo #34: Rear porch sitting on stone pillars that are showing signs of deterioration.

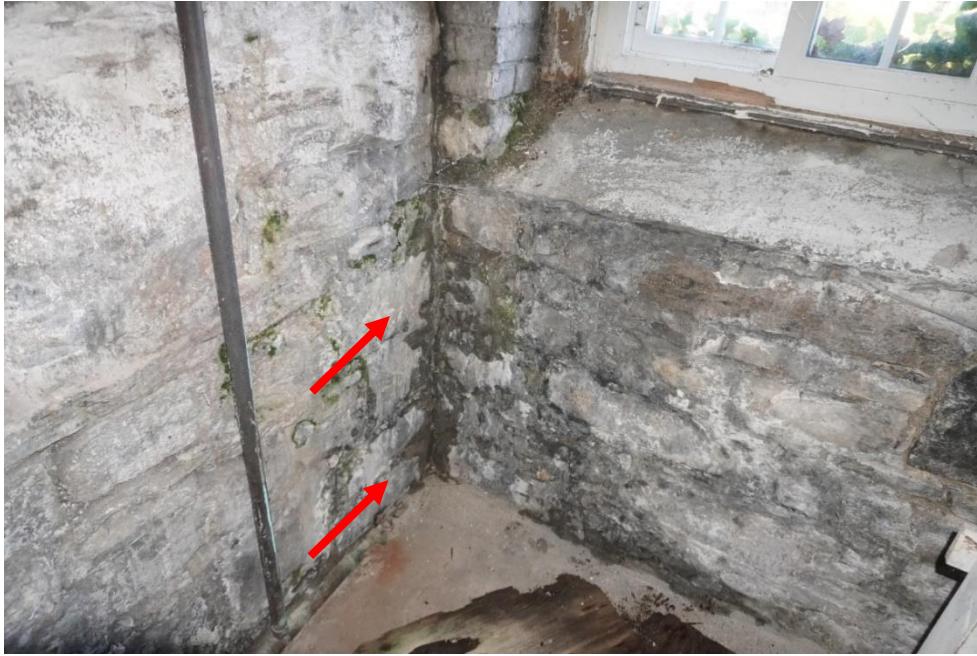
17. Water intrusion foundation wall, northeast corner of home at extension (Photo #36).
18. Water intrusion foundation, south wall of home at extension (Photo #37).

Photo #36: Water intrusion foundation wall, northeast corner of home at extension.

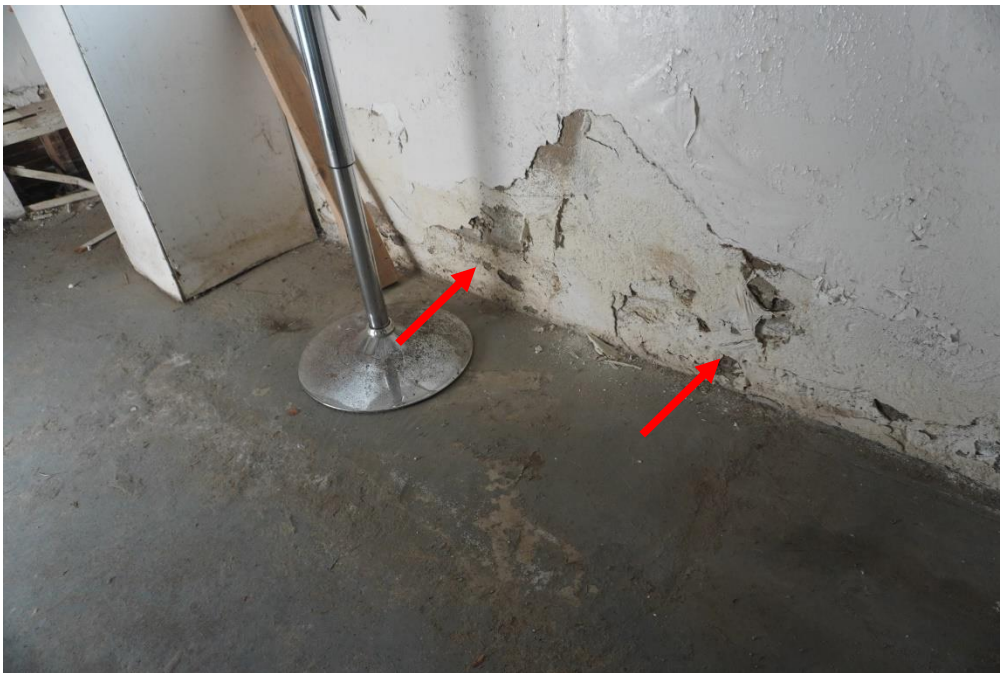
Photo #37: Water intrusion foundation, south wall of home at extension.

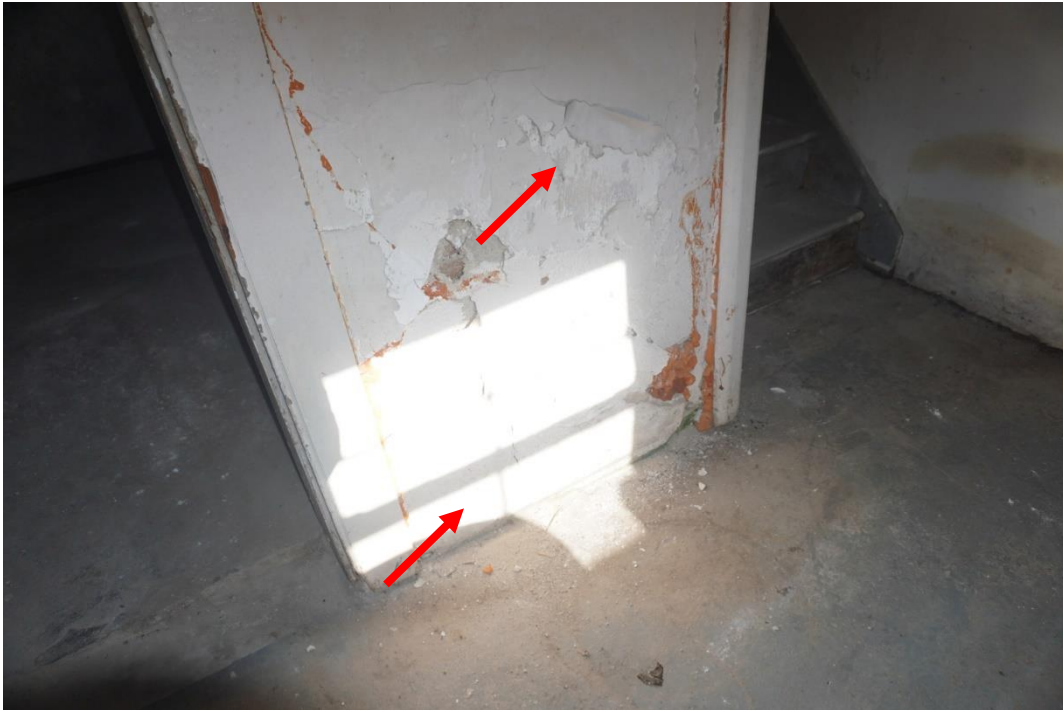
19. Mold formation and deteriorating damp plaster interior walls at cellar level due to water wicking up through cellar floor (Photo #38 & #39).
20. Water infiltration around cellar window, north façade of home at window well (Photo #40).

Photo #38: Mold formation and deteriorating damp plaster interior walls at cellar level due to water wicking up through cellar floor.
