**Re: *Biggest Fish Westchester LLC*
§11A-9 Economic Hardship Request (Certificate of Appropriateness)
*230 White Plains Road - Section 31. Block 3 Lot 13 ("Property")***

Property Location:	230 White Plains Road Tuckahoe, NY 10707
Inspection Dates:	Initial Inspection: 9/23/22 In Depth Inspection: 11/14/22 Probe Inspection: 12/13/22
Report Date:	1/28/23
Report By:	Peter Panagopoulos, P.E. <i>Principal</i> Pantec Engineering
Appendices:	Appendix A – Photos Appendix B – Probe Locations Appendix C – Structural Layout Appendix D – Deficiency Location Diagram Appendix E - Two Inner Chimney Georgia Colonial Layout

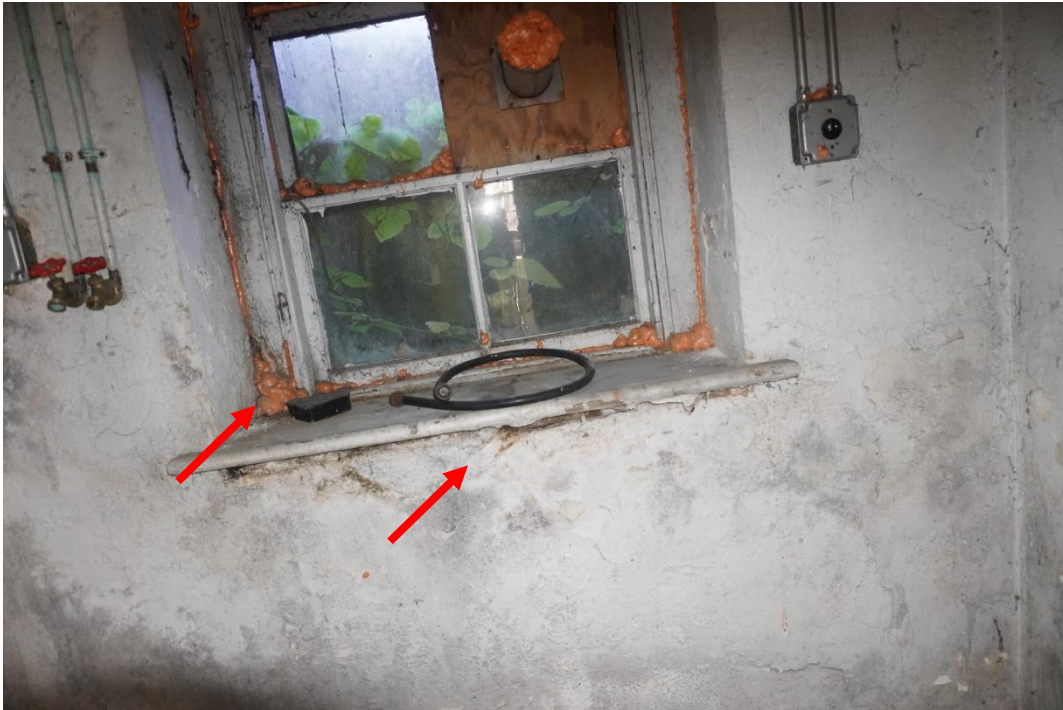
Photo #40: Water infiltration around cellar window, north façade of home at window well.

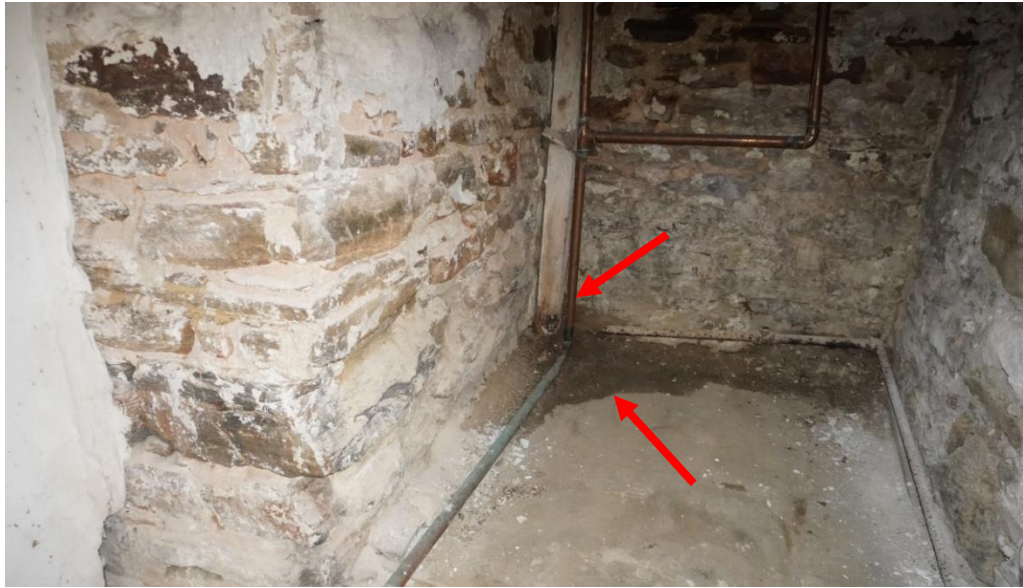
21. Horizontal crack has formed in concrete window well, north façade (Photo #41).
22. Water infiltration at base of inner, original foundation wall. Water is rotting base of wood support post. Crawlspace that spans the front side of the home is located on the other side of this wall (Photo #42).

Photo #42: Water infiltration at base of inner, original foundation wall. Water is rotting base of wood support post. Crawlspace that spans the front side of the home is located on the other side of this wall.

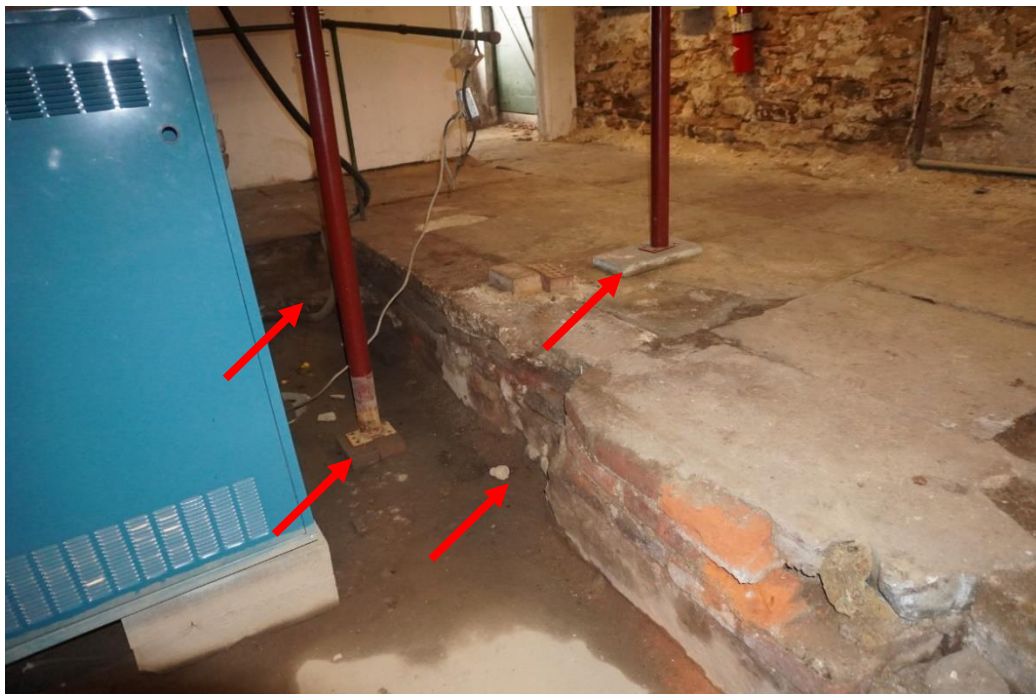
23. Water infiltration through foundation floor around perimeter of boiler pit (Photo #43).
24. Concrete footings were never poured beneath temporary support columns that were added to prop of failing girder in boiler room (Photo #43).

Photo #43: Water infiltration through foundation floor around perimeter of boiler pit. Concrete footings were never poured beneath temporary support columns that were added to prop up both failing girders in the cellar.

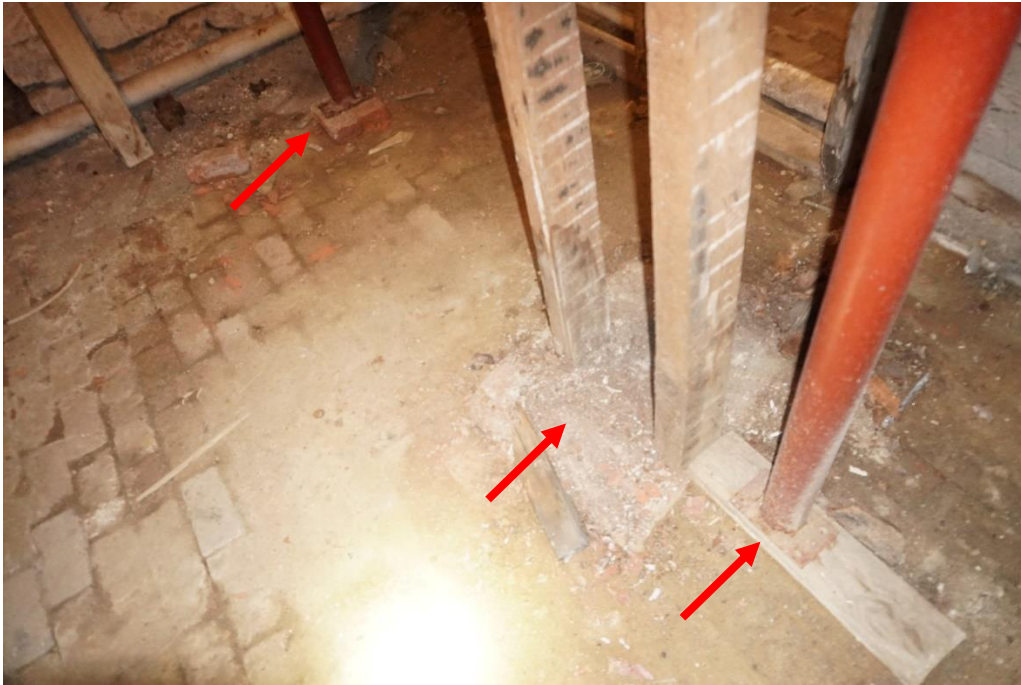
25. Concrete footings were never poured beneath temporary support columns that were added to prop of failing girder in west end of cellar (Photo #44).
26. Cellar floor observed to be composed of bricks with a cement stucco layer that is deteriorating (Photo #45).

Photo #44: Concrete footings were never poured beneath temporary support columns that were added to prop of both failing girders in the cellar.

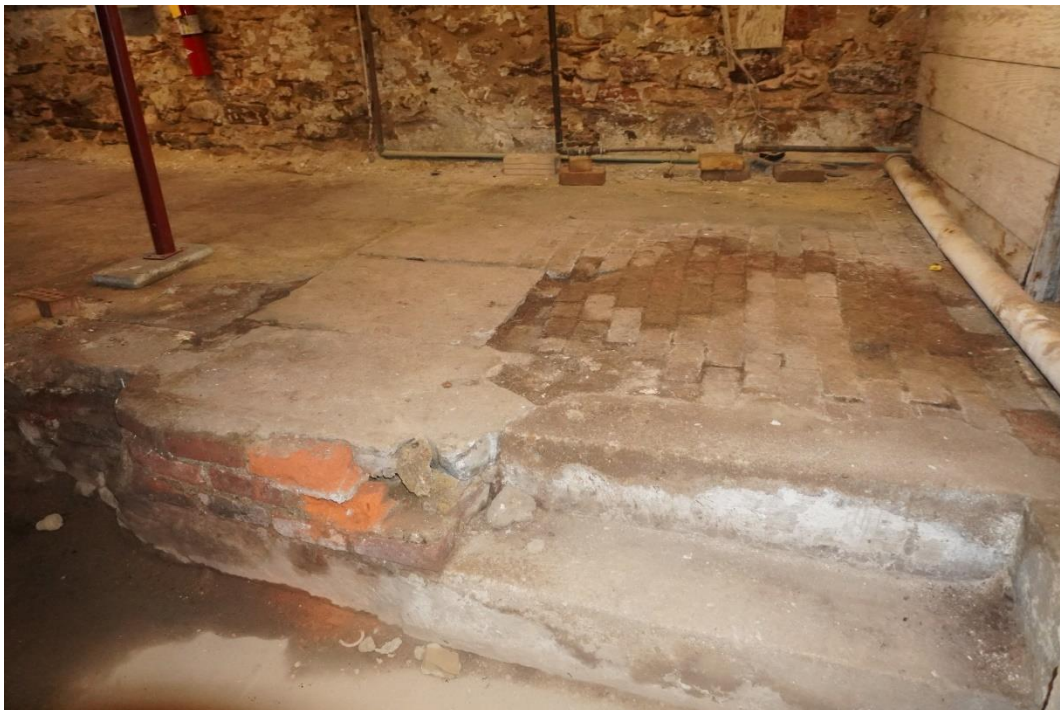
Photo #45: Cellar floor observed to be composed of bricks with a cement stucco layer that is deteriorating.

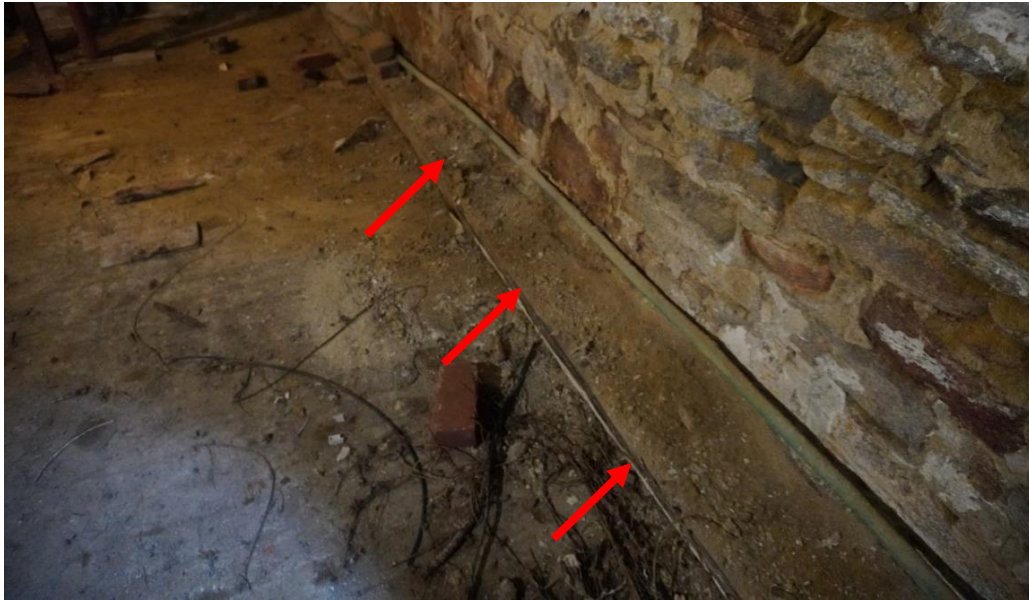
27. Water infiltrating through foundation is bringing in soil through spaces between dry laid rubble stone walls. Soil piling along inside of foundation walls (Photo #46 & #47).

Photo #46: Water infiltrating through foundation is bringing in soil through spaces between dry laid rubble stone walls. Soil piling along inside of foundation walls.

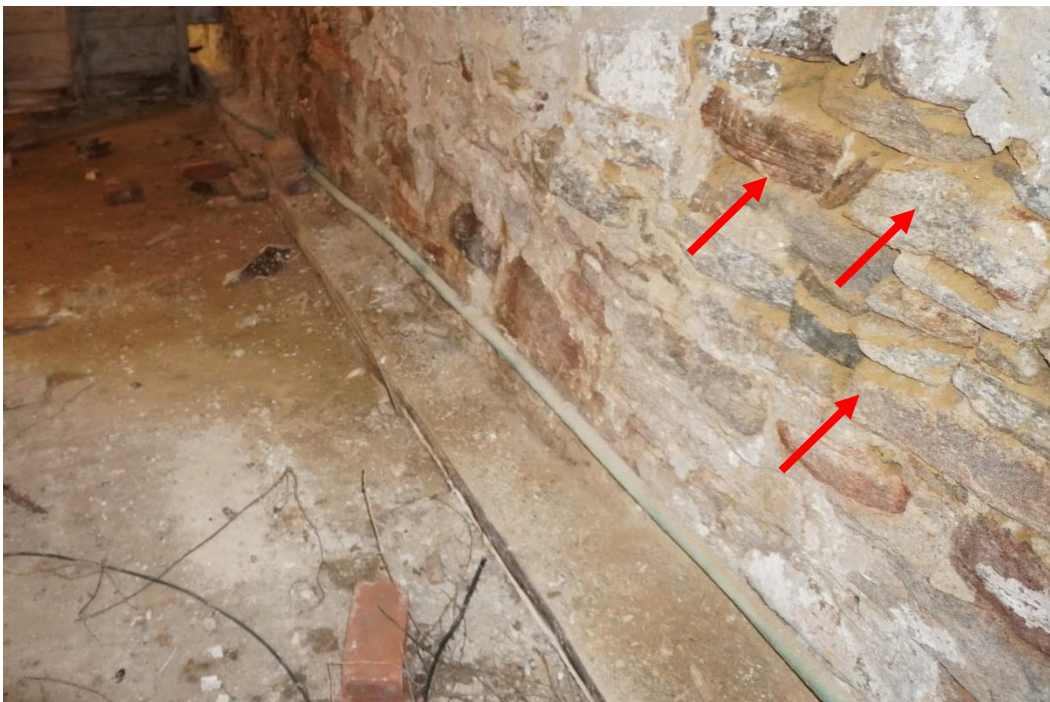
Photo #47: Water infiltrating through foundation is bringing in soil through spaces between dry laid rubble stone walls. Soil piling along inside of foundation walls.

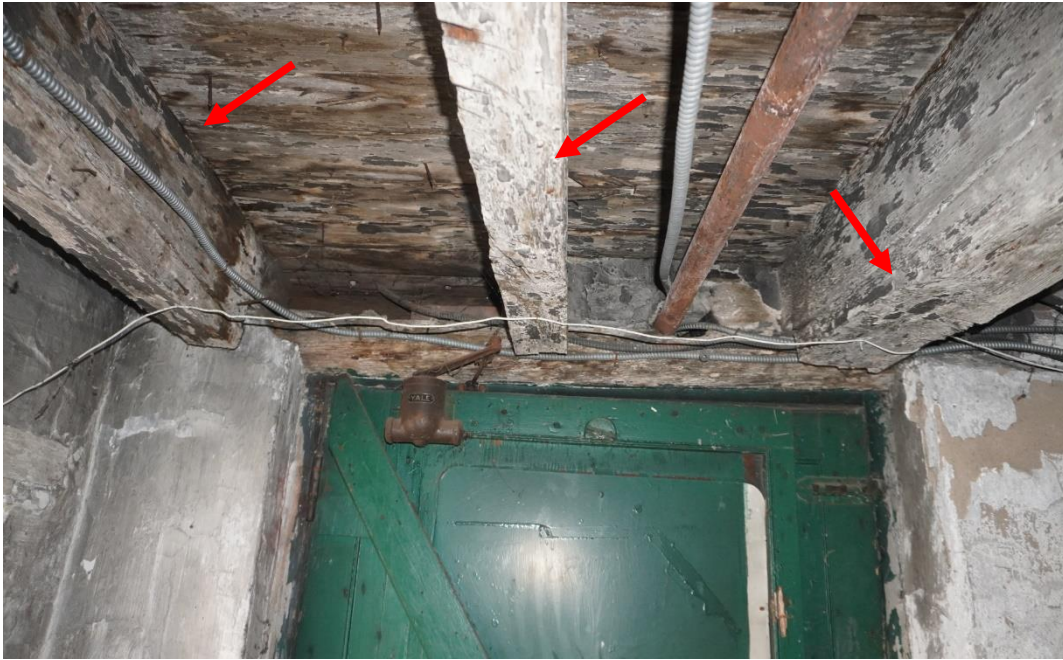
- b) A large 6"x9-1/4" beam was observed in basement, and it is unclear why it is sized larger than the other floor joists (Photo #48).
- c) Ceiling soffit contains a support beam that runs east to west below the exterior spandrel beam that runs north to south. Beam running east to west supports joists above at midspan. This is an atypical configuration that was most likely a modification done when chimney was moved and not part of the original timber framing design (Probe #2) (Photo #81 & 82).

Photo #48: Two 10x3 beams spaced 16 inches apart on left are spanning 19 feet. The reason 6"x9-1/4" beam on right is sized larger than other joists is unclear. It is uncommon for such a large member to be sitting on a door header.

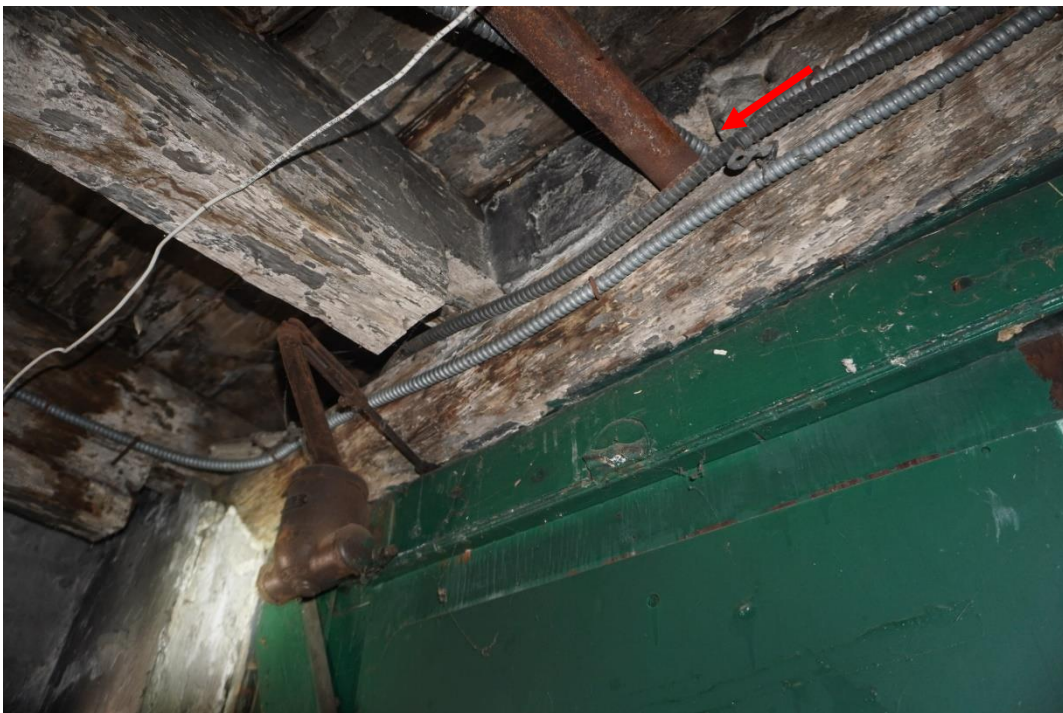
28. Pipe penetration drilled through door header leading out to rear yard (Photo #49).
29. Horizontal crack from shear stress resonating down entire member from notch at end of beam (Photo #50 & #51).

Photo #49: Pipe penetration drilled through door header leading out to rear yard.

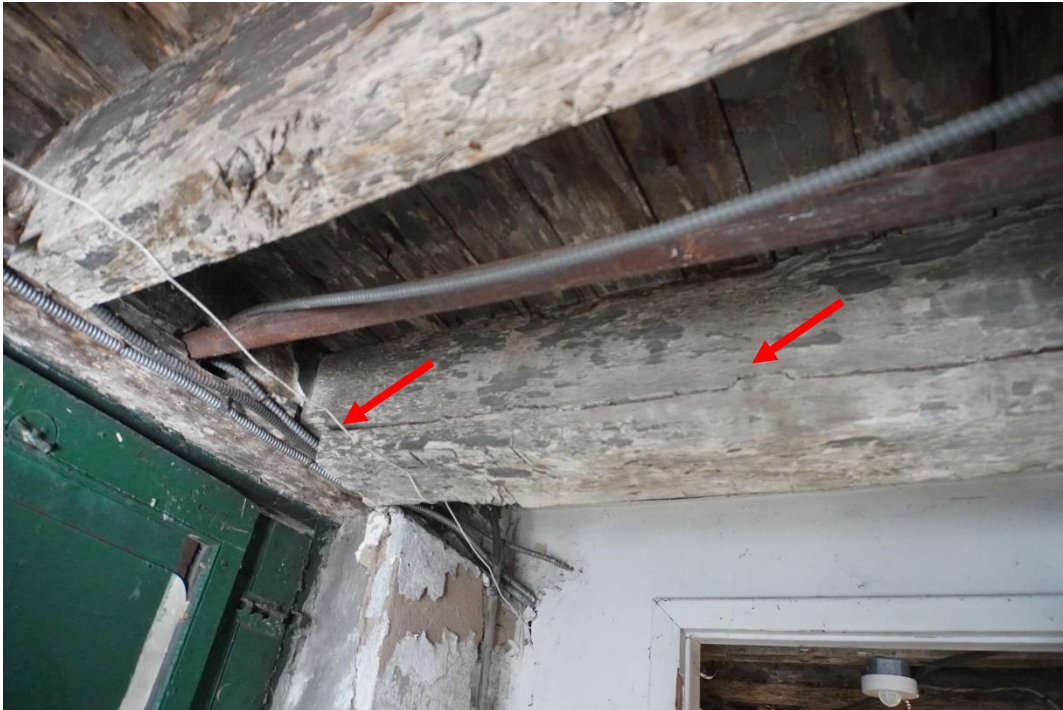
Photo #50: Horizontal crack from shear stress resonating down entire member from notch at end of beam.

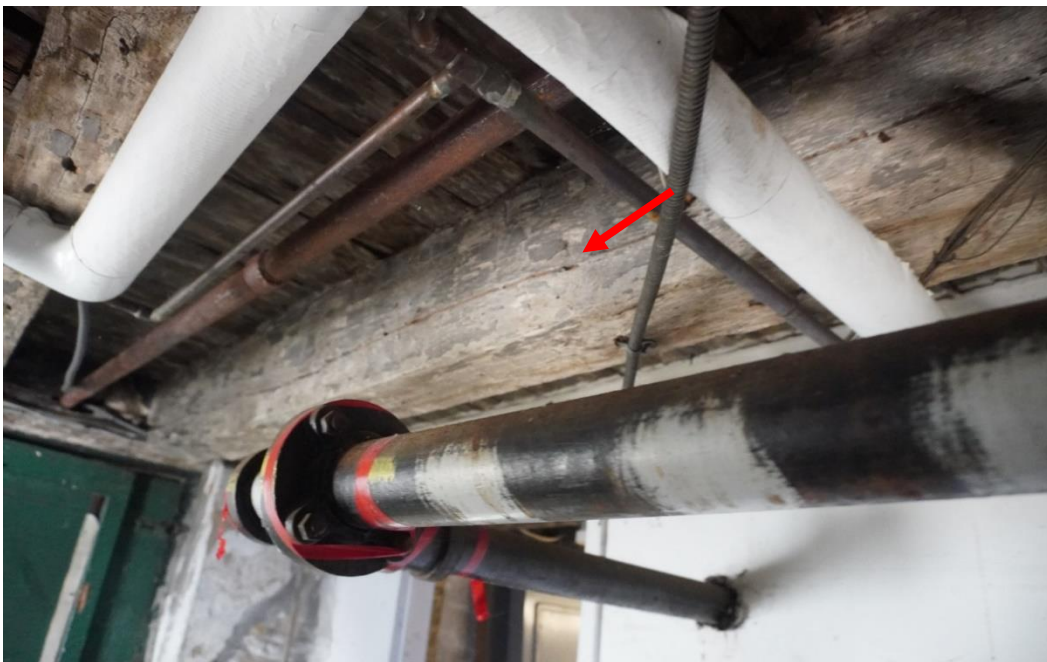
Photo #51: Horizontal crack from shear stress resonating down entire member from notch at end of beam.

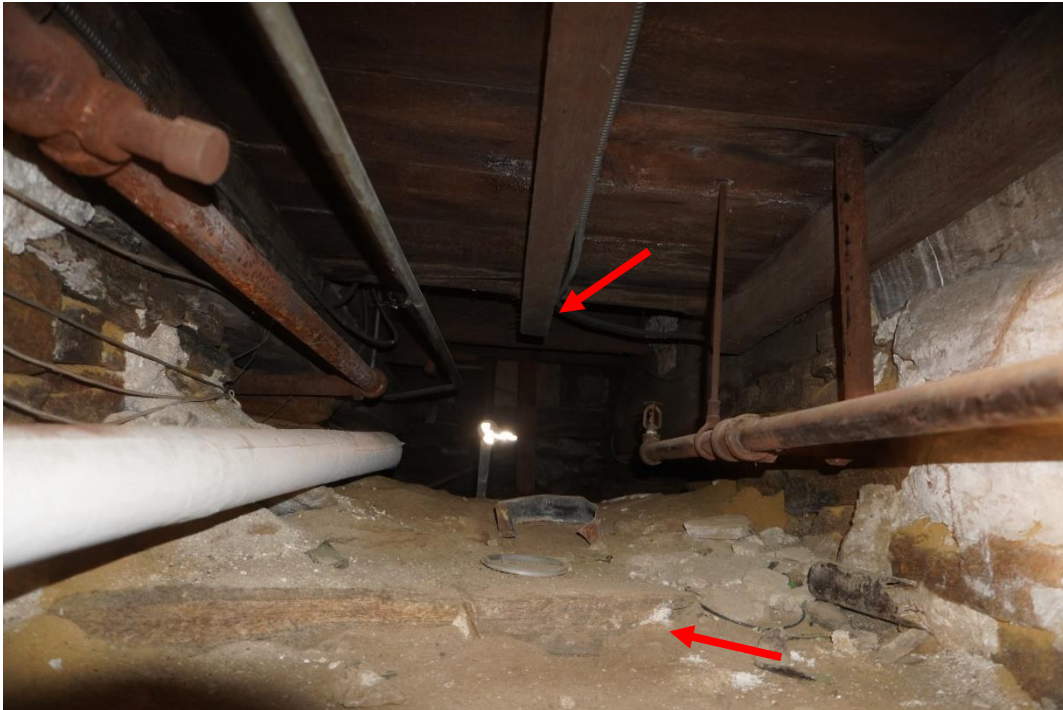
30. Wood joist observed to have a large extent of termite damage (Photo #52).
31. Joists connections in crawlspace observed to be coming apart. Piping was run into crawlspace through what potentially was an old window in original foundation wall (Photo #53).

Photo #53: Joists connections in crawlspace observed to be coming apart. Piping was run into crawlspace through what potentially was an old window in original foundation wall.

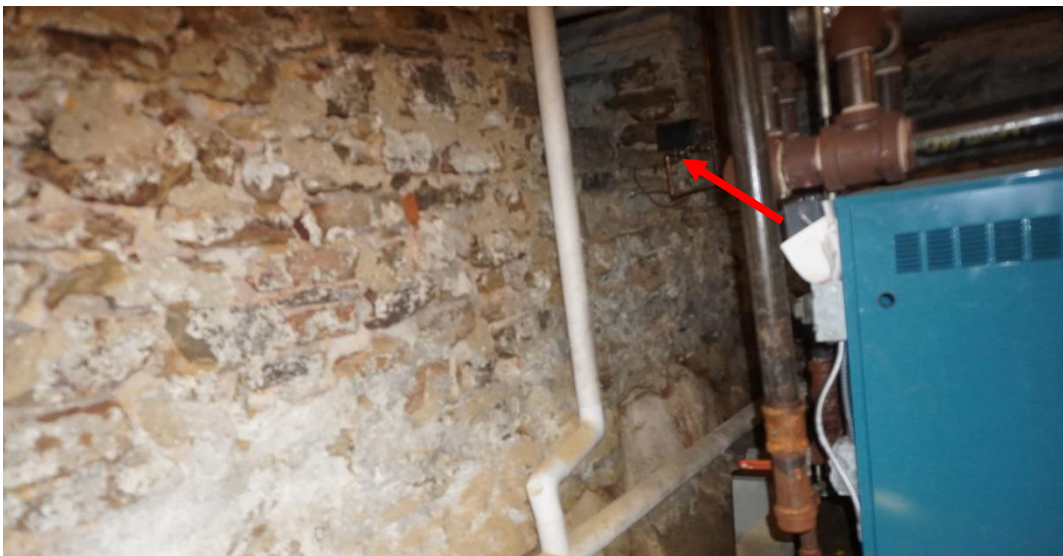
Photo #54: Piping was run into crawlspace through what potentially was an old window in original foundation wall.

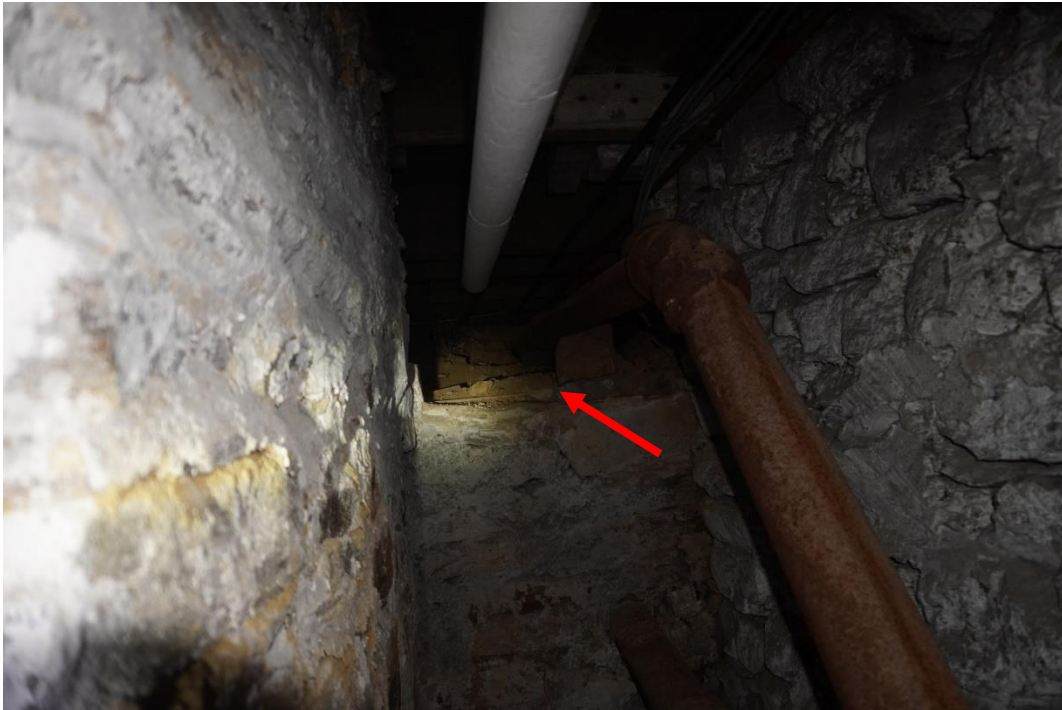
Photo #55: Piping was run into crawlspace through what potentially was an old window (second location) in original foundation wall.

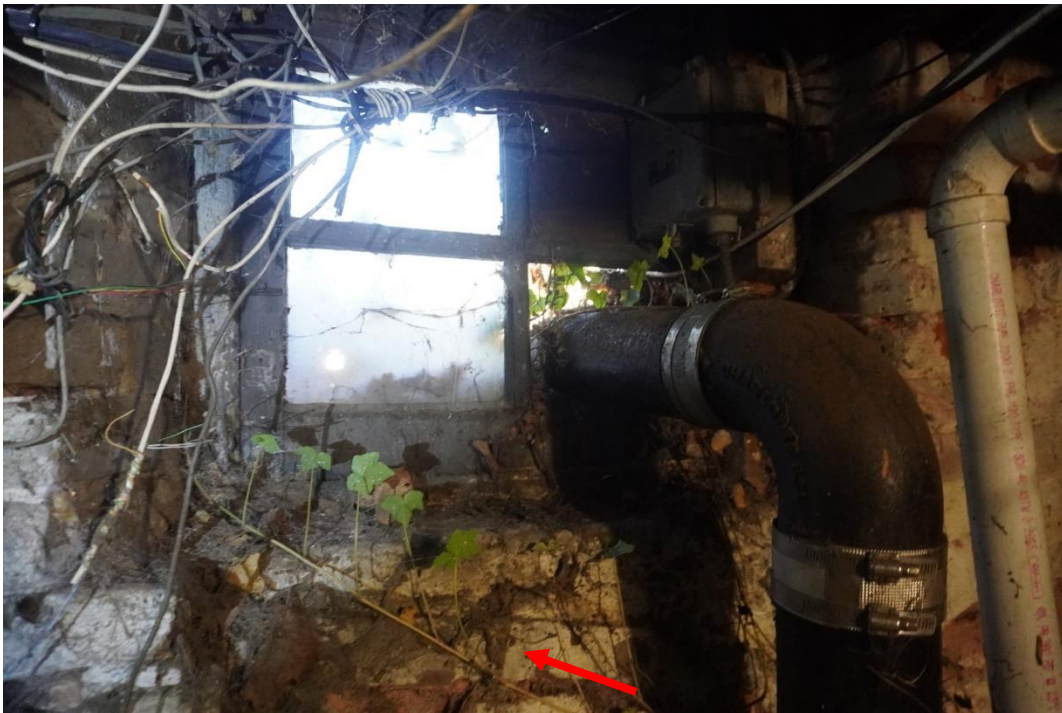
32. Dirt and soil infiltrating around window in cellar at west foundation wall (Photo #56).
33. Temporary support column being used to hold failing 9-1/2"x9-1/4" girder in boiler room. Column not mechanically attached to girder above (Photo #59).

Photo #56: Dirt and soil infiltrating around window in cellar at west foundation wall.

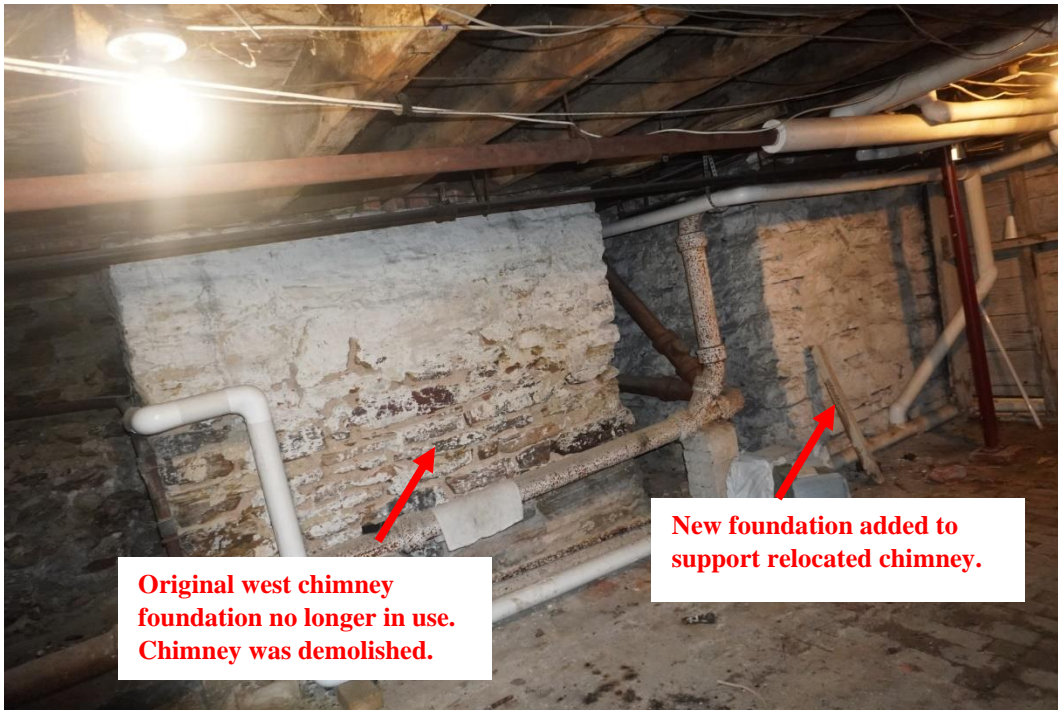
Photo #57: Original west chimney was relocated at some unknown time in the past.

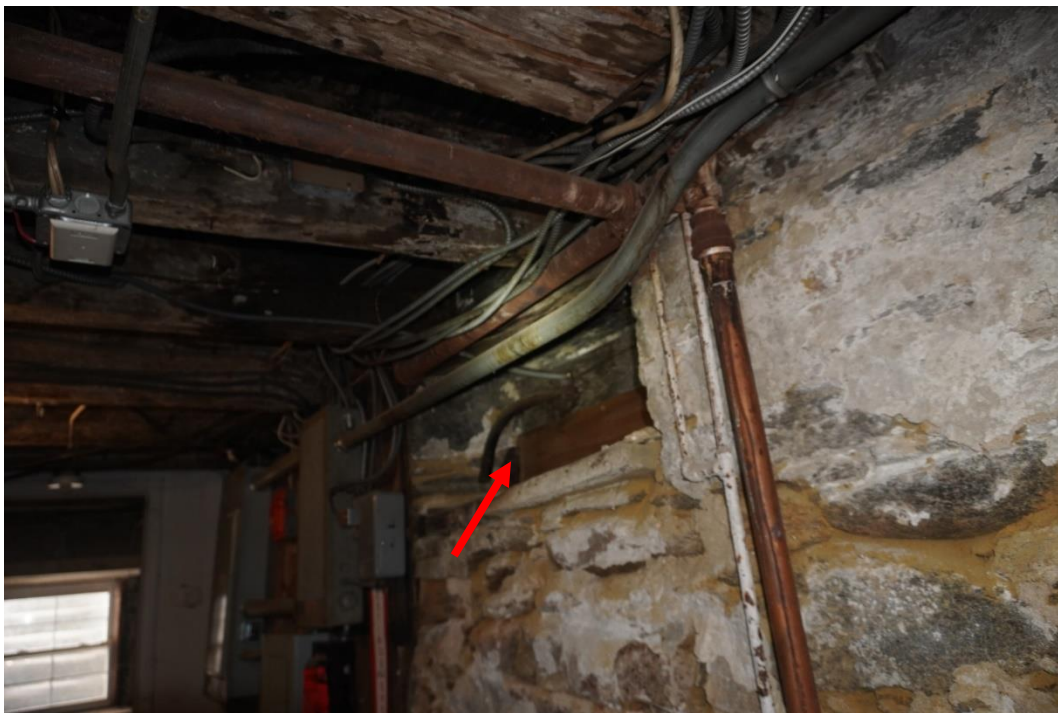
- e) Two cellar windows at boiler room south foundation wall have been covered up when porch was added to the rear of the home at some unknown point in the past (Photo #58 & #62). Porch also was observed to have two different sets of support pillars (Photos #31 - #34). It appears porch that was added to home got extended at some unknown point in the past.

Photo #58: Cellar window at boiler room south foundation wall has been covered up when porch was added to the rear of the home.

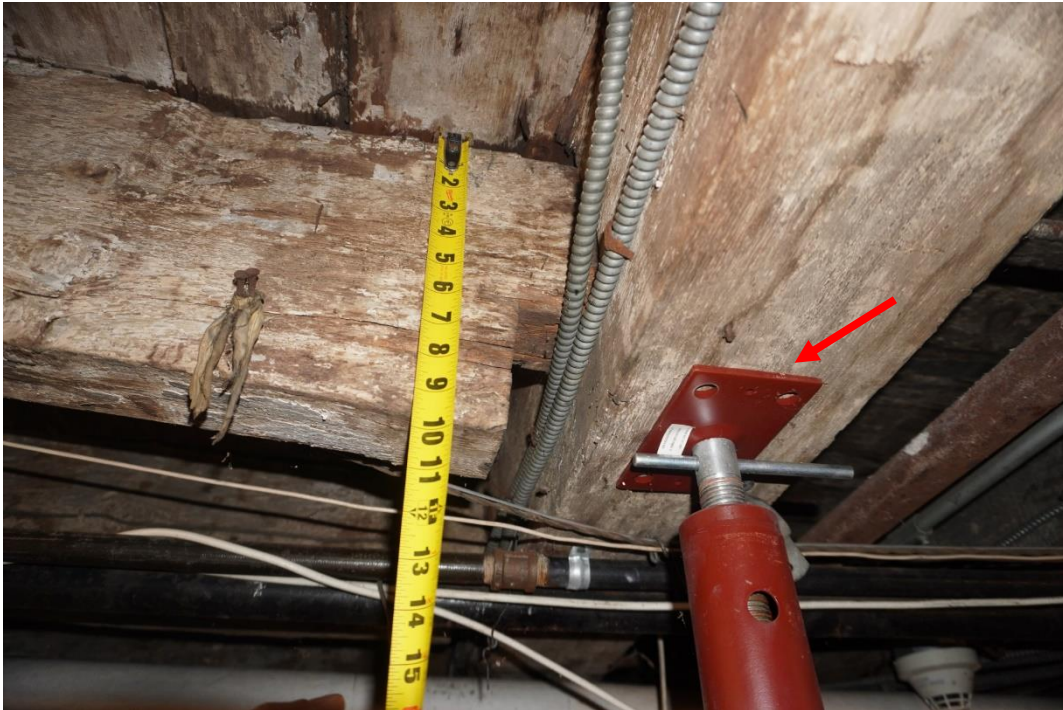
Photo #59: Temporary support column being used to hold failing 9-1/2"x9-1/4" girder in boiler room. Column not mechanically attached to girder above and does not have a proper footing.

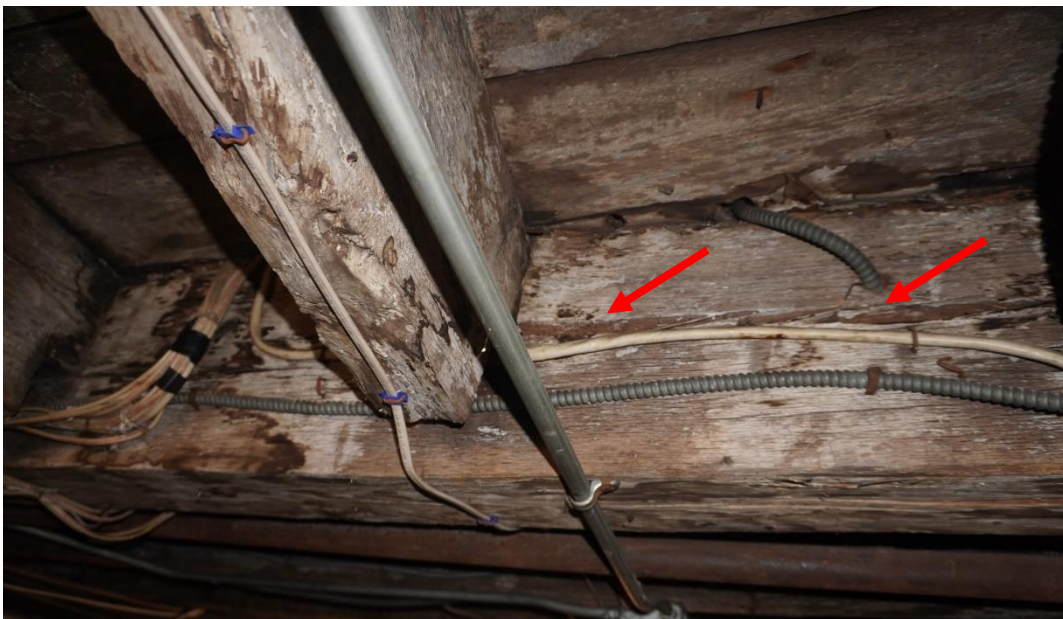
34. Large horizontal crack in 9-1/2"x9-1/4" girder in boiler radiating from mortise-and-tenon joint connections (Photo #60).
35. Wood joist observed to have a large extent of termite damage (Photo #61).

Photo #60: Large horizontal crack in 9-1/2"x9-1/4" girder in boiler radiating from mortise-and-tenon joint connections.

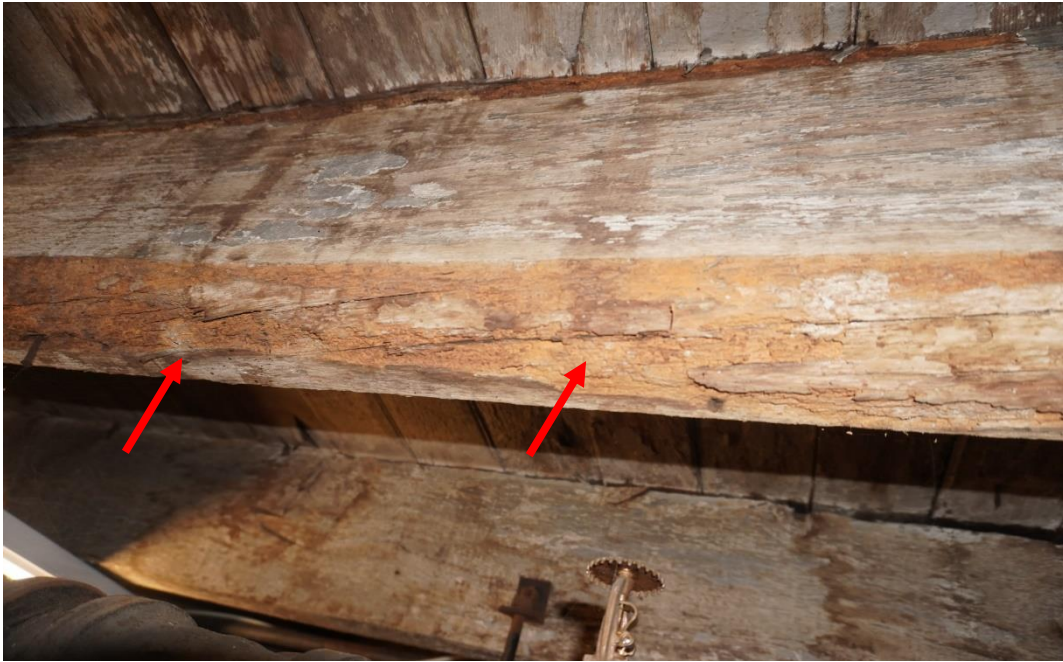
Photo #61: Wood joist observed to have a large extent of termite damage.

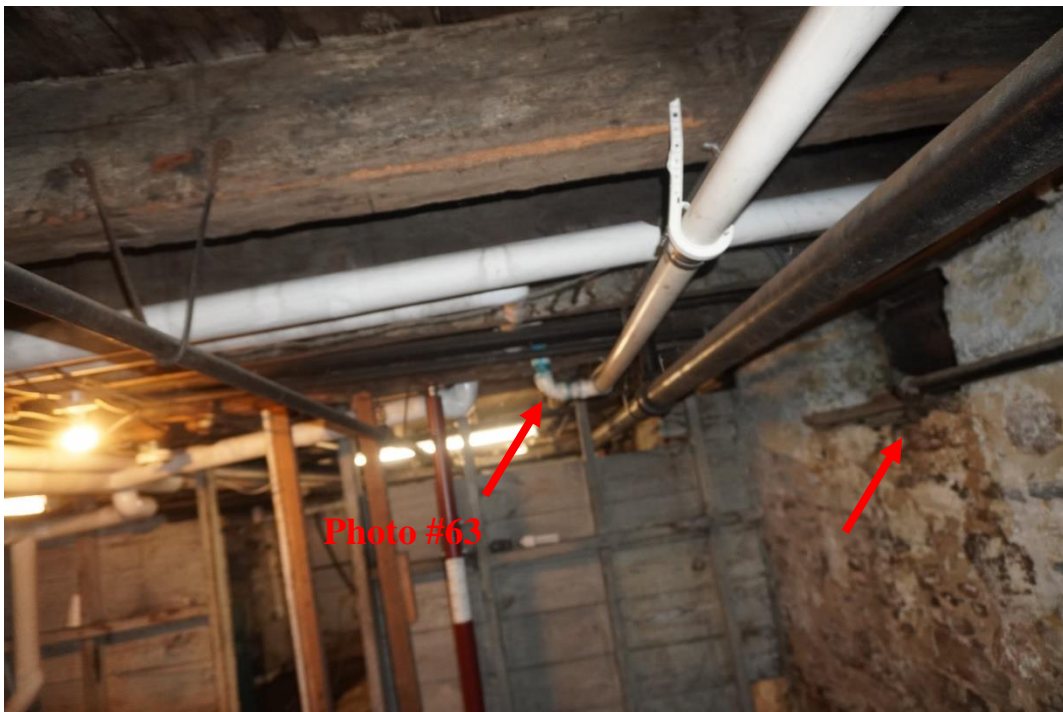
36. Plumbing pipe drilled directly through main girder in the vertical direction, west end of cellar (Photo #62 & 63).

Photo #62: Cellar window (second location) at west end of home on south foundation wall has been covered up when porch was added to the rear of the home. Plumbing pipe drilled directly through main girder in the vertical direction, west end of cellar.

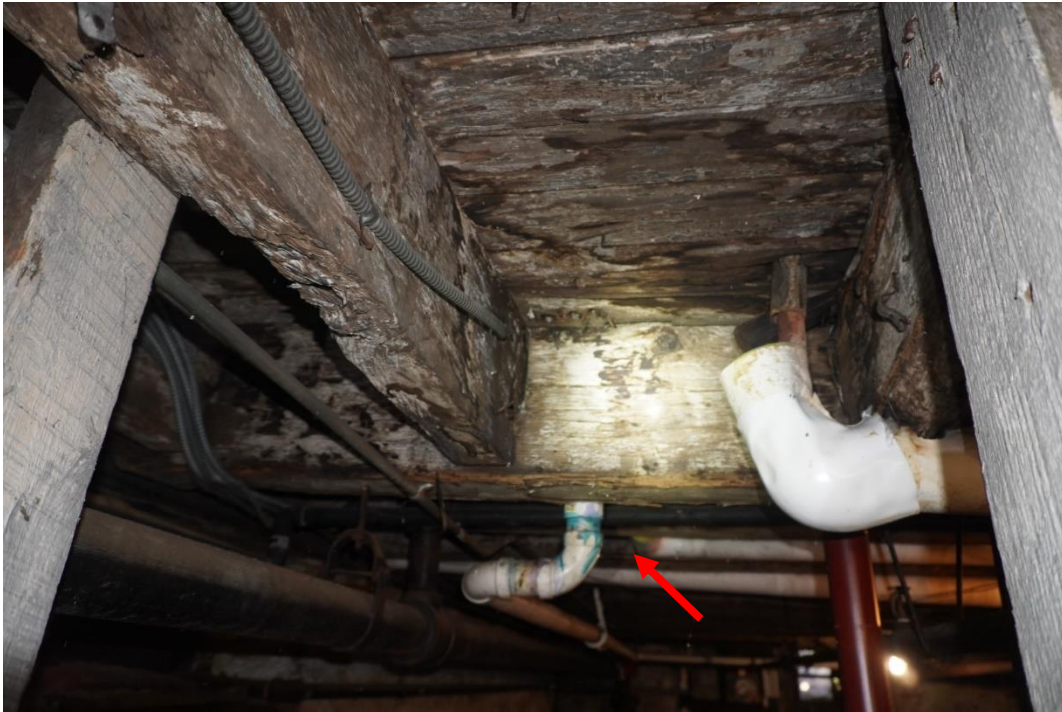
Photo #63: Plumbing pipe drilled directly through main girder in the vertical direction, west end of cellar.

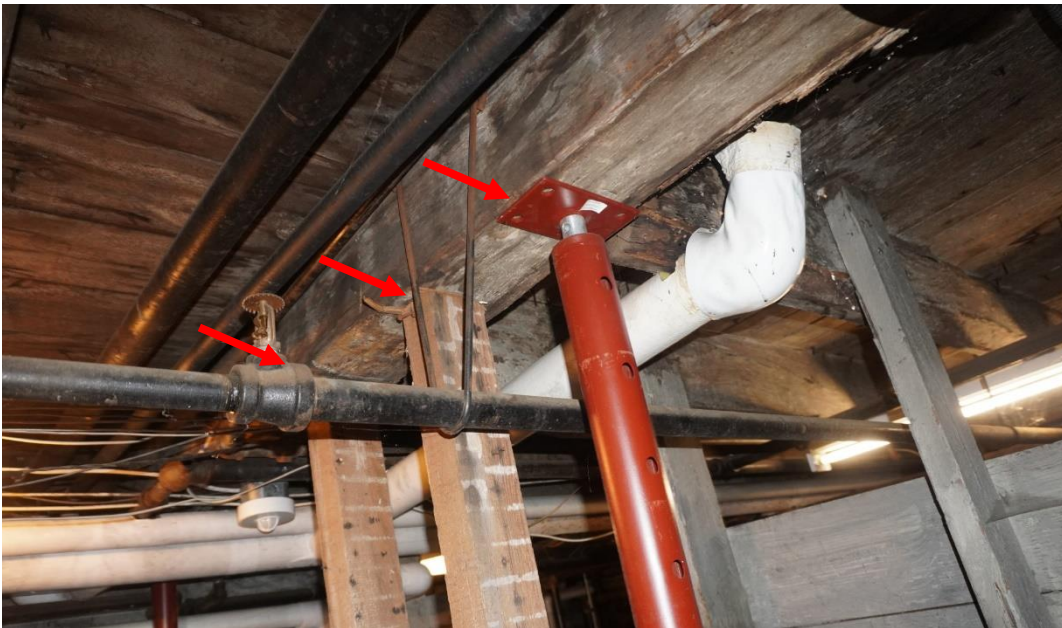
37. Temporary support columns being used to hold failing 6-3/4"x10-1/2" girder in place west end of cellar. Columns are not mechanically (Photo #64).
38. Joist with inadequate support resting on foundation wall that is deteriorated and that has been damaged to make a pipe penetration into crawlspace (Photo #65).

Photo #64: Temporary support columns being used to hold failing 6-3/4"x10-1/2" girder in place west end of cellar. Columns are not mechanically attached to girder above and do not have proper footings.

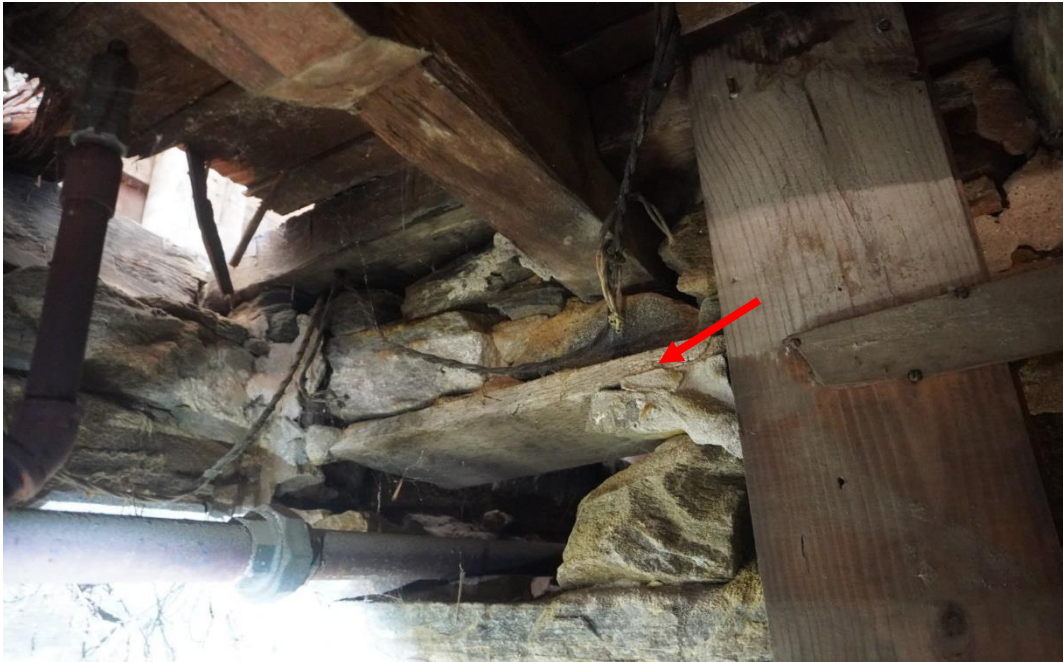
Photo #65: Joist with inadequate support resting on foundation wall that is deteriorated and that has been damaged to make a pipe penetration into crawlspace.

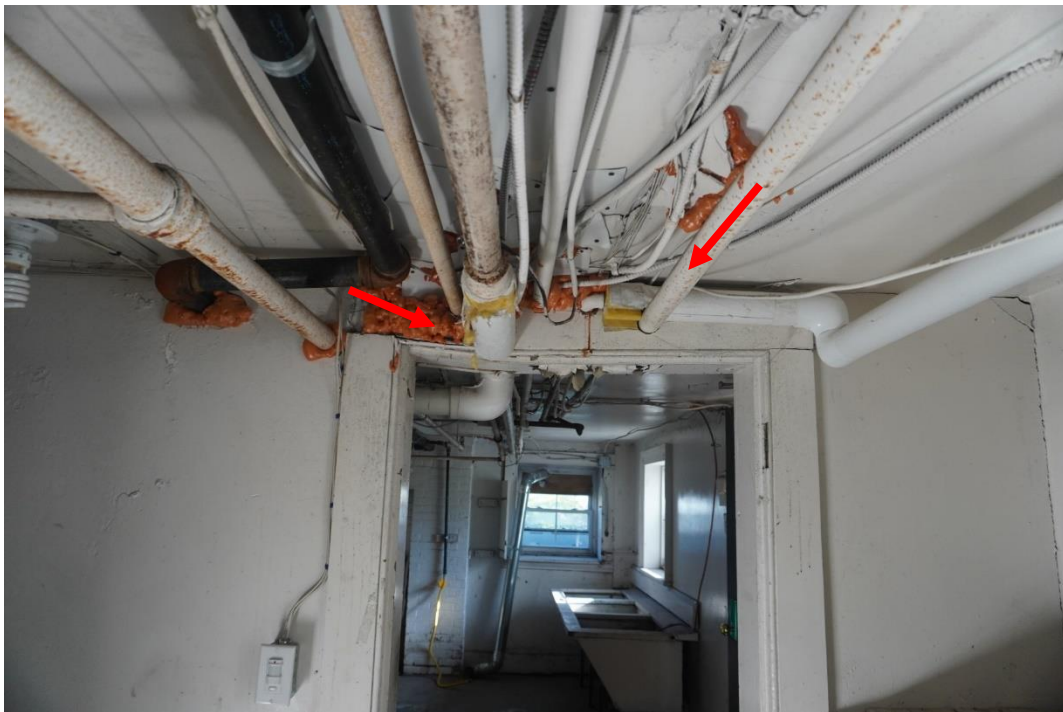
39. Multiple penetrations have been made through a door header that is observed to be failing. There is a wall on the first-floor level directly above this header (Photo #66).

Photo #66: Multiple penetrations have been made through a door header that is observed to be failing. There is a wall on the first-floor level directly above this header.

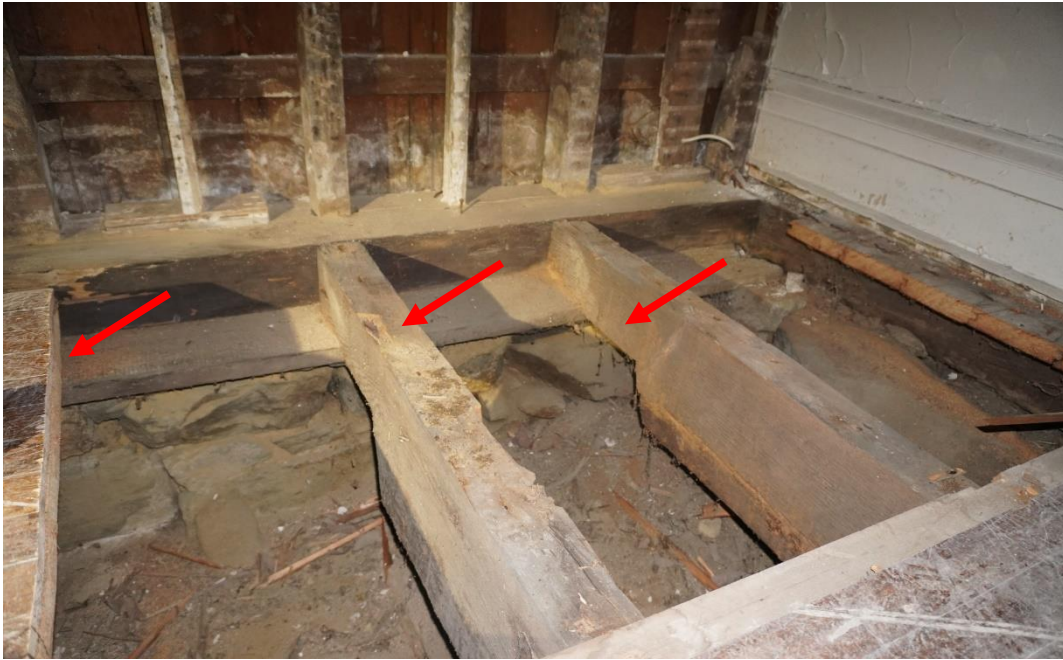
Photo #67: Joists spanning crawlspace sit on a thin sill plate which is not a standard timber framing technique. Typically, wood joists would be notched into the sill beam with use of a mortise and tenon connections (Probe #1).

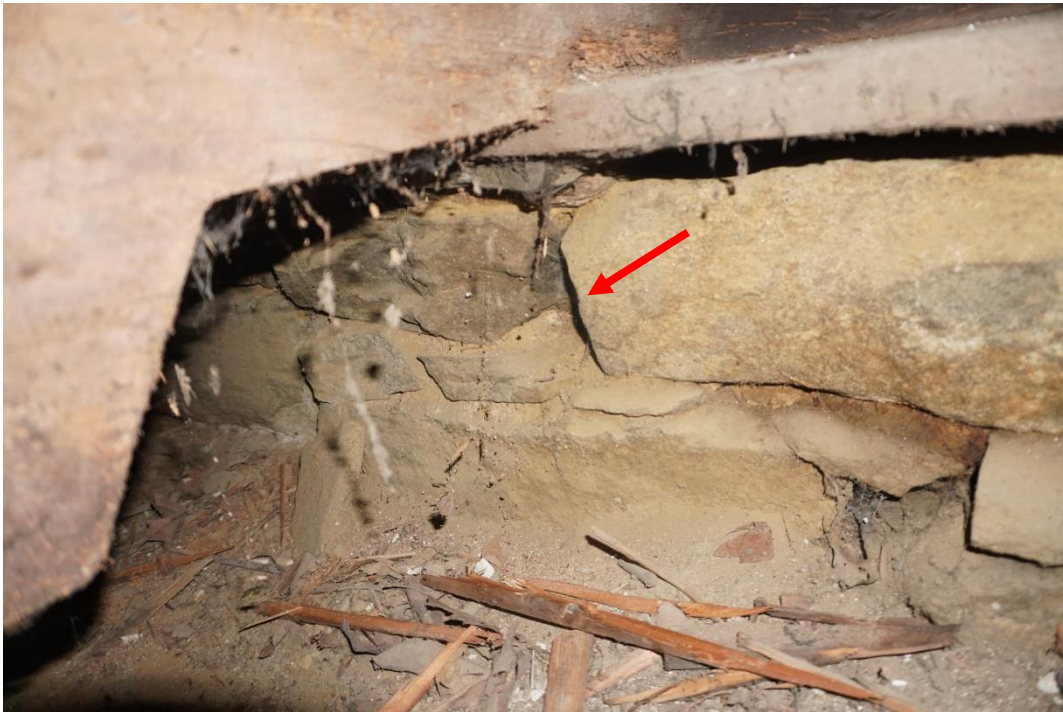
Photo #68: Thin sill plate, joists spanning crawlspace are sitting on, is being supported by a rubble stone foundation wall that is coming apart (Probe #1).

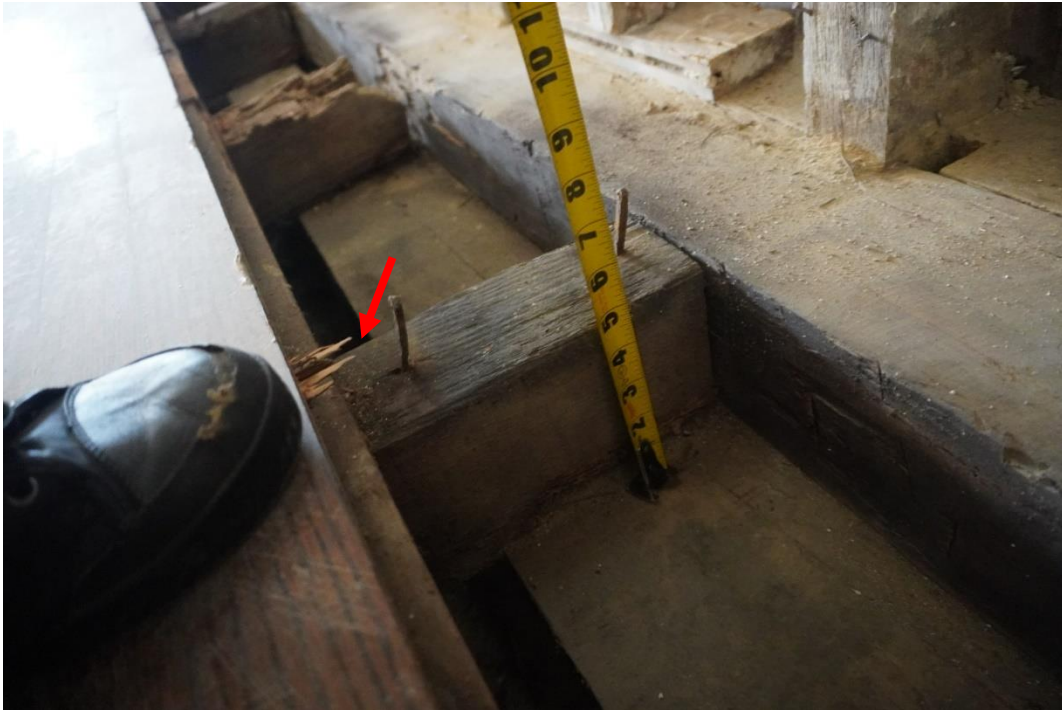
- c) Layouts on all floors of original home have been altered to make bedrooms and to add bathrooms for original structure to be used as a dorm.
- d) Original floorboards above crawlspace have been removed. Photo #69 & Photo #70 show that there is no original wood flooring beneath new wood flooring above crawlspace. New wood flooring observed to be directly attached to joists. Additionally, no original wood flooring was observed anywhere else in the house.

Photo #69: Original floorboards above crawlspace have been removed. New wood flooring directly attached to joists. Crawl space joists sitting on an improperly supported sill plate.
