**Re: *Biggest Fish Westchester LLC*
§11A-9 Economic Hardship Request (Certificate of Appropriateness)
*230 White Plains Road - Section 31. Block 3 Lot 13 ("Property")***

Property Location:	230 White Plains Road Tuckahoe, NY 10707
Inspection Dates:	Initial Inspection: 9/23/22 In Depth Inspection: 11/14/22 Probe Inspection: 12/13/22
Report Date:	1/28/23
Report By:	Peter Panagopoulos, P.E. <i>Principal</i> Pantec Engineering
Appendices:	Appendix A – Photos Appendix B – Probe Locations Appendix C – Structural Layout Appendix D – Deficiency Location Diagram Appendix E - Two Inner Chimney Georgia Colonial Layout

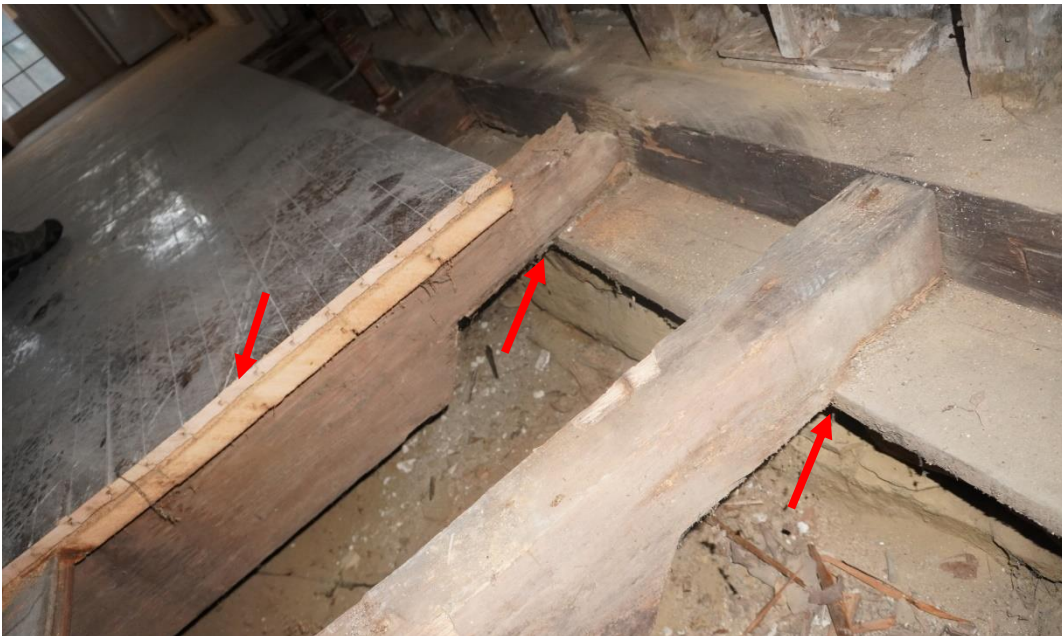
Photo #70: Original floorboards above crawlspace have been removed. New wood flooring directly attached to joists. Crawl space joists sitting on an improperly supported sill plate (Probe#1).

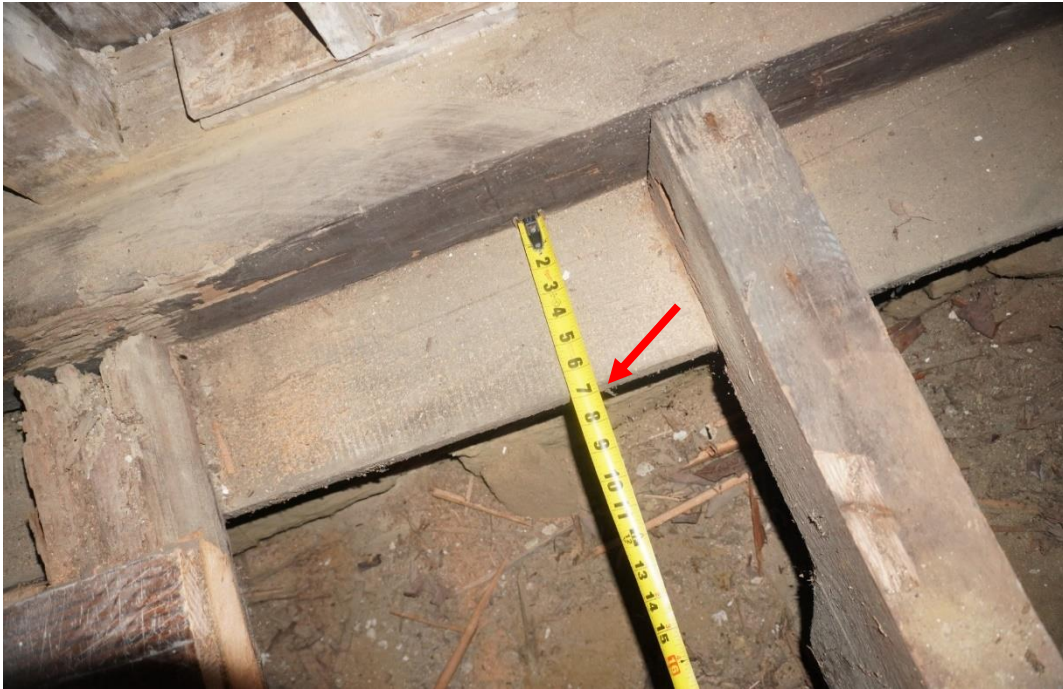
40. Crawl space joists sit on a 7-inch sill plate that is only bearing 3 inches onto deteriorating foundation wall below. Sill plate has a four-inch unsupported overhang (Probe #1) (Photo #67 - #72).

Photo #71: Crawl space joists sit on a 7-inch sill plate that is only bearing 3 inches onto deteriorating foundation wall below. Sill plate has a four-inch unsupported overhang (Probe #1).

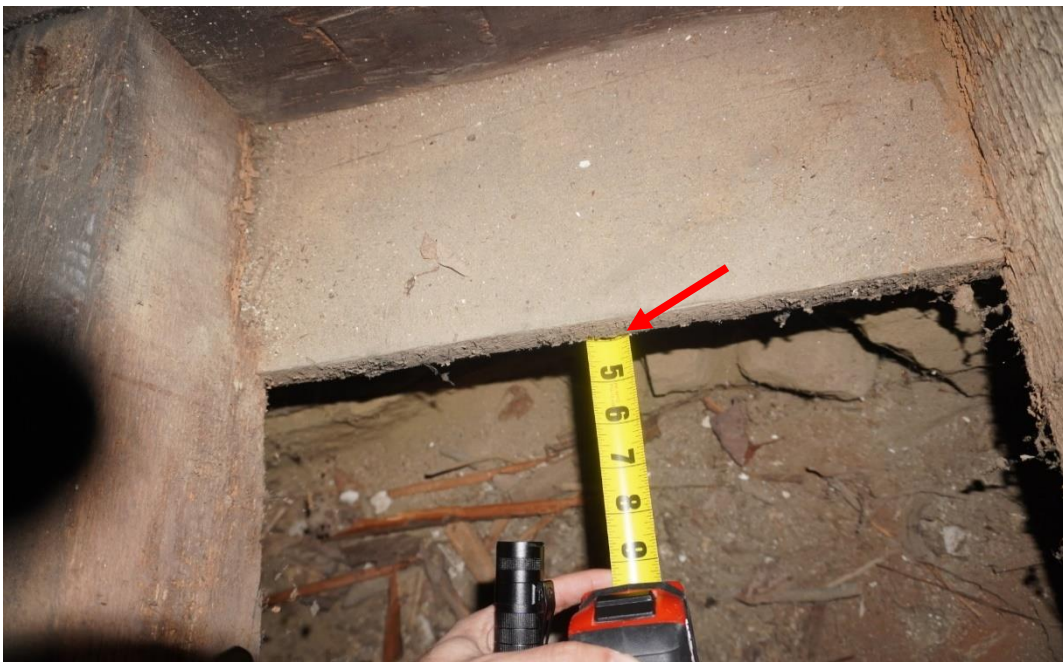
Photo #72: Crawl space joists sit on a 7-inch sill plate that is only bearing 3 inches onto deteriorating foundation wall below. Sill plate has a four-inch unsupported overhang (Probe #1).

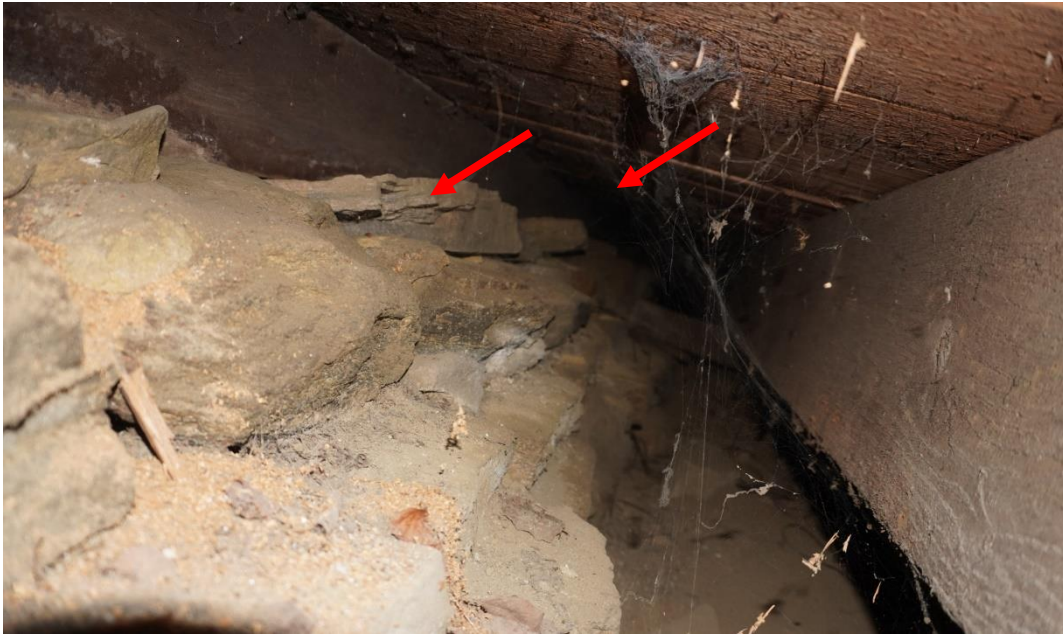
41. Exterior foundation along north side of home below sill beam is deteriorating and observed to have displaced (Probe #1) (Photo #73).
42. Wood joists spanning crawl space are being inadequately supported at midspans by wood members that are balanced above unstable pieces of stone (Probe #1) (Photo #75).

Photo #73: Exterior foundation along north side of home below sill beam is deteriorating and observed to have displaced. (Probe #1)

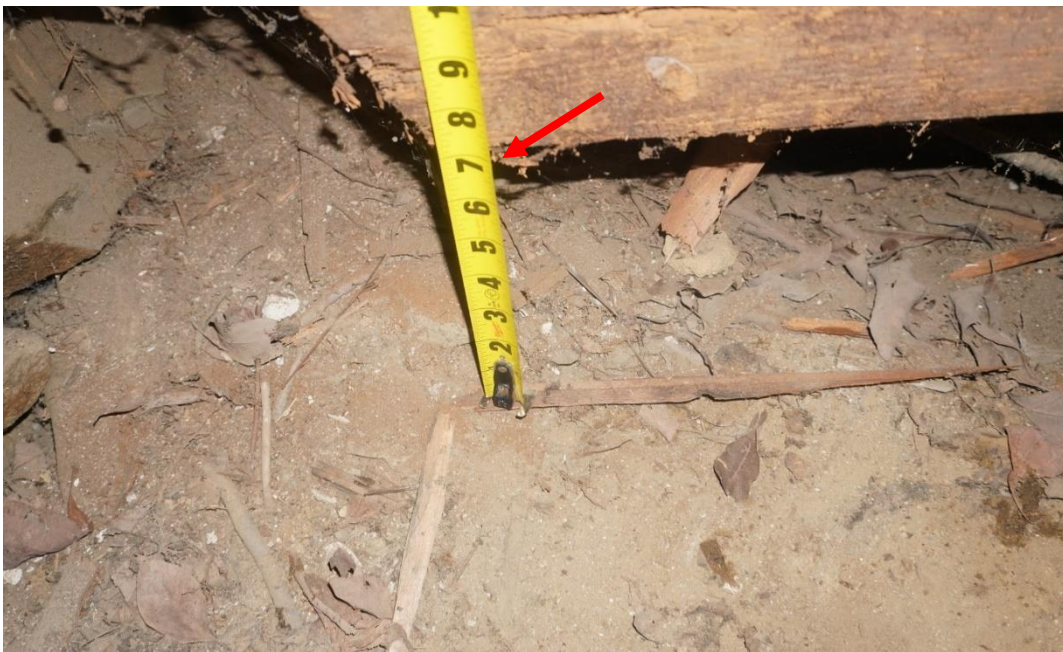
Photo #74: Wood joists in crawlspace are sitting 7 inches above exposed dirt beneath crawlspace. Crawlspace is inaccessible. Crawlspace foundation most likely does not extend below the frost line (Probe #1). Further investigation required.

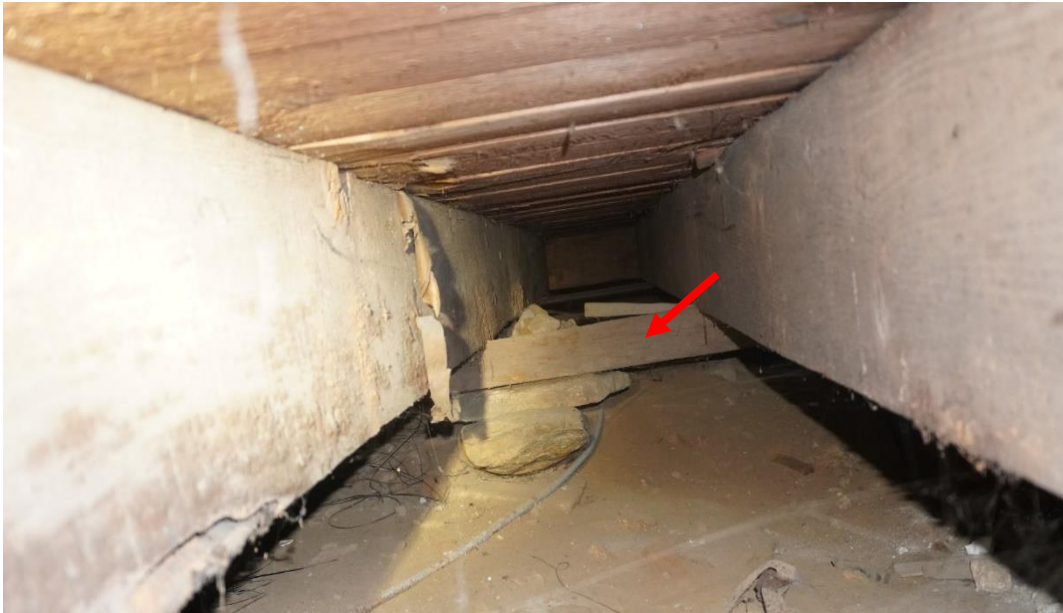
Photo #75: Wood joists spanning crawl space are being inadequately supported at midspans by wood members that are balanced above unstable pieces of stone (Probe #1).

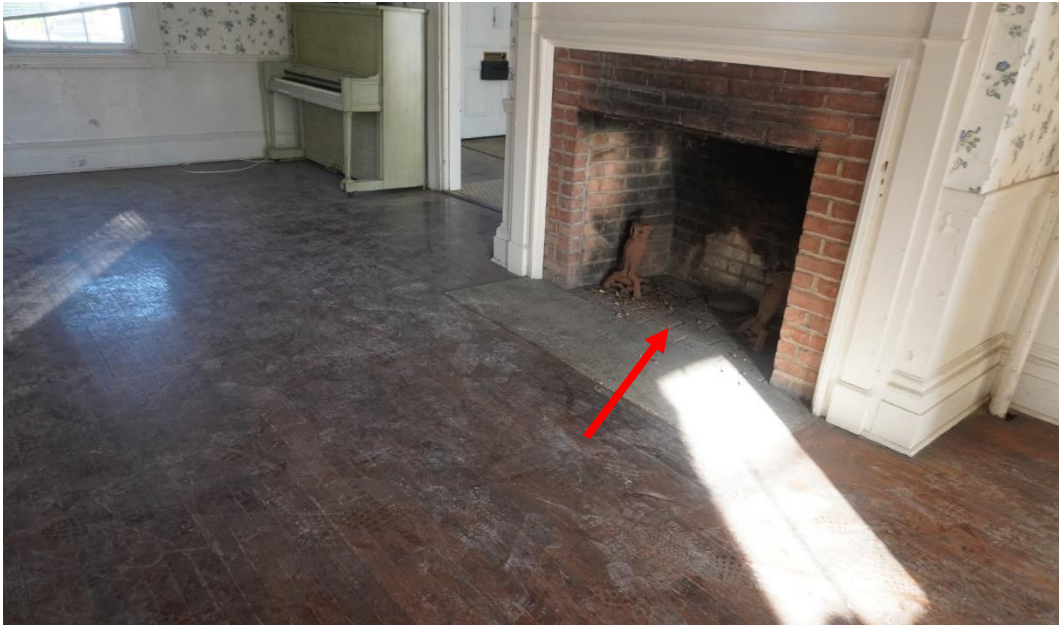
Photo #77: Chimney was added to this location at some unknown point in the past. Presumably when the original west chimney was demoed.

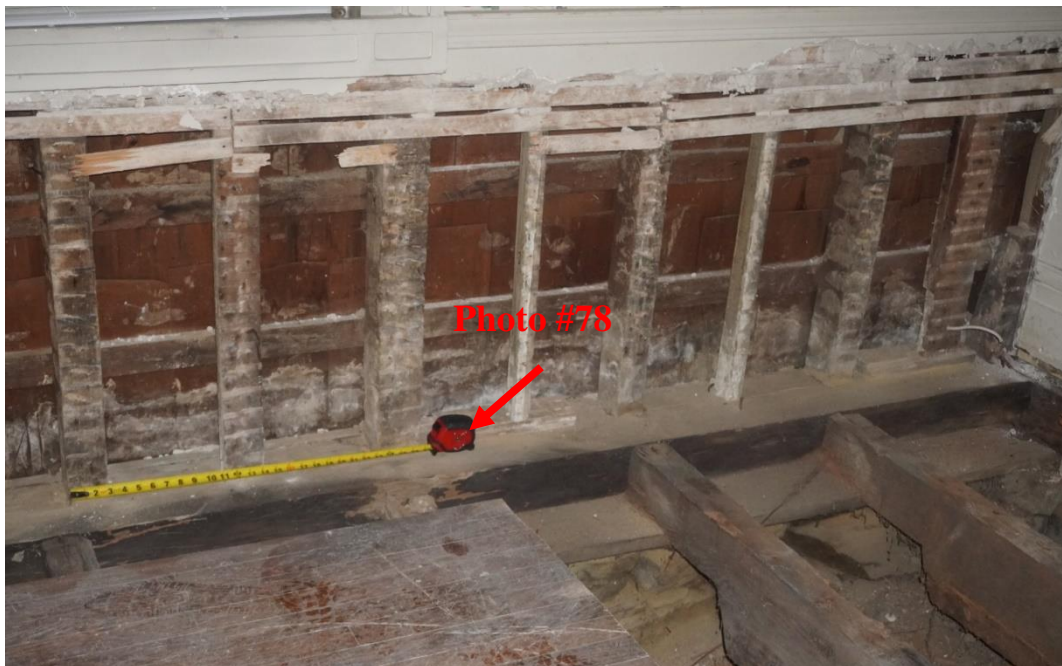
Photo #78: Vertical exterior framing members spaced at approximately 10 to 11 inches apart along west façade sitting on sill beam (Probe #1).

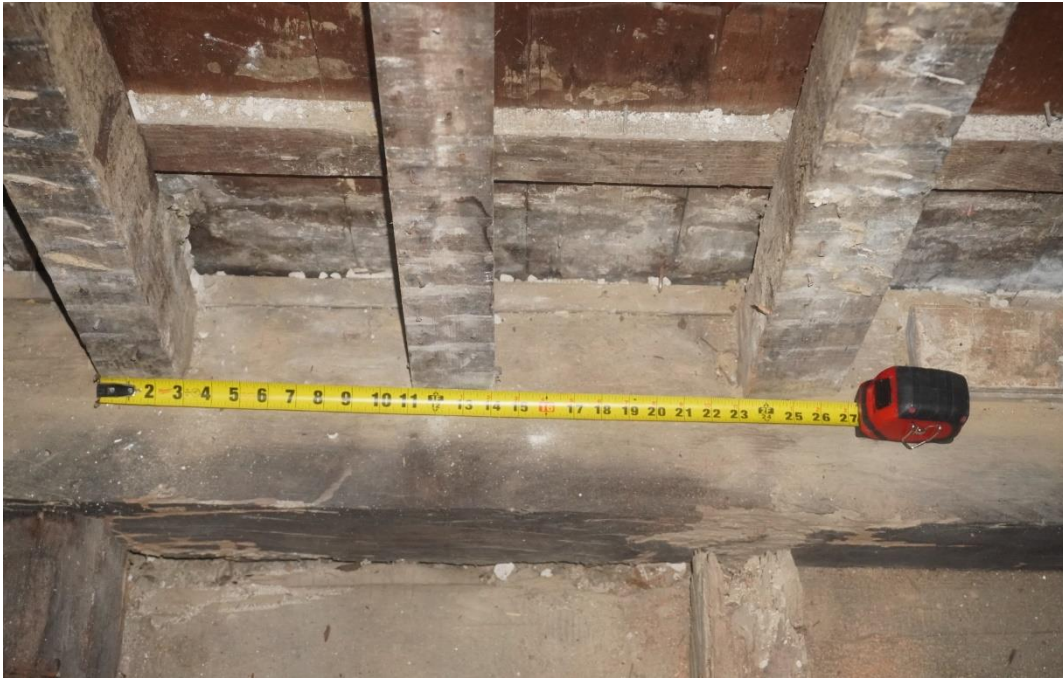
Photo #79: Vertical exterior framing members spaced at approximately 10 to 11 inches apart along west façade sitting on sill beam (Probe #1).

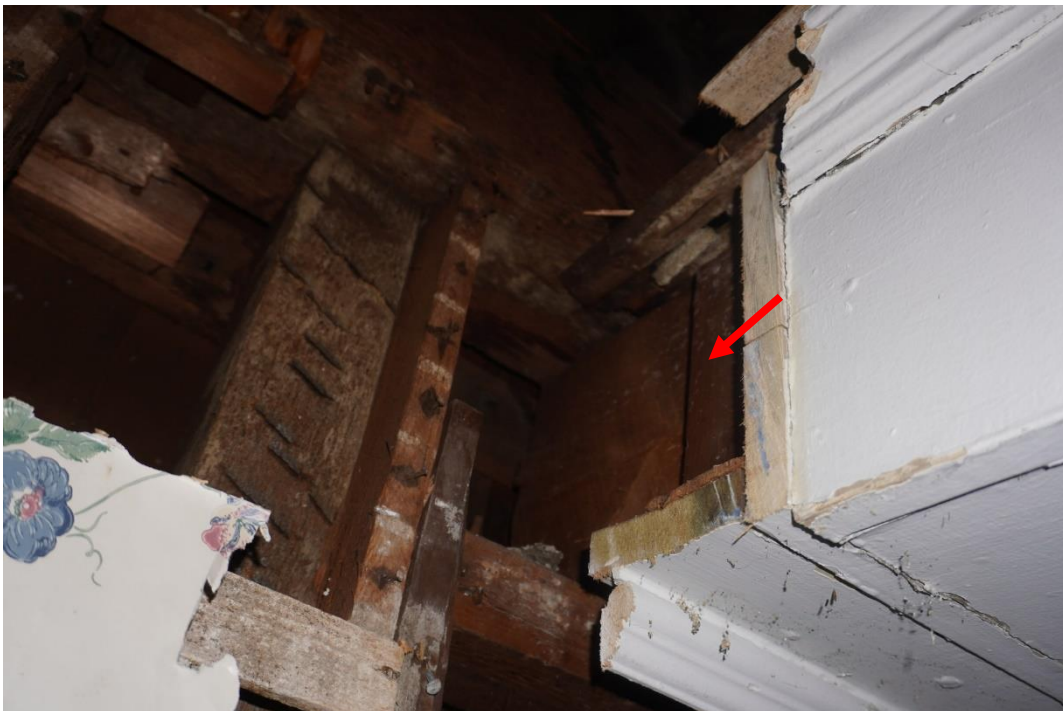
Photo #80: Large beam observed in ceiling soffit spanning east to west. Beam is acting as a midspan support for floor joists above that span north to south (Probe #2).

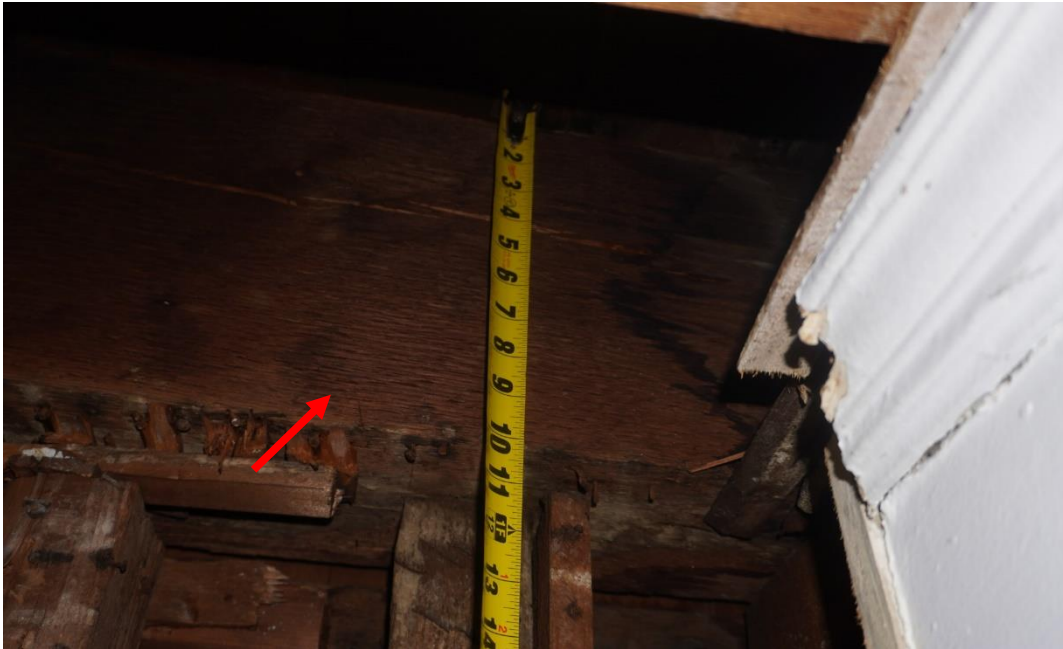
Photo #81: 10x7 Exterior spandrel beam running north to south 1st floor ceiling level along west exterior wall. (Probe #2)

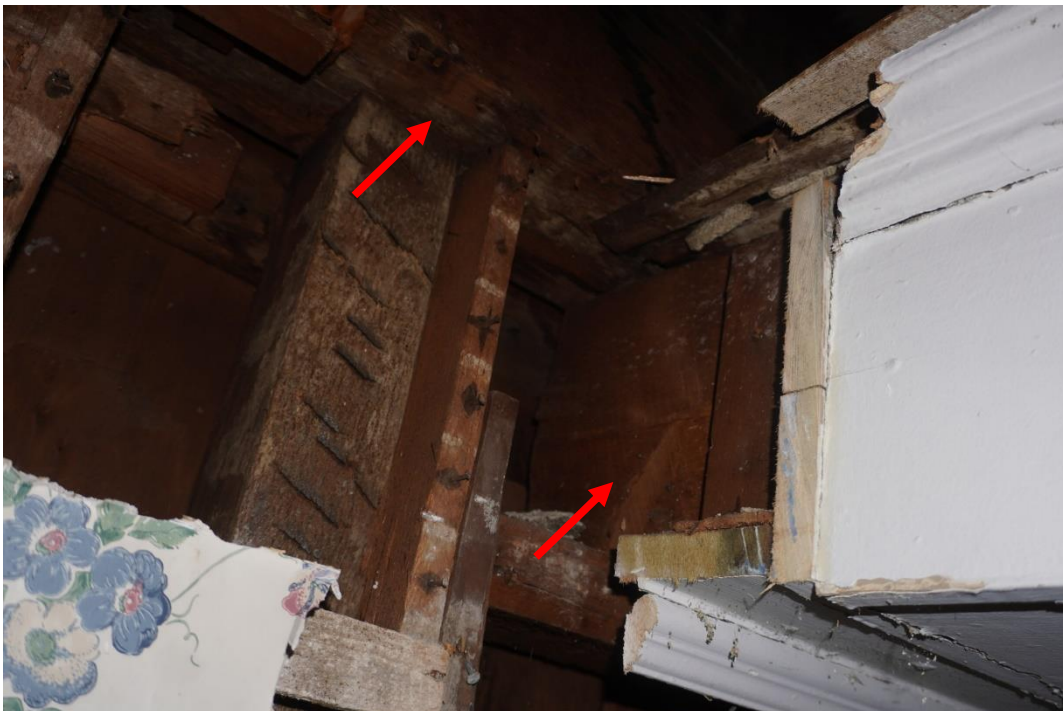
- b) A large 6"x9-1/4" beam was observed in basement, and it is unclear why it is sized larger than the other floor joists (Photo #48).
- c) Ceiling soffit contains a support beam that runs east to west below the exterior spandrel beam that runs north to south. Beam running east to west supports joists above at midspan. This is an atypical configuration that was most likely a modification done when chimney was moved and not part of the original timber framing design (Probe #2) (Photo #81 & 82).

Photo #82: Ceiling soffit contains a support beam that runs east to west below the spandrel beam. Beam running east to west supports joists above at midspan. This is an atypical configuration that was most likely a modification and not part of the original timber framing design (Probe #2).

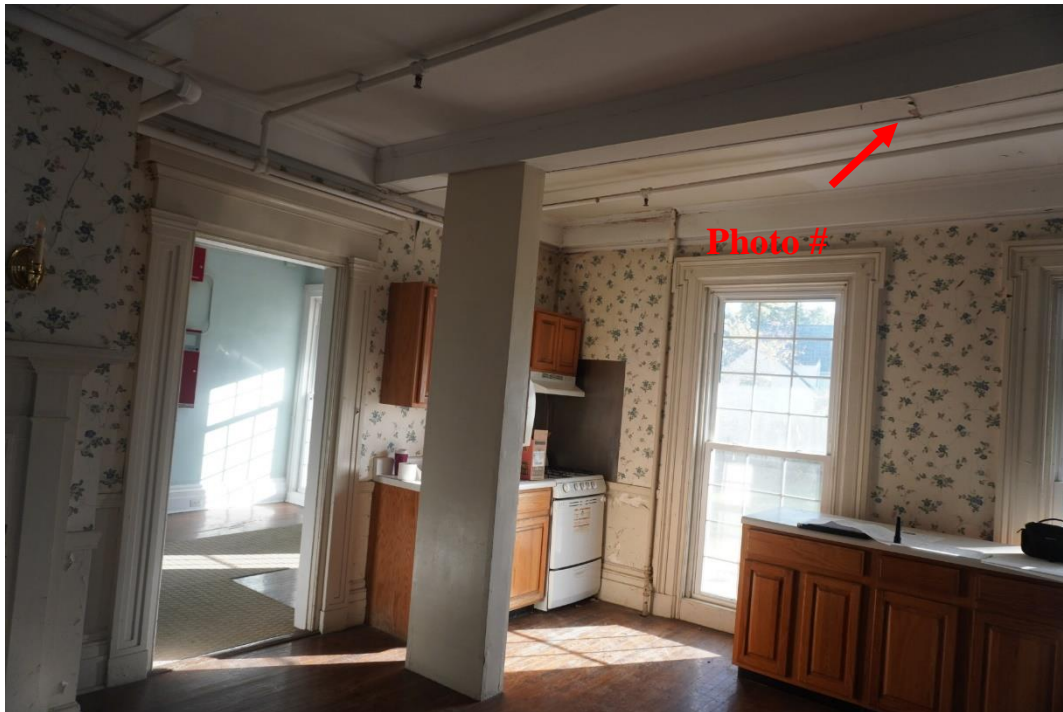
Photo #83: Soffit was opened up to further investigate crack. When soffit at this location was opened up it was empty inside and apparently was just there for aesthetic purposes (Probe #3).

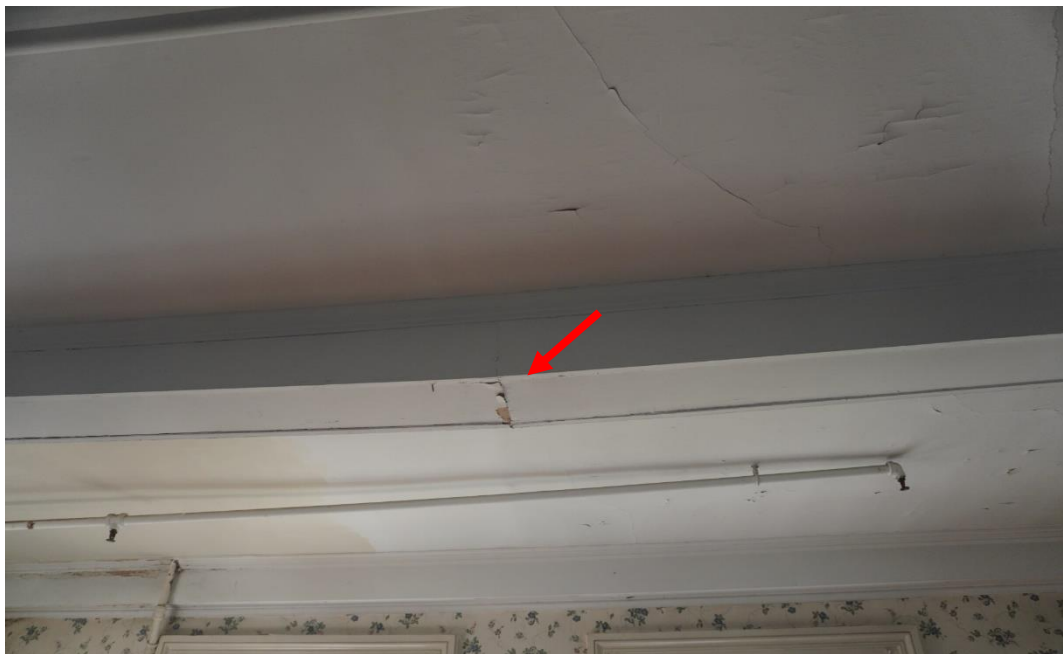
Photo #84: Soffit was opened up to further investigate crack. When soffit at this location was opened up it was empty inside and was just apparently there for aesthetic purposes (Probe #3).

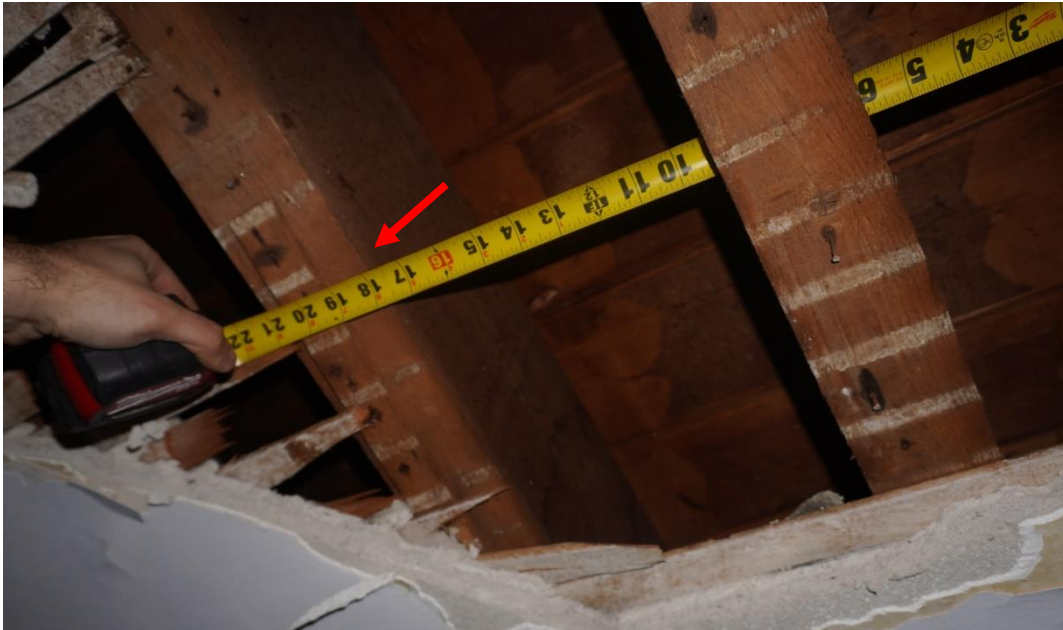
- d) Photo #85: Joists above faux soffit are running north to south and are spaced at 18" inches apart. All other floor joists observed in the original structure above the ground level are running perpendicular to these joists (Probe #3) (Photo #85). Further investigation required.

Photo #85: Joists above faux soffit are running north to south and are spaced at 18” inches apart. All other floor joists observed in the original structure above the ground level are running perpendicular to these joists (Probe #3). Further investigation required.

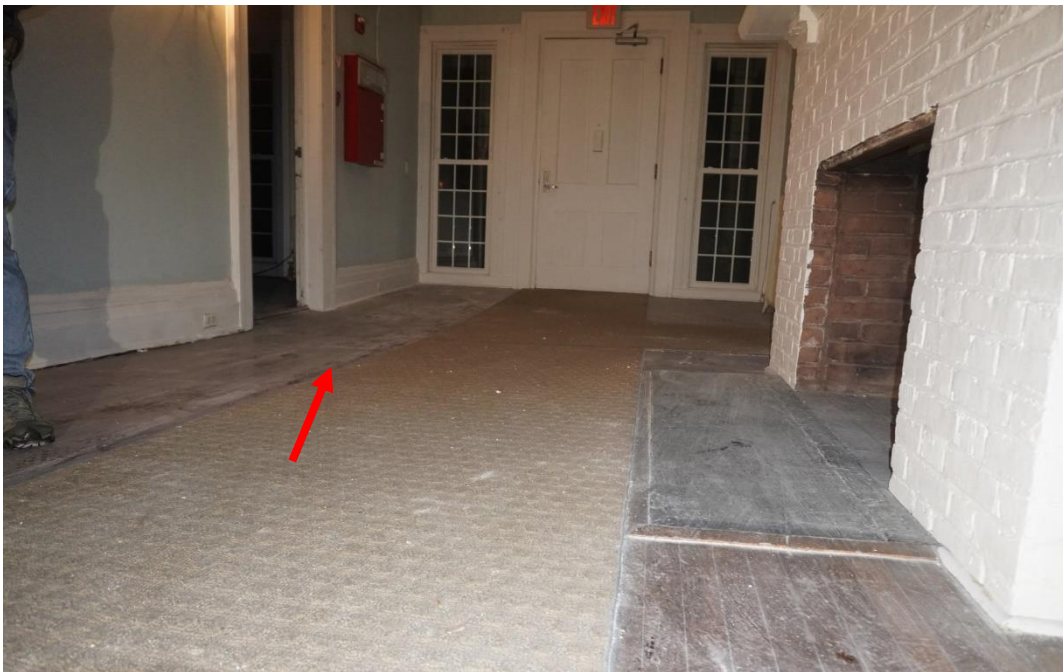
Photo #86: Large floor depression adjacent to load bearing wall 1st floor. This area is directly above girder that is failing in the boiler area and being propped up with temporary columns. Staircase to go up to the second floor was originally located somewhere in this room.

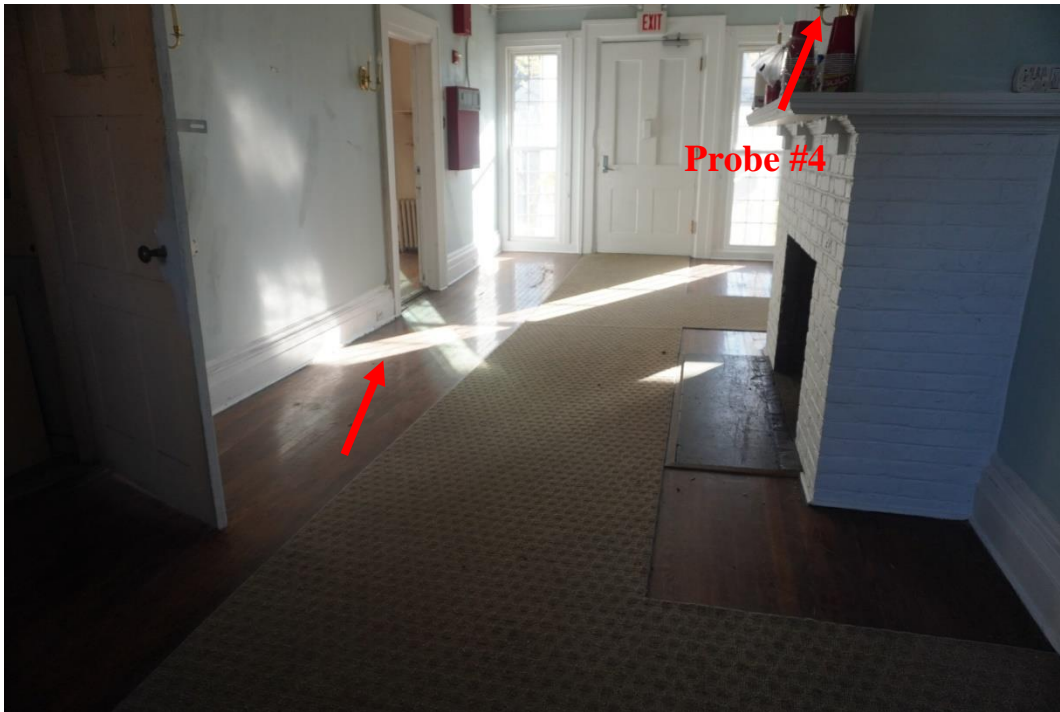
Photo #87: Large floor depression adjacent to load bearing wall 1st floor. This area is directly above girder that is failing in the boiler area and being propped up with temporary columns. Staircase to go up to the second floor was originally located somewhere in this room.

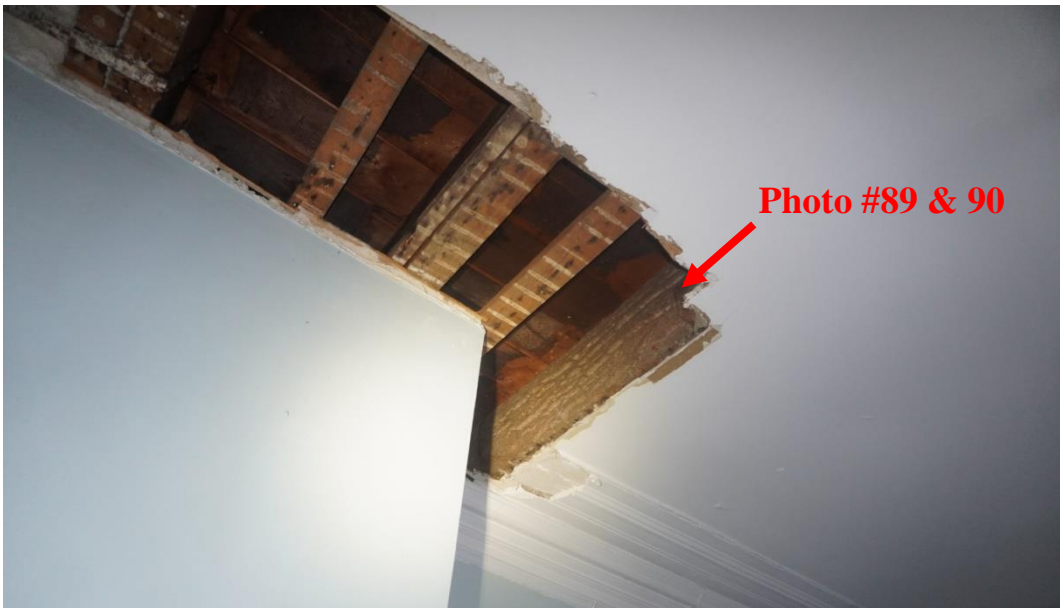
Photo #88: Ceiling joist that was never fully scored into a square framing member and still has bark exterior (Probe #4).

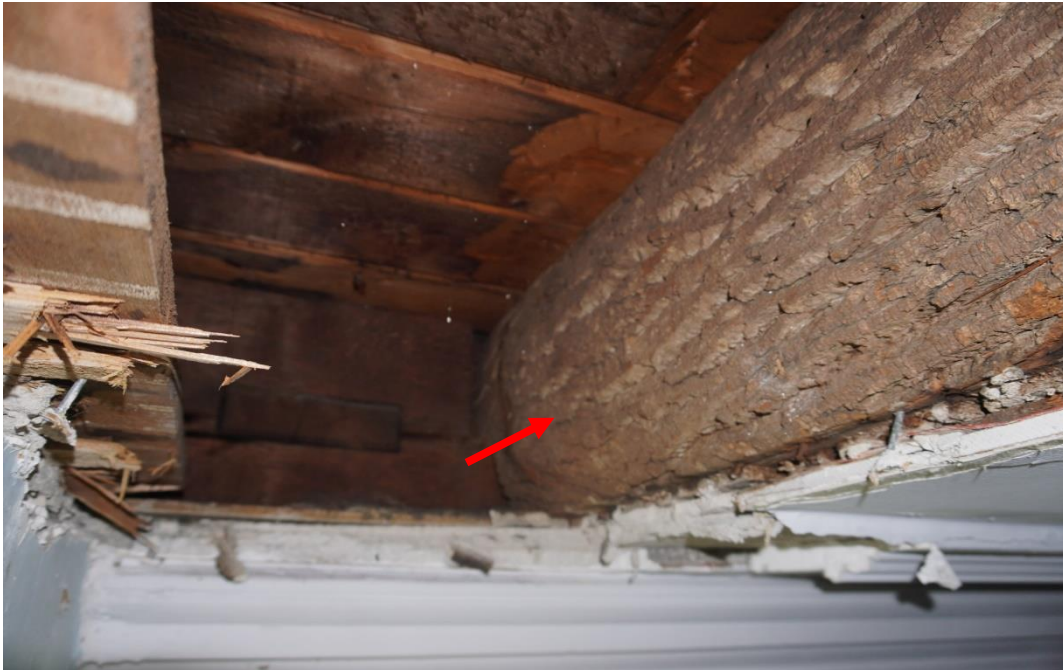
Photo #89: Ceiling joist that was never fully scored into a square framing member and still has bark exterior (Probe #4).

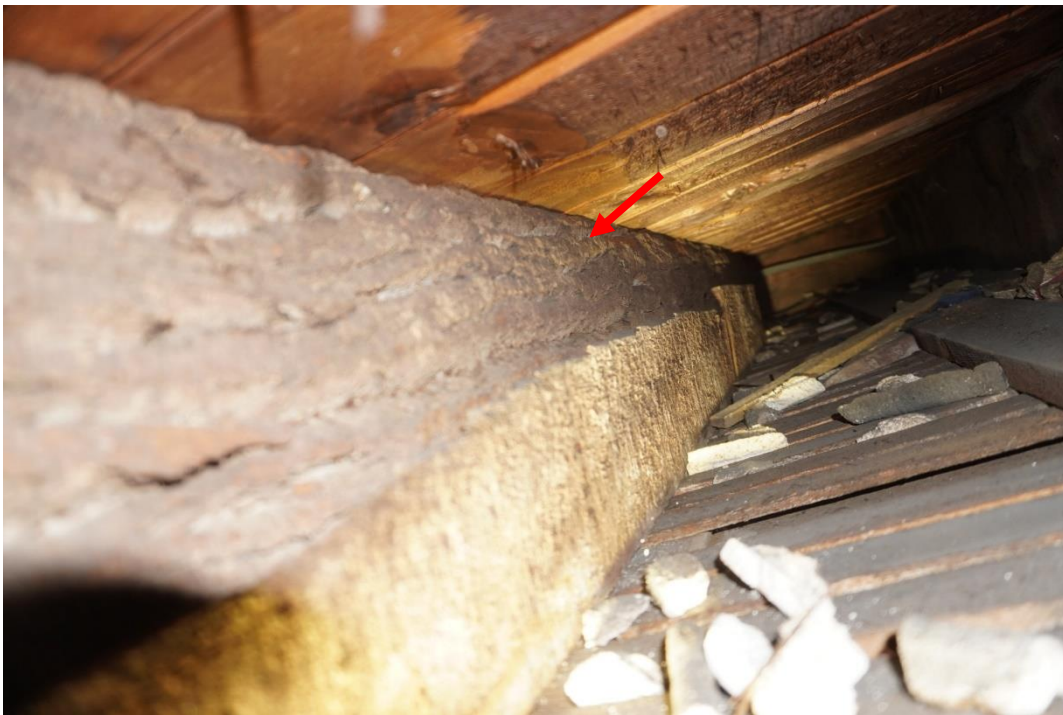
Photo #90: Ceiling joist that was never fully scored into a square framing member and still has bark exterior (Probe #4).

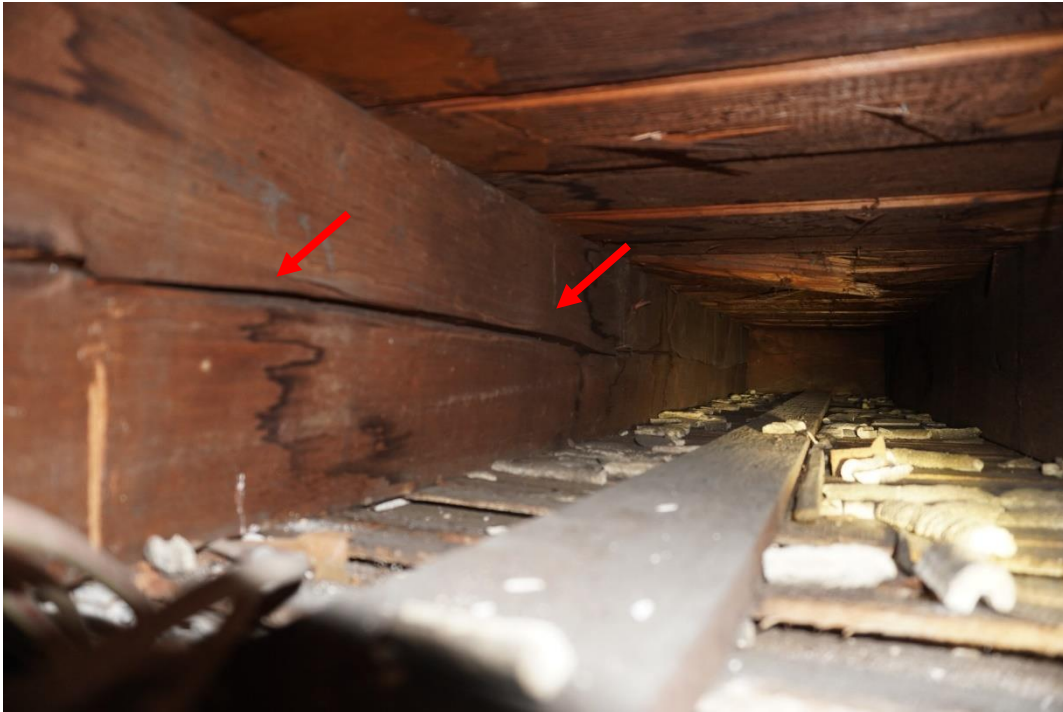
Photo #91: Large shrinkage crack that runs entire floor joist (Probe #4).

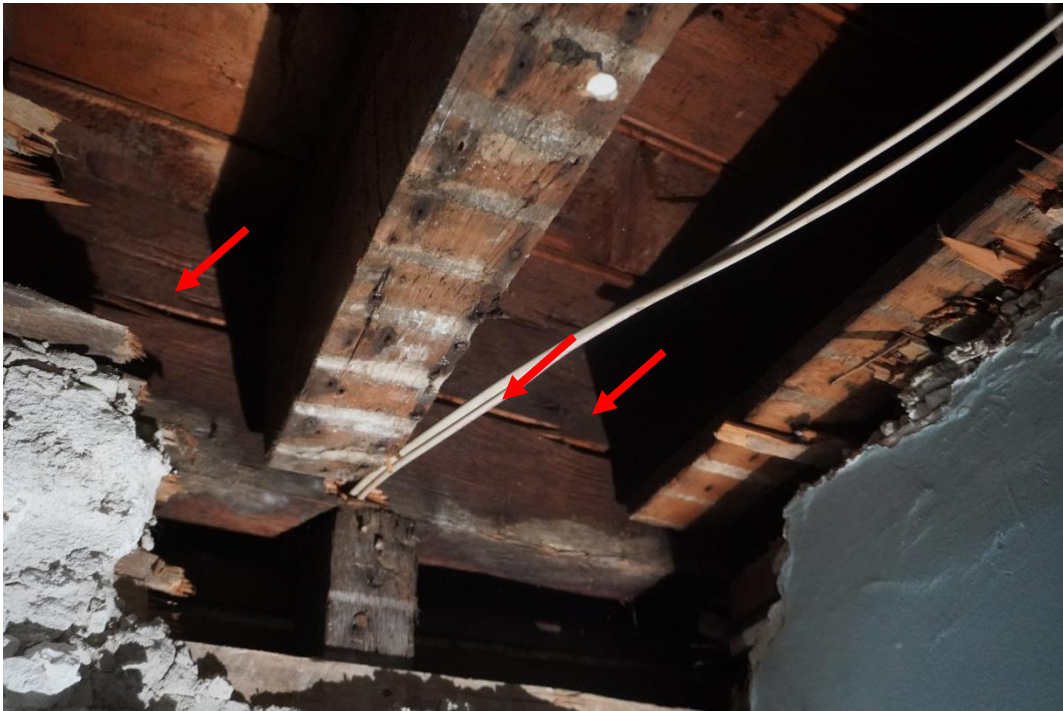
Photo #92: Interior girder running north to south is splitting along the mortise and tenon joint connections (Probe #4).

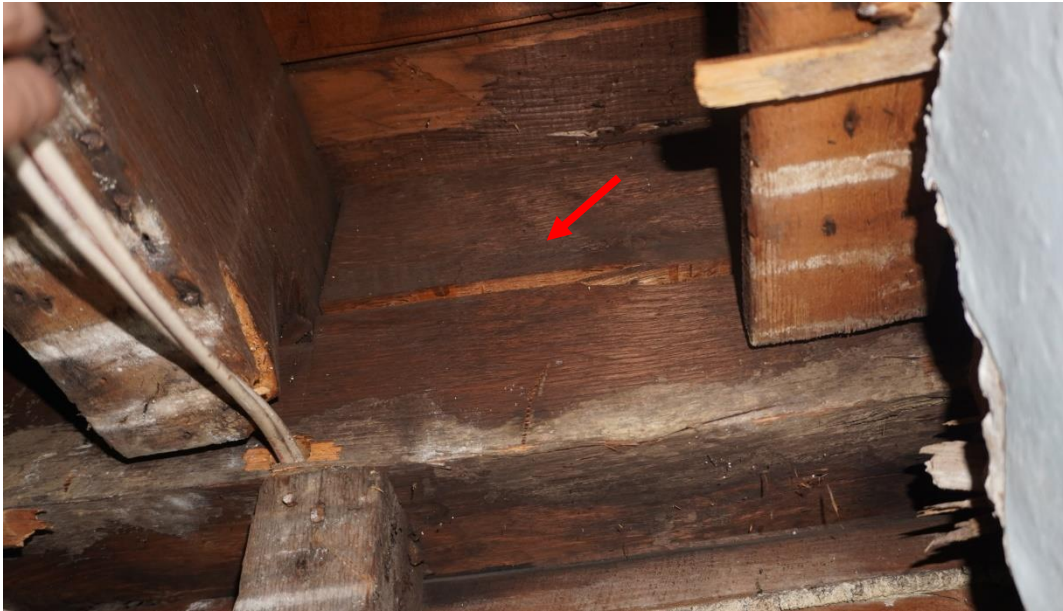
Photo #93: Interior girder running north to south is splitting along the mortise and tenon joint connections (Probe #4).

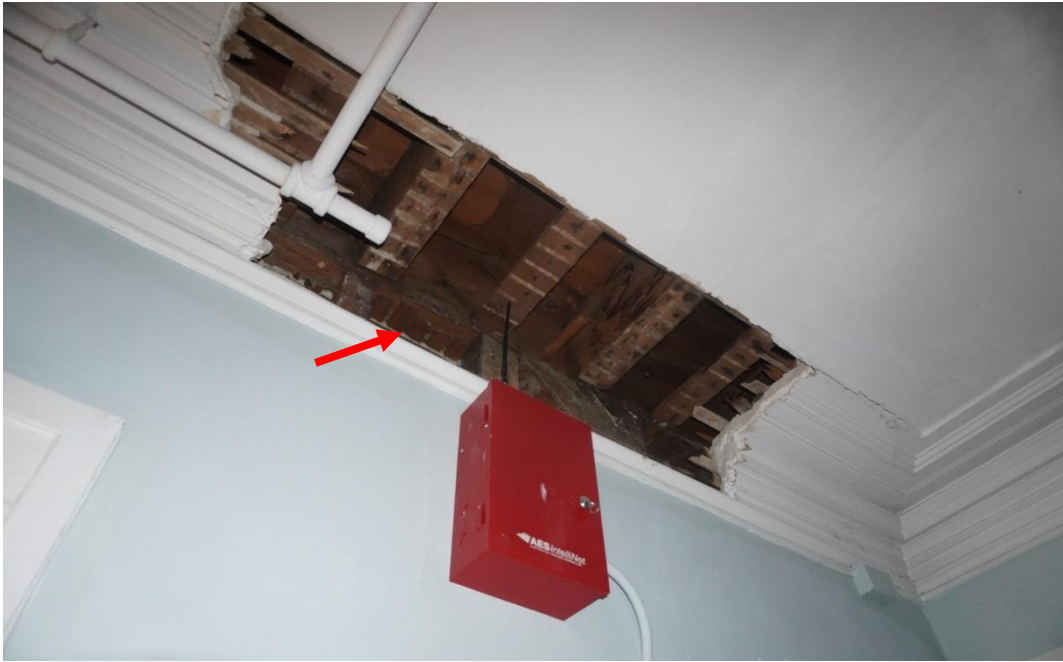
Photo #95: Interior girder that is showing signs of deflection. Girder is directly above girder that is failing in the boiler room area and is being propped up with temporary columns (Probe #5).

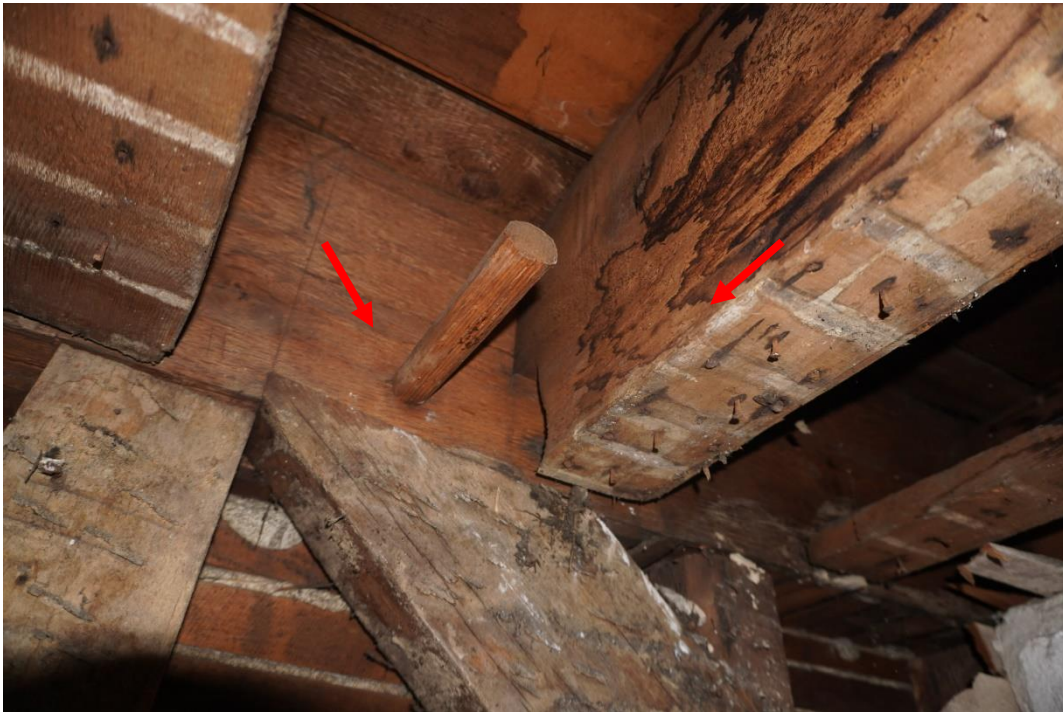
43. Both staircases leading from ground floor to second floor have varying stair riser heights exceeding code max tolerance creating a fall hazard.
44. Large floor depression adjacent to load bearing wall 1st floor. This area is directly above girder that is failing in the boiler area and being propped up with temporary columns. Staircase to go up to the second floor was originally located somewhere in this room (Photo #86 & #87).
45. Large shrinkage crack that runs entire floor joist (Probe #4) (Photo #91).
46. Interior girder running north to south is splitting along the mortise and tenon joist connections (Probe #4) (Photo #92 & #93).
47. Wall containing girder beam showing signs of deflection. This girder is directly above girder that is failing in the boiler room area and is being propped up with temporary columns (Probe #5) (Photo #94 & #96).

Photo #96: Mortise and tenon connection between a bracing member and interior girder being held in place with a wooden peg. (Probe #5)

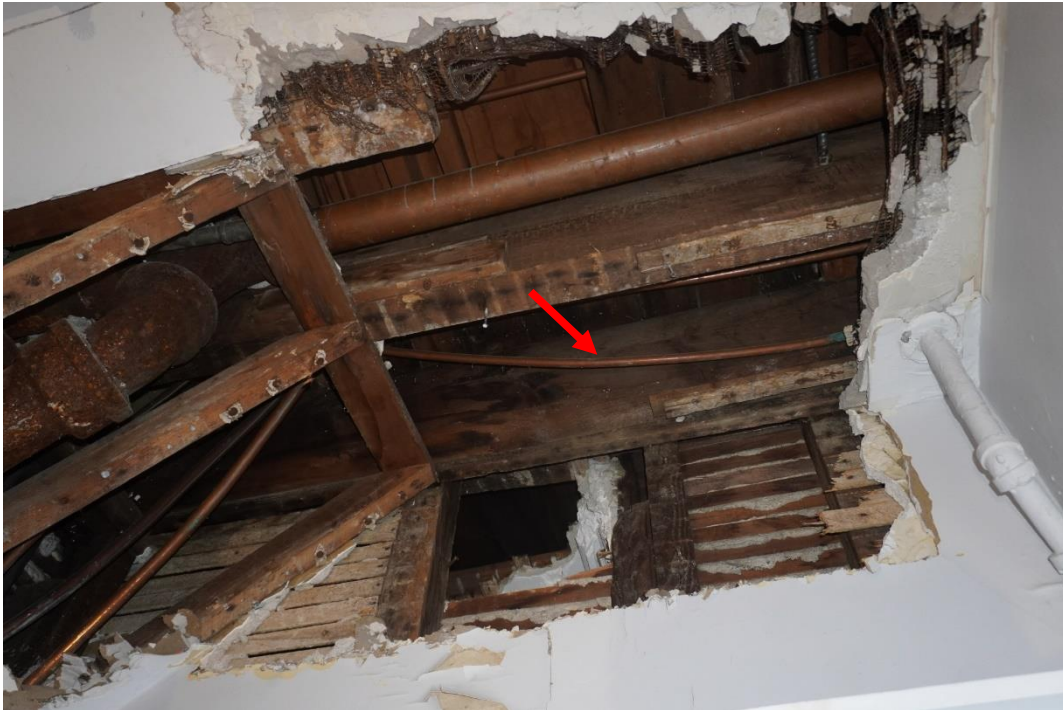
Photo #97: Girder beam that runs north to south in wall that use to be the exterior wall of the original structure (Probe #6).

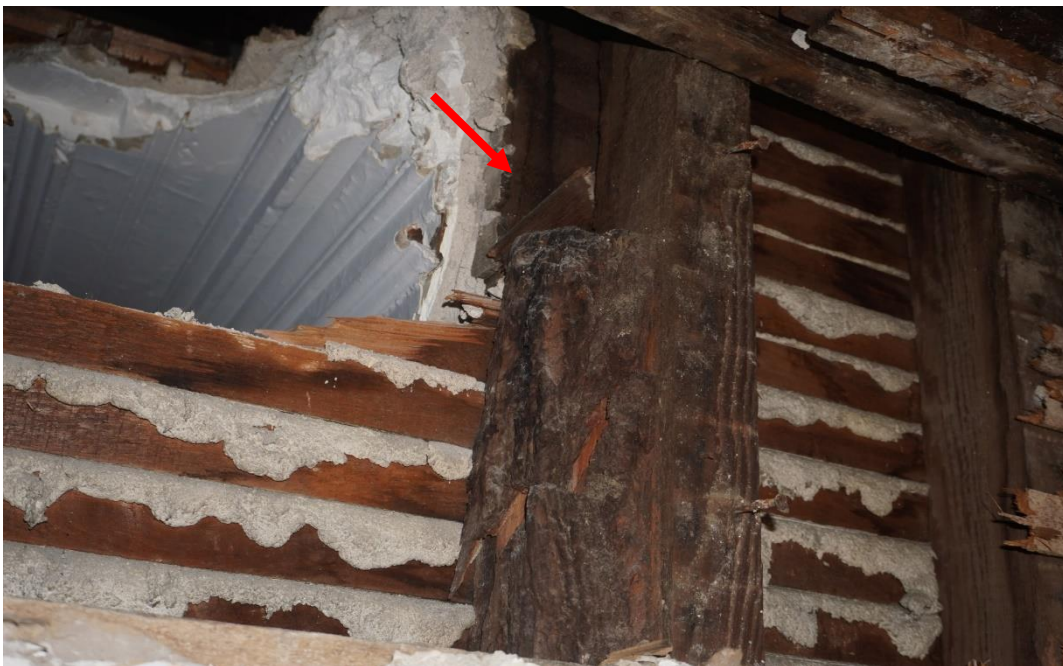
Photo #98: Old exterior wall vertical member that was never scored down into a square (Probe #6).

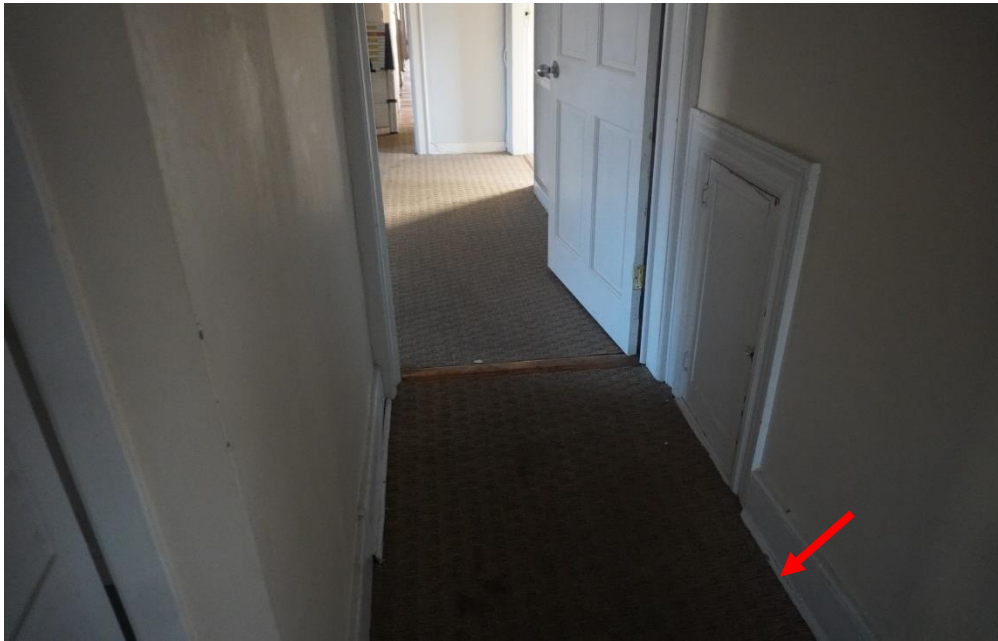
48. Stairs leading from second floor to attic have varying stair riser heights exceeding code max tolerance creating a fall hazard.
49. Depression in second floor hallway. Most likely due to weight of walls and bathroom added in this area. Further investigation would be required to figure out exact cause (Photo #99).

Photo #99: Depression in second floor hallway. Most likely due to weight of walls and bathroom added in this area. Further investigation would be required to figure out exact cause.

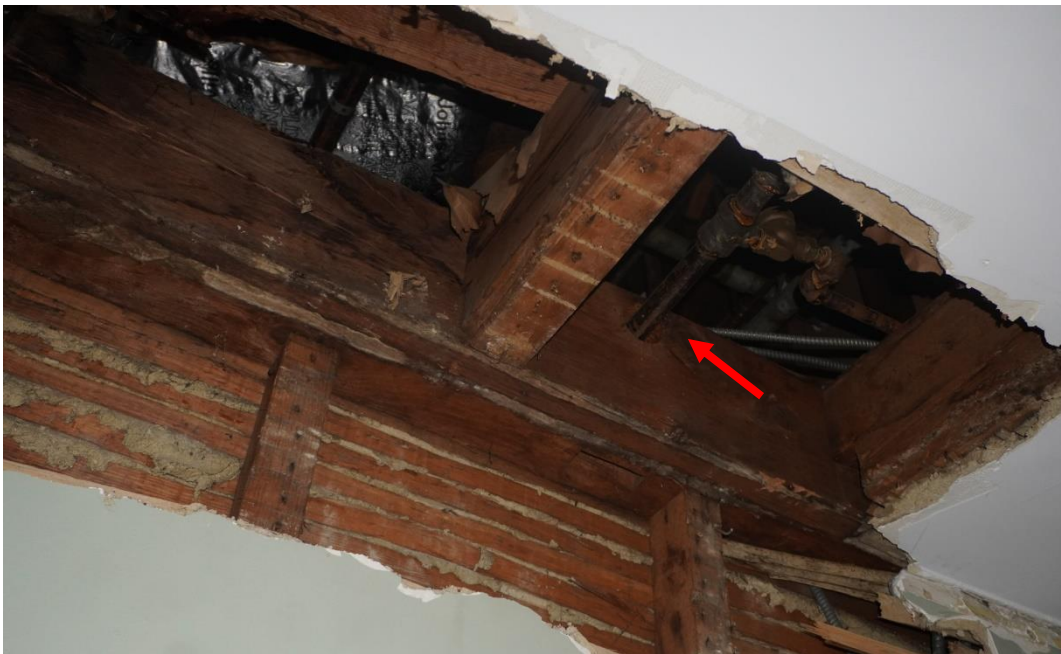
50. Floor joists supporting attic above observed at second floor level are oriented east to west. Large hole drilled through girder for pipe penetration (Probe #7) (Photo #100 #101).
51. Past termite damage was observed in floor joist supporting attic level (Probe #7) (Photo #102).
52. Multiple joists supporting attic floor above have holes drilled above their neutral axis at the joists ends where shear force is the highest (Probe #8) (Photo #104).
53. Water damage adjacent to east exterior wall of addition. Cause unknown, further investigation required (Photo #107).
54. View facing northeast in roof void between 2nd floor ceiling joists and roof joists in the addition. Roof joists do not align with ceiling joists and are being supported at midspan with blocking that is resting right onto plaster ceiling (Probe #9) (Photo #108 &109).

Photo #100: Floor joists supporting attic above observed at second floor level are oriented east to west. Large hole drilled through girder for pipe penetration (Probe #7).
