**Re: *Biggest Fish Westchester LLC*
§11A-9 Economic Hardship Request (Certificate of Appropriateness)
*230 White Plains Road - Section 31. Block 3 Lot 13 ("Property")***

Property Location:	230 White Plains Road Tuckahoe, NY 10707
Inspection Dates:	Initial Inspection: 9/23/22 In Depth Inspection: 11/14/22 Probe Inspection: 12/13/22
Report Date:	1/28/23
Report By:	Peter Panagopoulos, P.E. <i>Principal</i> Pantec Engineering
Appendices:	Appendix A – Photos Appendix B – Probe Locations Appendix C – Structural Layout Appendix D – Deficiency Location Diagram Appendix E - Two Inner Chimney Georgia Colonial Layout

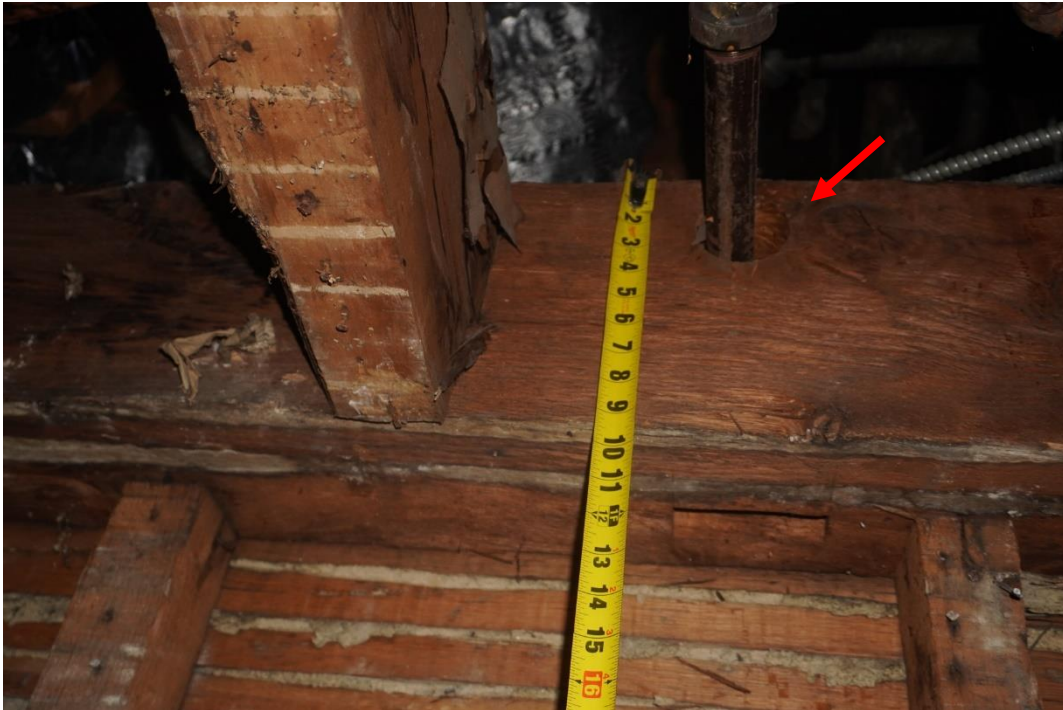
Photo #101: Floor joists supporting attic above observed at second floor level are oriented east to west. Large hold drilled through girder for pipe penetration (Probe #7).

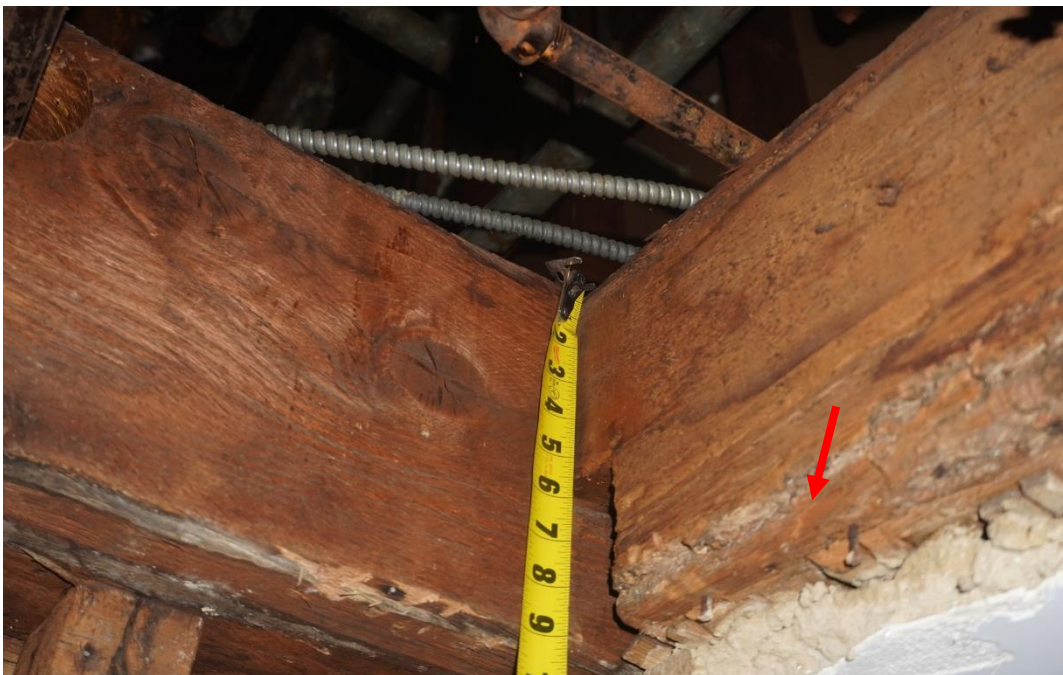
Photo #102: Past termite damage was observed in floor joist supporting attic level (Probe #7).

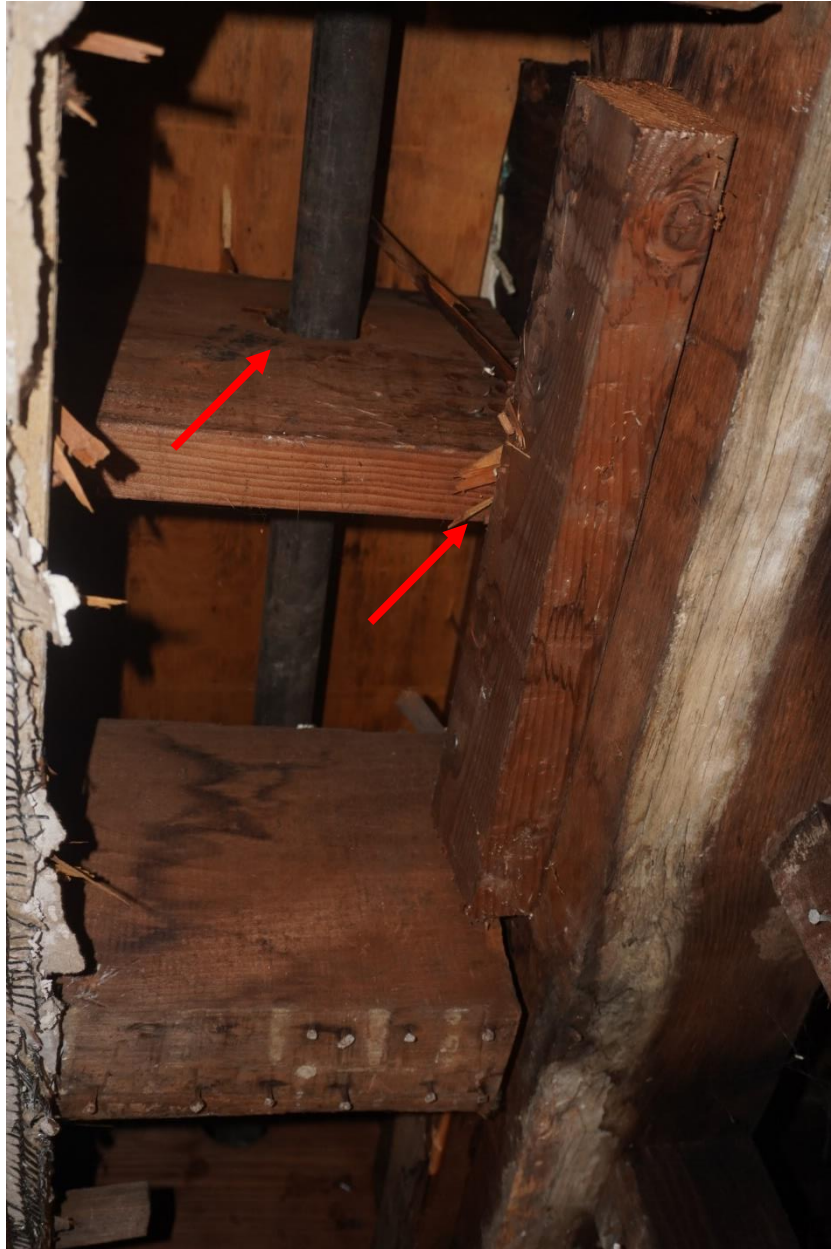
- e) New joists observed, 2nd floor ceiling, running east to west have been installed at a higher level than original joists and are resting on 2x4 wood ledges that have been nailed to girder to support attic floor above. It is unclear why these joists were installed. Most likely to add additional space for piping below showers and toilets in attic. Further investigation required. Original joists left in place and still supporting ceiling below (Probe #8) (Photo #103 - #106, #115, & 116).

Photo #104: New joists running east to west have been installed at higher level than original joists and are resting on a 2x4 wood ledges that have been nailed to girder to support attic floor above. It is unclear why these joists were installed. Further investigation required to figure out why this was done. Original joists left in place and still supporting ceiling below. Multiple joists supporting attic floor above have holes drilled above their neutral axis at the joists ends where shear force is the highest (Probe #8).

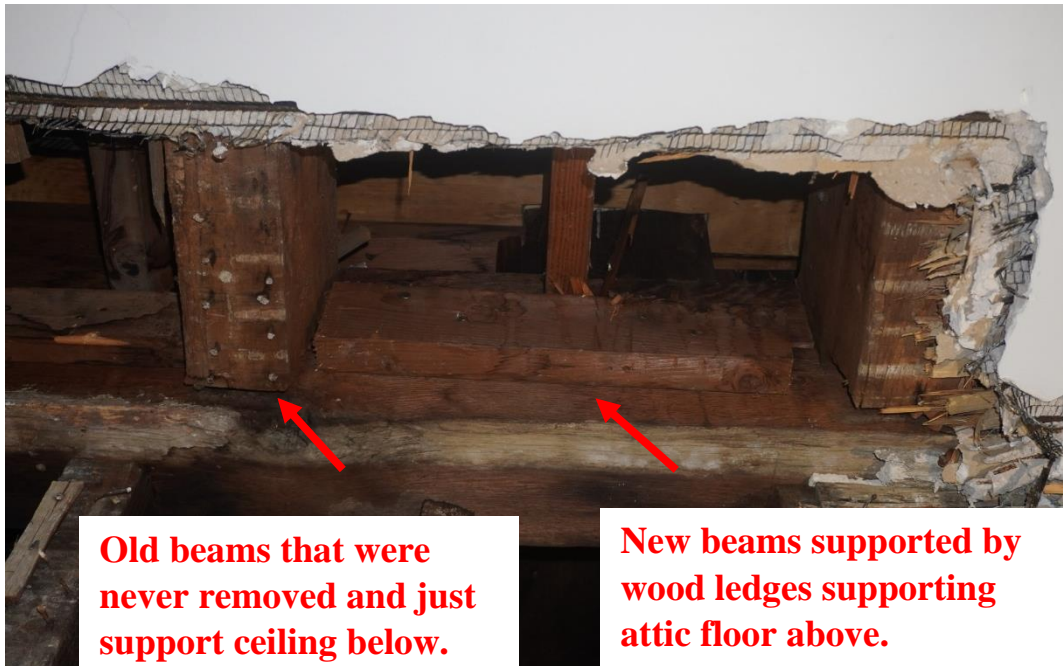
Photo #105: New joists running east to west have been installed at higher level than original joists and are resting on a wood ledge 2x4s that have been nailed to girder to support attic floor above (Probe #8).

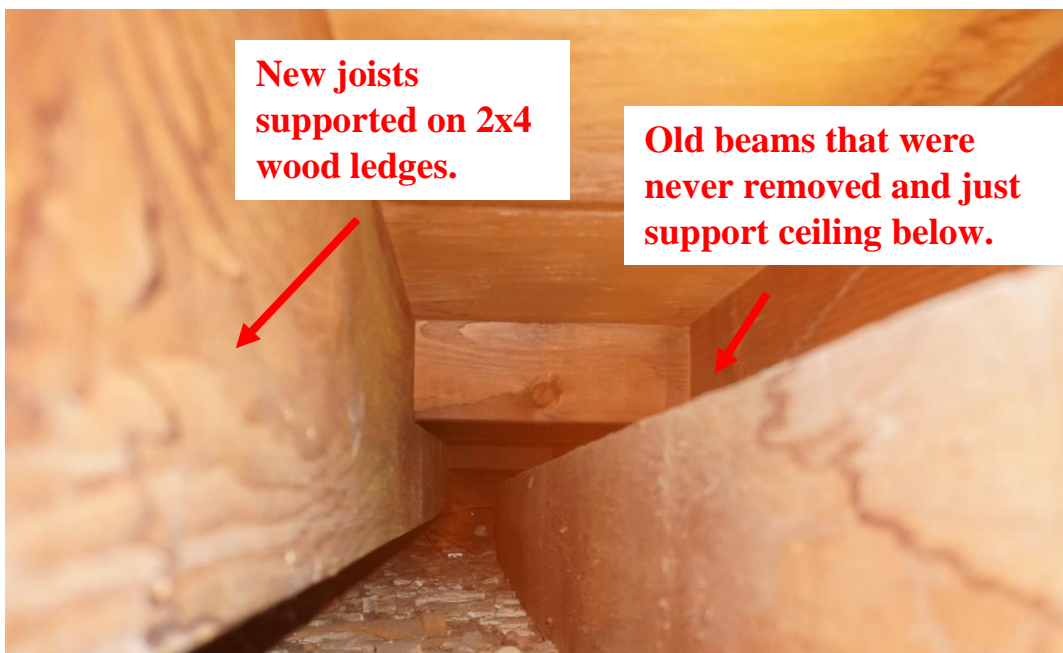
Photo #106: New joists running east to west have been installed at higher level than original joists and are resting on a wood ledge 2x4s that have been nailed to girder to support attic floor above (Probe #8). (Probe #8)

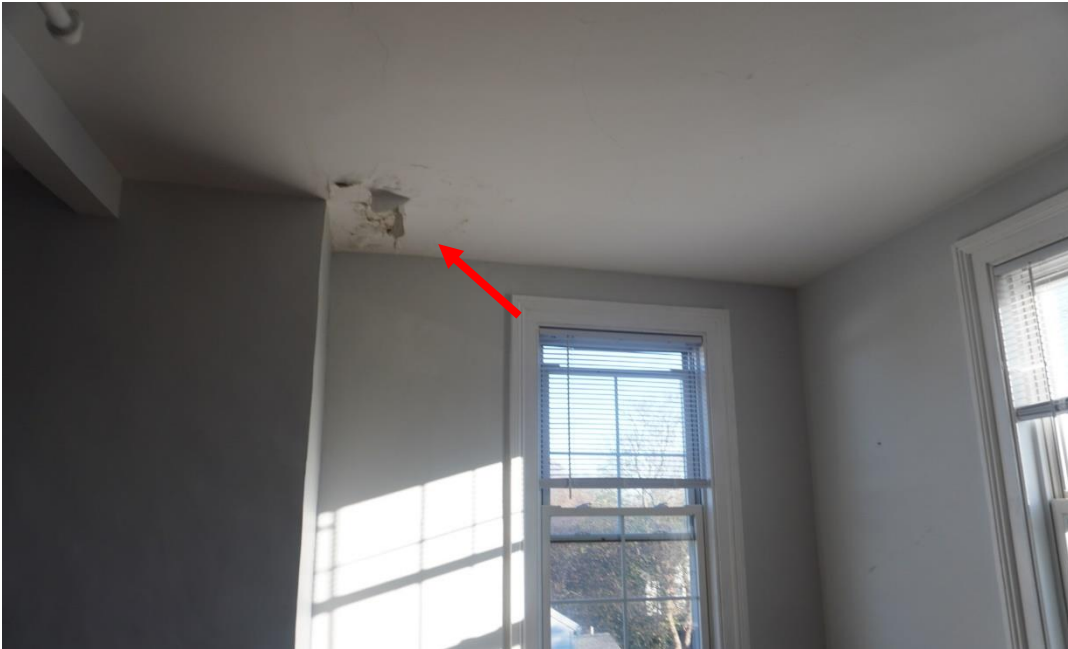
Photo #107: Water damage adjacent to east exterior wall of addition. Cause unknown, further investigation required.

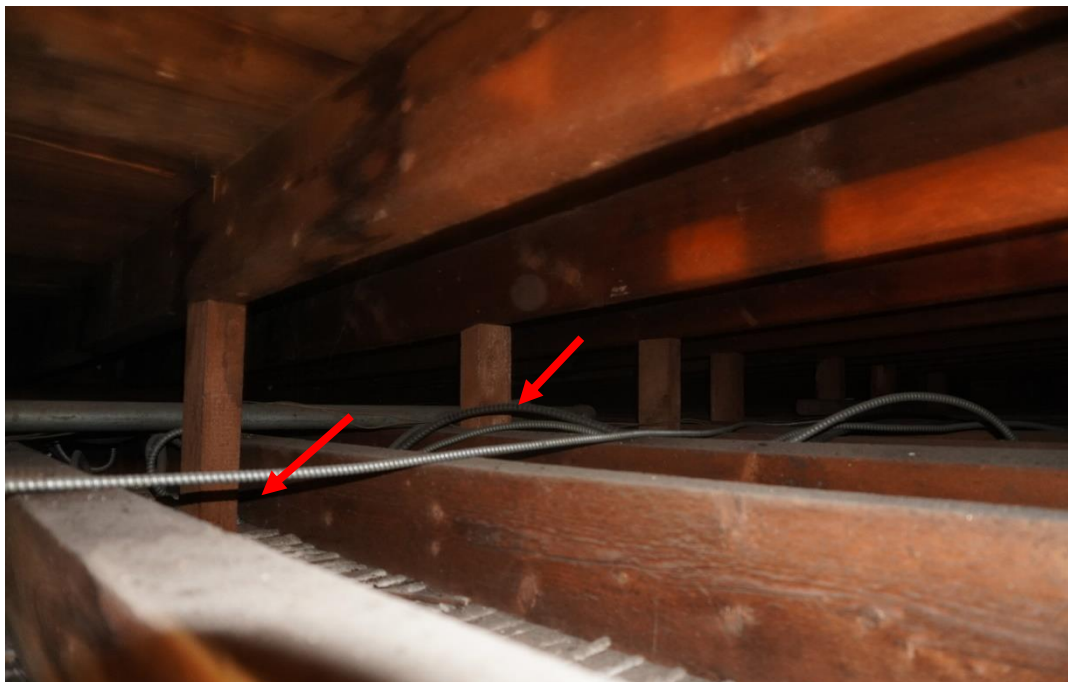
Photo #108: View facing northeast in roof void between 2nd floor ceiling joists and roof joists in the addition. Roof joists do not align with ceiling joists and are being supported at midspan with blocking that is resting right onto plaster ceiling (Probe #9).

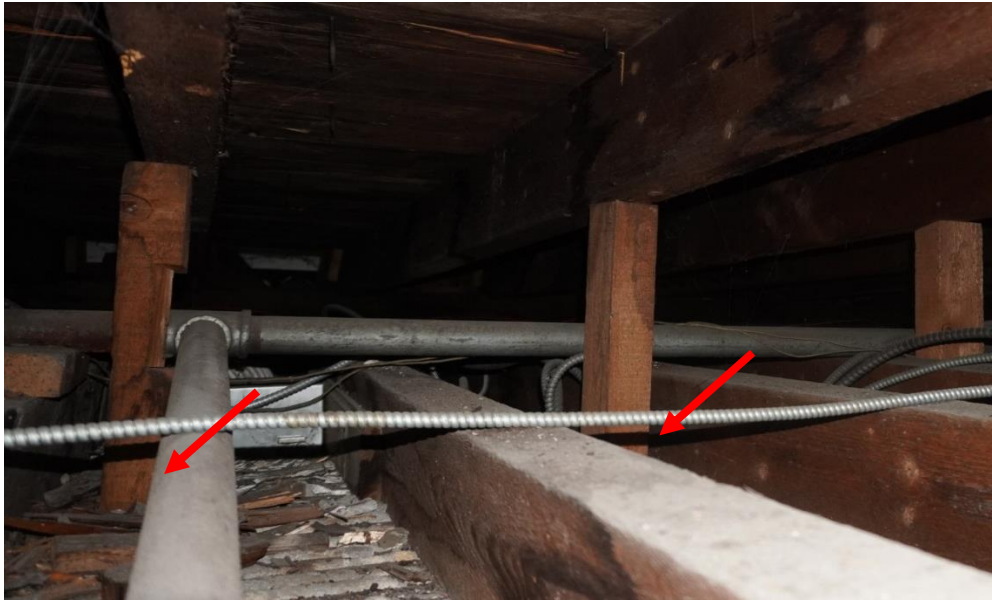
Photo #109: View facing northeast in roof void between 2nd floor ceiling joists and roof joists in the addition. Roof joists do not align with ceiling joists and are being supported at midspan with blocking that is resting right onto plaster ceiling (Probe #9).

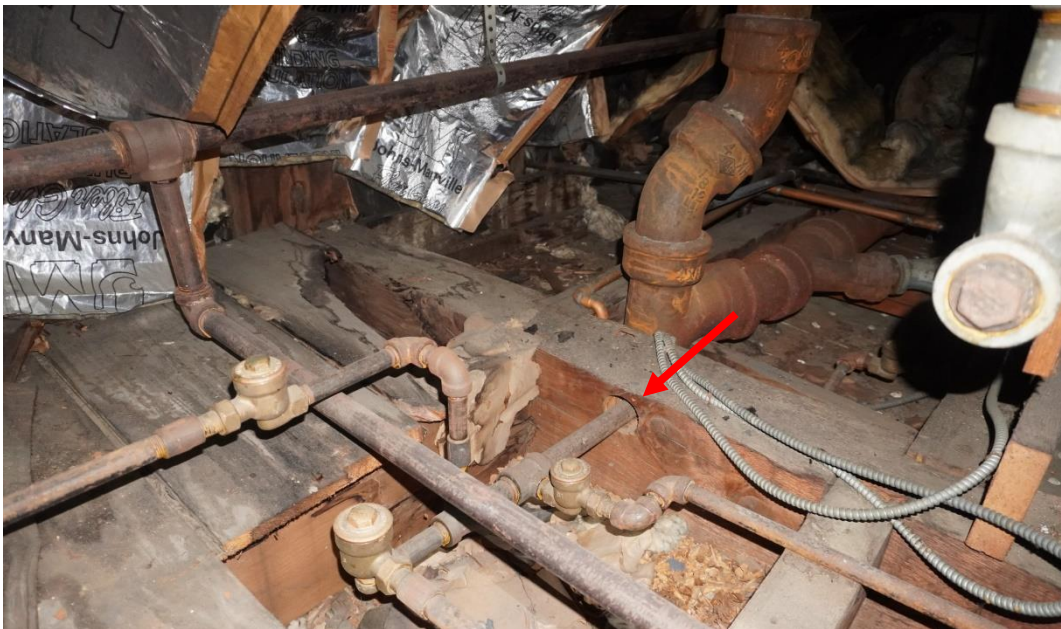
Photo #110: Pipe penetration drilled through girder drilled above its neutral axis. Observed in unfinished attic area, north side of original structure.

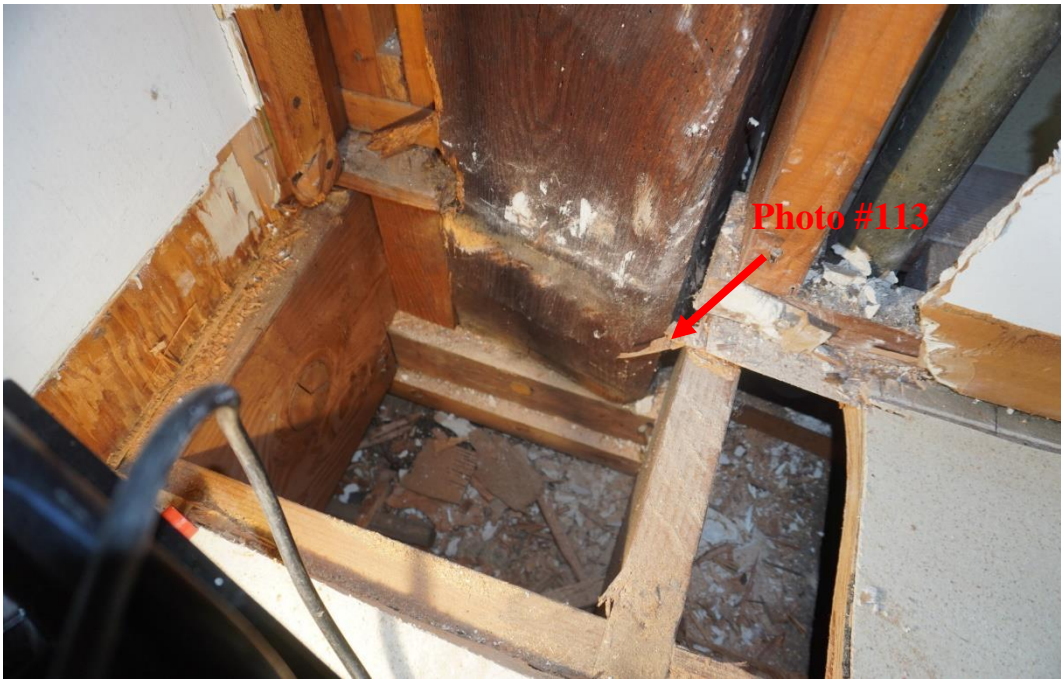
55. Post in attic space has moved out of place. Mortise and tenon joint that was connecting post to girder below has failed allowing member to rotate (Probe #11) (Photo #111 - #113).
56. Vertical crack that has opened more towards the bottom observed, attic post Unclear why this has occurred. Further investigation required (Probe #12) (Photo #114 &115).
57. Roof support beam observed to be coming apart (Photo #117 &118).

Photo #112: Post in attic space has moved out of place. Mortise and tenon joint that was connecting post to girder below has failed allowing member to rotate (Probe #11).

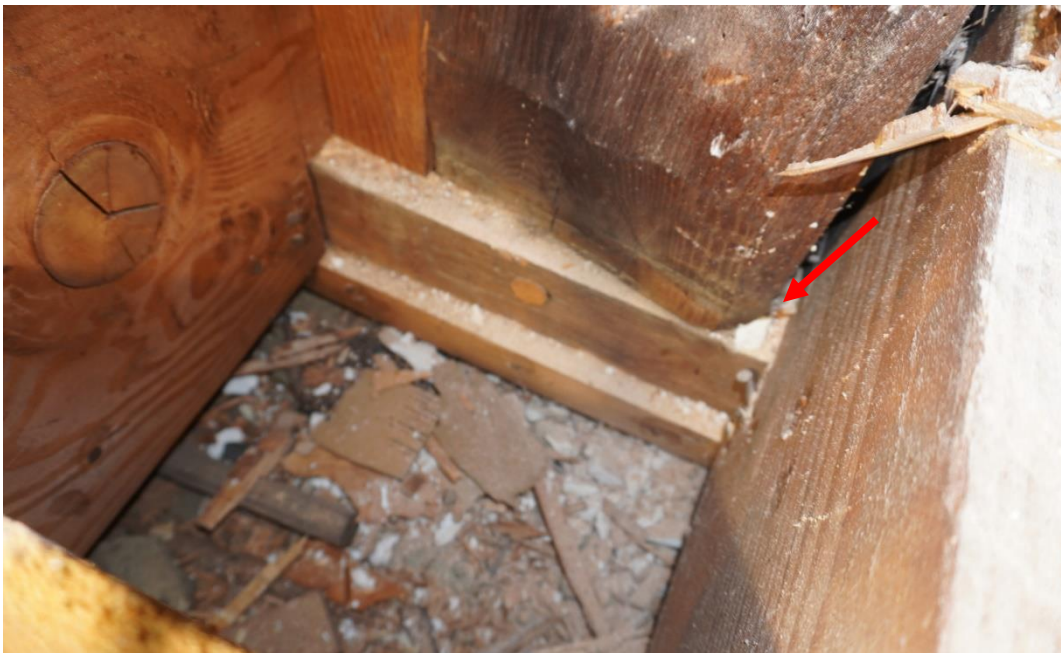
Photo #113: Post in attic space has moved out of place. Mortise and tenon joint that was connecting post to girder below has failed allowing member to rotate (Probe #11).

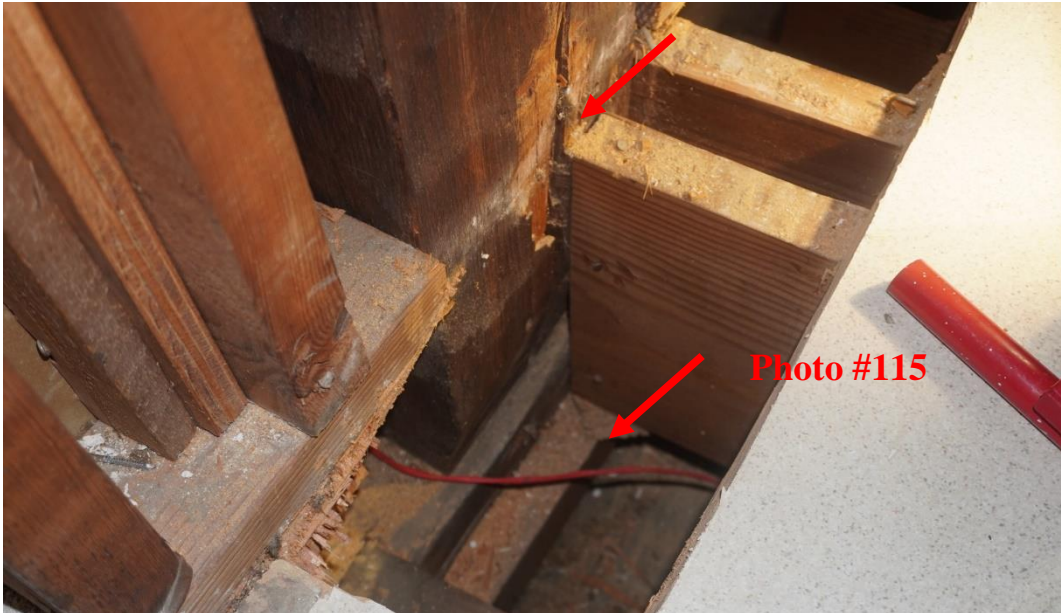
Photo #115: Vertical crack that has opened more towards the bottom observed, attic post. Unclear why this has occurred. Further investigation required. New wood joists have been installed going east to west bearing on wood ledge that has been nailed into girder. It is unclear why this was done. Further investigation required (Probe #12).

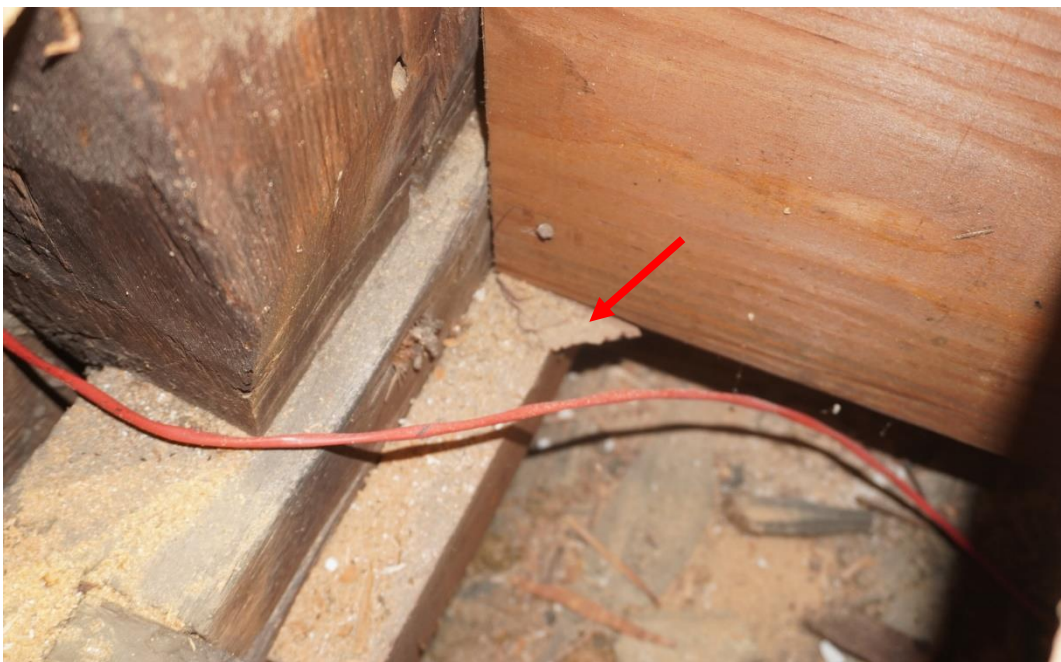
Photo #116: New wood joists have been installed going east to west bearing on wood ledge that has been nailed into girder. It is unclear why this was done. Further investigation required (Probe #12).

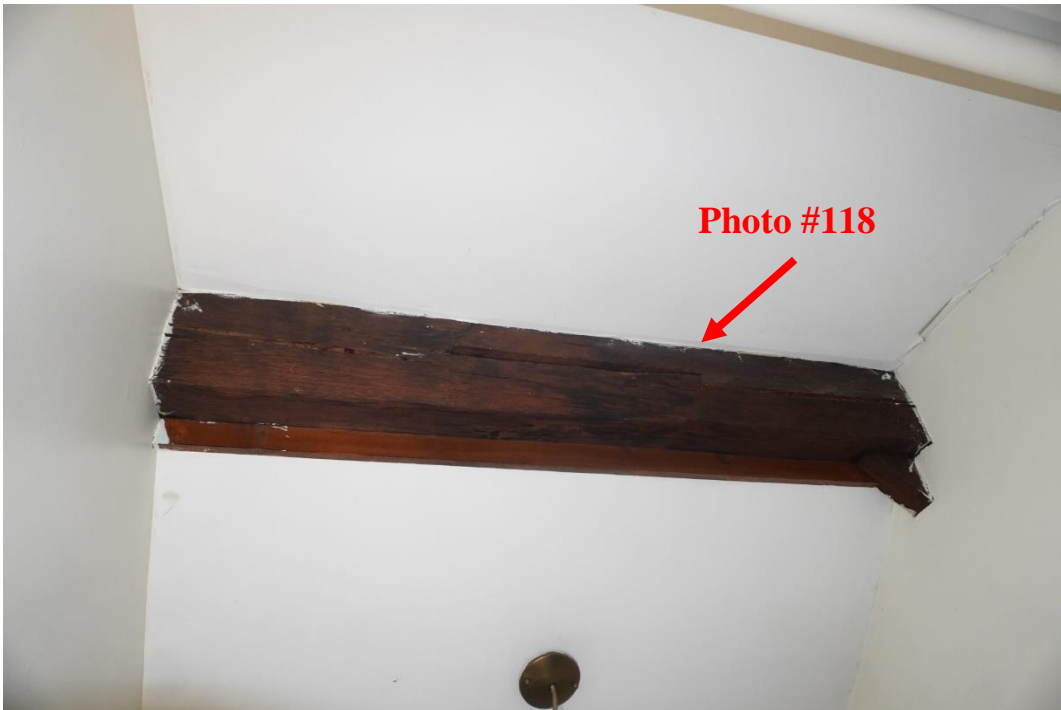
Photo #117: Roof support beam observed to be coming apart.

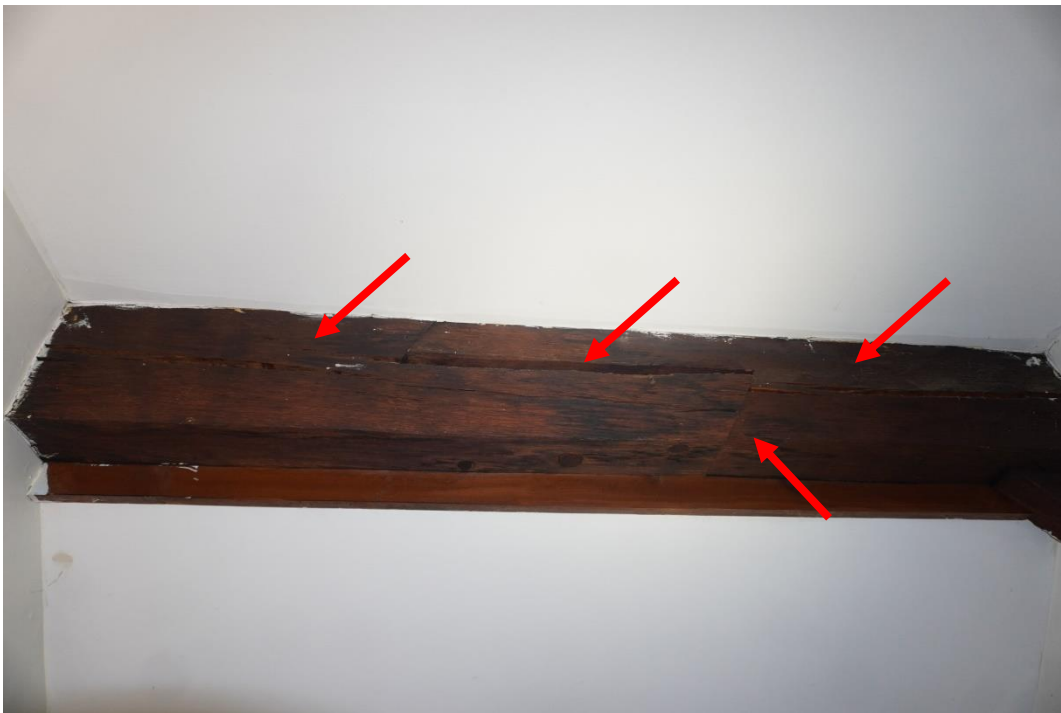
Photo #118: Roof support beam observed to be coming apart.

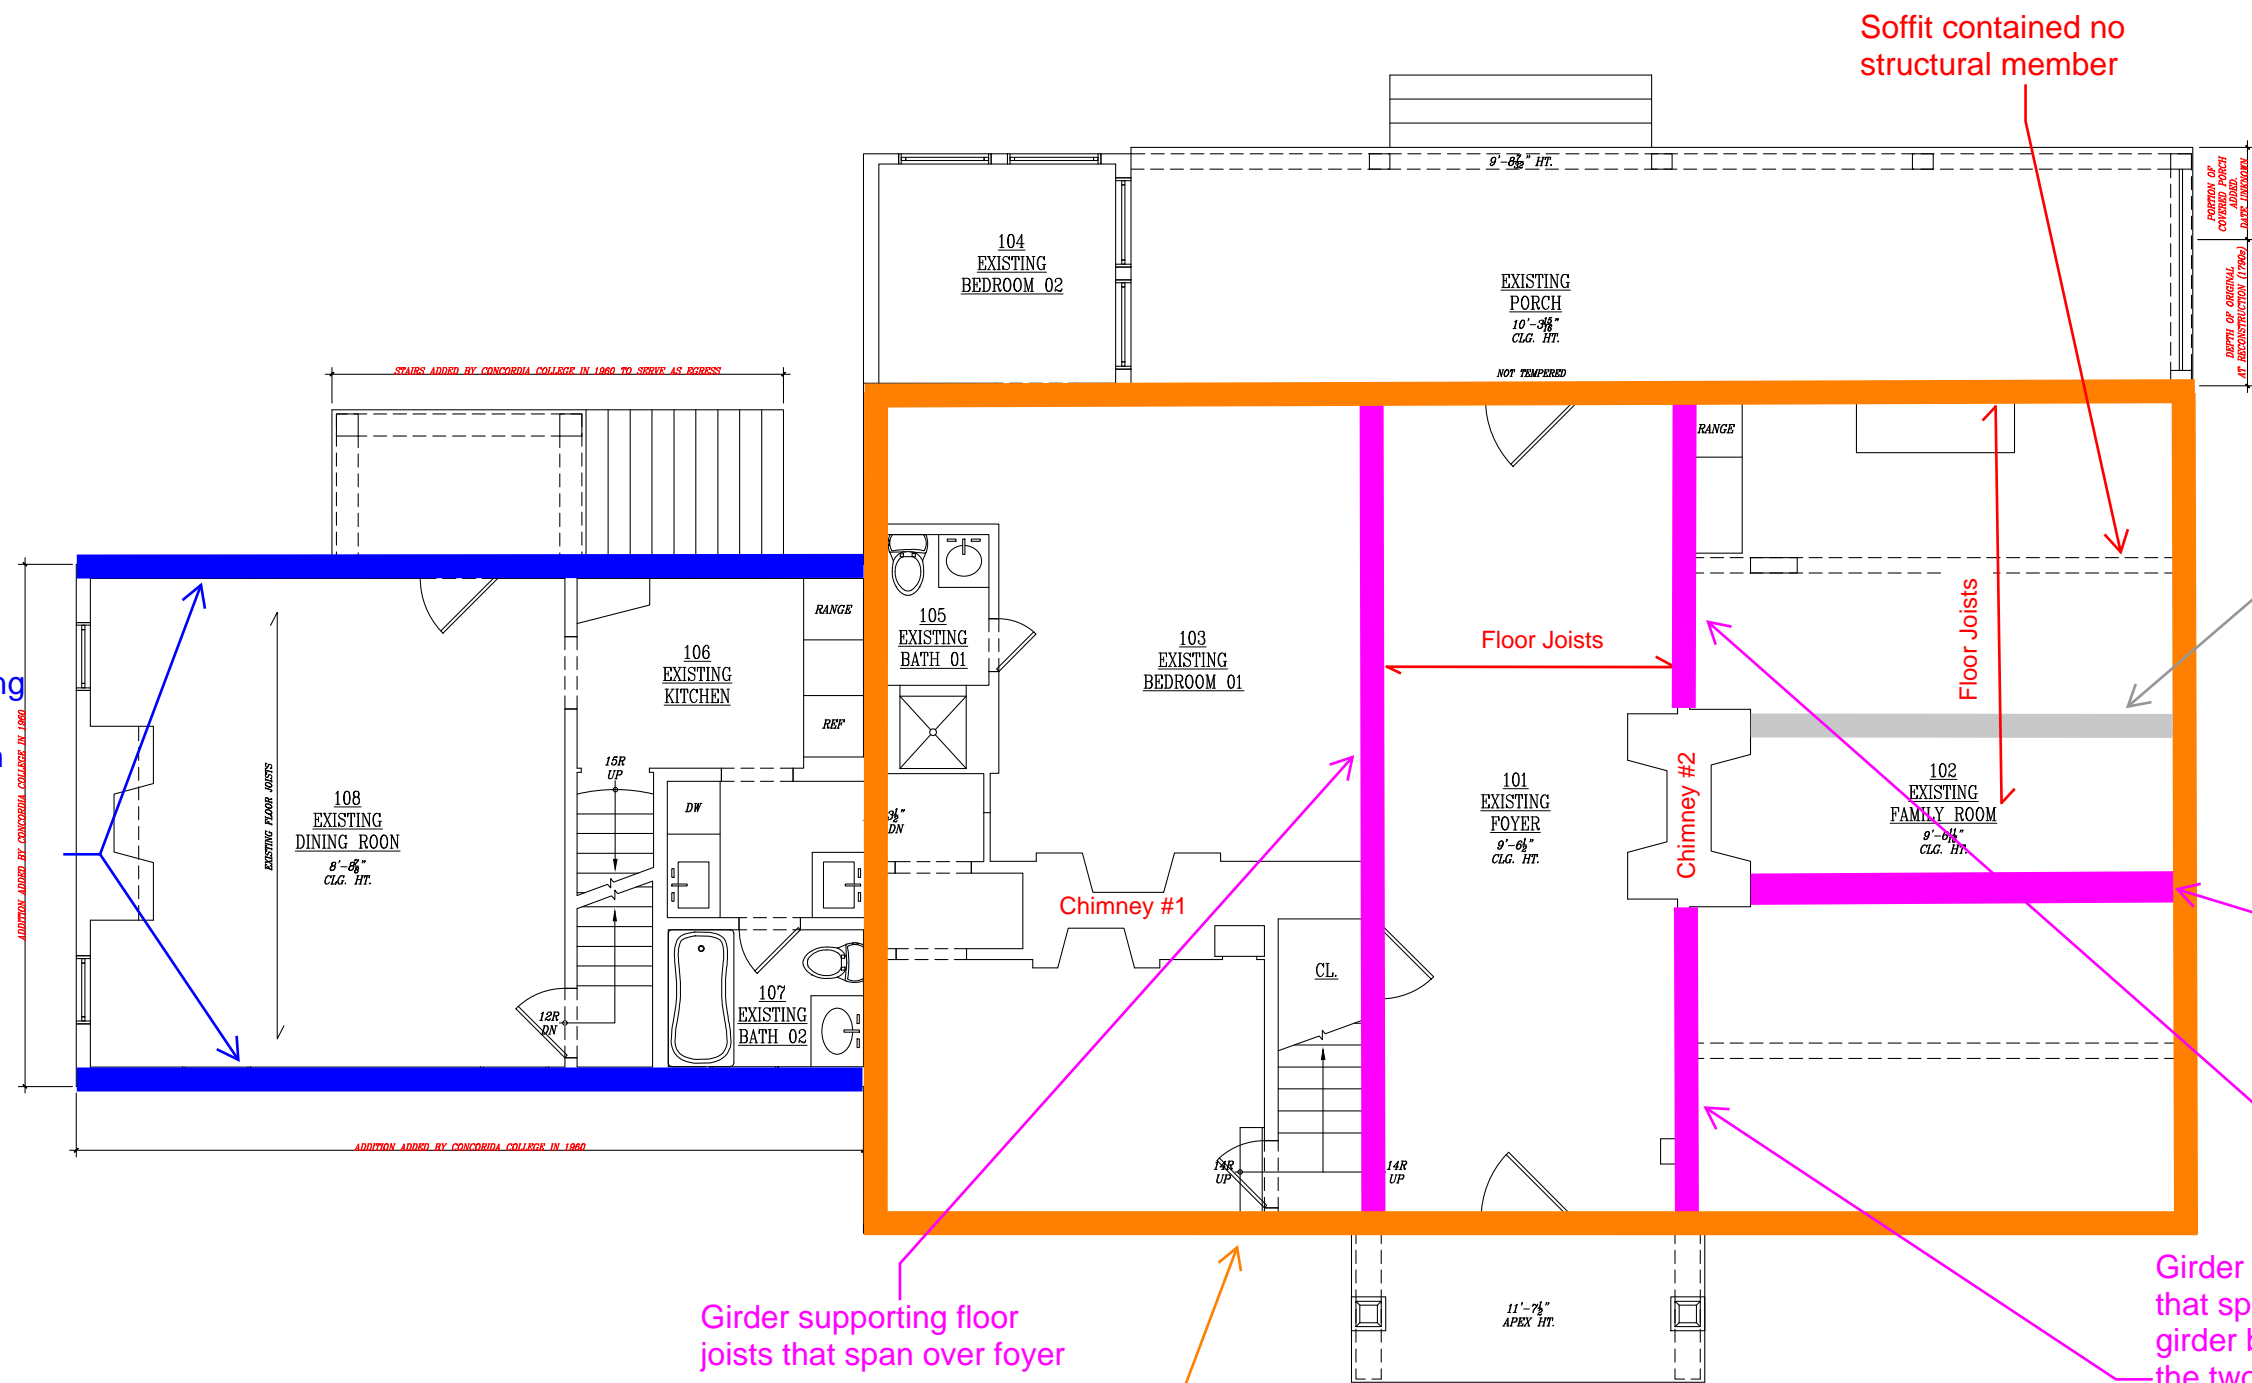
Appendix C – Structural Layout

Soffit contains large wooden member running below floor joists. Wood member is below ceiling level and is acting as additional support for floor joists. This is not a standard timber framing layout. Was a modification made after, potentially when the chimney was moved.

Floor joists connect to girder with mortise and tenon connections. Girder is above ceiling level.

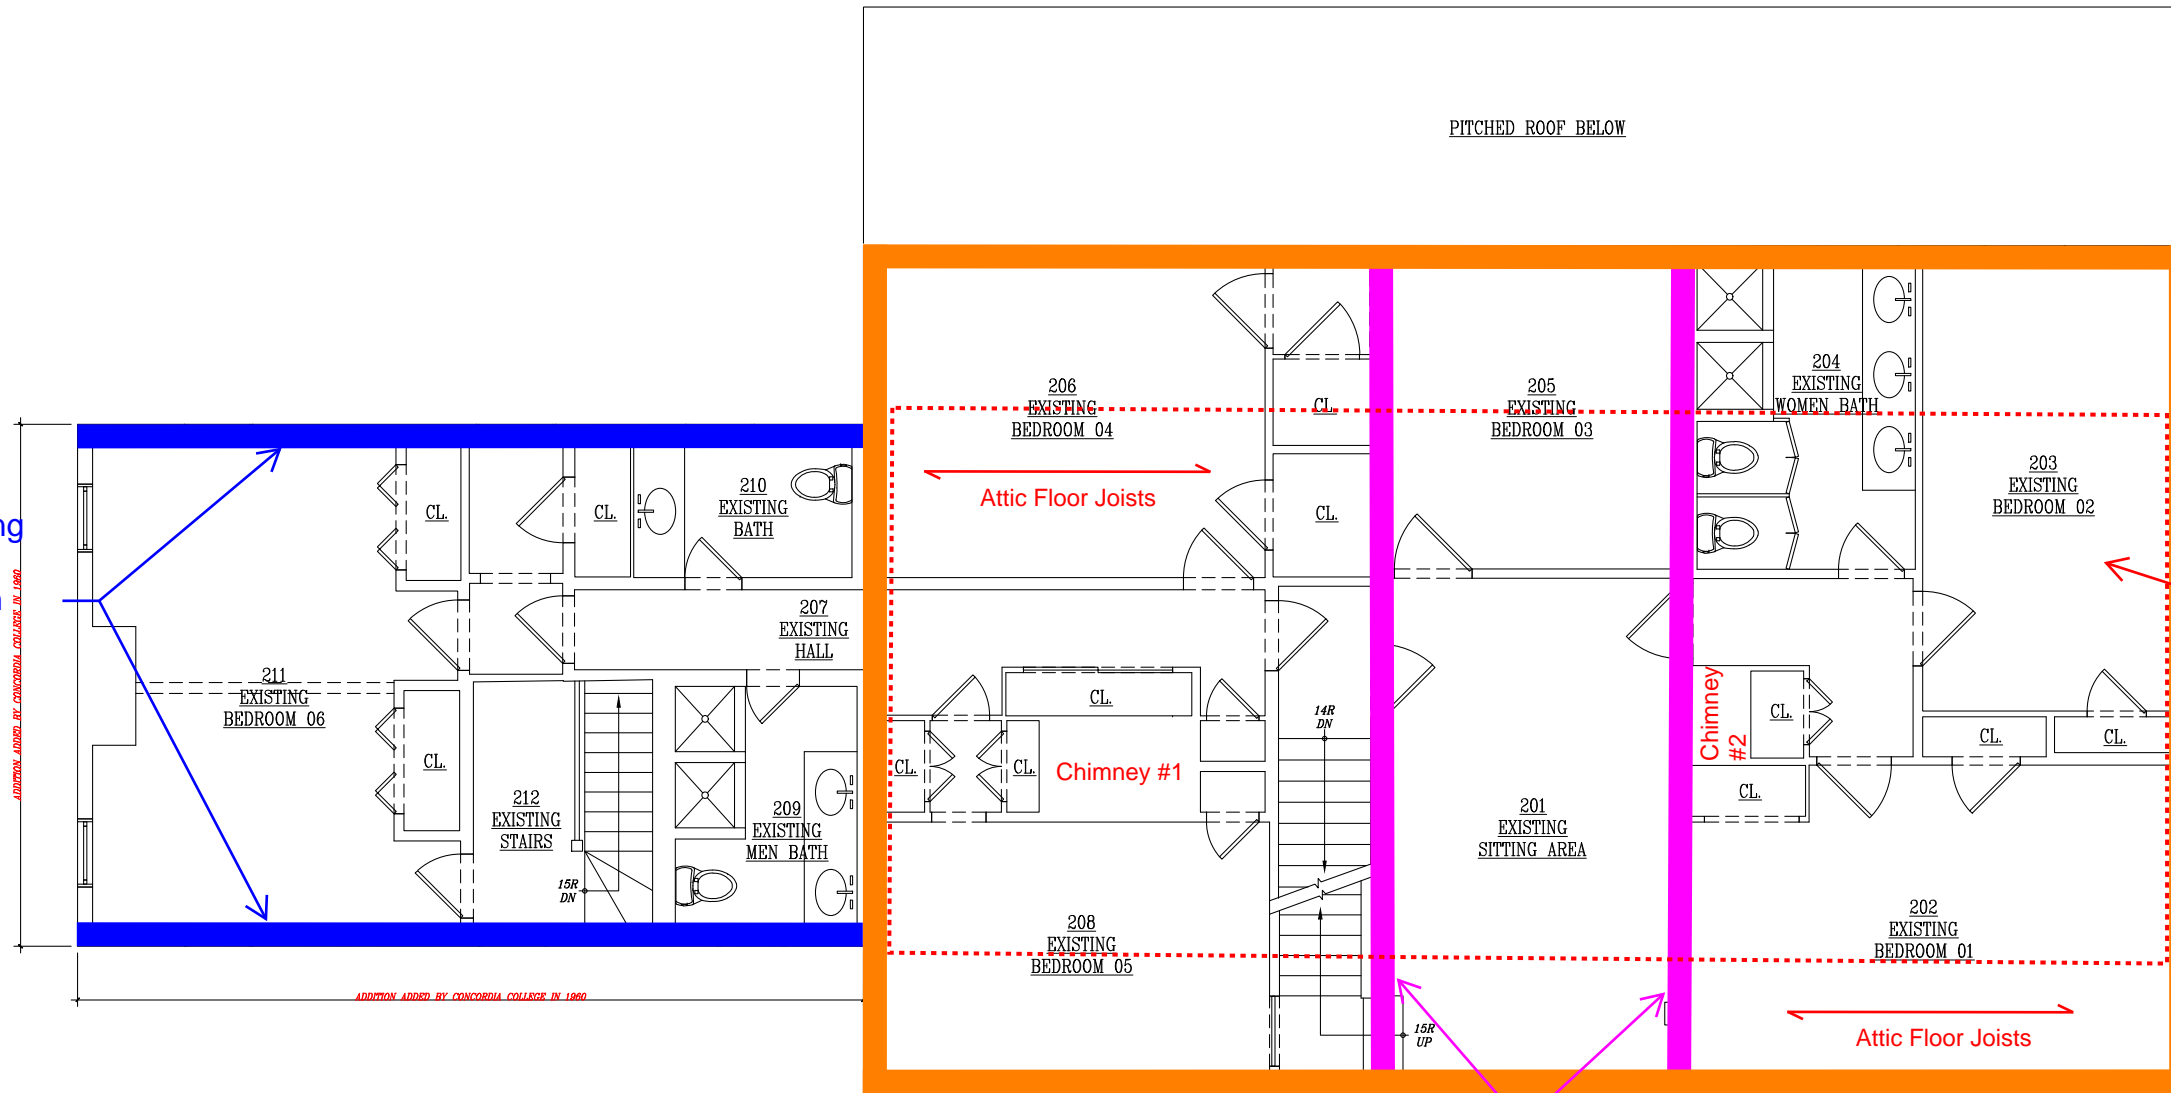
2nd Floor (Attic Floor Framing)

New joists have been installed in dashed area at a higher level to increase floor height in attic. Most likely to add additional space for piping below showers and toilets in attic. Older joists have been left in place.

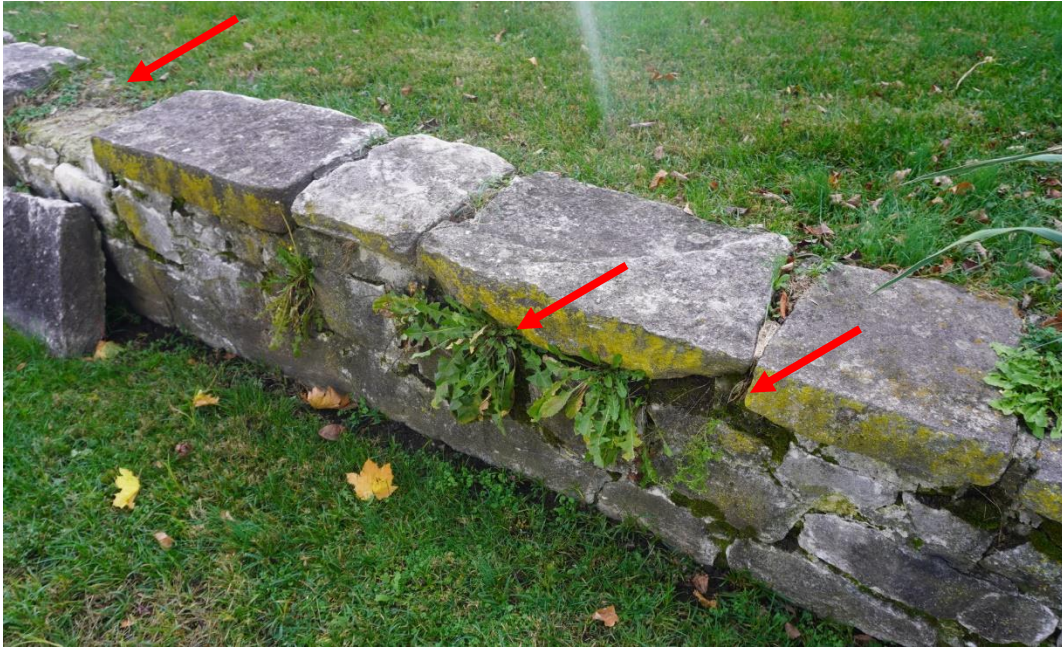
Photo #1: Retaining wall that runs from between front entrance and driveway is deteriorating throughout. Joints have filled with dirt. Multiple stone pieces no longer attached.

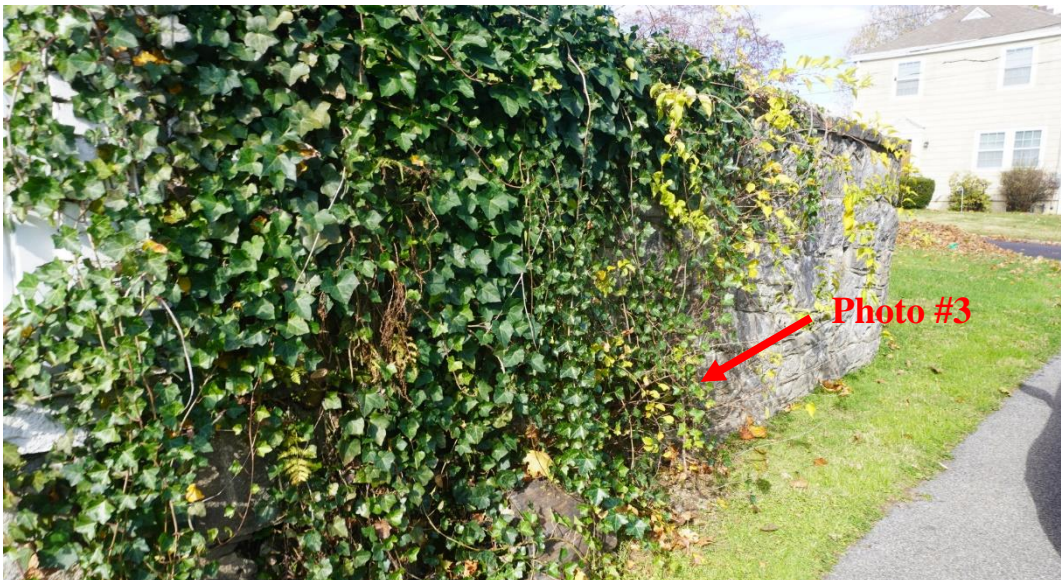
Photo #2: Retaining wall that runs from between front entrance and driveway is deteriorating throughout. Roots/ large weeds growing through joints of walls multiple locations.

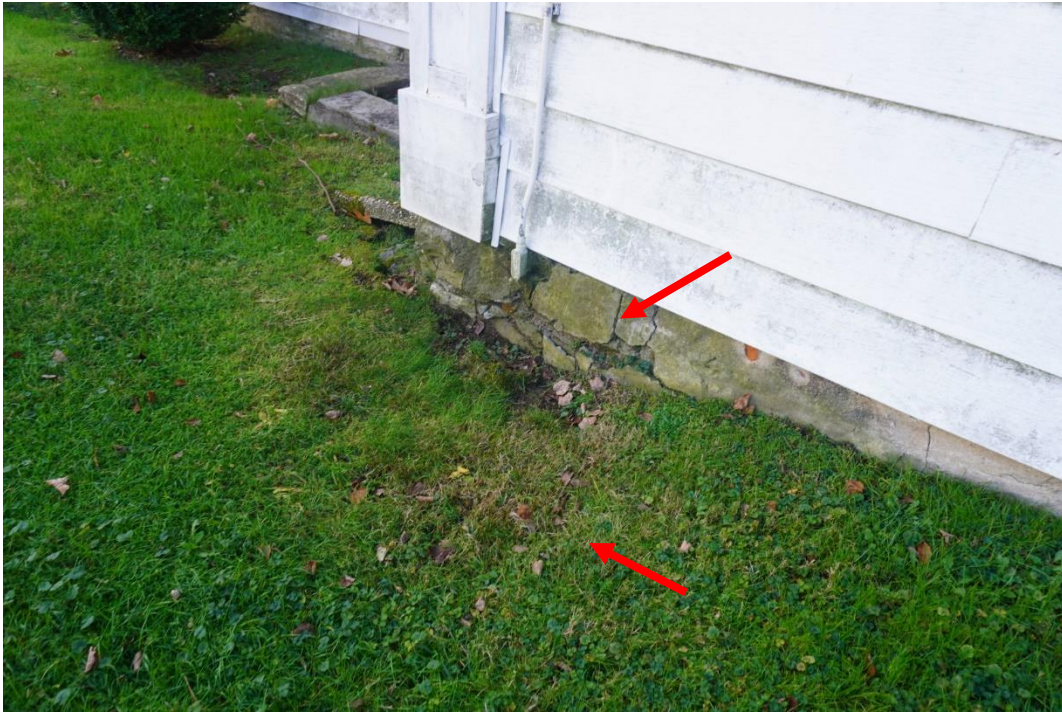
Photo #5: Negative grading front of home between entrance and northeast corner of home. Water pooling up against foundation wall and most likely infiltrating into crawlspace. Signs of foundation deterioration.

3. Negative grading front of home. Water pooling up against foundation wall and most likely infiltrating into crawlspace. Signs of foundation deterioration (Photo #4 - #6).
4. Stone slabs have settled/heaved creating multiple trip hazards, stone walkway rear yard (Photo #7).
5. Stone slabs have settled/ heaved creating multiple trip hazards, stone patio rear yard (Photo #8 - #10).

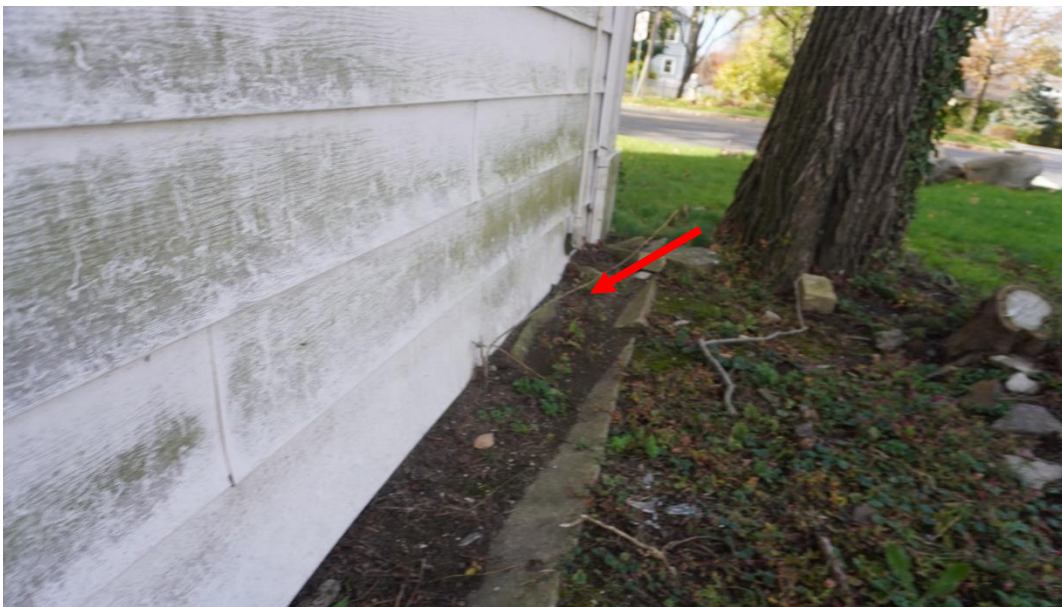
Photo #6: Negative grading front of home between entrance and northwest corner of home. Water pooling up against exterior foundation wall of crawlspace.

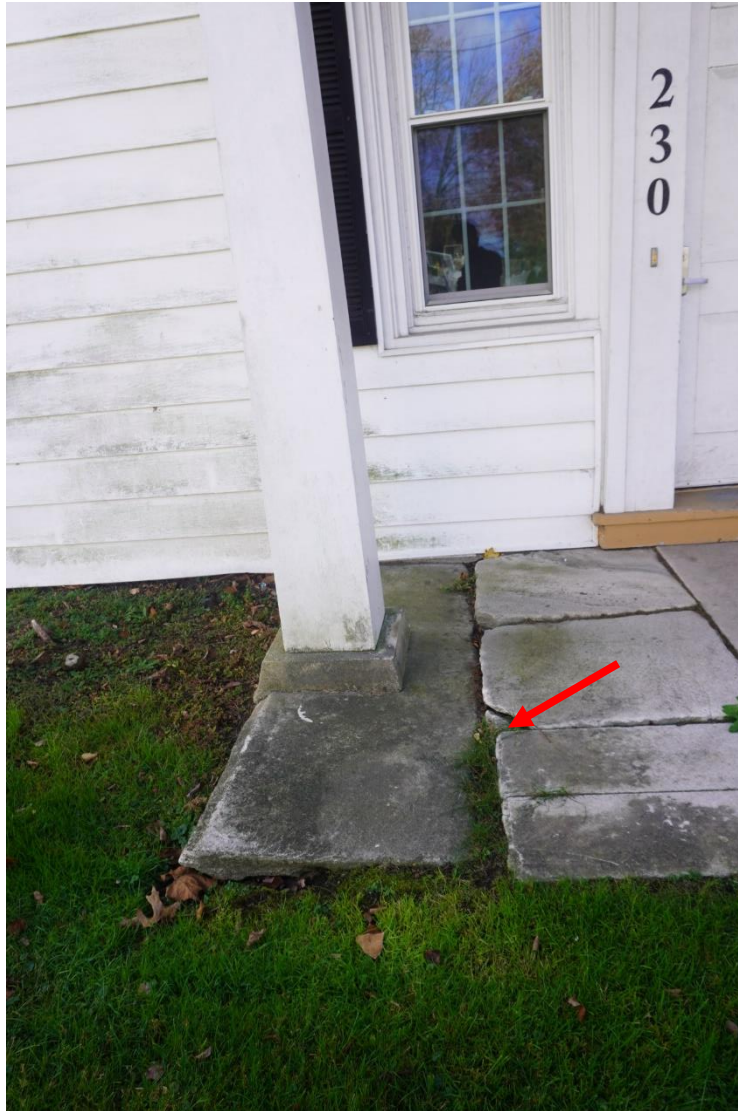
Photo #19: Base of column support for front portico showing signs of differential settlement.

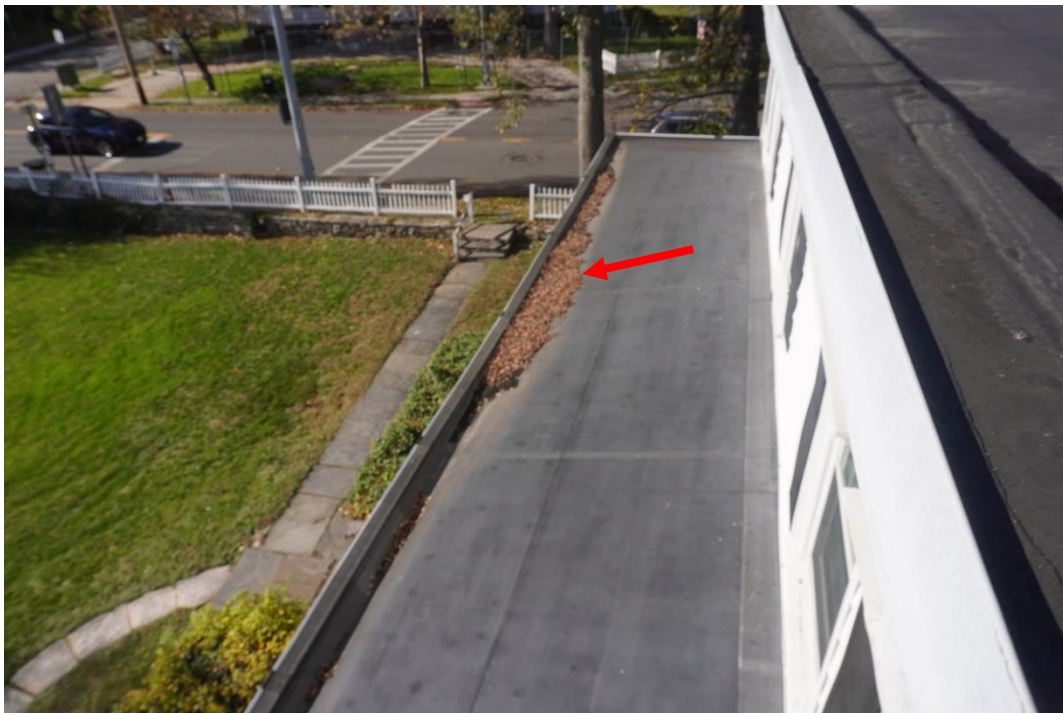
Photo #27: Rear porch roof deflecting over stairs causing water to pool and leaf build up.

13. Rear porch roof deflecting over stairs causing water to pool and leaf build up (Photo #25 - #27).
14. Rear porch sitting on stone pillars that are showing signs of deterioration (Photo #31 - #34).
15. Rear porch stairs deteriorated. No longer usable (Photo #35).
