**Re: *Biggest Fish Westchester LLC*
§11A-9 Economic Hardship Request (Certificate of Appropriateness)
*230 White Plains Road - Section 31. Block 3 Lot 13 ("Property")***

Property Location:	230 White Plains Road Tuckahoe, NY 10707
Inspection Dates:	Initial Inspection: 9/23/22 In Depth Inspection: 11/14/22 Probe Inspection: 12/13/22
Report Date:	1/28/23
Report By:	Peter Panagopoulos, P.E. <i>Principal</i> Pantec Engineering
Appendices:	Appendix A – Photos Appendix B – Probe Locations Appendix C – Structural Layout Appendix D – Deficiency Location Diagram Appendix E - Two Inner Chimney Georgia Colonial Layout

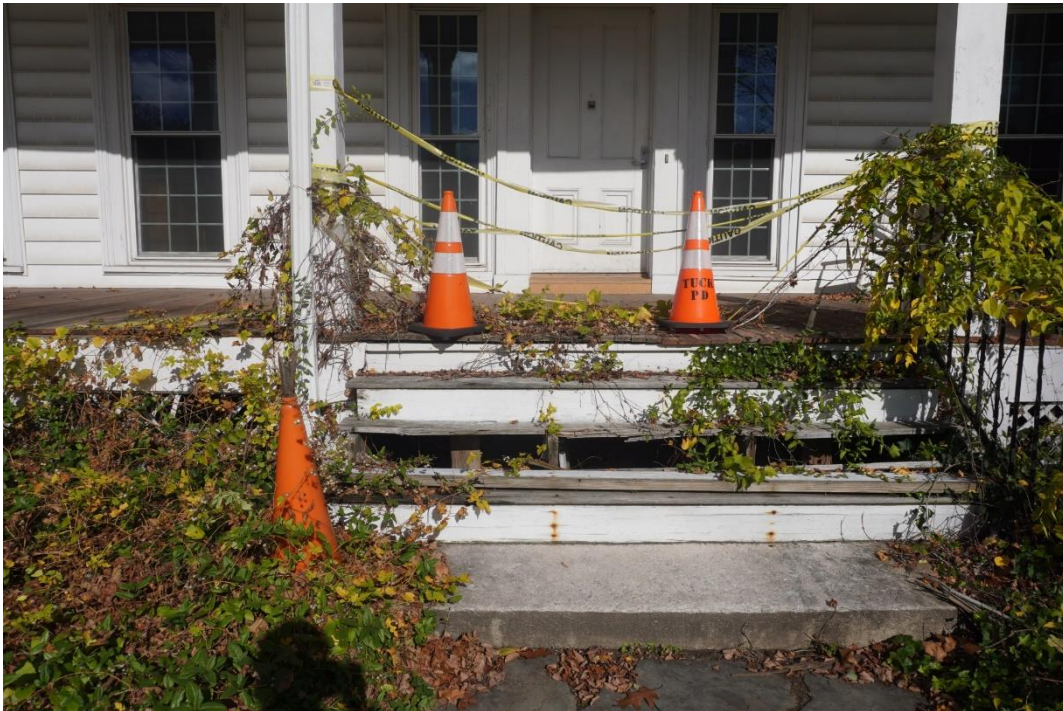
Photo #35: Rear porch stairs deteriorated. No longer usable. Unsafe condition.

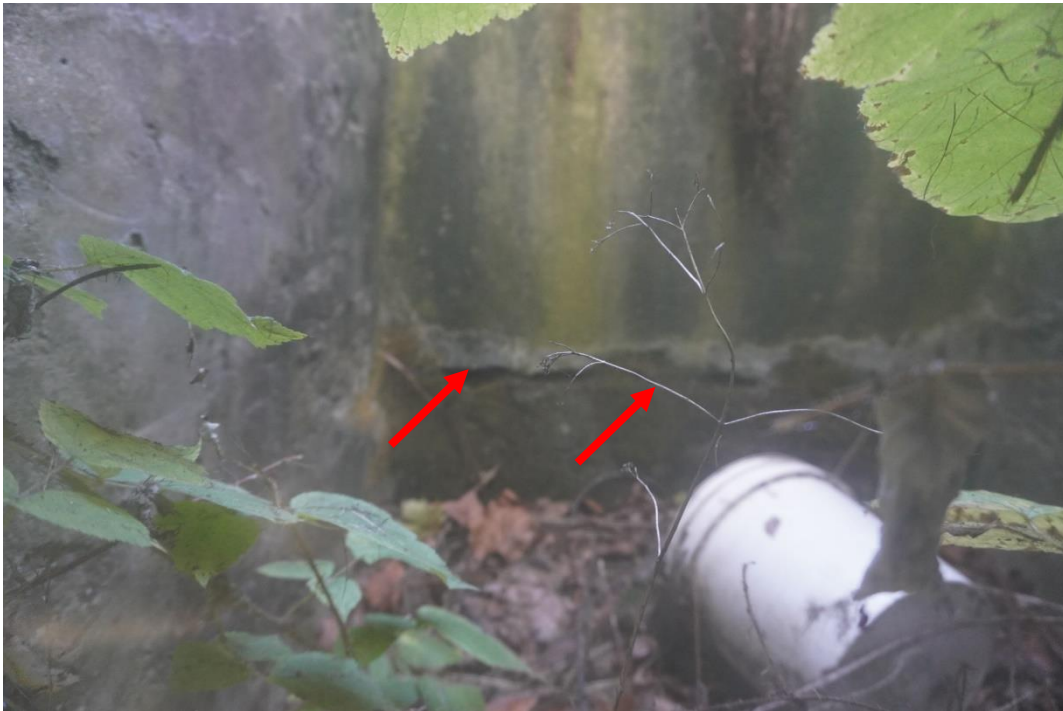
Photo #41: Horizontal crack has formed in concrete window well, north façade.

21. Horizontal crack has formed in concrete window well, north façade (Photo #41).
22. Water infiltration at base of inner, original foundation wall. Water is rotting base of wood support post. Crawlspace that spans the front side of the home is located on the other side of this wall (Photo #42).

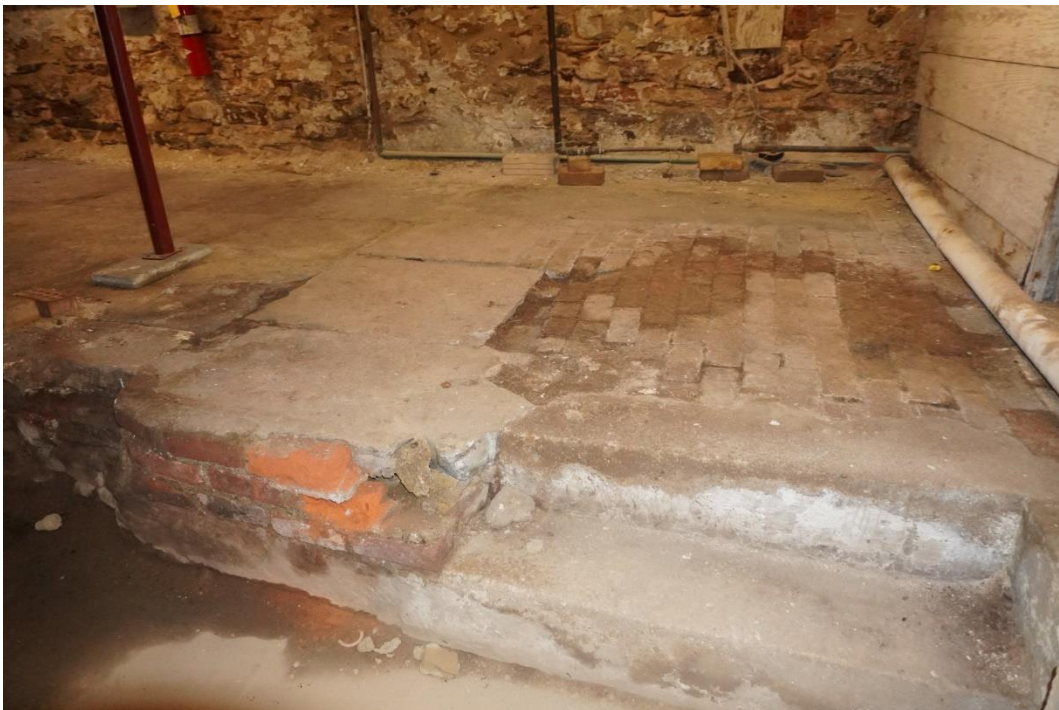
Photo #45: Cellar floor observed to be composed of bricks with a cement stucco layer that is deteriorating.

25. Concrete footings were never poured beneath temporary support columns that were added to prop of failing girder in west end of cellar (Photo #44).
26. Cellar floor observed to be composed of bricks with a cement stucco layer that is deteriorating (Photo #45).

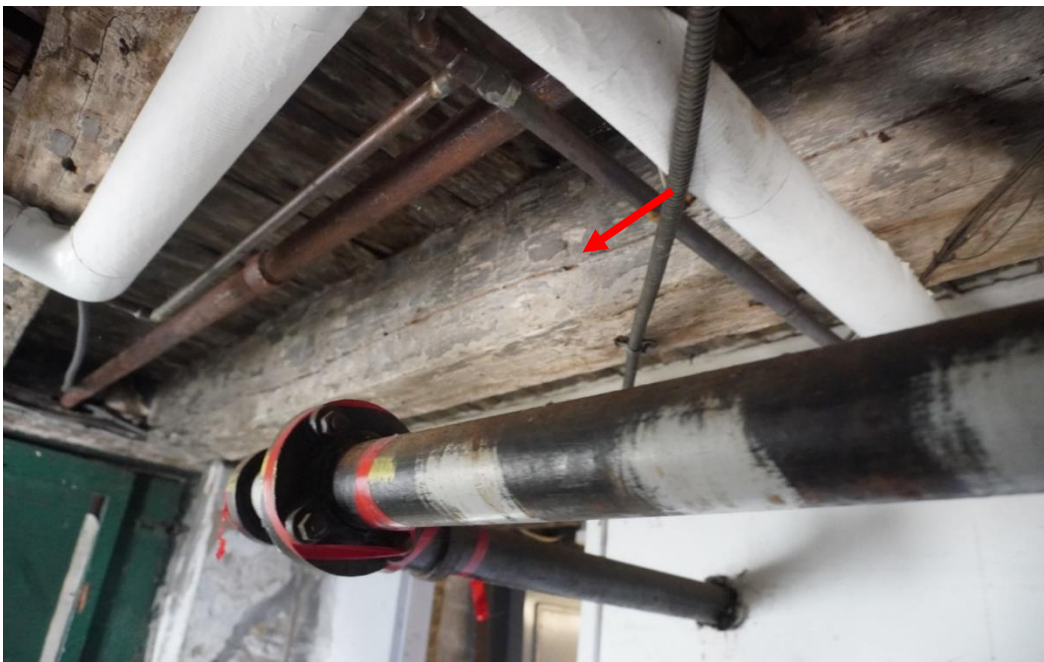
Photo #51: Horizontal crack from shear stress resonating down entire member from notch at end of beam.

28. Pipe penetration drilled through door header leading out to rear yard (Photo #49).
29. Horizontal crack from shear stress resonating down entire member from notch at end of beam (Photo #50 & #51).

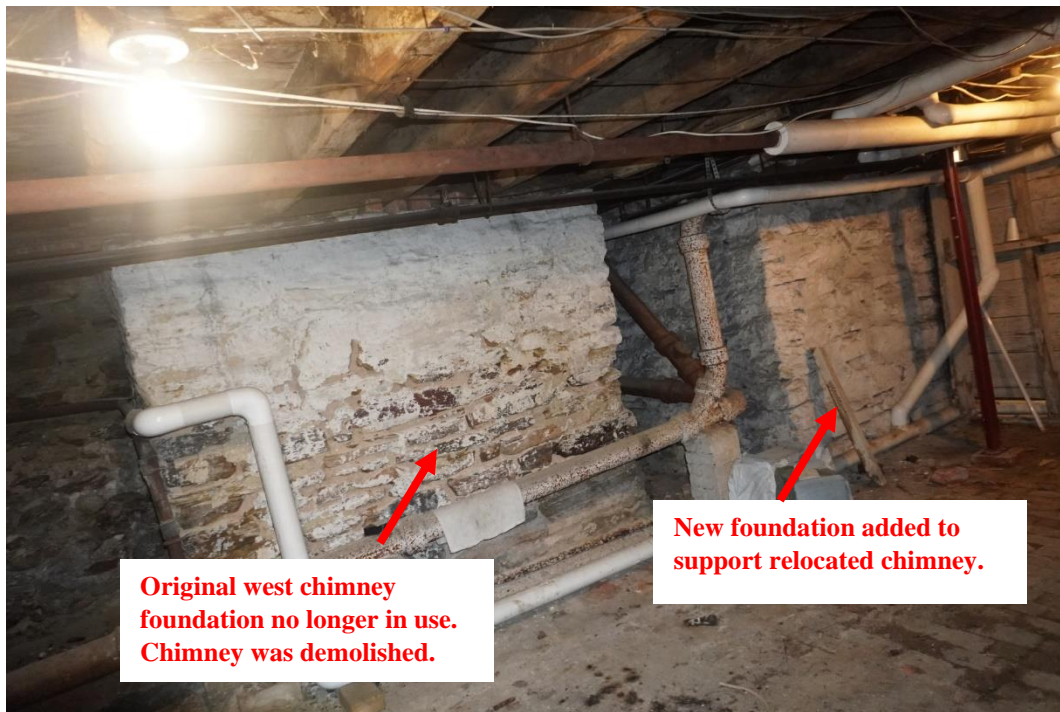
Photo #57: Original west chimney was relocated at some unknown time in the past.

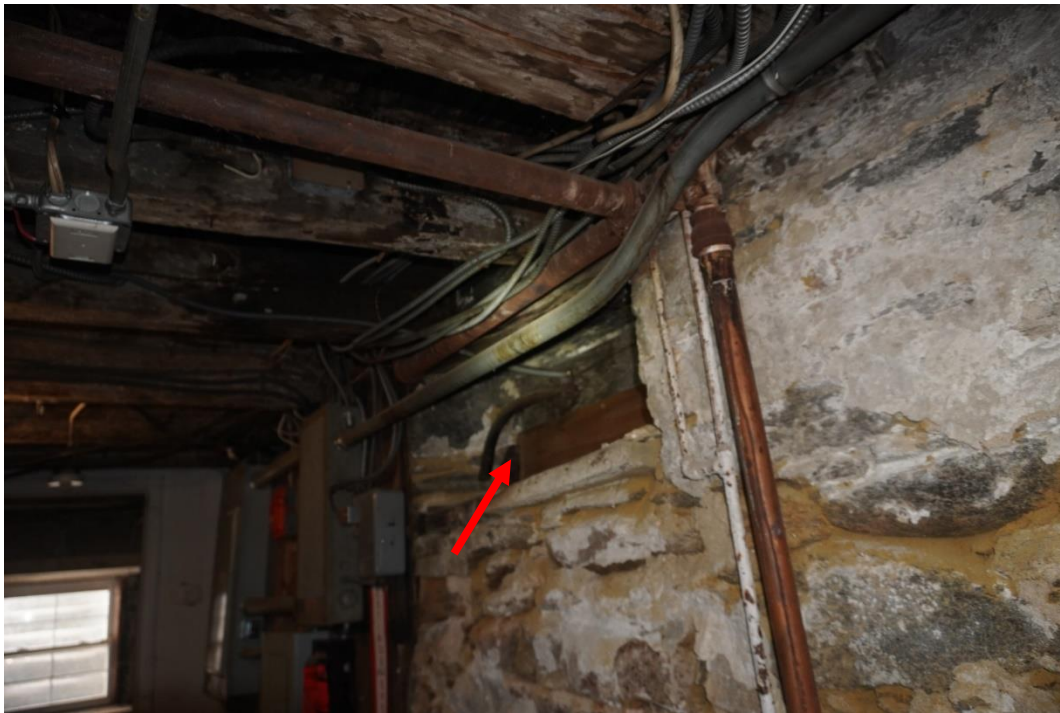
Photo #58: Cellar window at boiler room south foundation wall has been covered up when porch was added to the rear of the home.

- e) Two cellar windows at boiler room south foundation wall have been covered up when porch was added to the rear of the home at some unknown point in the past (Photo #58 & #62). Porch also was observed to have two different sets of support pillars (Photos #31 - #34). It appears porch that was added to home got extended at some unknown point in the past.

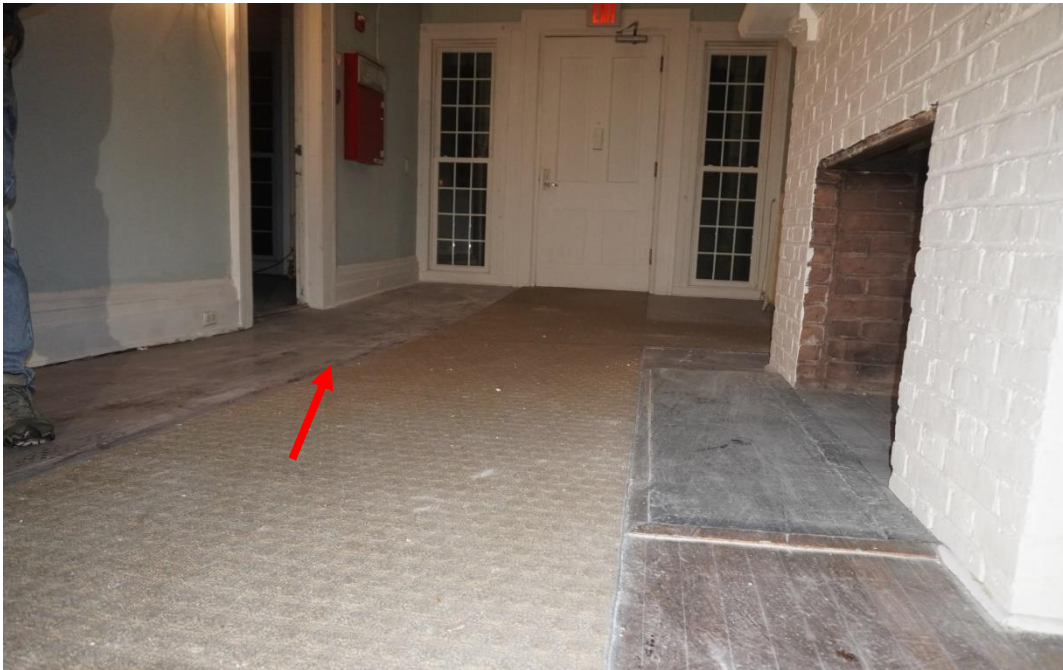
Photo #86: Large floor depression adjacent to load bearing wall 1st floor. This area is directly above girder that is failing in the boiler area and being propped up with temporary columns. Staircase to go up to the second floor was originally located somewhere in this room.

- a) The current staircase is not common for a Georgian styled colonial house. Staircase to go up to the second floor was originally located somewhere in the entrance foyer but was demolished and moved in the past. See Appendix E, photo #86, and photo #87 to see original location and new location. Current stairs in original home from ground level to 2nd floor is a narrow staircase with walls on each side. Original staircase to the home would of be a wider staircase that is open on one side with a handrail with balusters.

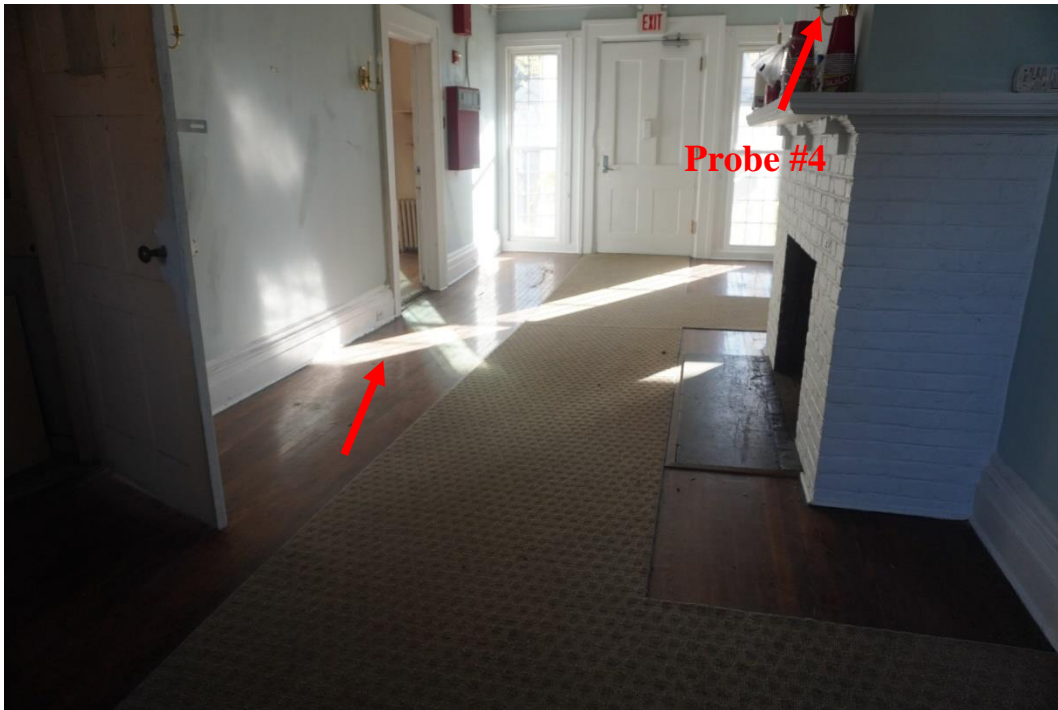
Photo #87: Large floor depression adjacent to load bearing wall 1st floor. This area is directly above girder that is failing in the boiler area and being propped up with temporary columns. Staircase to go up to the second floor was originally located somewhere in this room.

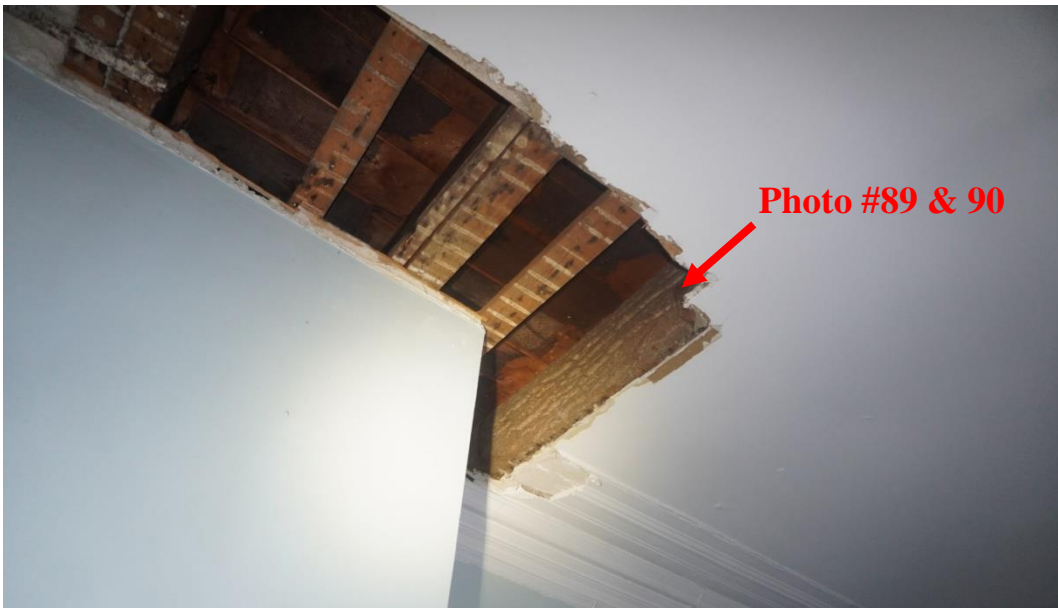
Photo #88: Ceiling joist that was never fully scored into a square framing member and still has bark exterior (Probe #4).

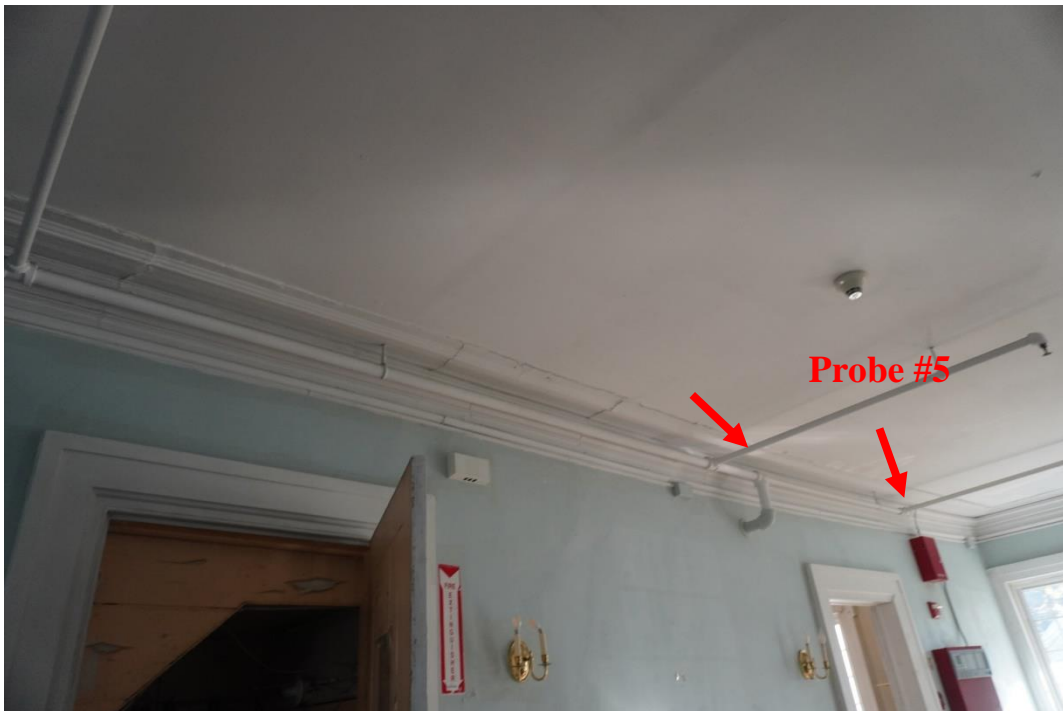
Photo #94: Wall containing girder beam showing signs of deflection. This girder is directly above girder that is failing in the boiler room area and is being propped up with temporary columns (Probe #5).

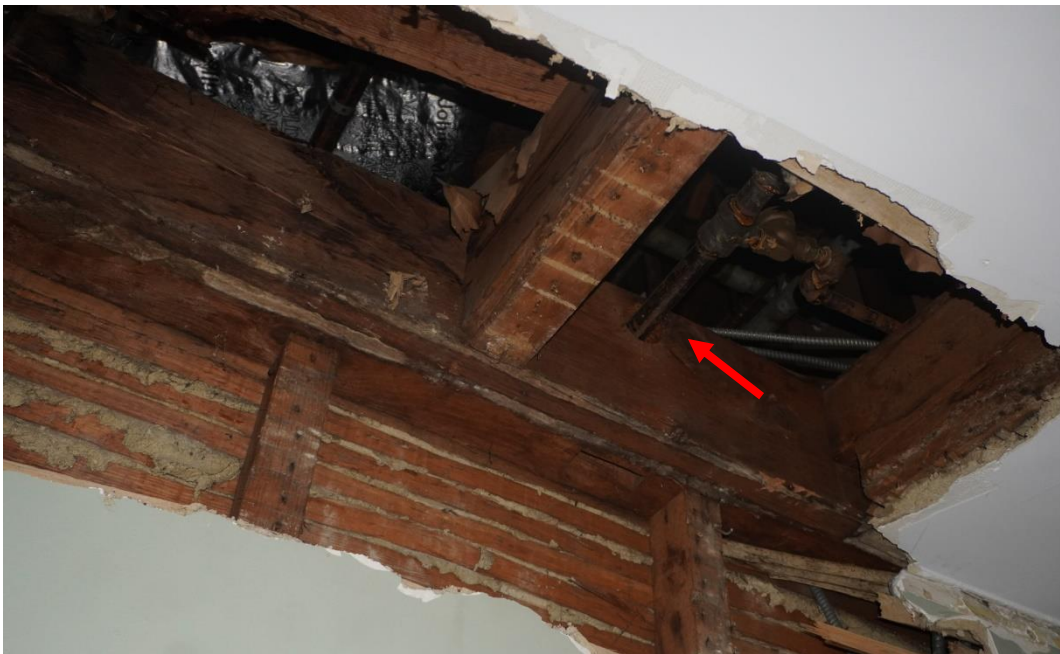
Photo #100: Floor joists supporting attic above observed at second floor level are oriented east to west. Large hole drilled through girder for pipe penetration (Probe #7).

50. Floor joists supporting attic above observed at second floor level are oriented east to west. Large hole drilled through girder for pipe penetration (Probe #7) (Photo #100 #101).
51. Past termite damage was observed in floor joist supporting attic level (Probe #7) (Photo #102).
52. Multiple joists supporting attic floor above have holes drilled above their neutral axis at the joists ends where shear force is the highest (Probe #8) (Photo #104).
53. Water damage adjacent to east exterior wall of addition. Cause unknown, further investigation required (Photo #107).
54. View facing northeast in roof void between 2nd floor ceiling joists and roof joists in the addition. Roof joists do not align with ceiling joists and are being supported at midspan with blocking that is resting right onto plaster ceiling (Probe #9) (Photo #108 &109).

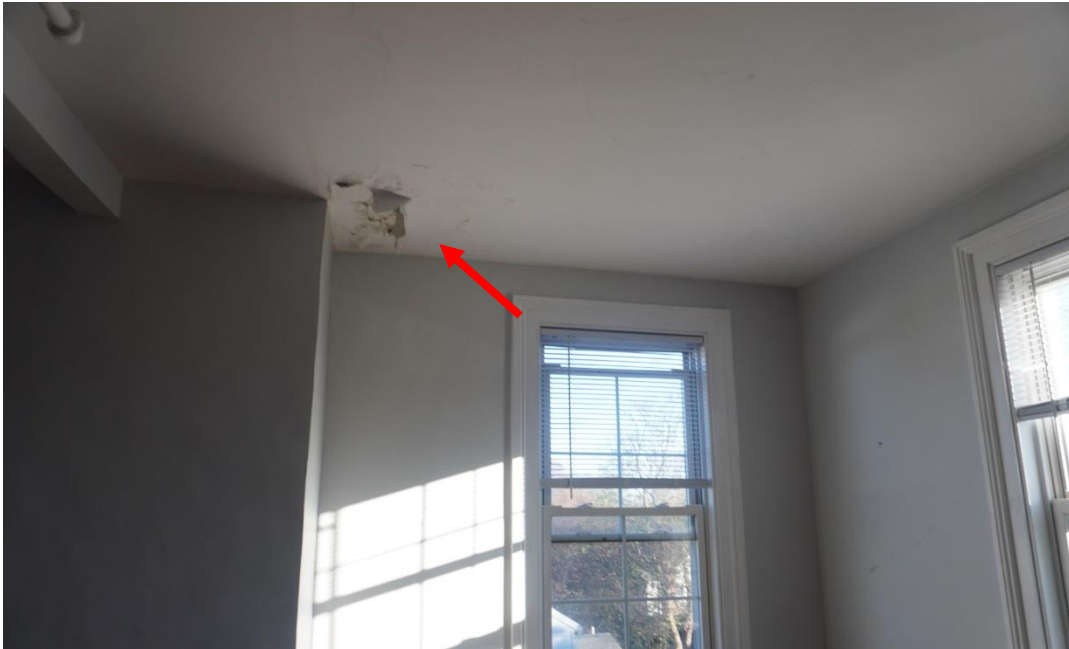
Photo #107: Water damage adjacent to east exterior wall of addition. Cause unknown, further investigation required.

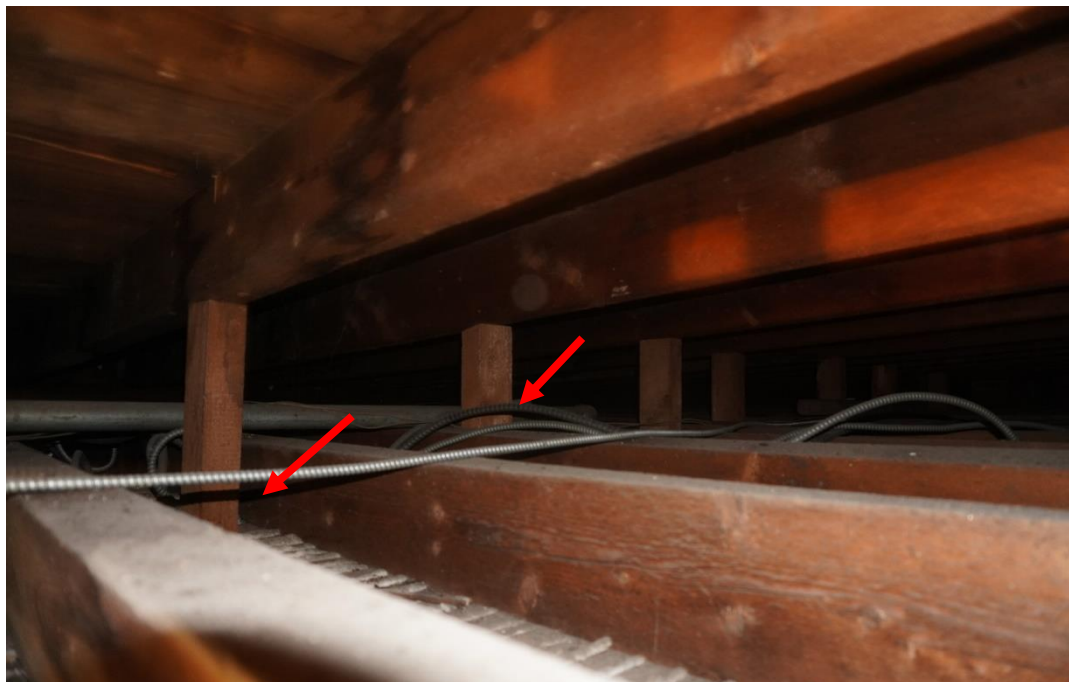
Photo #108: View facing northeast in roof void between 2nd floor ceiling joists and roof joists in the addition. Roof joists do not align with ceiling joists and are being supported at midspan with blocking that is resting right onto plaster ceiling (Probe #9).

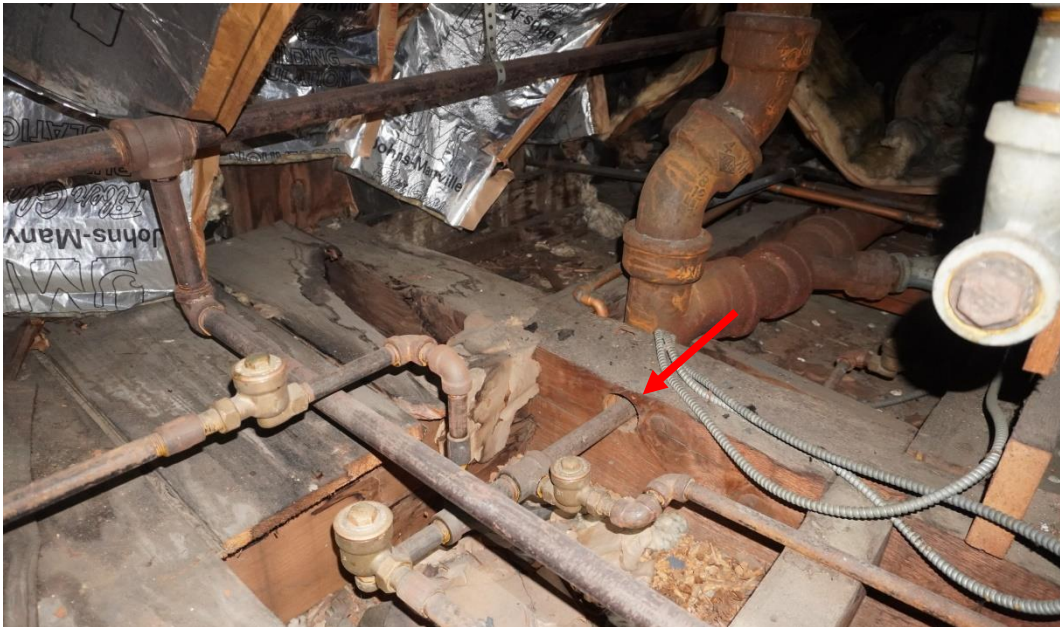
Photo #110: Pipe penetration drilled through girder drilled above its neutral axis. Observed in unfinished attic area, north side of original structure.

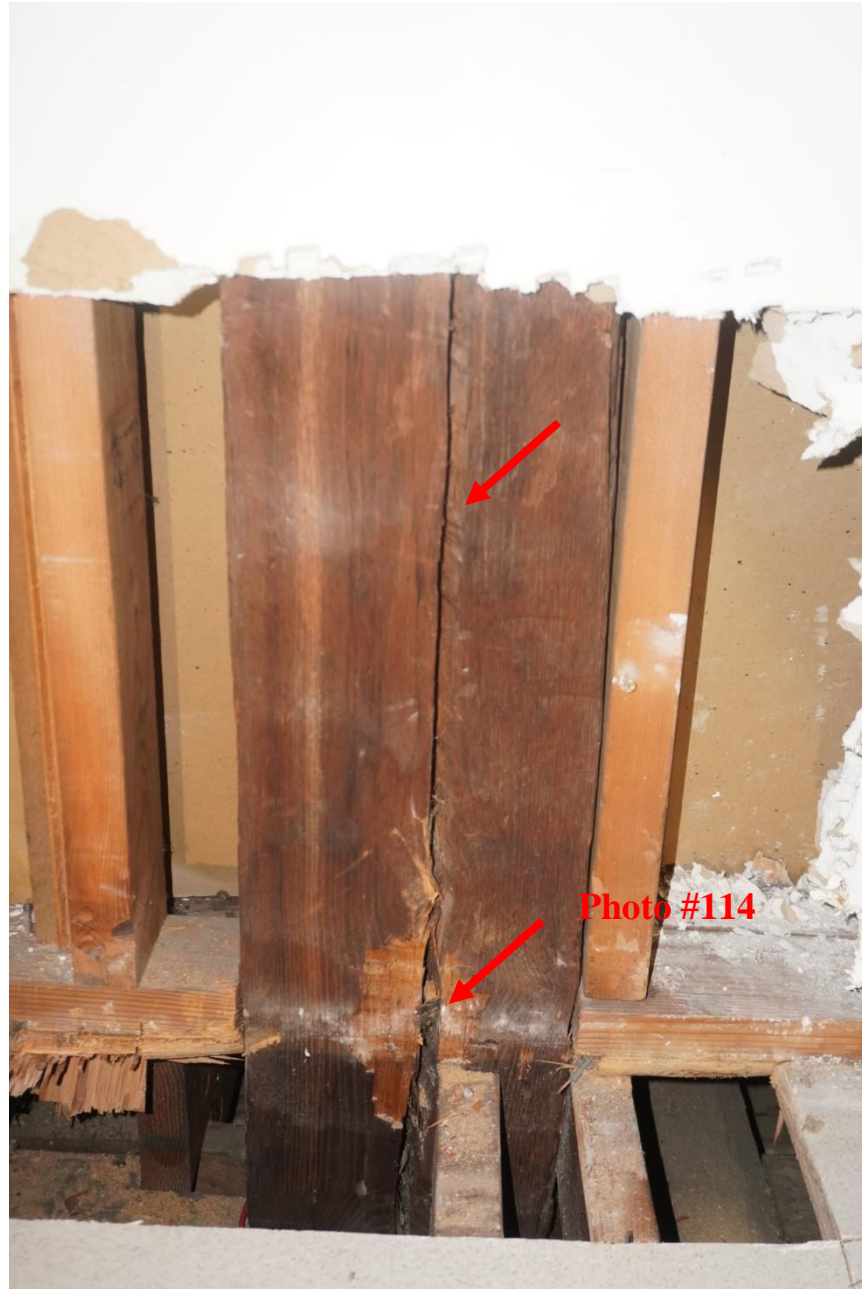
Photo #114: Vertical crack that has opened more towards the bottom observed, attic post
Unclear why this has occurred. Further investigation required (Probe #12).

55. Post in attic space has moved out of place. Mortise and tenon joint that was connecting post to girder below has failed allowing member to rotate (Probe #11) (Photo #111 - #113).
56. Vertical crack that has opened more towards the bottom observed, attic post Unclear why this has occurred. Further investigation required (Probe #12) (Photo #114 &115).
57. Roof support beam observed to be coming apart (Photo #117 &118).

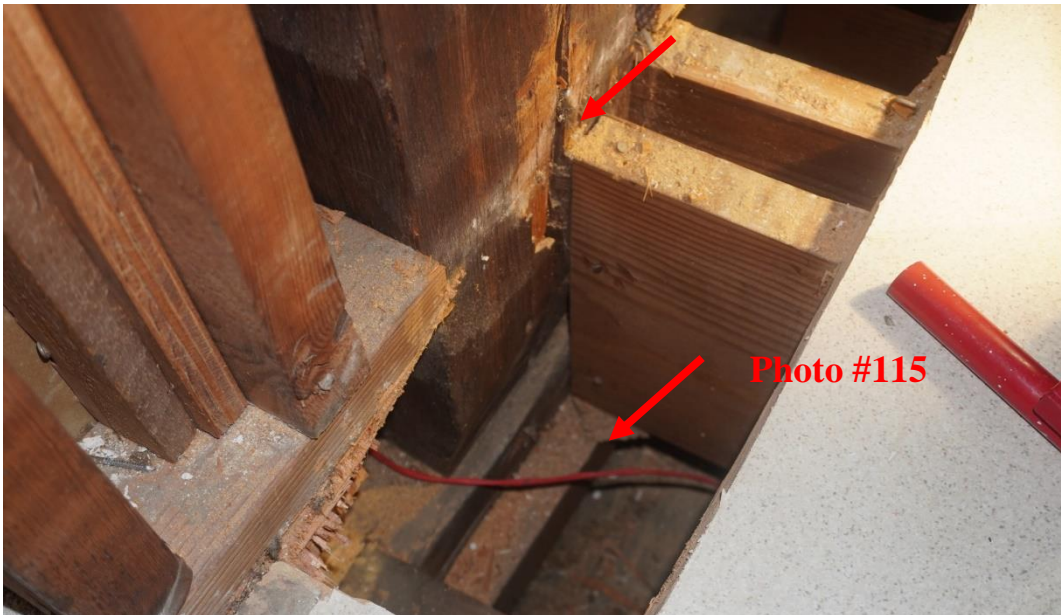
Photo #115: Vertical crack that has opened more towards the bottom observed, attic post. Unclear why this has occurred. Further investigation required. New wood joists have been installed going east to west bearing on wood ledge that has been nailed into girder. It is unclear why this was done. Further investigation required (Probe #12).

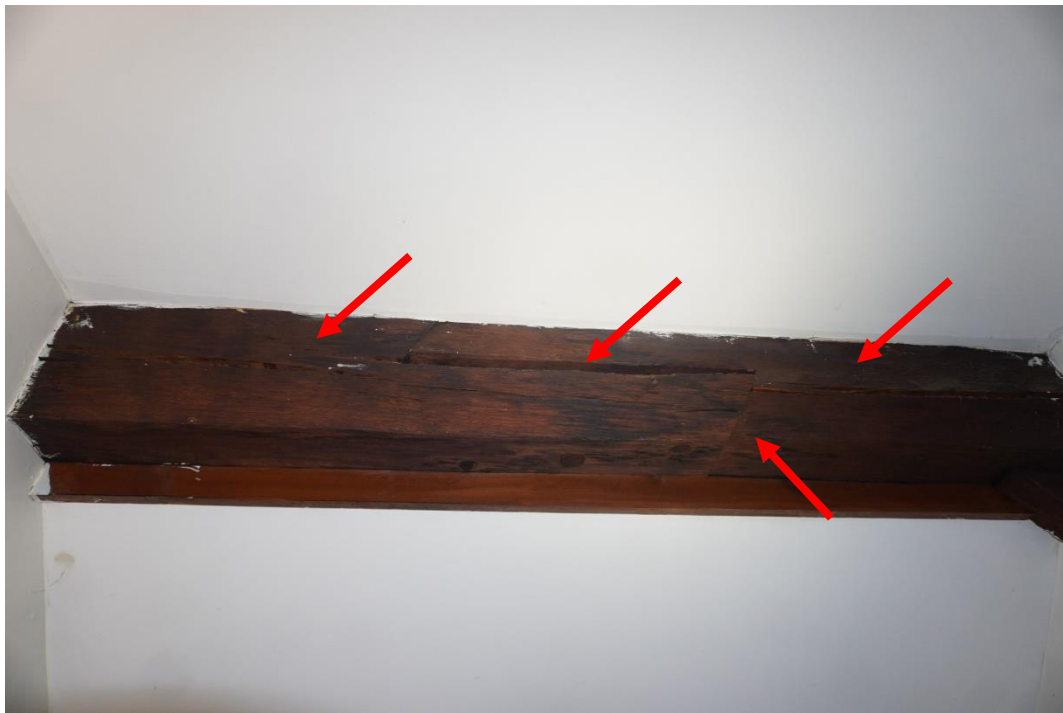
Photo #118: Roof support beam observed to be coming apart.

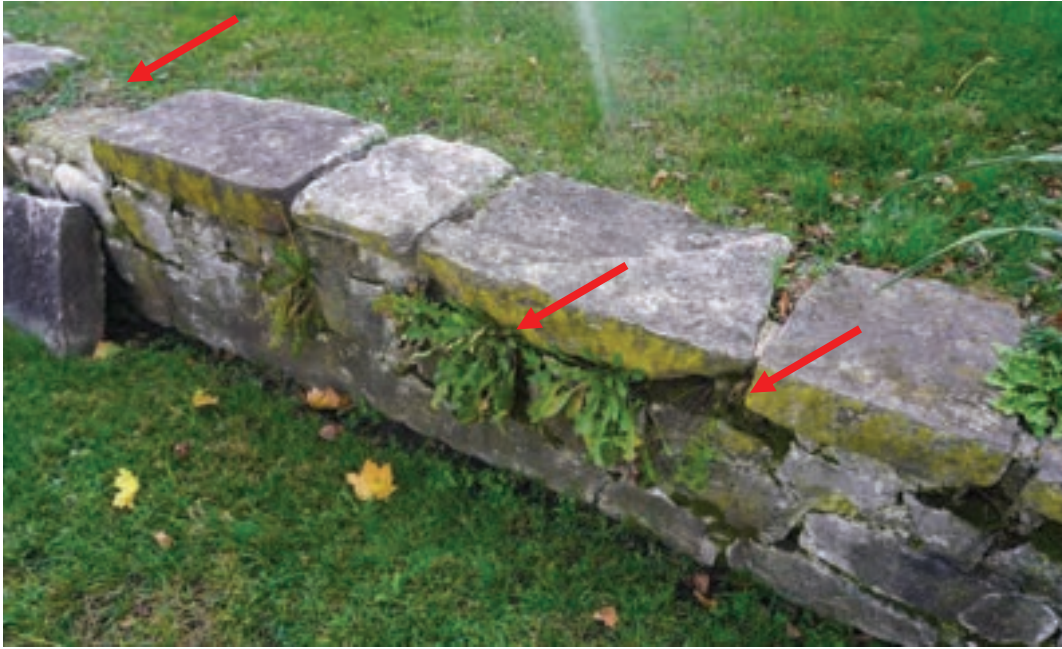
1. Retaining wall that runs from between front entrance and driveway is deteriorating throughout. Joints have filled with dirt. Multiple stone pieces no longer attached. Roots/ large weeds growing through joints of walls multiple locations. (Photo #1-3)
2. Retaining wall that runs between rear yard and adjacent sidewalk deteriorating throughout. Broken stones and joints between stones have filled with dirt/ organic growths. (Photo #11)

Photo #1: Retaining wall that runs from between front entrance and driveway is deteriorating throughout. Joints have filled with dirt. Multiple stone pieces no longer attached.

easily
repaired
surviving
historic dry
laid wall
with mortar

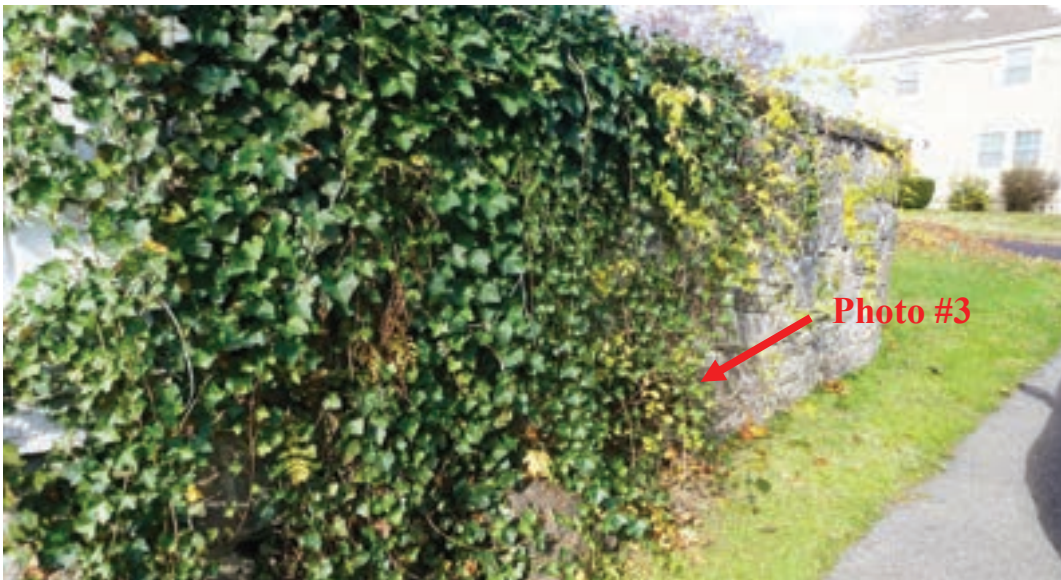
Photo #2: Retaining wall that runs from between front entrance and driveway is deteriorating throughout. Roots/ large weeds growing through joints of walls multiple locations.

great
looking
stone wall
with ivy
maintain &
poss. add
weep holes

trim/pull
weeds
growing at
weeps

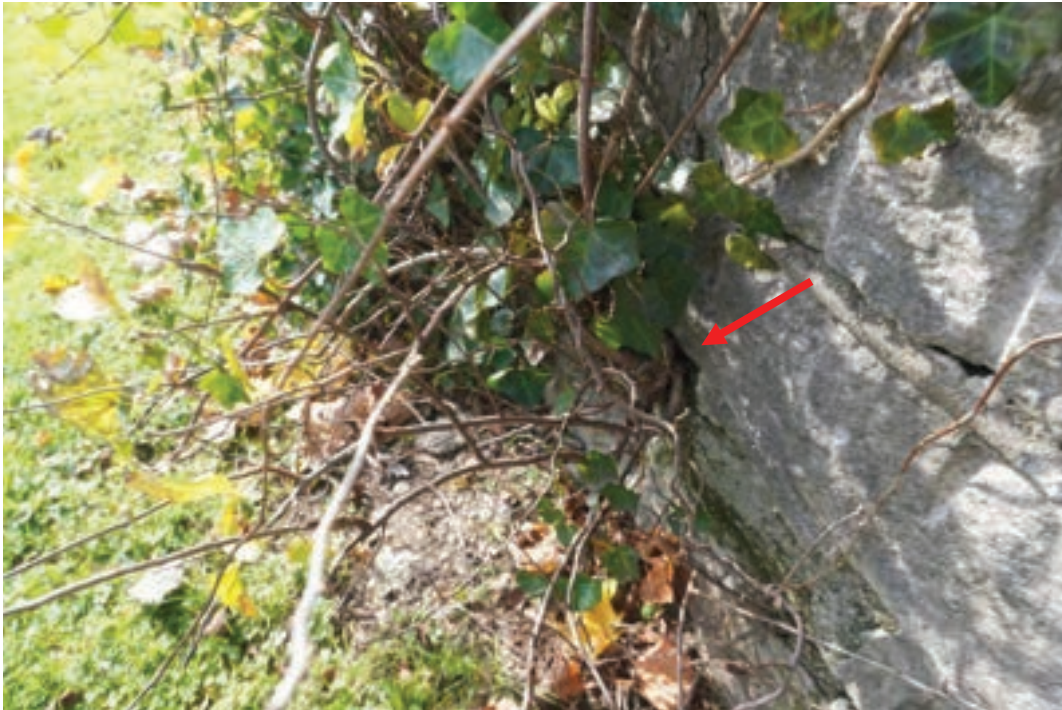
Photo #3: Retaining wall that runs from between front entrance and driveway is deteriorating throughout. Roots/ large weeds growing through joints of walls multiple locations.

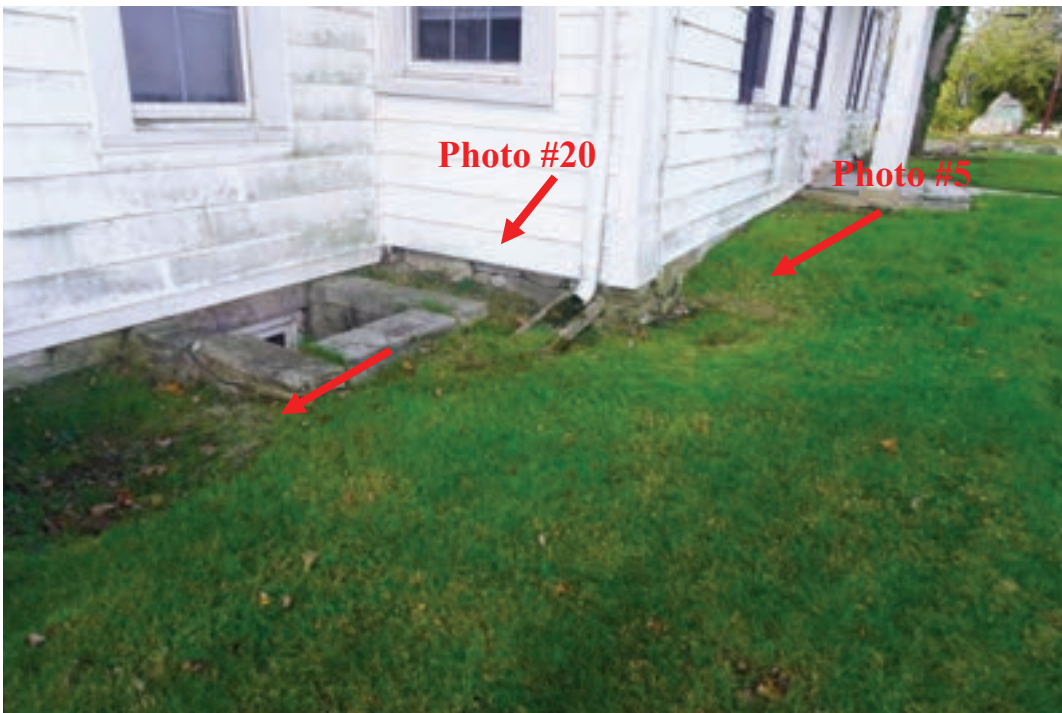
3. Negative grading front of home. Water pooling up against foundation wall and most likely infiltrating into crawlspace. Signs of foundation deterioration (Photo #4 - #6).
4. Stone slabs have settled/heaved creating multiple trip hazards, stone walkway rear yard (Photo #7).
5. Stone slabs have settled/ heaved creating multiple trip hazards, stone patio rear yard (Photo #8 - #10).

Photo #4: Negative grading front of home between entrance and northeast corner of original structure. Water pooling up against foundation wall and most likely infiltrating into crawlspace.

easy to locally regrade given general site conditions in this location

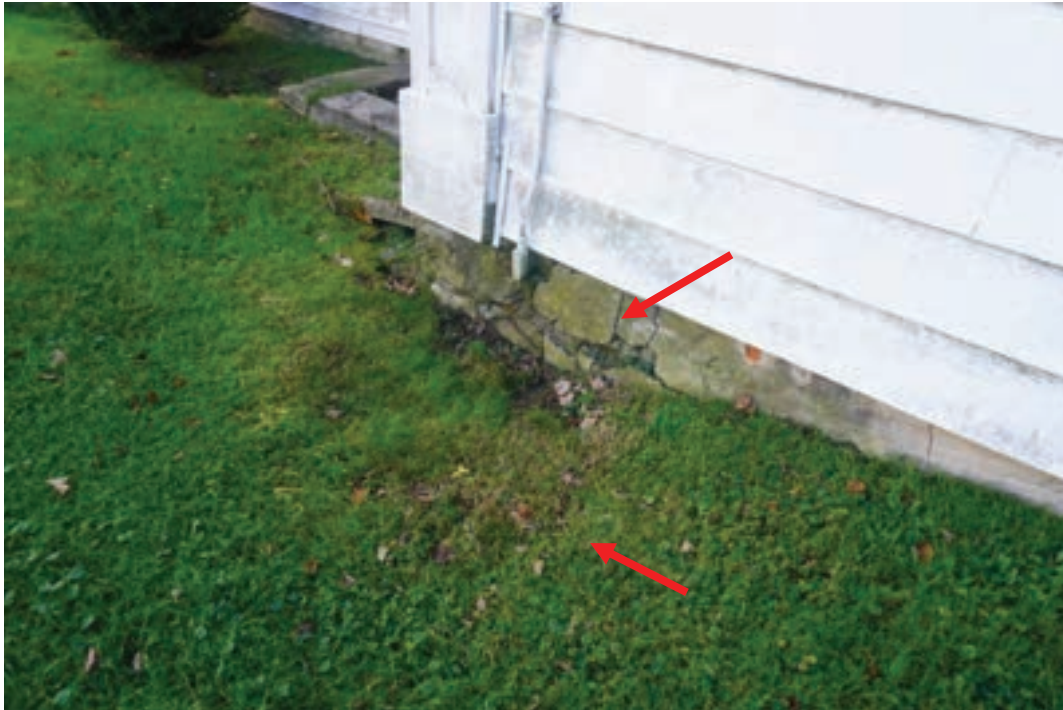
most likely?
or is it?

Photo #5: Negative grading front of home between entrance and northeast corner of home. Water pooling up against foundation wall and **most likely** infiltrating into crawlspace. Signs of foundation deterioration.

easily
regraded

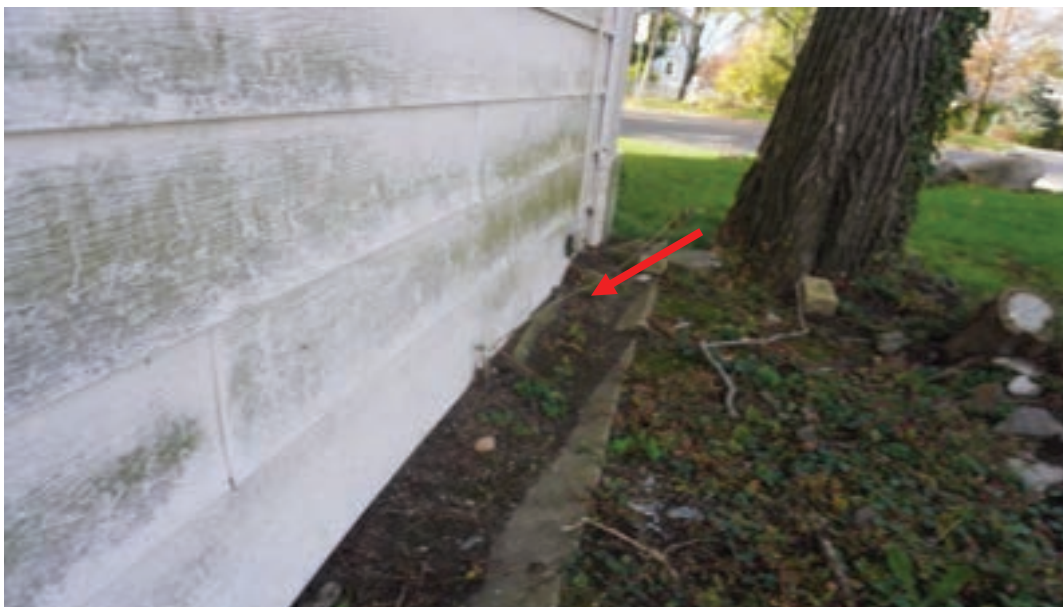
Photo #6: Negative grading front of home between entrance and northwest corner of home. Water pooling up against exterior foundation wall of crawlspace.

easily regraded

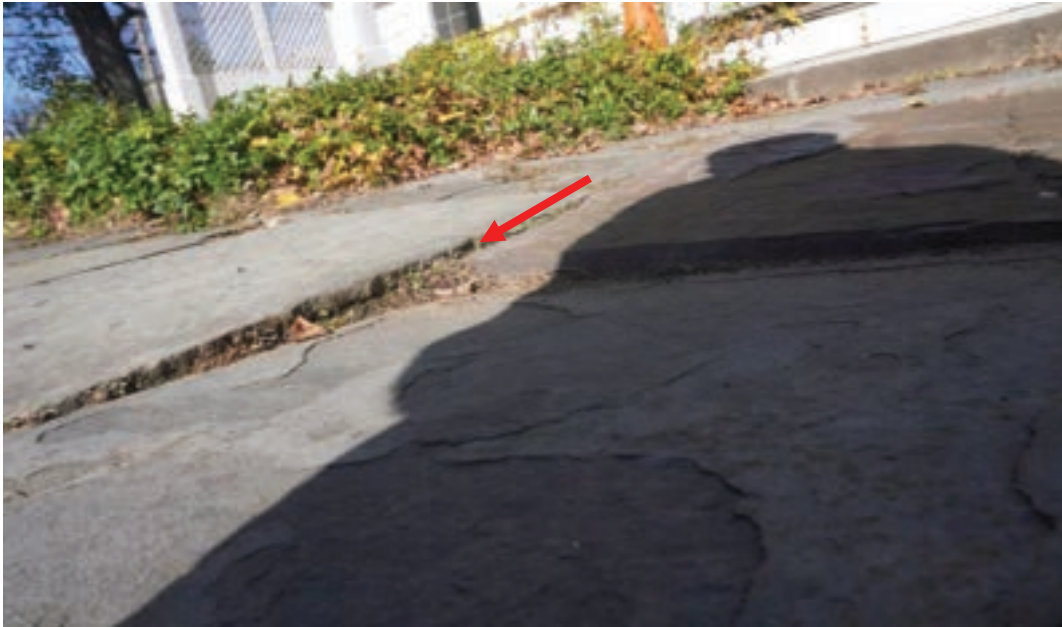
Photo #7: Stone slabs have settled/heaved creating multiple trip hazards, stone walkway rear yard.

duh?
reset!

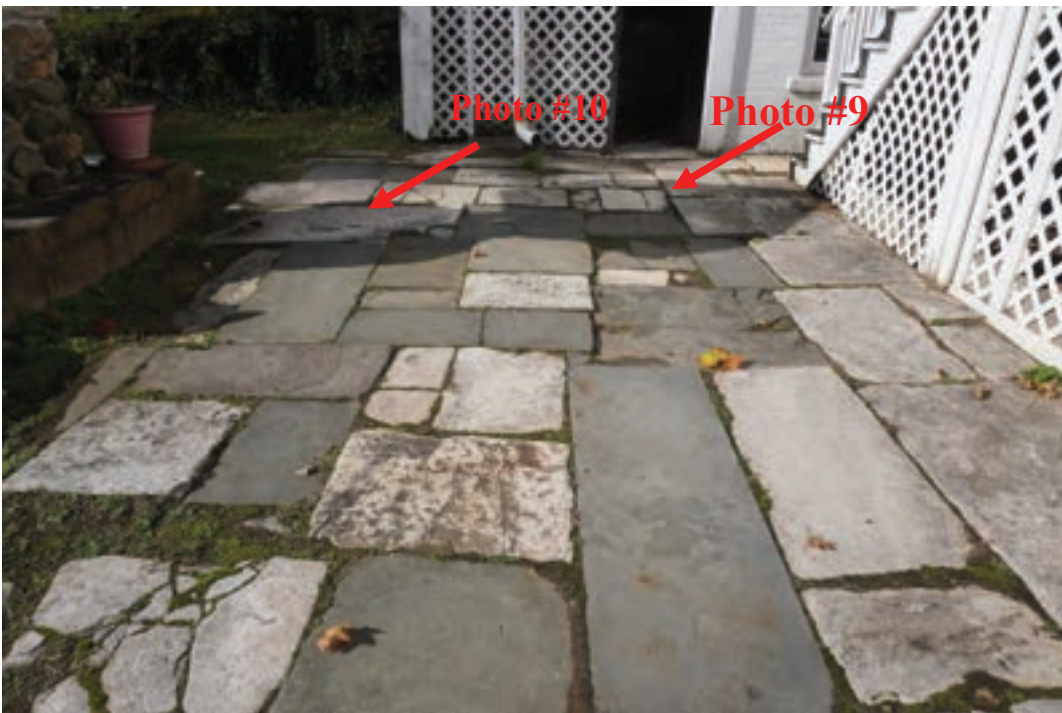
Photo #8: Stone slabs have settled/ heaved creating multiple trip hazards, stone patio rear yard.

pretty nice
looking
terrace!
----easy to
reset

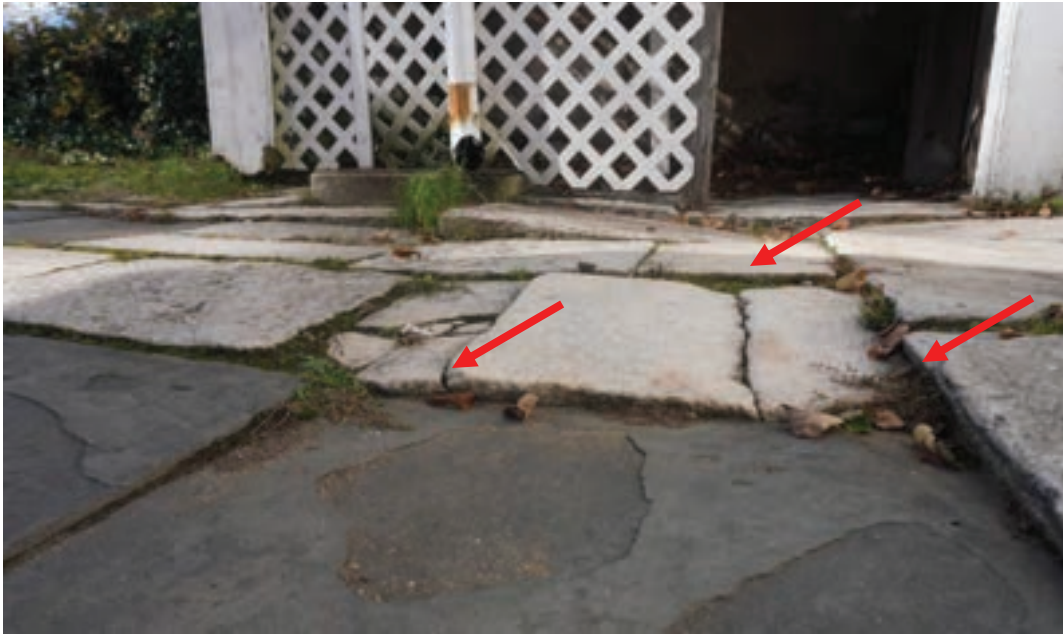
Photo #9: Stone slabs have settled/ heaved creating multiple trip hazards, stone patio rear yard.

easily reset

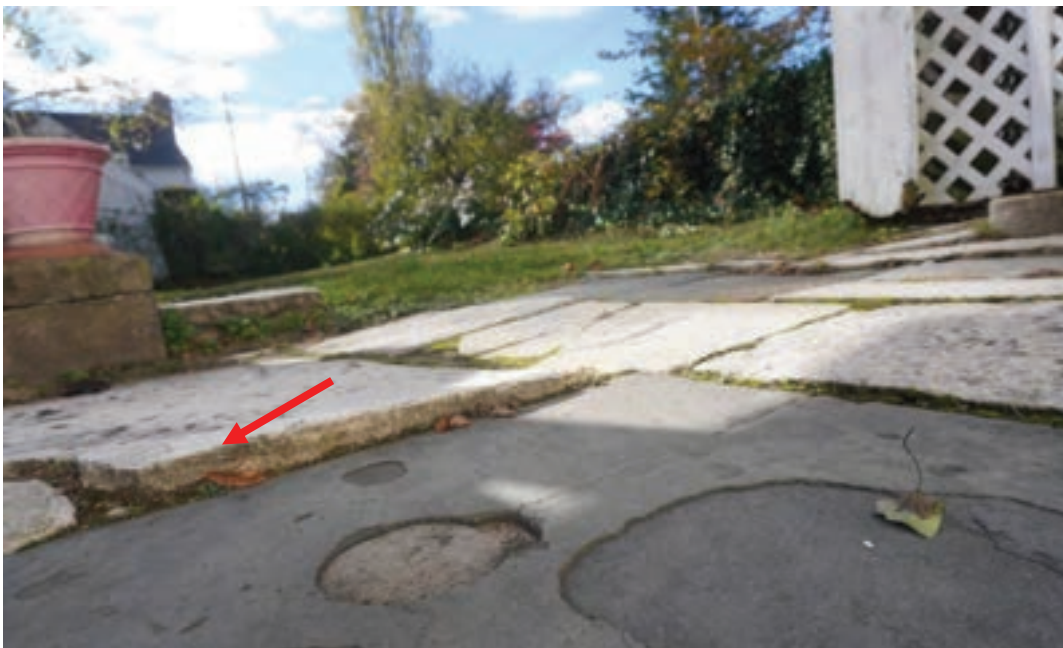
Photo #10: Stone slabs have settled/ heaved creating multiple trip hazards, stone patio rear yard.

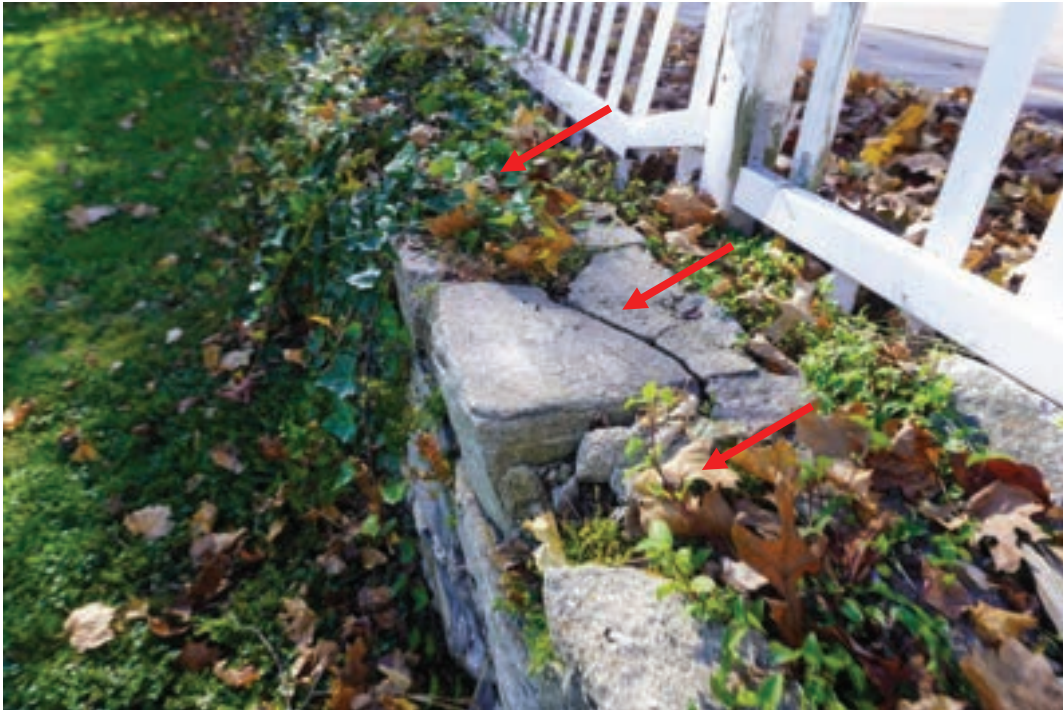
Photo #11: Retaining wall that runs between rear yard and adjacent sidewalk deteriorating throughout. Broken stones and joints between stones have filled with dirt/ organic growths.

reset as low
dry laid or add
mortar
