**Re: *Biggest Fish Westchester LLC*
§11A-9 Economic Hardship Request (Certificate of Appropriateness)
*230 White Plains Road - Section 31. Block 3 Lot 13 ("Property")***

Property Location:	230 White Plains Road Tuckahoe, NY 10707
Inspection Dates:	Initial Inspection: 9/23/22 In Depth Inspection: 11/14/22 Probe Inspection: 12/13/22
Report Date:	1/28/23
Report By:	Peter Panagopoulos, P.E. <i>Principal</i> Pantec Engineering
Appendices:	Appendix A – Photos Appendix B – Probe Locations Appendix C – Structural Layout Appendix D – Deficiency Location Diagram Appendix E - Two Inner Chimney Georgia Colonial Layout

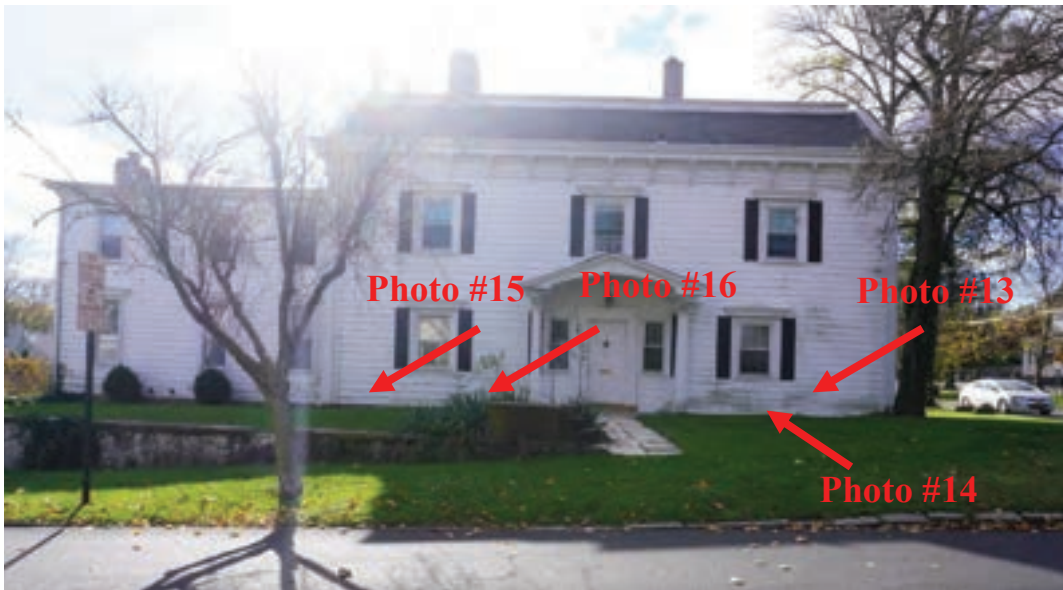
6. Foundation along front façade of original structure is low and at same level as grading. Water **can** infiltrate above foundation wall and rot out wood sill beam that runs along top of foundation (Photo #12, #13, #15, & #16). **can?**

Photo #12: Foundation along front façade of original structure is low and at same level as grading. Water can infiltrate above foundation wall and rot out wood sill beam that runs along top of foundation.

once again condition can
easily be regraded if
infiltration is occurring

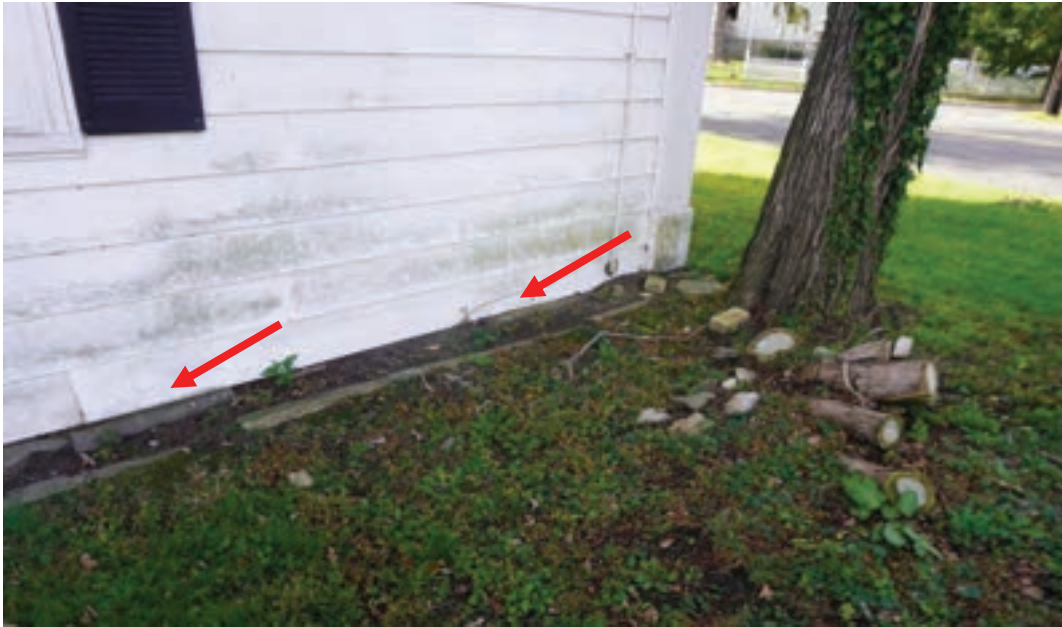
Photo #13: Foundation along front façade of original structure is low and at same level as grading. Water can infiltrate above foundation wall and rot out wood sill beam that runs along top of foundation.
once again condition can easily be regraded if infiltration is occurring

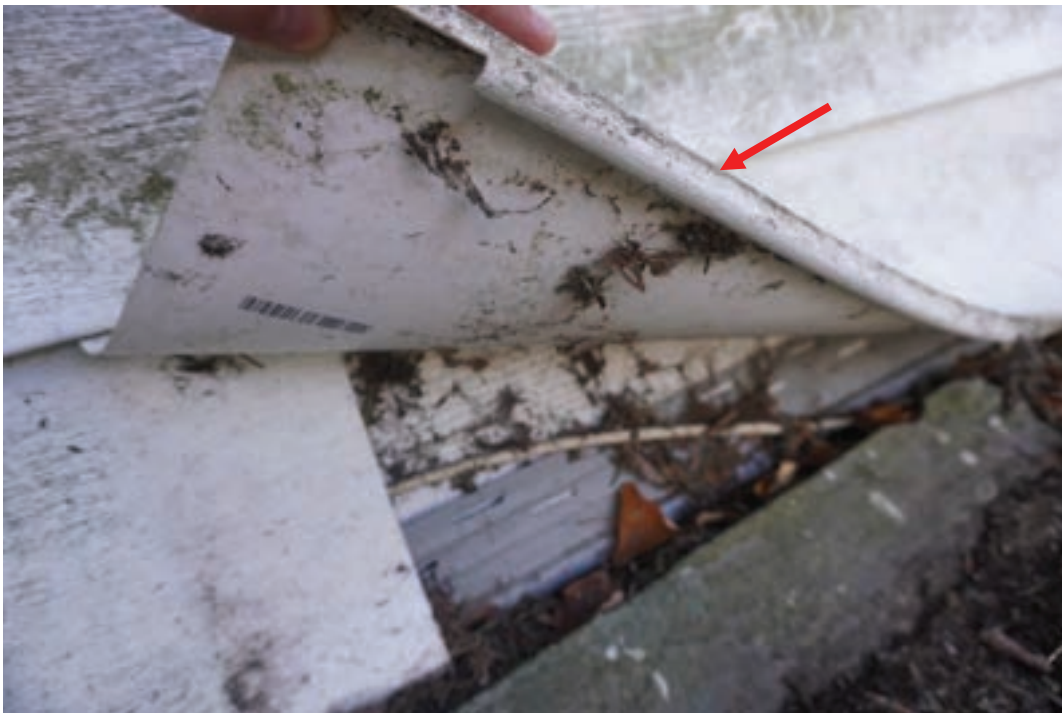
Photo #14: Exterior of building covered in vinyl siding which is not the homes original exterior building material.

cool! siding is still there protected by the vinyl--remove and inspect, repair clapboard siding as has been frequently done elsewhere !

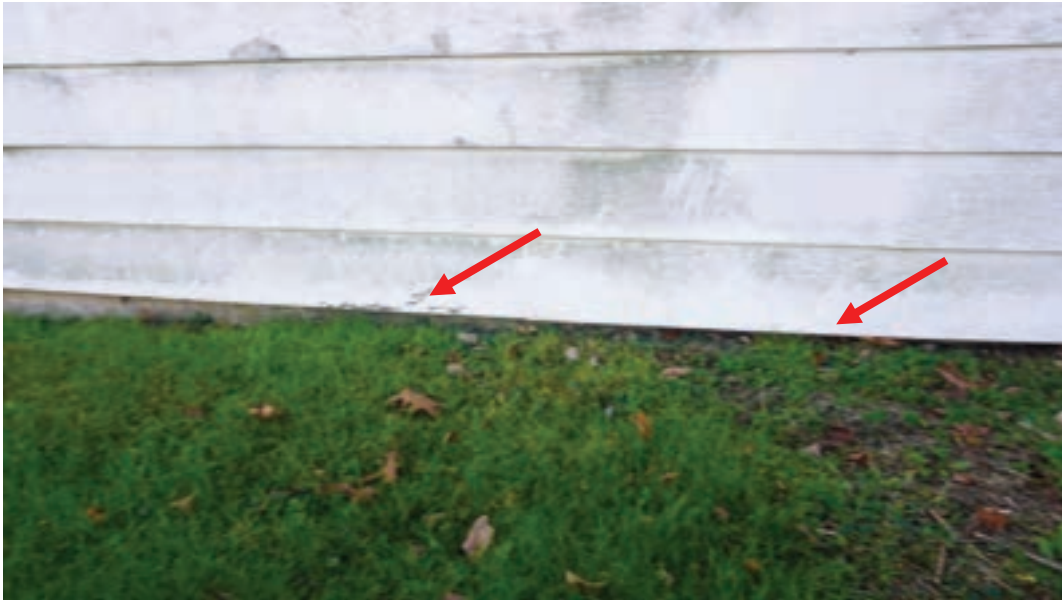
8. Exposed exterior side of rumble foundation deteriorating (Photo #20).
9. Bulge noticed between first and second floors, west façade of home. Cause unknown. Further investigation required (Photo #21 & #22).

Photo #15: Foundation along front façade of original structure is low and at same level as grading. Water **can infiltrate** above foundation wall and rot out wood sill beam that runs along top of foundation.

easily regraded

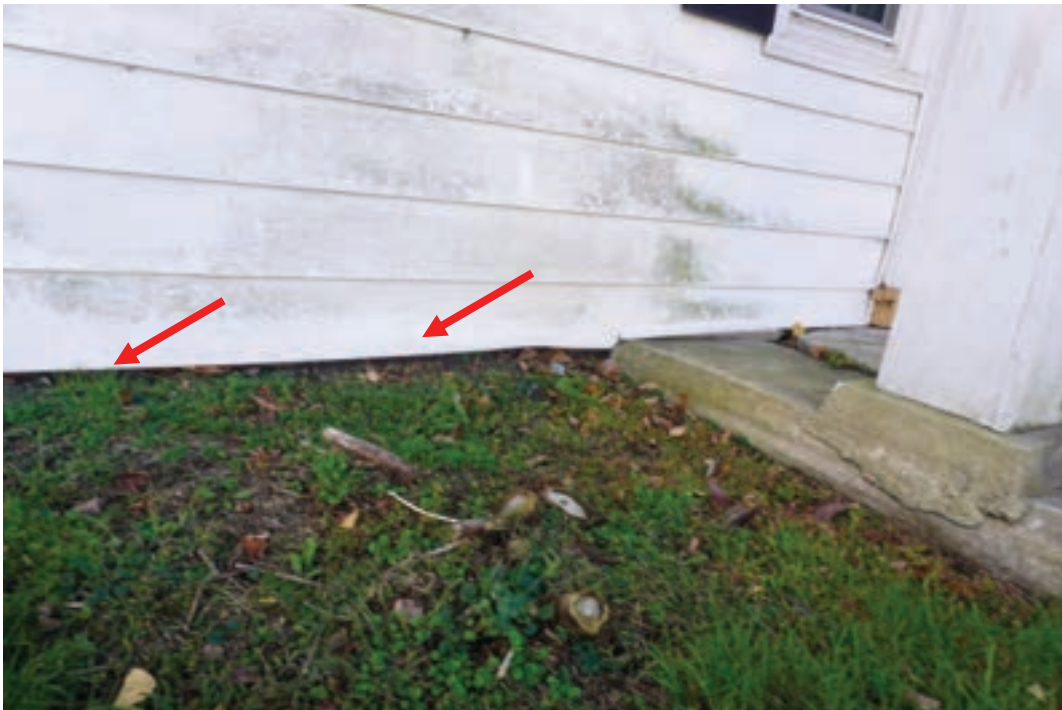
Photo #16: Foundation along front façade of original structure is low and at same level as grading. Water **can** infiltrate above foundation wall and rot out wood sill beam that runs along top of foundation.

easily regraded
-- if it does
infiltrate

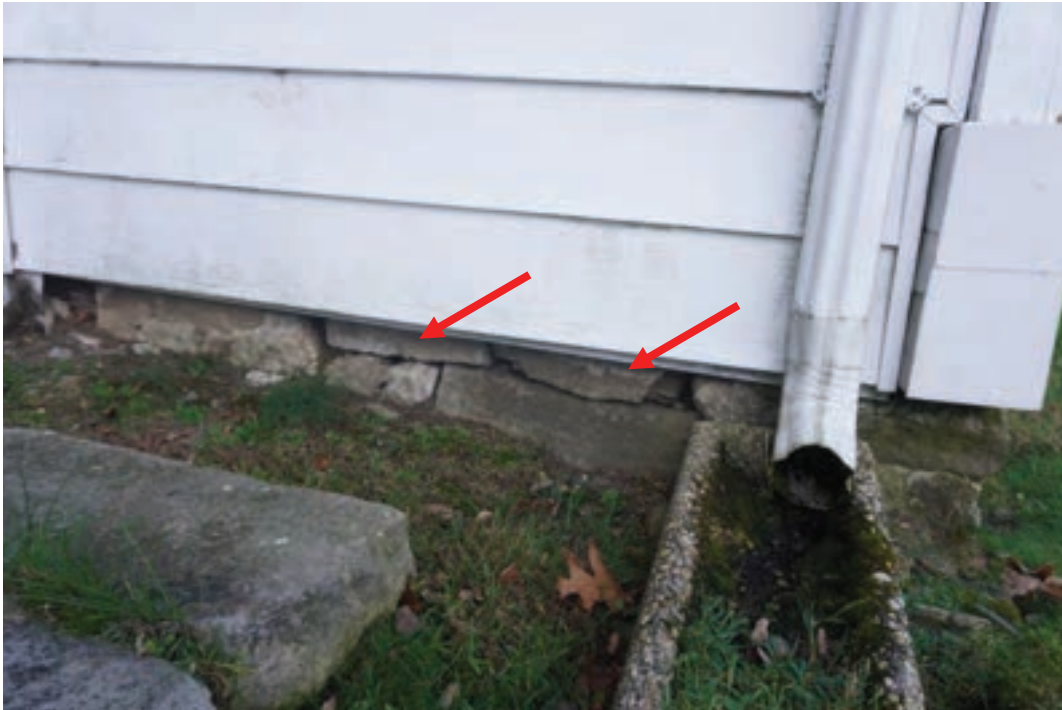
Photo #20: Exposed exterior side of rumble foundation deteriorating. No mortar between stones. loose laid footers testimony to historic foundation condition. easily addressed, repointed, if critters are entering

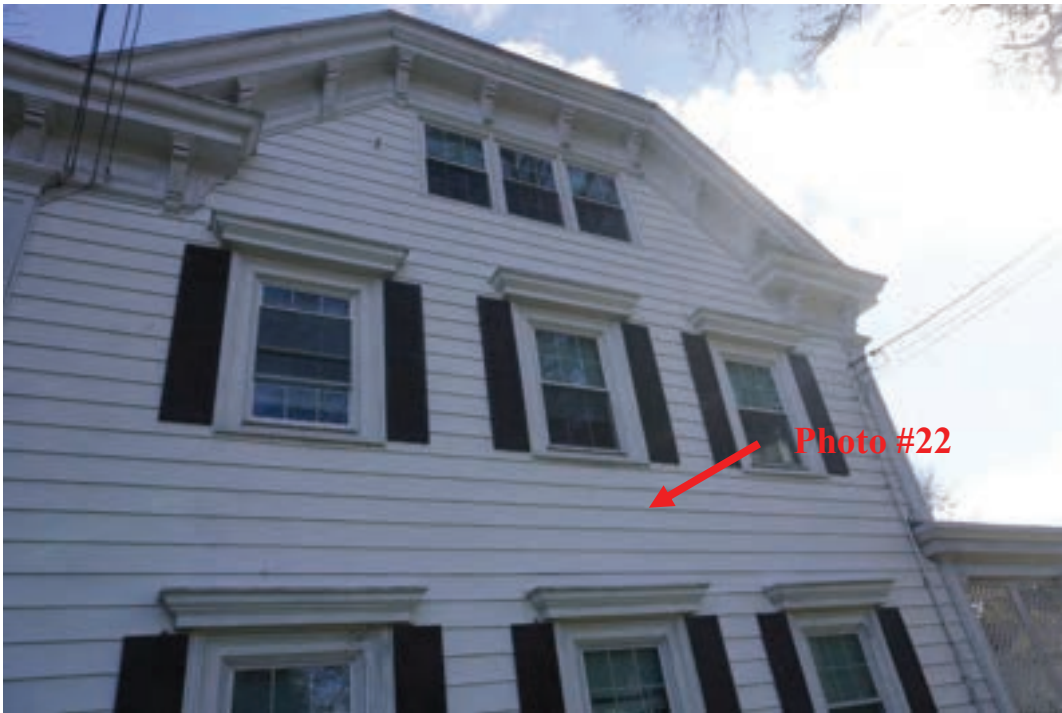
Photo #21: Bulge noticed between first and second floors, west façade of home. Cause unknown. Further investigation required.

remember: vinyl siding does expand and contract
overall building appears quite plumb and true

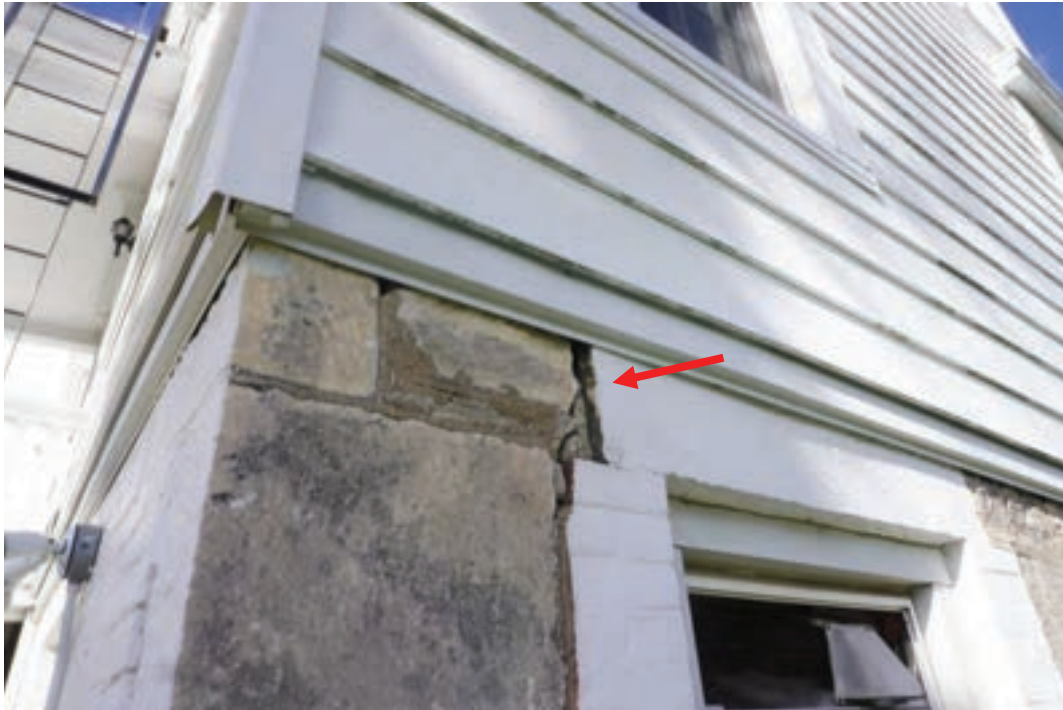
10. Southeast corner of structure showing signs of inwards movement towards the top. Cause unknown. Vertical crack ground level stonework. Further investigation required (Photo #23 & #24).

Photo #24: Vertical crack ground level stonework east façade, southeast corner of structure at addition.

no other signs of movement apparent; apply crack gauge & monitor; this is a standard kind of condition we encounter; & is just an occasion for analysis before a standard repair with a soft or hard joint to prevent water entry

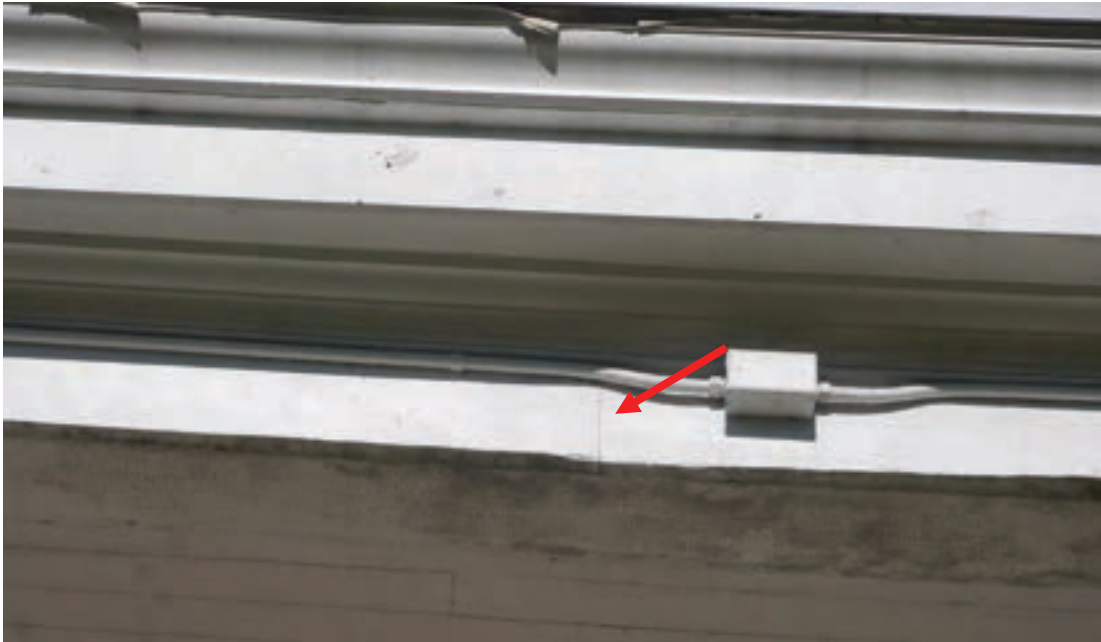
13. Rear porch roof deflecting over stairs causing water to pool and leaf build up (Photo #25 - #27).
14. Rear porch sitting on stone pillars that are showing signs of deterioration (Photo #31 - #34).
15. Rear porch stairs deteriorated. No longer usable (Photo #35).

Photo #26: Rear porch roof deflecting over stairs causing water to pool and leaf build up.

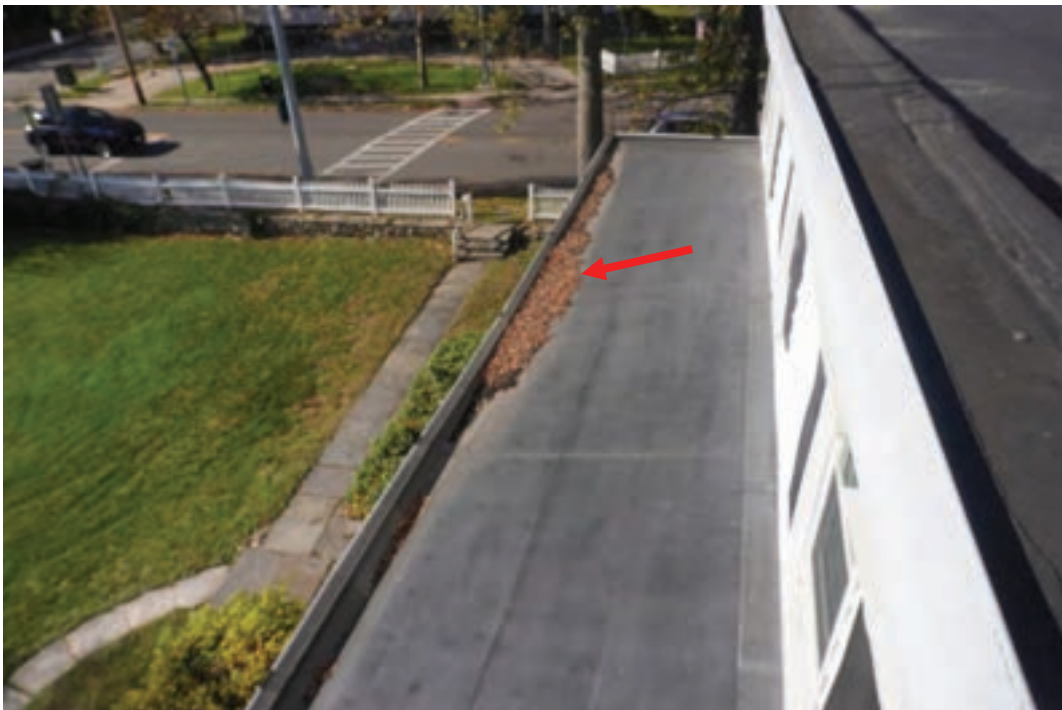
Photo #27: Rear porch roof deflecting over stairs causing water to pool and leaf build up.

built in gutter needs to be pitched to drains at both ends
instead of one leader that can be clogged

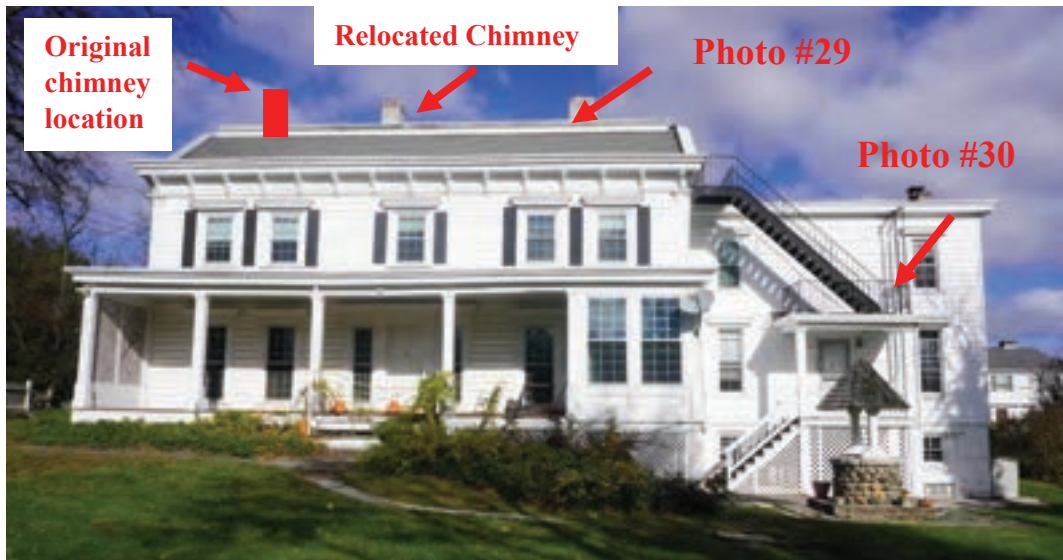
- f) Typically, the front of home had the double lines of windows on either side of the door. At 230 White Plains Road the front façade has only one line of windows on each side of the door and what is now the rear façade with the porch has two lines of windows on each side of the door. This means the rear of the home at 230 White Plains Rd was the original front of the home (Appendix E, Photo #12, and Photo #28). It is unclear at what point in time this change was made.

Photo #28: Rear south façade. Chimneys in colonial era Georgian style homes were symmetrically placed. Original chimney was demolished and relocated at some unknown point in the past. Typically, the front of home had the double sets of windows on either side of the door for this type of Georgian colonial. This means the façade that is now the front of the home that only has one window on each side of the door was most likely the old rear façade of the home.

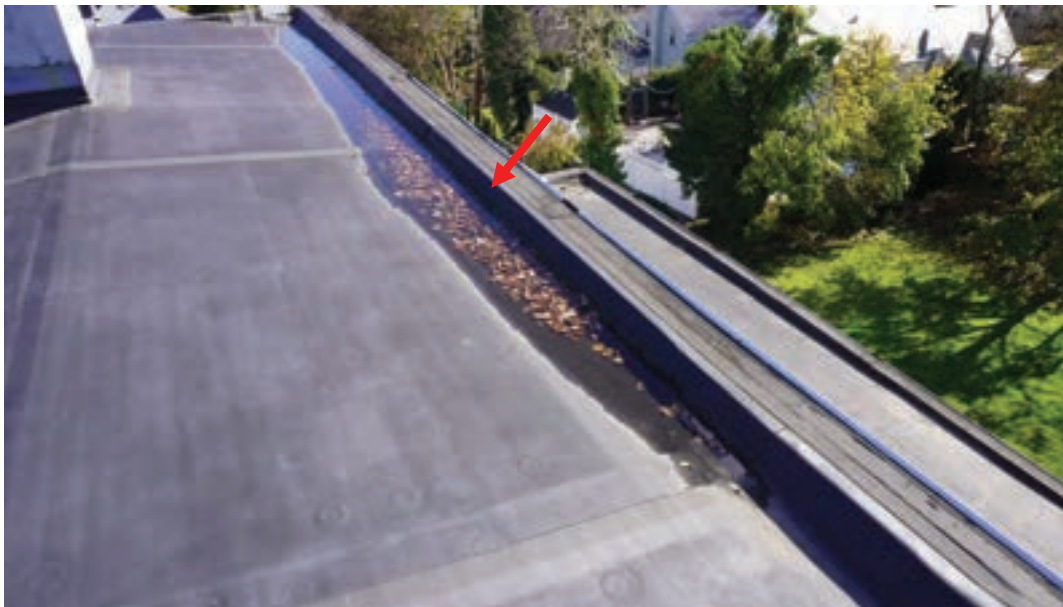
11. Roof structure has deflected causing water to pool. Roofing membrane observed to be fairly new (Photo #28 & #29).
12. Exterior metal stair egress just sitting on roofing membrane and not attached to structure (Photo #28 & #30).

Photo #29: Roof structure has deflected causing water to pool. Roofing membrane observed to be fairly new.

built in gutter needs to be pitched to drains at both ends instead of one leader that can be clogged

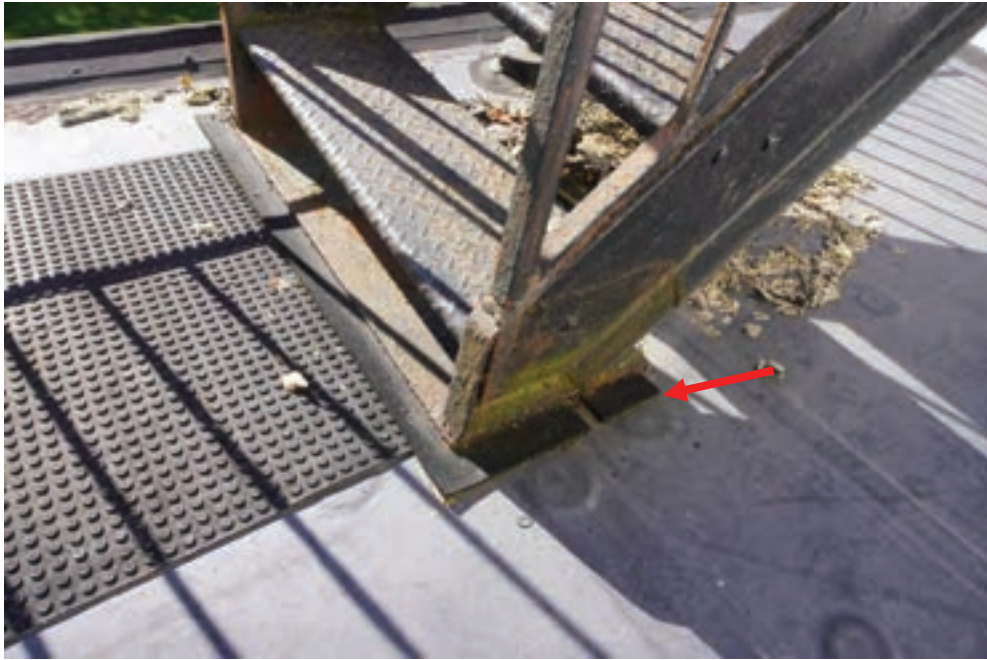
Photo #30: Exterior metal stair egress just sitting on roofing membrane and not attached to structure.

no evidence of damage or movement visible but connection could be easily added with pitch pocket or other sealed connection if needed

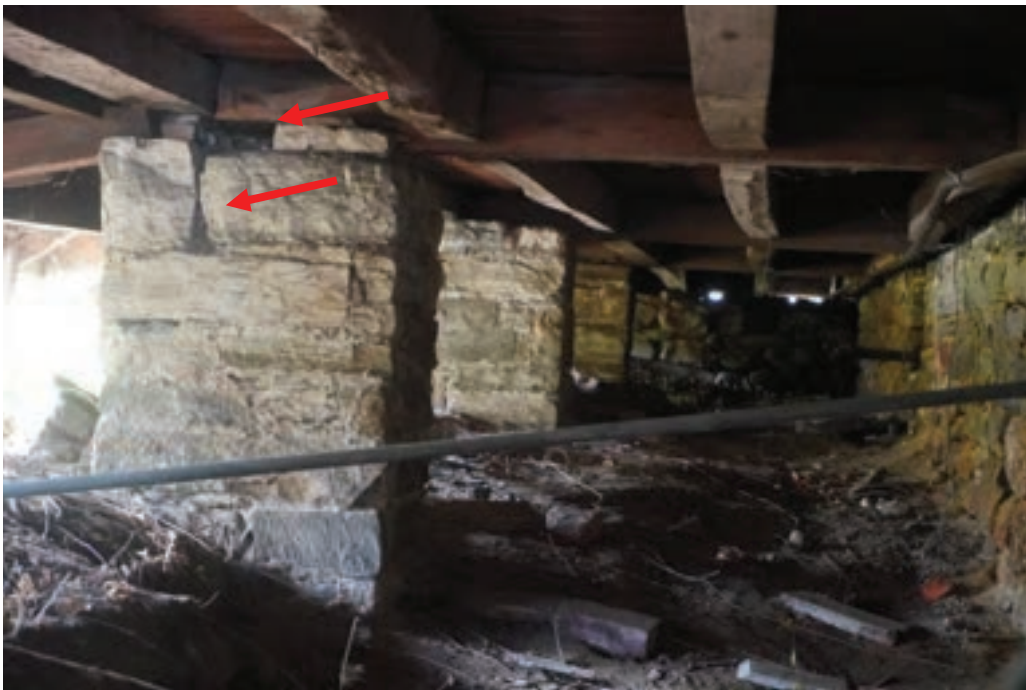
Photo #31: Rear porch sitting on stone pillars that are showing signs of deterioration.

Thanks for showing us the historic hand-hewn porch framing still intact--beautiful! Stone pillars in relatively good shape, but bearing condition is easily repaired at top

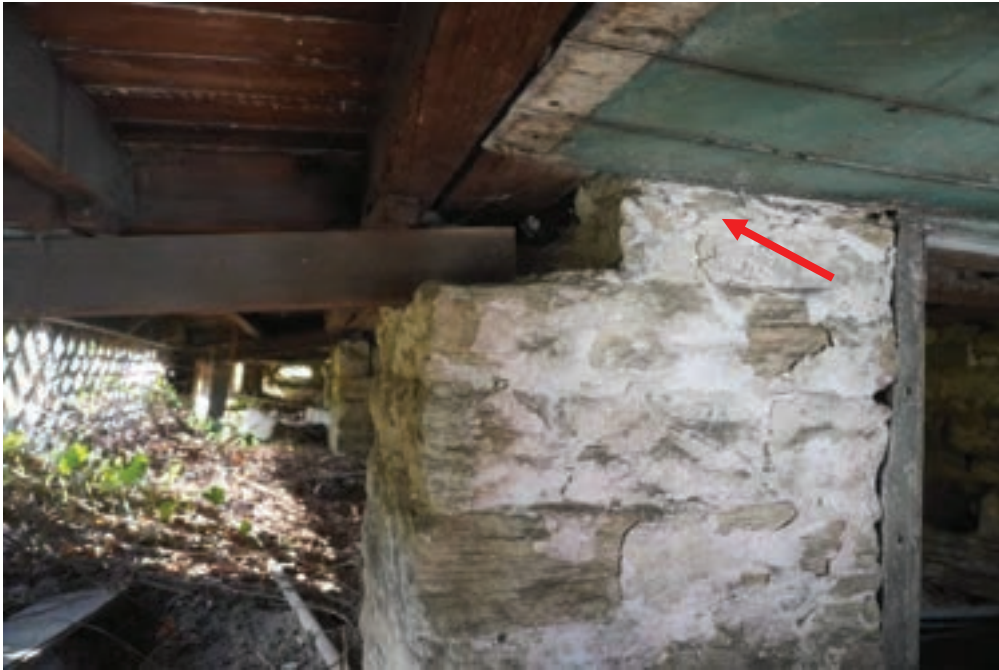
Photo #32: Rear porch sitting on stone pillars that are showing signs of deterioration.
sacrificial lime coating can be redone and repointing undertaken as required.

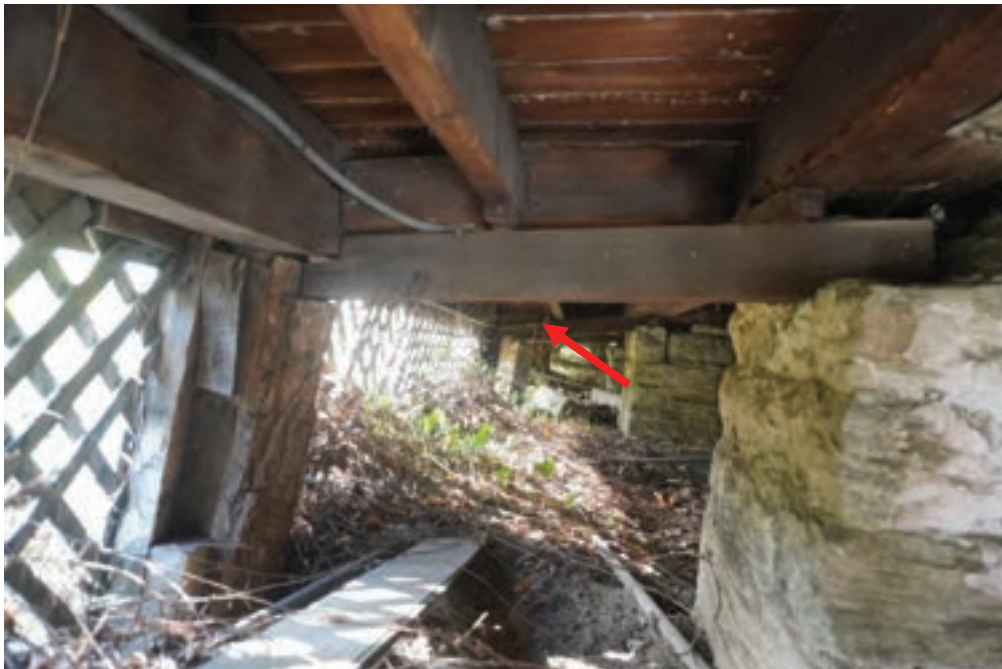
Photo #33: Rear porch was extended to be made wider at some unknown time in the past.

lattice is non-historic (replace) but note bark still on posts; repair and reset exterior posts and check footers

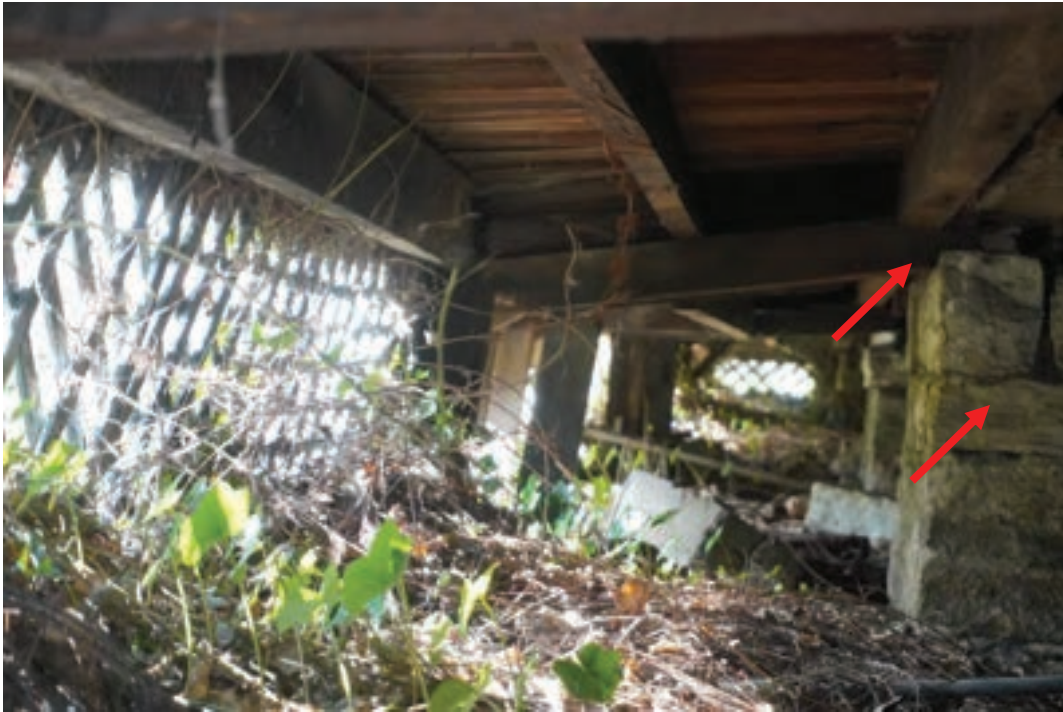
Photo #34: Rear porch sitting on stone pillars that are showing signs of deterioration. clear organic material & reset posts to maintain required slope on porch

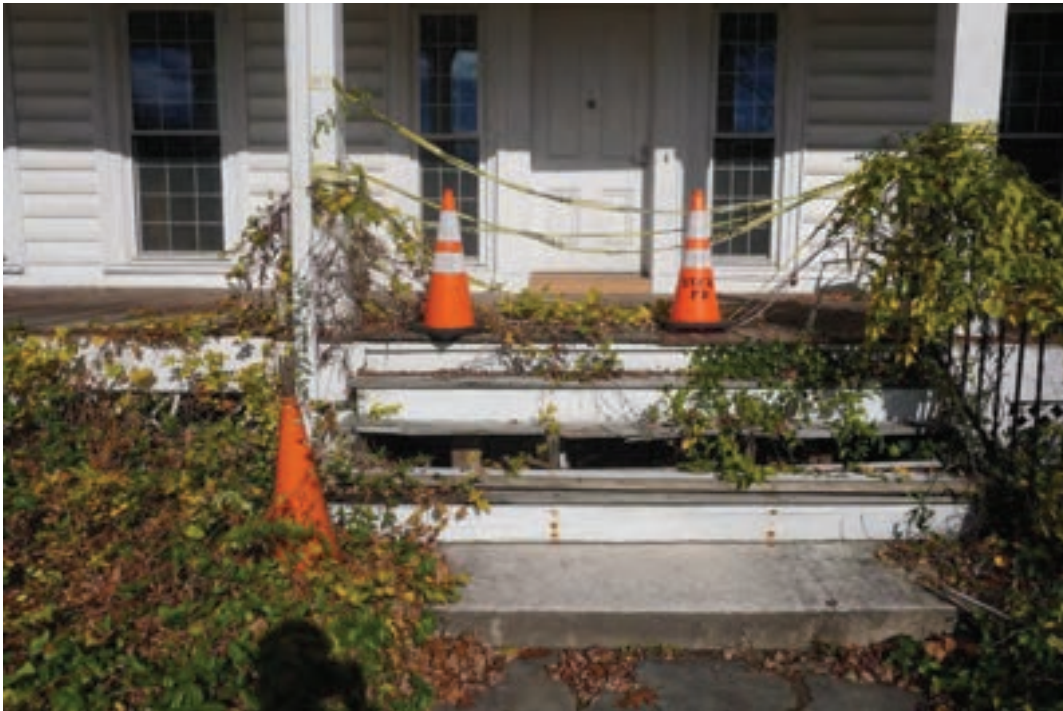
Photo #35: Rear porch stairs deteriorated. No longer usable. Unsafe condition. agree; porches and exterior wood steps need periodic TLC!

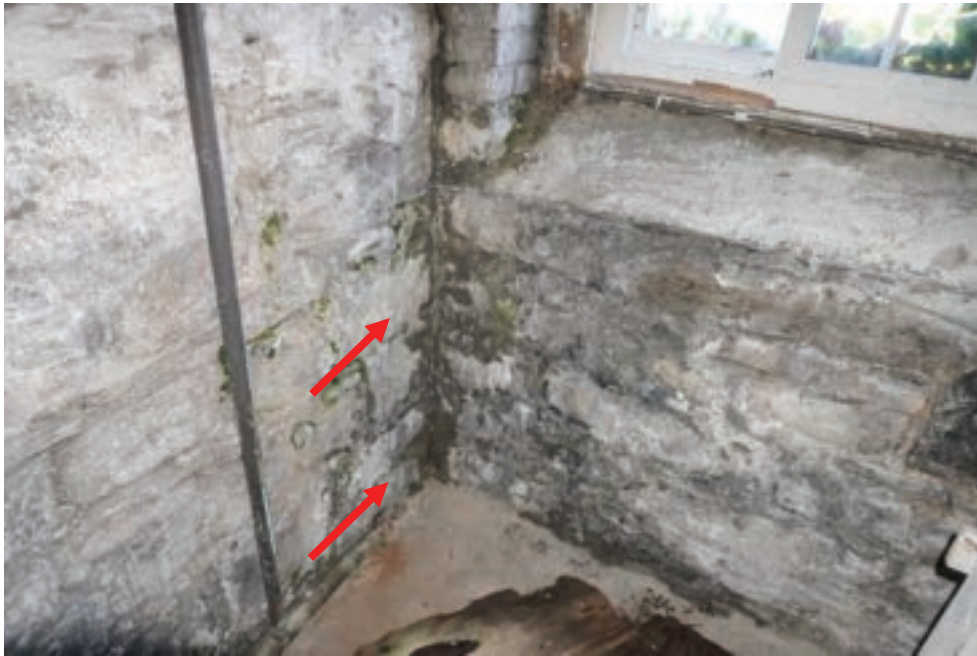
17. Water intrusion foundation wall, northeast corner of home at extension (Photo #36).
18. Water intrusion foundation, south wall of home at extension (Photo #37).

Photo #36: Water intrusion foundation wall, northeast corner of home at extension. for better or worse a feature of historic rubble stone walls; as mentioned earlier, try to send exterior water away from the building; nothing here of serious concern

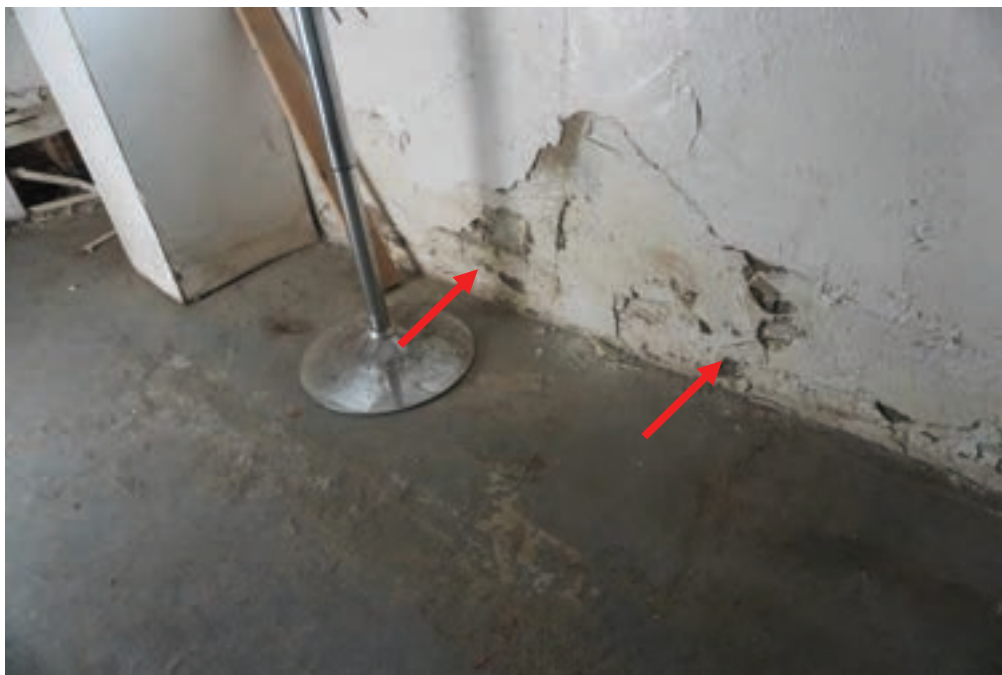
Photo #37: Water intrusion foundation, south wall of home at extension.

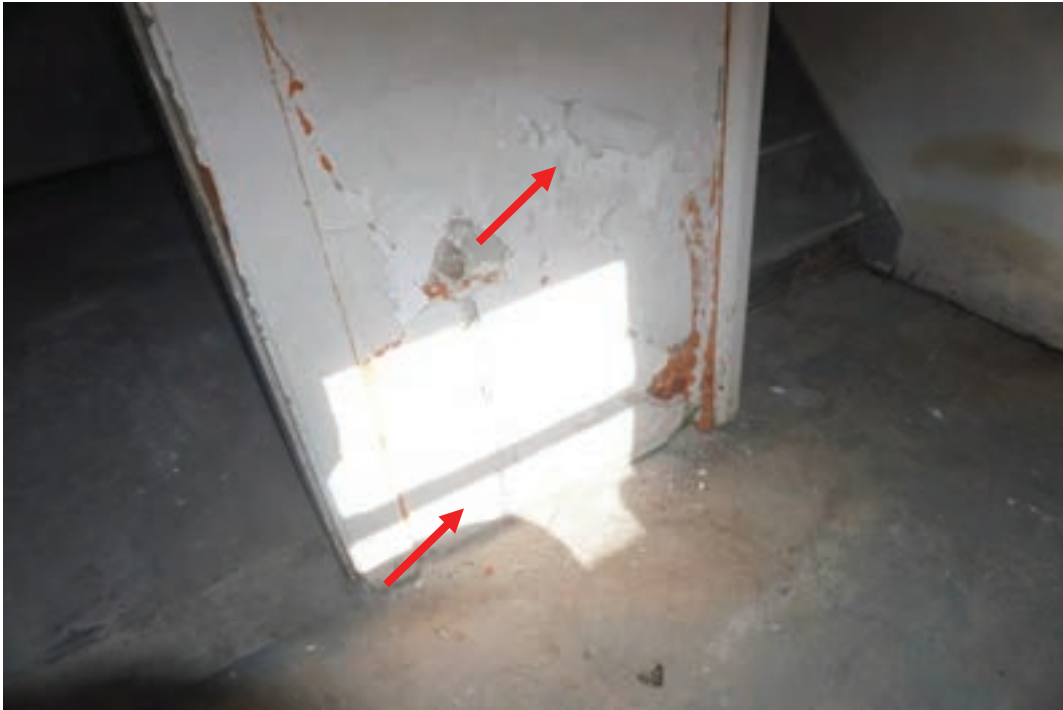
19. Mold formation and deteriorating damp plaster interior walls at cellar level due to water wicking up through cellar floor (Photo #38 & #39).
20. Water infiltration around cellar window, north façade of home at window well (Photo #40).

Photo #38: Mold formation and deteriorating damp plaster interior walls at cellar level due to water wicking up through cellar floor.

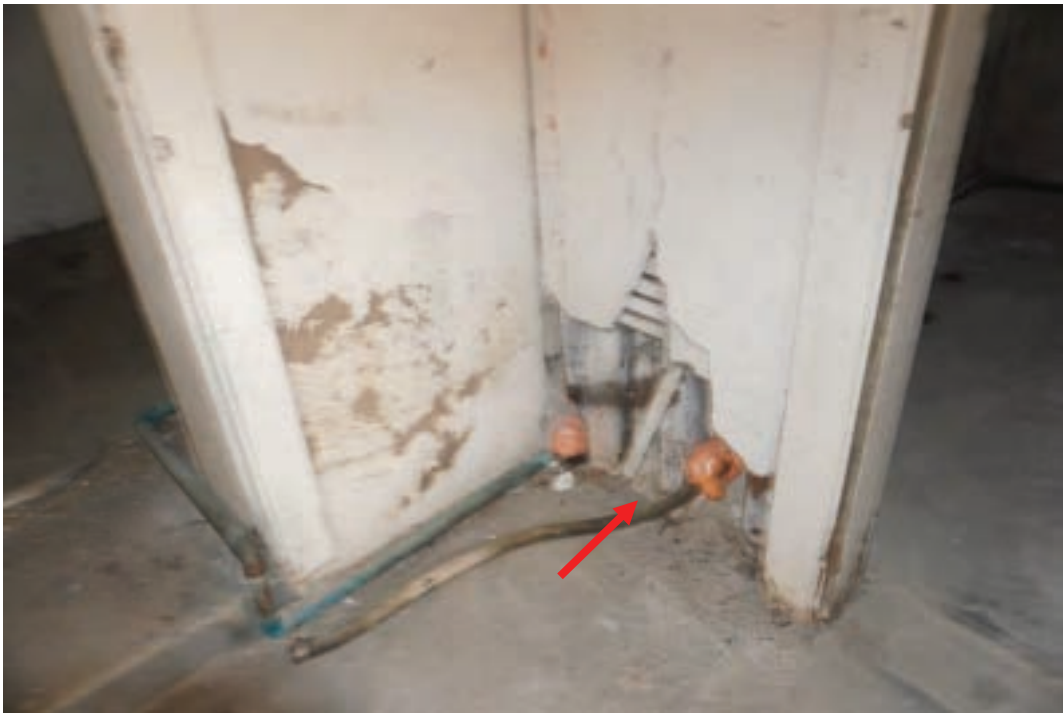
Photo #39: Mold formation and deteriorating damp plaster interior walls at cellar level due to water wicking up through cellar floor.

efflorescence is due to common salt migration; easily repaired

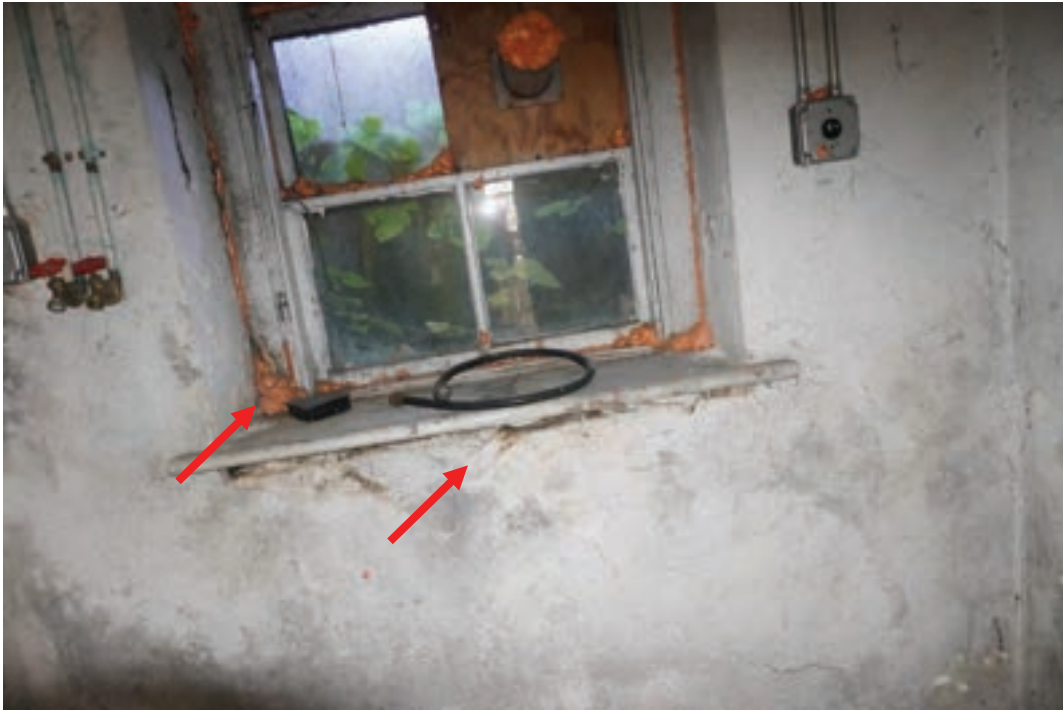
Photo #40: Water infiltration around cellar window, north façade of home at window well.
maintain exterior; clear window well of organics

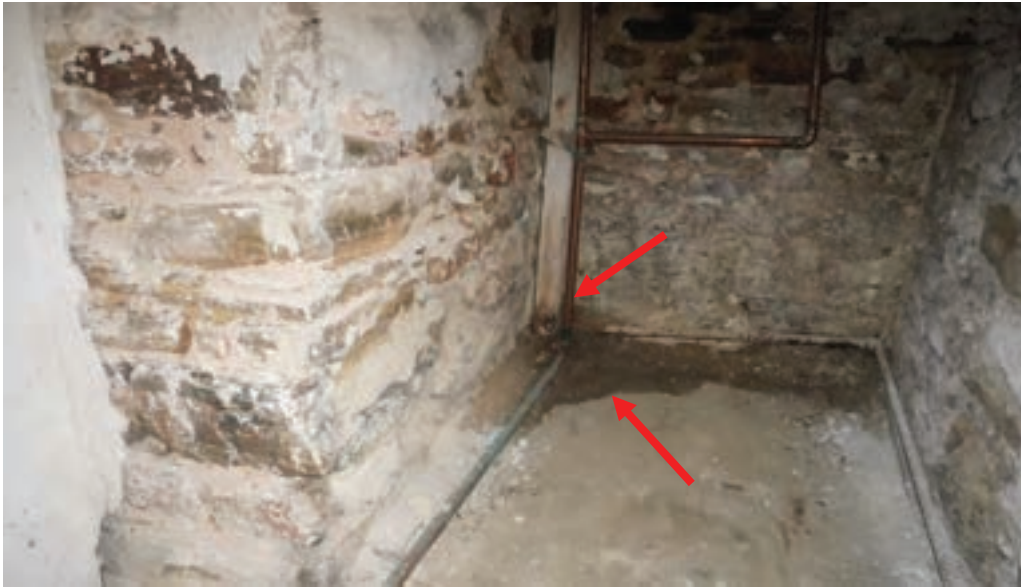
21. Horizontal crack has formed in concrete window well, north façade (Photo #41).
22. Water infiltration at base of inner, original foundation wall. Water is rotting base of wood support post. Crawlspace that spans the front side of the home is located on the other side of this wall (Photo #42).

Photo #42: Water infiltration at base of inner, original foundation wall. Water is rotting base of wood support post. Crawlspace that spans the front side of the home is located on the other side of this wall.

common basement condition; use PT in these locations

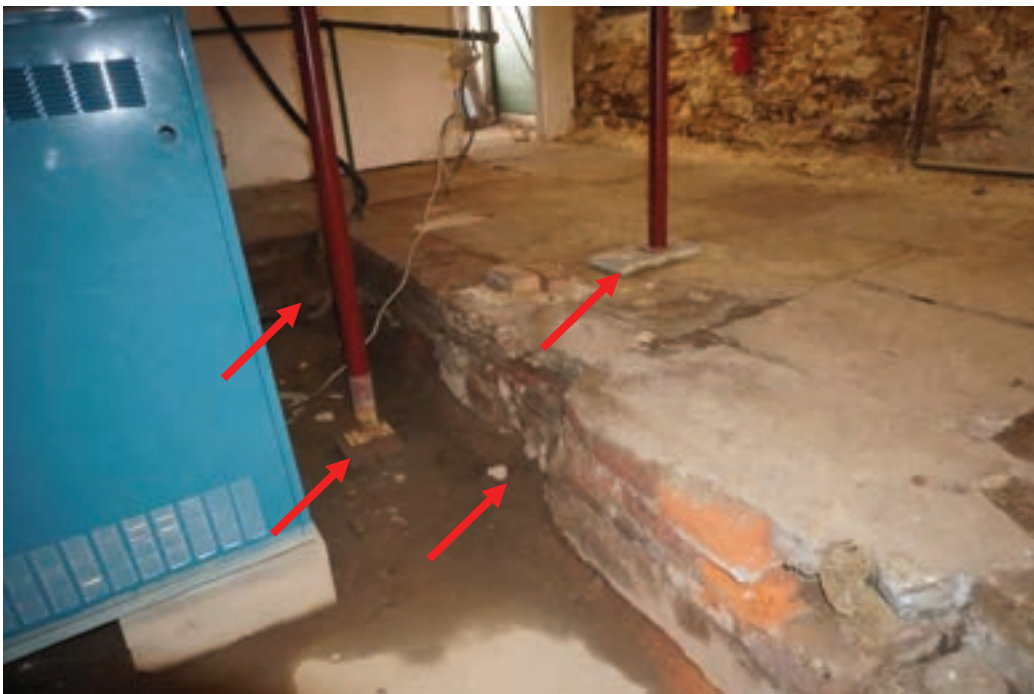
23. Water infiltration through foundation floor around perimeter of boiler pit (Photo #43).
24. Concrete footings were never poured beneath temporary support columns that were added to prop of failing girder in boiler room (Photo #43).

Photo #43: Water infiltration through foundation floor around perimeter of boiler pit. Concrete footings were never poured beneath temporary support columns that were added to prop up both failing girders in the cellar.

need to see girder to determine if "failing" or "deflecting" is the right term, but not a bad idea to provide 2 x 2 footings and address water entry if possible.

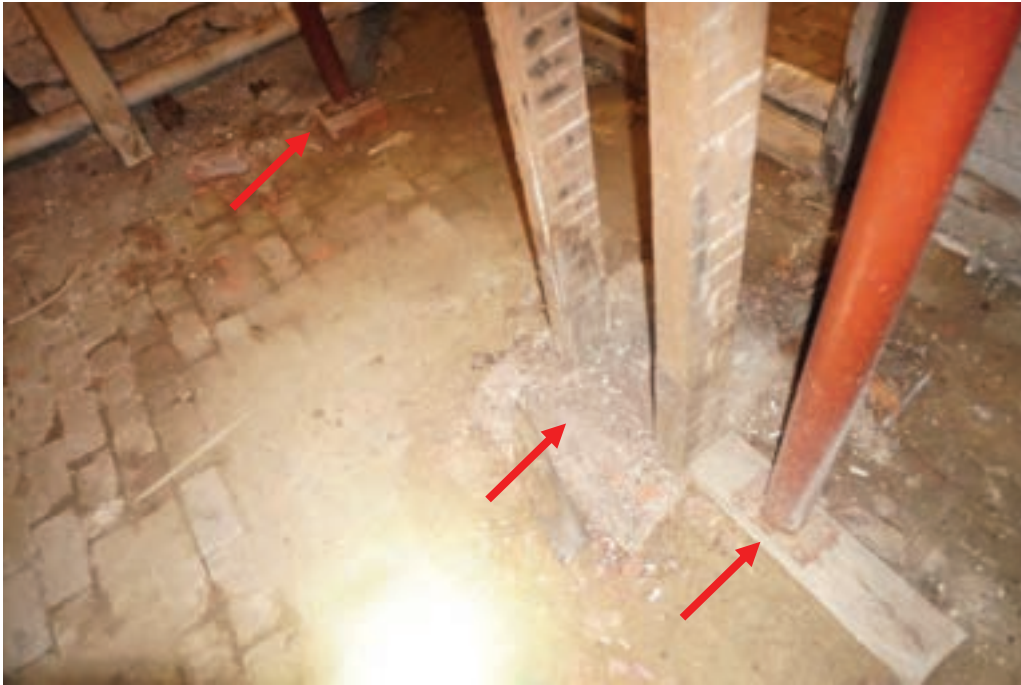
25. Concrete footings were never poured beneath temporary support columns that were added to prop of failing girder in west end of cellar (Photo #44).
26. Cellar floor observed to be composed of bricks with a cement stucco layer that is deteriorating (Photo #45).

Photo #44: Concrete footings were never poured beneath temporary support columns that were added to prop of both failing girders in the cellar.

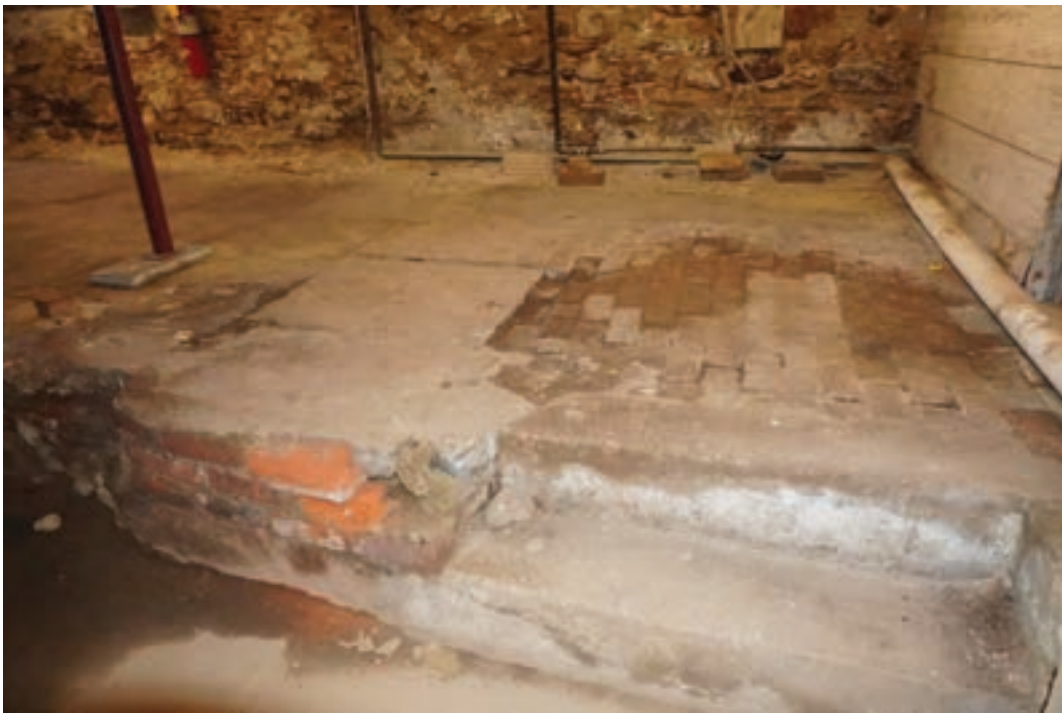
Photo #45: Cellar floor observed to be composed of bricks with a cement stucco layer that is deteriorating.

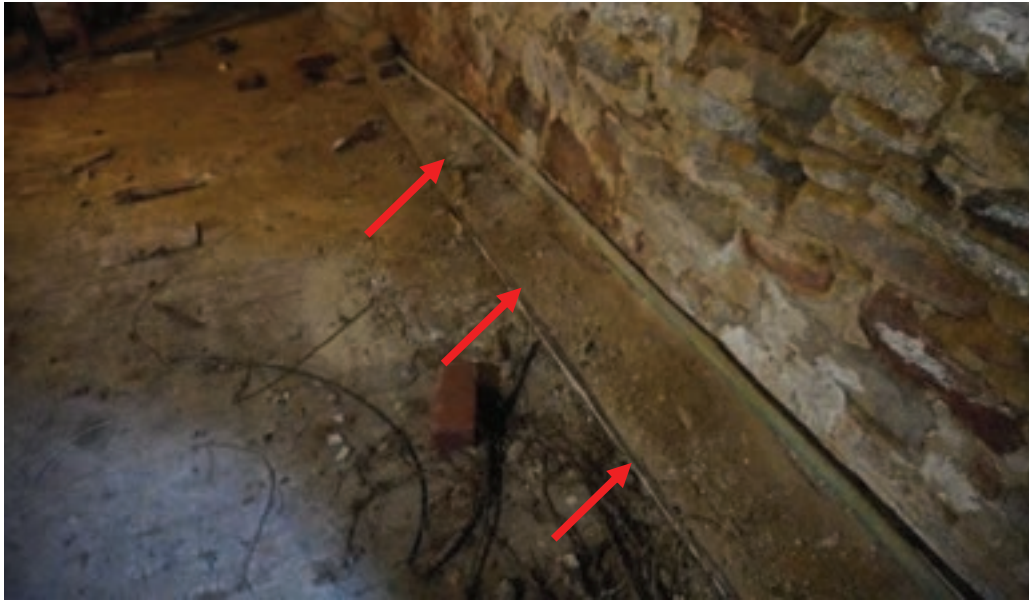
27. Water infiltrating through foundation is bringing in soil through spaces between dry laid rubble stone walls. Soil piling along inside of foundation walls (Photo #46 & #47).

Photo #46: Water infiltrating through foundation is bringing in soil through spaces between dry laid rubble stone walls. Soil piling along inside of foundation walls.
