**Re: *Biggest Fish Westchester LLC*
§11A-9 Economic Hardship Request (Certificate of Appropriateness)
*230 White Plains Road - Section 31. Block 3 Lot 13 ("Property")***

Property Location:	230 White Plains Road Tuckahoe, NY 10707
Inspection Dates:	Initial Inspection: 9/23/22 In Depth Inspection: 11/14/22 Probe Inspection: 12/13/22
Report Date:	1/28/23
Report By:	Peter Panagopoulos, P.E. <i>Principal</i> Pantec Engineering
Appendices:	Appendix A – Photos Appendix B – Probe Locations Appendix C – Structural Layout Appendix D – Deficiency Location Diagram Appendix E - Two Inner Chimney Georgia Colonial Layout

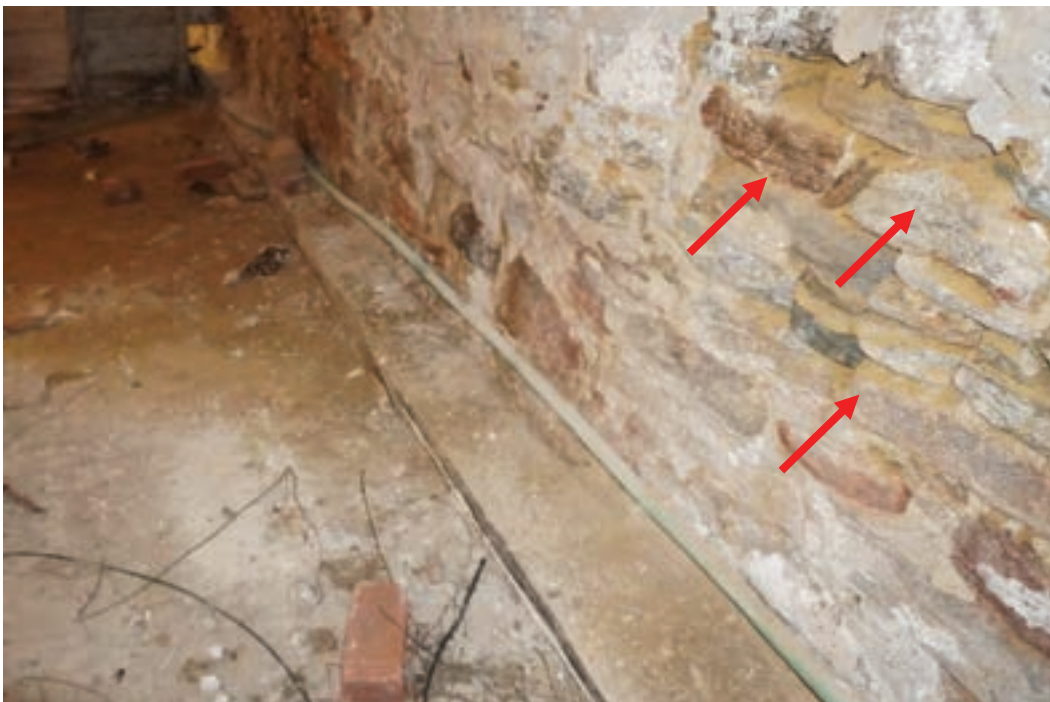
27. Water infiltrating through foundation is bringing in soil through spaces between dry laid rubble stone walls. Soil piling along inside of foundation walls (Photo #46 & #47).

Photo #47: Water infiltrating through foundation is bringing in soil through spaces between dry laid rubble stone walls. Soil piling along inside of foundation walls.

again these are all common in rubble stone basements and crawl spaces and exterior water should be directed away from the building. This is not a failure however.

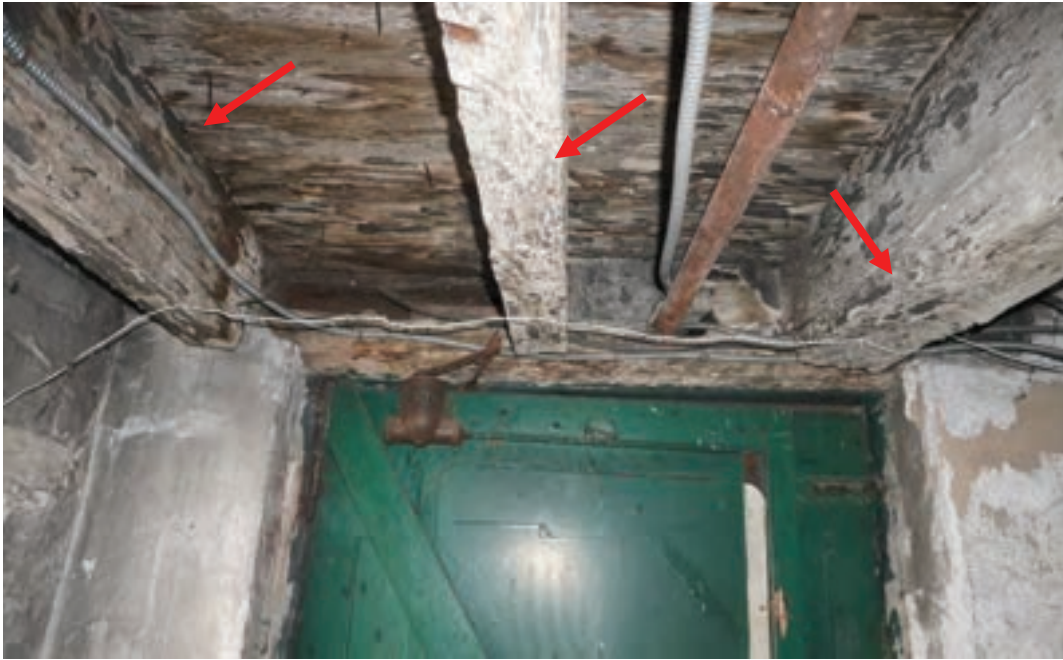
- b) A large 6"x9-1/4" beam was observed in basement, and it is unclear why it is sized larger than the other floor joists (Photo #48).
- c) Ceiling soffit contains a support beam that runs east to west below the exterior spandrel beam that runs north to south. Beam running east to west supports joists above at midspan. This is an atypical configuration that was most likely a modification done when chimney was moved and not part of the original timber framing design (Probe #2) (Photo #81 & 82).

Photo #48: Two 10x3 beams spaced 16 inches apart on left are spanning 19 feet. The reason 6"x9-1/4" beam on right is sized larger than other joists is unclear. It is uncommon for such a large member to be sitting on a door header.

we see these conditions frequently including the reuse of beams from nearby barns

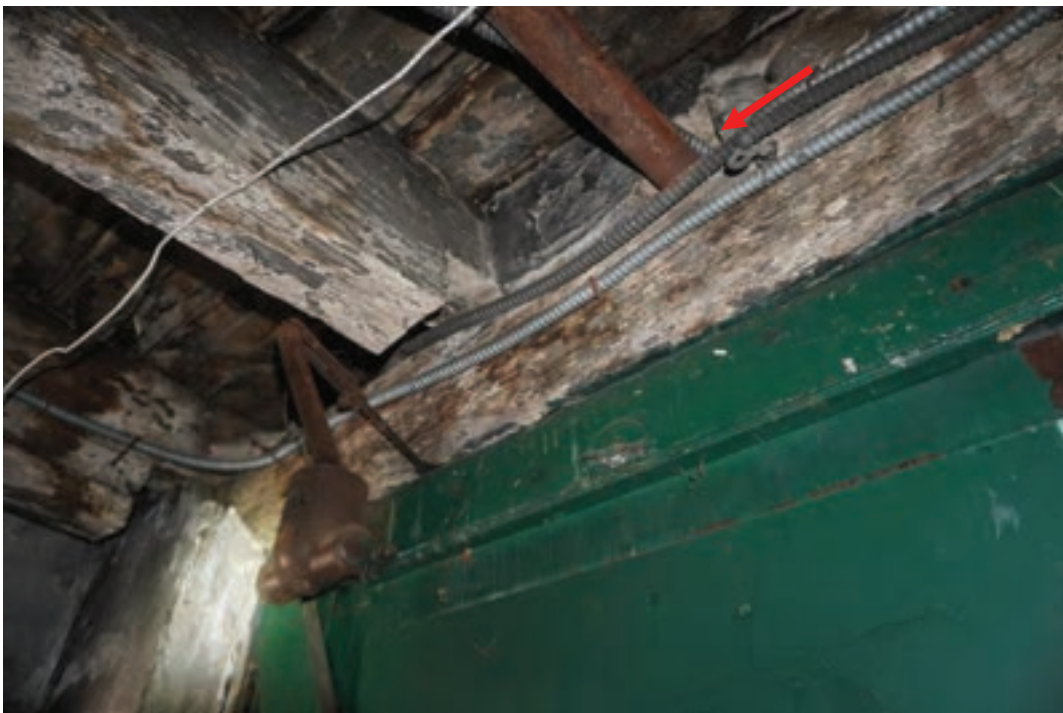
28. Pipe penetration drilled through door header leading out to rear yard (Photo #49).
29. Horizontal crack from shear stress resonating down entire member from notch at end of beam (Photo #50 & #51).

Photo #49: Pipe penetration drilled through door header leading out to rear yard.

plumbers are the enemies of structure; we have seen examples holes chiseled by hand through main beams; through the middle is better than notched top or bottom!

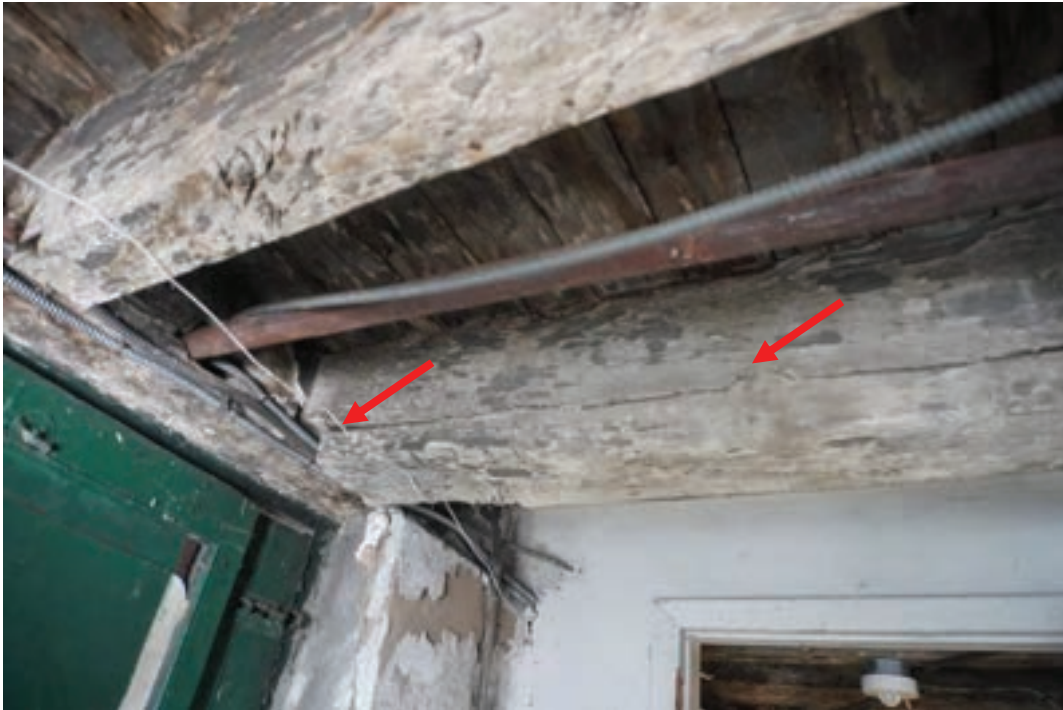
Photo #50: Horizontal crack from shear stress resonating down entire member from notch at end of beam.

need to visit to see if it is a stress crack or check; does not appear to be failing or opening up further at bearing point; a repair is not difficult since the member is exposed

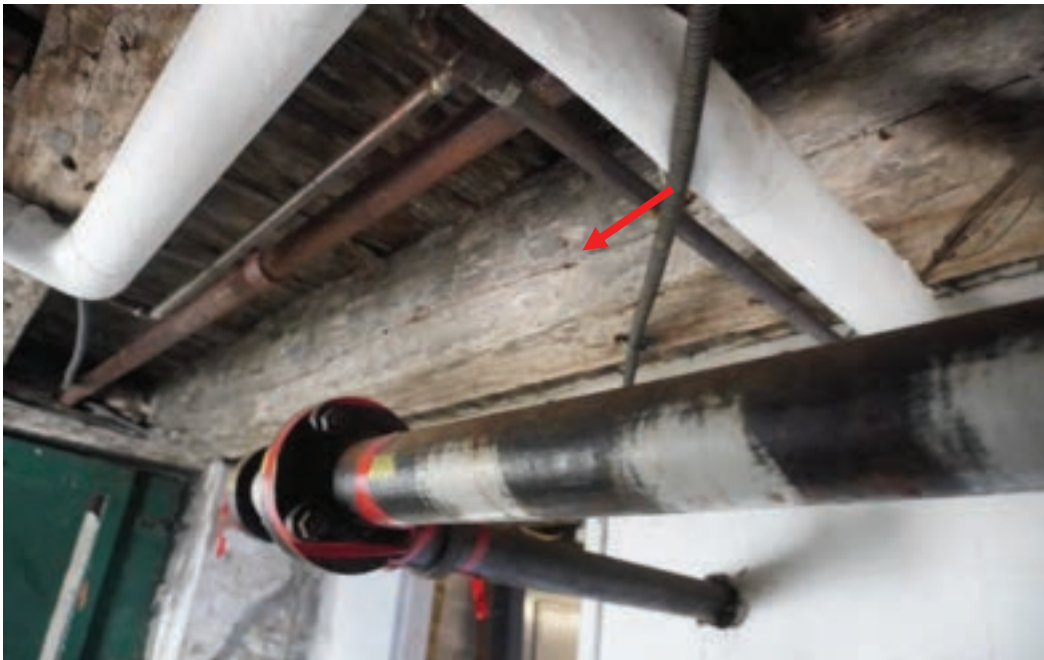
Photo #51: Horizontal crack from shear stress resonating down entire member from notch at end of beam.

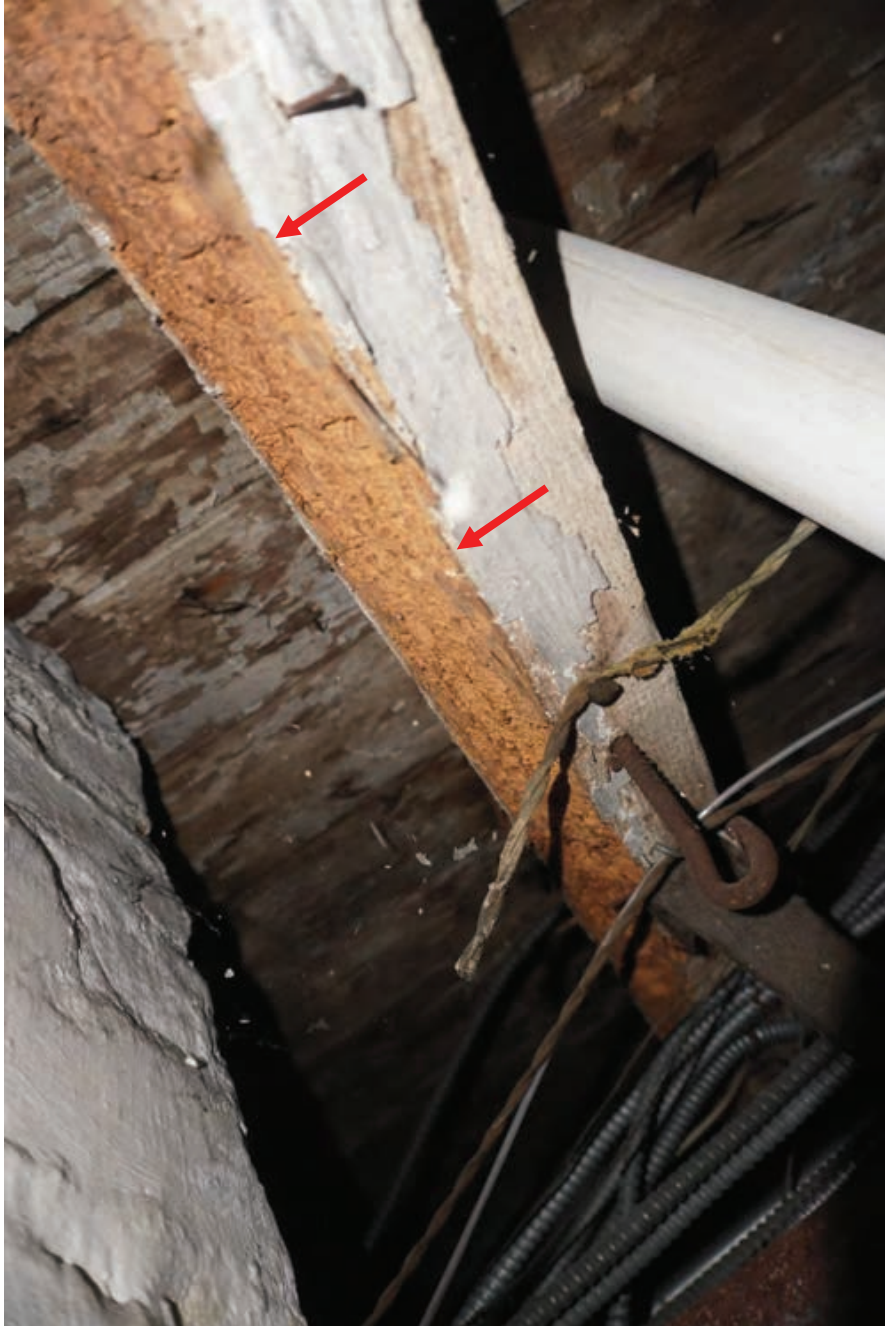
30. Wood joist observed to have a large extent of termite damage (Photo #52).
31. Joists connections in crawlspace observed to be coming apart. Piping was run into crawlspace through what potentially was an old window in original foundation wall (Photo #53).

Photo #52: Wood joist observed to have a large extent of termite damage.

treat if active otherwise test drill to see viable section--no failure visible

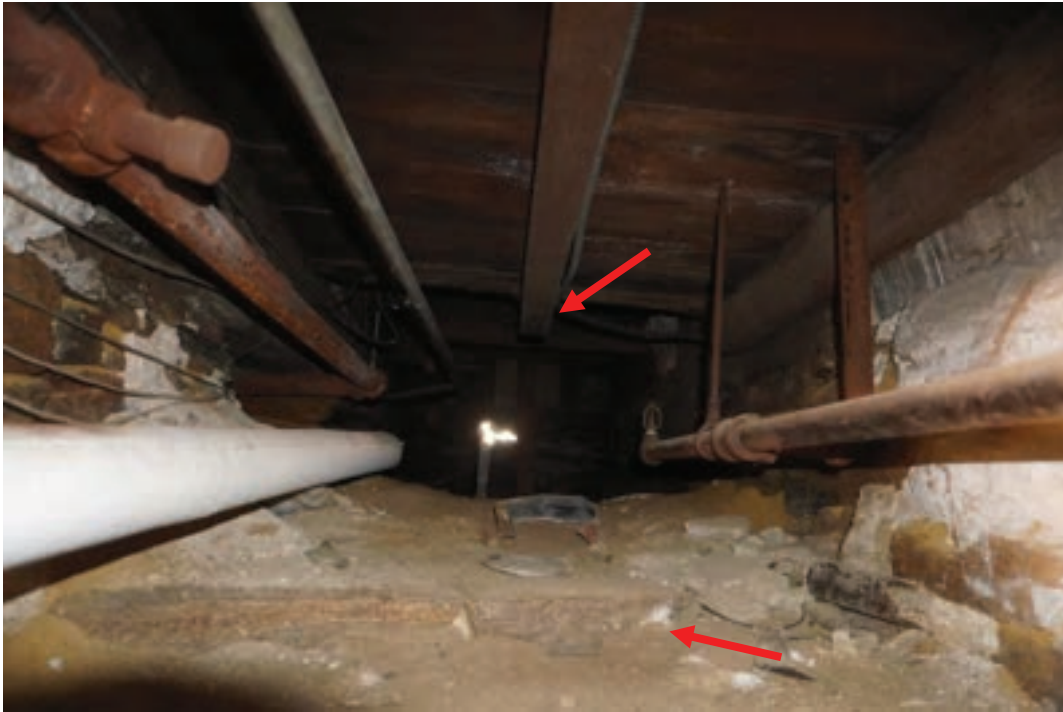
Photo #53: Joists connections in crawlspace observed to be coming apart. Piping was run into crawlspace through what potentially was an old window in original foundation wall.

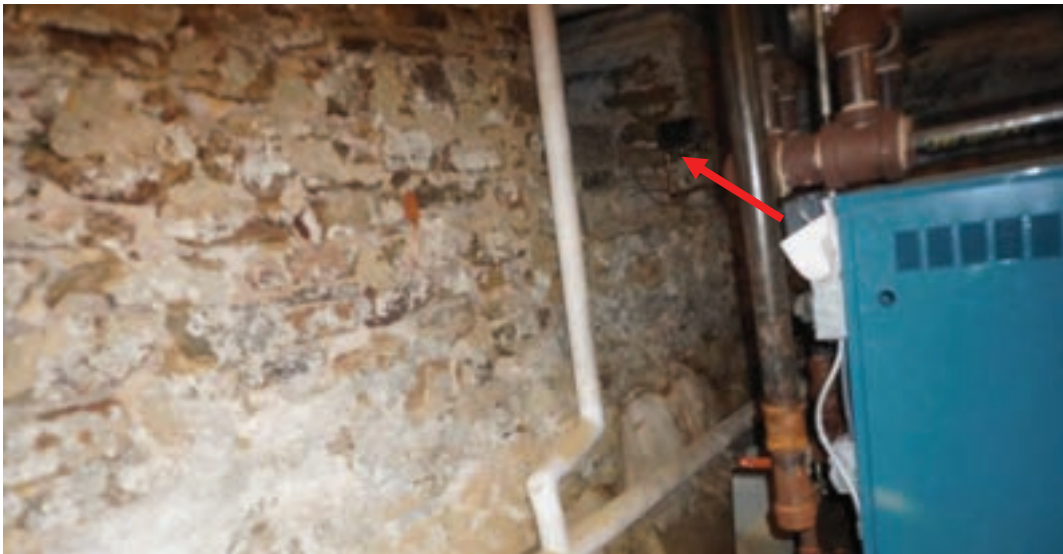
Photo #54: Piping was run into crawlspace through what potentially was an old window in original foundation wall.

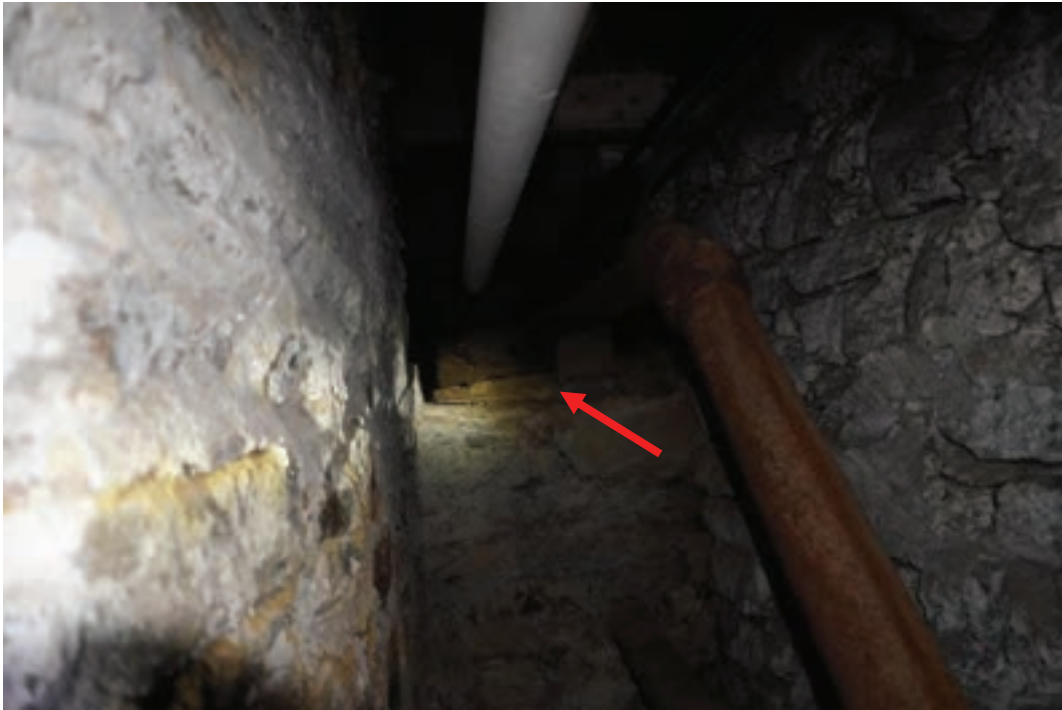
Photo #55: Piping was run into crawlspace through what potentially was an old window (second location) in original foundation wall.

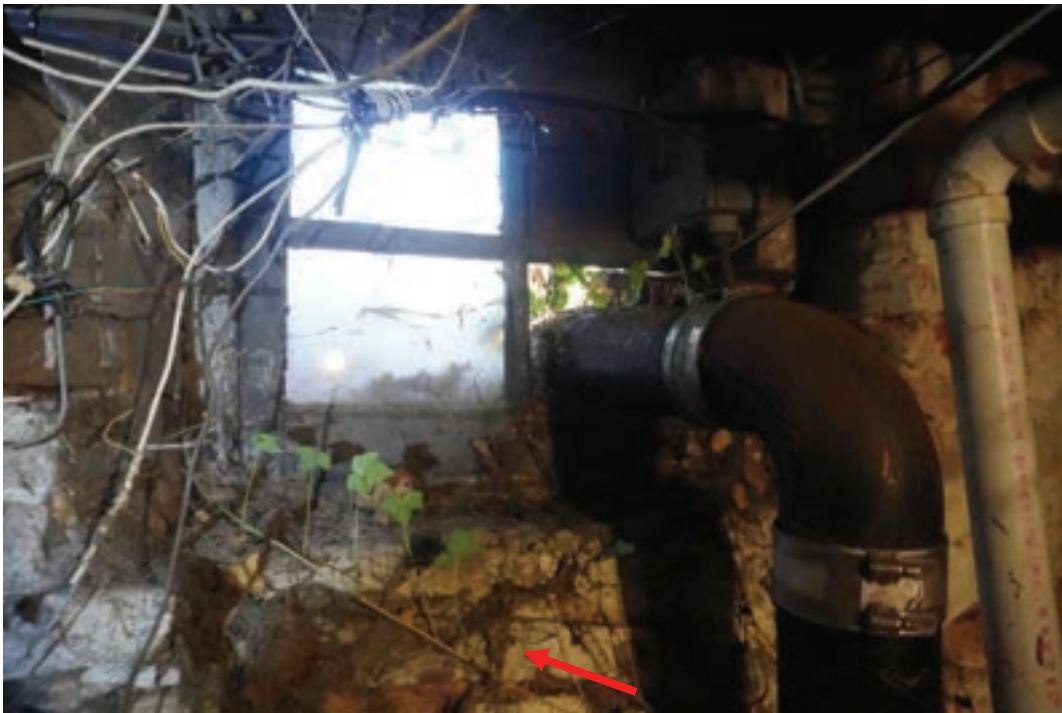
32. Dirt and soil infiltrating around window in cellar at west foundation wall (Photo #56).
33. Temporary support column being used to hold failing 9-1/2"x9-1/4" girder in boiler room. Column not mechanically attached to girder above (Photo #59).

Photo #56: Dirt and soil infiltrating around window in cellar at west foundation wall.

looks messy but again can be readily cleaned up; not a failure

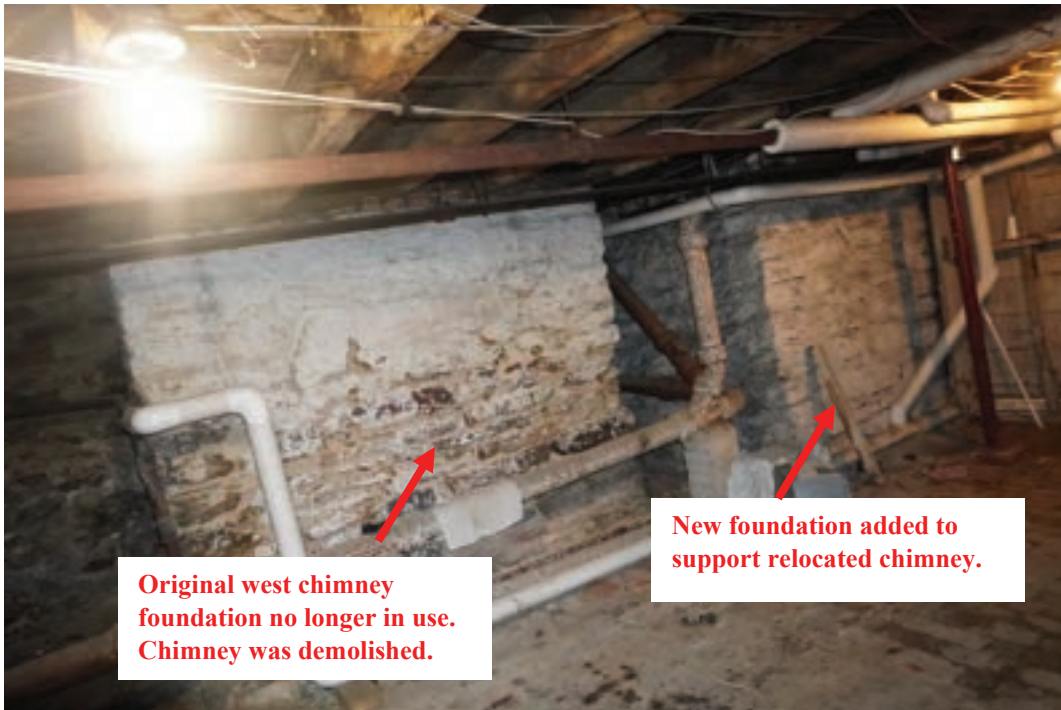
Original west chimney foundation no longer in use. Chimney was demolished.

New foundation added to support relocated chimney.

Photo #57: Original west chimney was relocated at some unknown time in the past.
interesting...

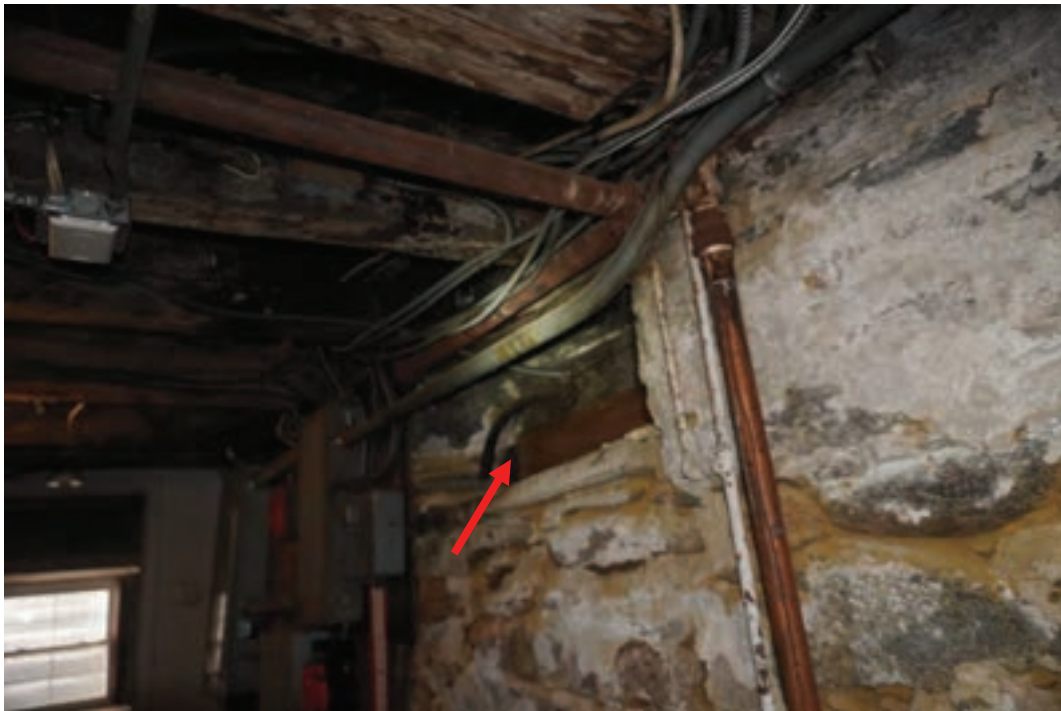
Photo #58: Cellar window at boiler room south foundation wall has been covered up when porch was added to the rear of the home.

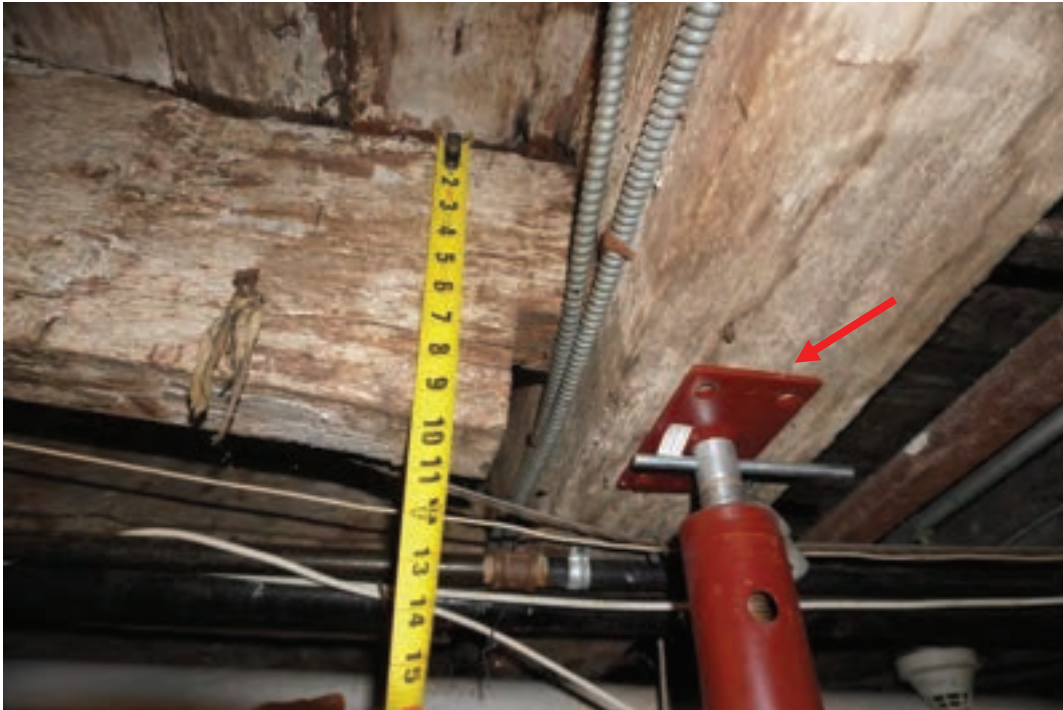
Photo #59: Temporary support column being used to hold failing 9-1/2"x9-1/4" girder in boiler room. Column not mechanically attached to girder above and does not have a proper footing. not an uncommon "temporary" repair when certain loads (piano?) are added above or floor feels bouncy. As noted, can be made permanent with designed footing and connection.

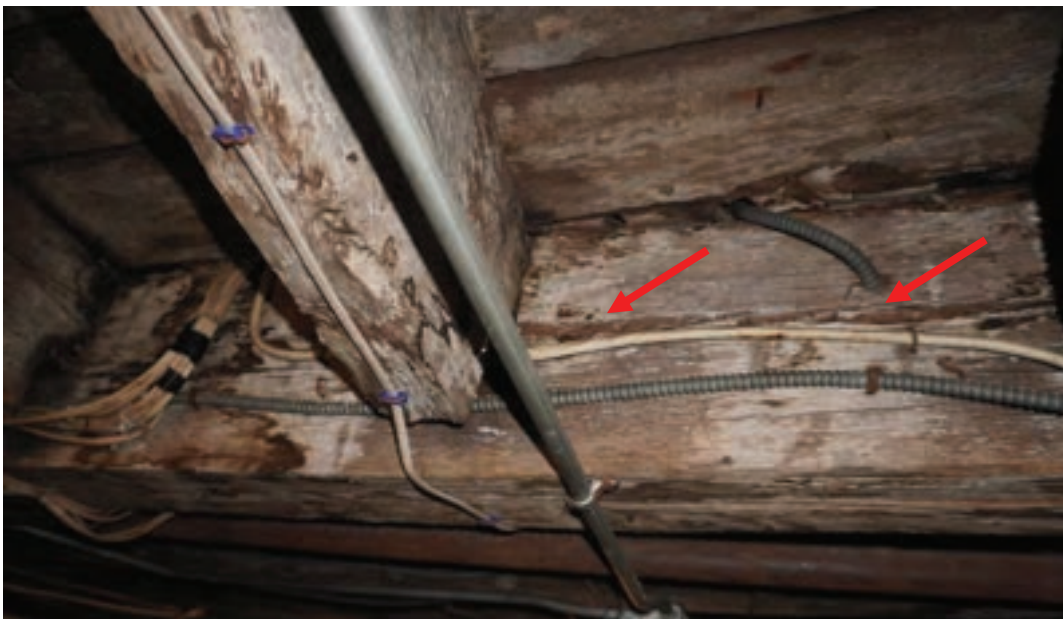
34. Large horizontal crack in 9-1/2"x9-1/4" girder in boiler radiating from mortise-and-tenon joint connections (Photo #60).
35. Wood joist observed to have a large extent of termite damage (Photo #61).

Photo #60: Large horizontal crack in 9-1/2"x9-1/4" girder in boiler radiating from mortise-and-tenon joint connections.

we see these checks and cracks frequently in timber frame buildings since they are a natural feature of large timbers. We only need to address them in certain cases after analysis

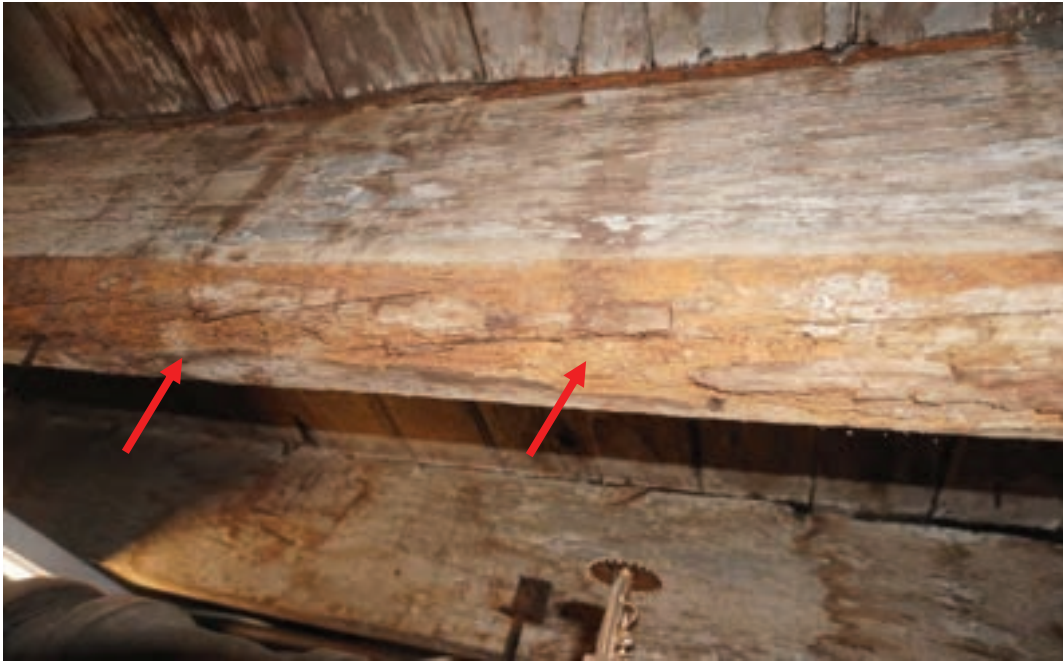
Photo #61: Wood joist observed to have a large extent of termite damage.
need to determine if remaining section in this species meets the load; most members are significantly oversized

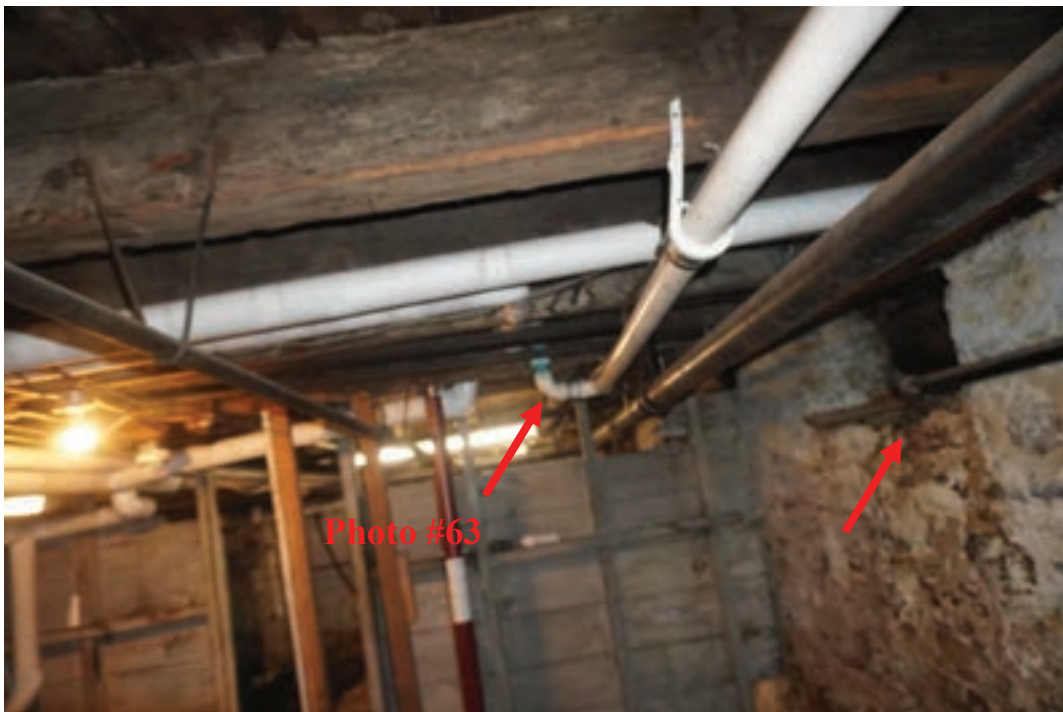
36. Plumbing pipe drilled directly through main girder in the vertical direction, west end of cellar (Photo #62 & 63).

Photo #62: Cellar window (second location) at west end of home on south foundation wall has been covered up when porch was added to the rear of the home. Plumbing pipe drilled directly through main girder in the vertical direction, west end of cellar.

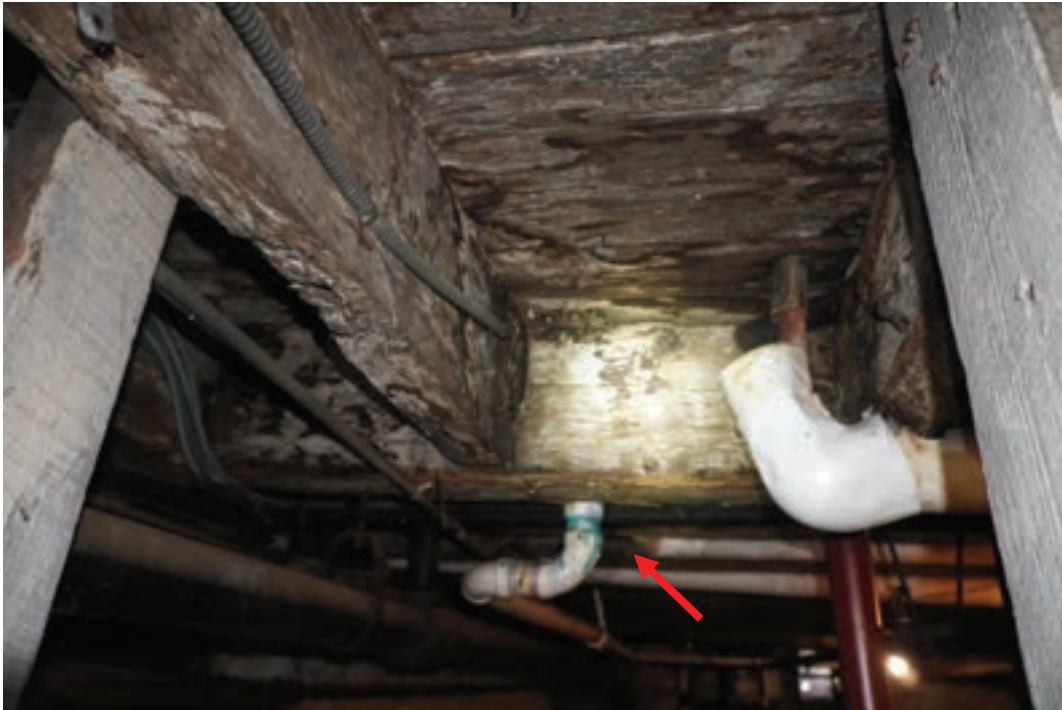
Photo #63: Plumbing pipe drilled directly through main girder in the vertical direction, west end of cellar.
plumbers again; often redundant load paths compensate; does not appear to be movement here.

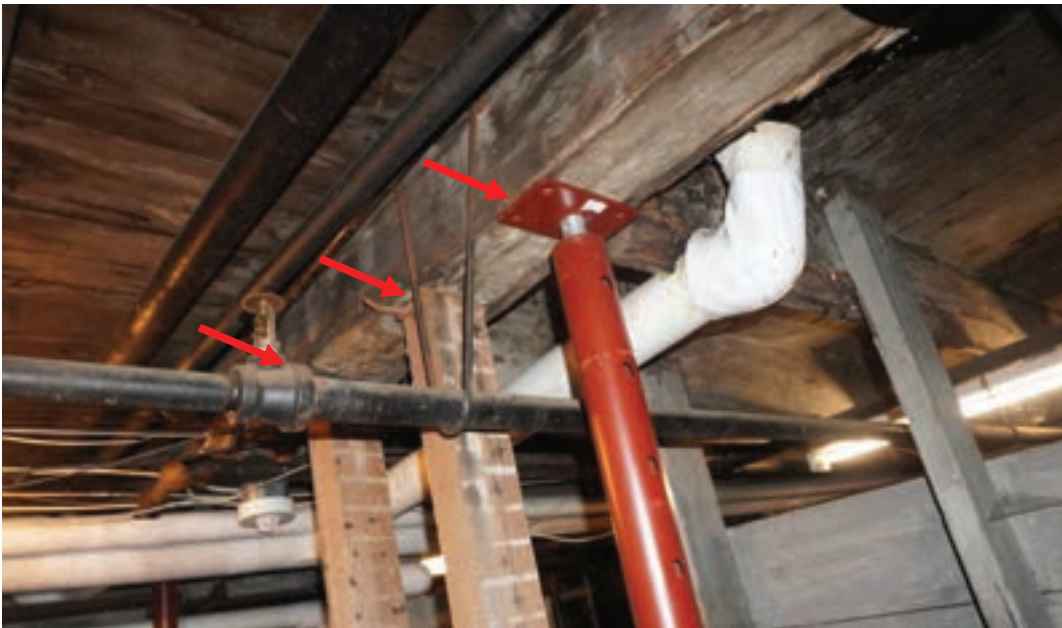
37. Temporary support columns being used to hold failing 6-3/4"x10-1/2" girder in place west end of cellar. Columns are not mechanically (Photo #64).
38. Joist with inadequate support resting on foundation wall that is deteriorated and that has been damaged to make a pipe penetration into crawlspace (Photo #65).

Photo #64: Temporary support columns being used to hold failing 6-3/4"x10-1/2" girder in place west end of cellar. Columns are not mechanically attached to girder above and do not have proper footings.

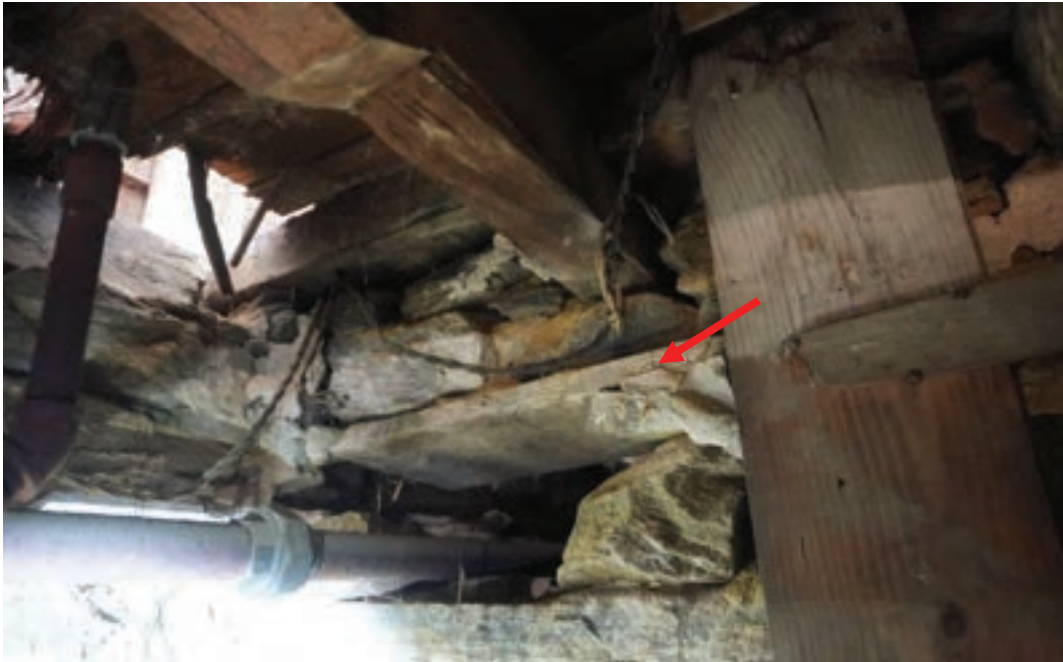
Photo #65: Joist with inadequate support resting on foundation wall that is deteriorated and that has been damaged to make a pipe penetration into crawlspace.

hard to see this; repair can be made if necessary

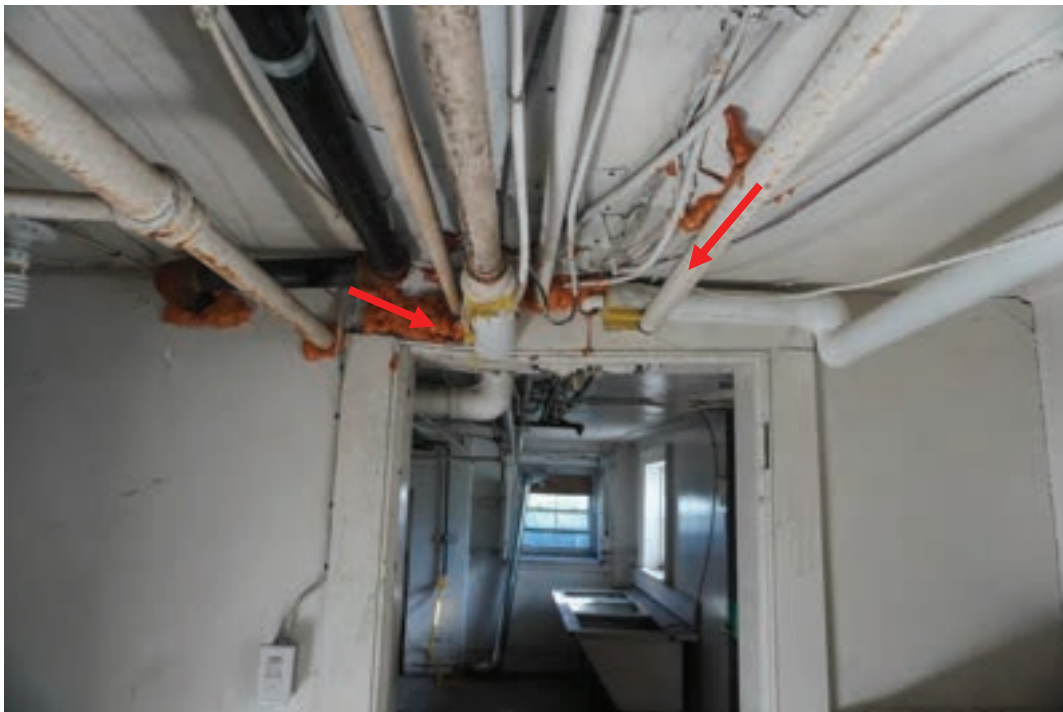
39. Multiple penetrations have been made through a door header that is observed to be failing. There is a wall on the first-floor level directly above this header (Photo #66).

Photo #66: Multiple penetrations have been made through a door header that is observed to be failing. There is a wall on the first-floor level directly above this header.

deflection is noted but beaded trim appears to have been in this condition for a while

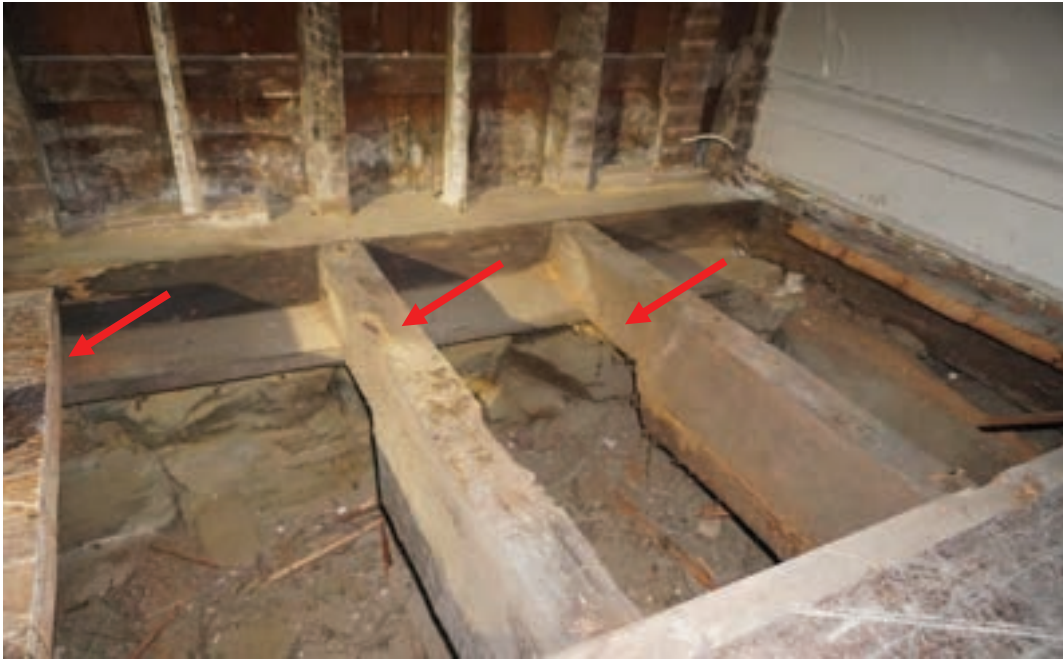
Photo #67: Joists spanning crawlspace sit on a thin sill plate which is not a standard timber framing technique. Typically, wood joists would be notched into the sill beam with use of a mortise and tenon connections (Probe #1).

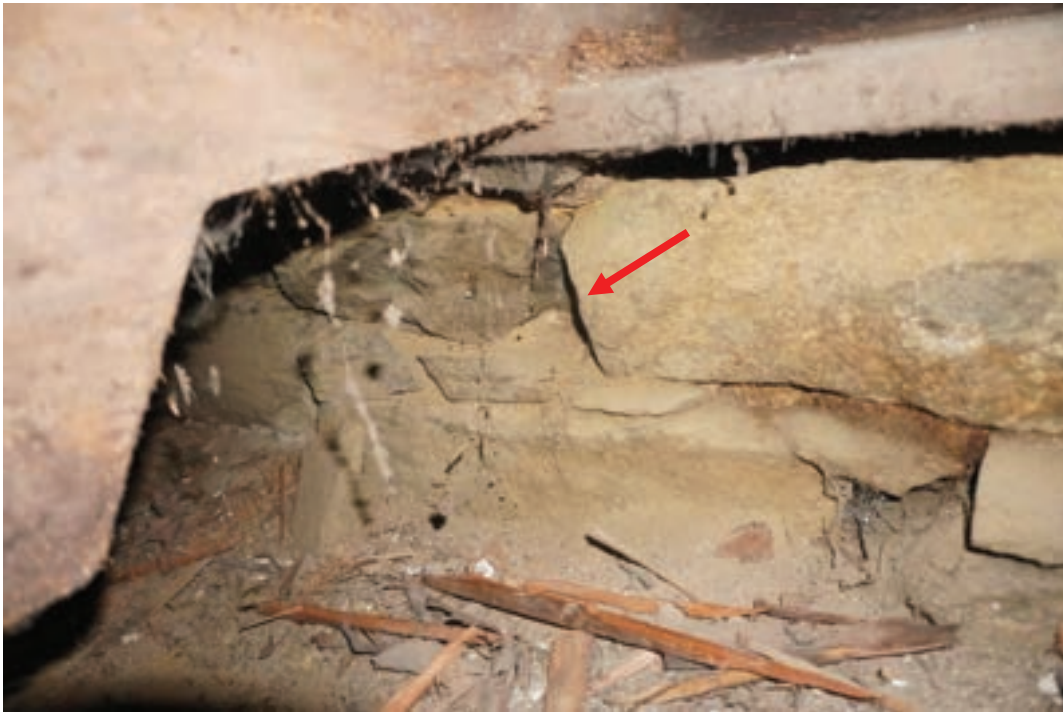
Photo #68: Thin sill plate, joists spanning crawlspace are sitting on, is being supported by a rubble stone foundation wall that is coming apart (Probe #1).

interesting to see this condition; may be a retrofit; we typically add a ground membrane in these locations

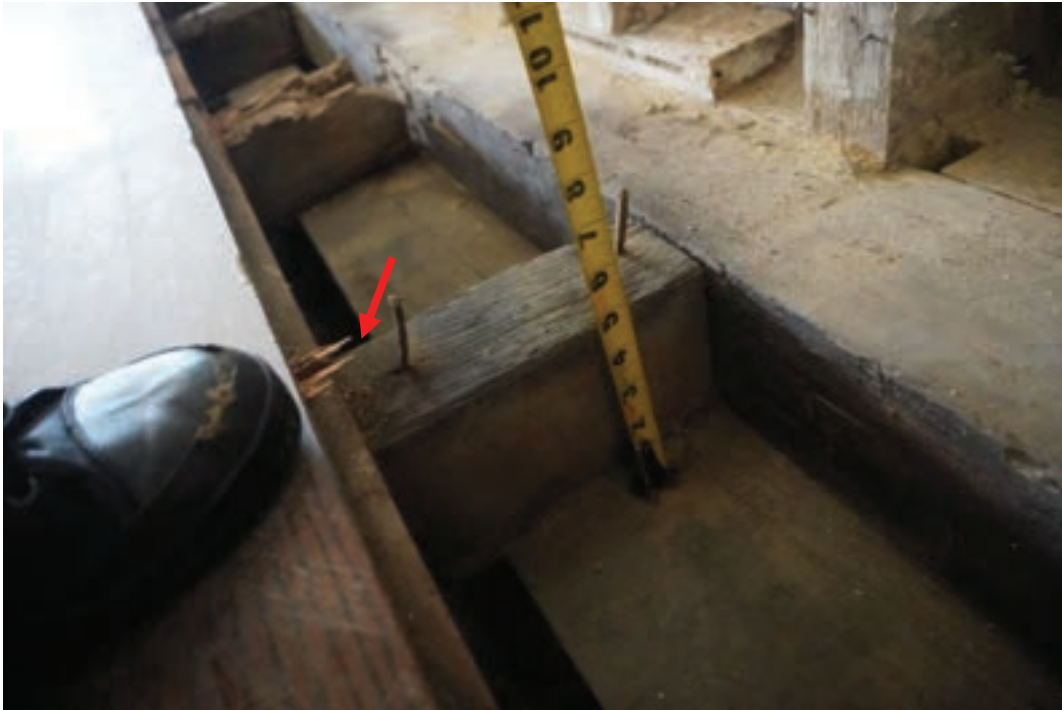
- c) Layouts on all floors of original home have been altered to make bedrooms and to add bathrooms for original structure to be used as a dorm.
- d) Original floorboards above crawlspace have been removed. Photo #69 & Photo #70 show that there is no original wood flooring beneath new wood flooring above crawlspace. New wood flooring observed to be directly attached to joists. Additionally, no original wood flooring was observed anywhere else in the house.

Photo #69: Original floorboards above crawlspace have been removed. New wood flooring directly attached to joists. Crawl space joists sitting on an improperly supported sill plate.

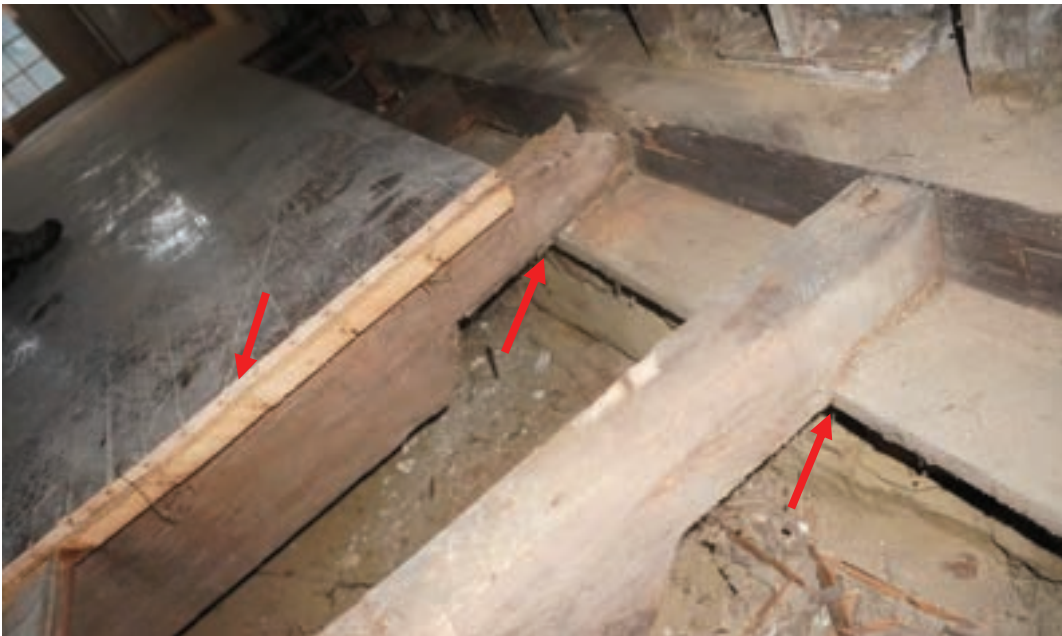
Photo #70: Original floorboards above crawlspace have been removed. New wood flooring directly attached to joists. Crawl space joists sitting on an improperly supported sill plate (Probe#1).

exposure allows repairs to be effected if needed

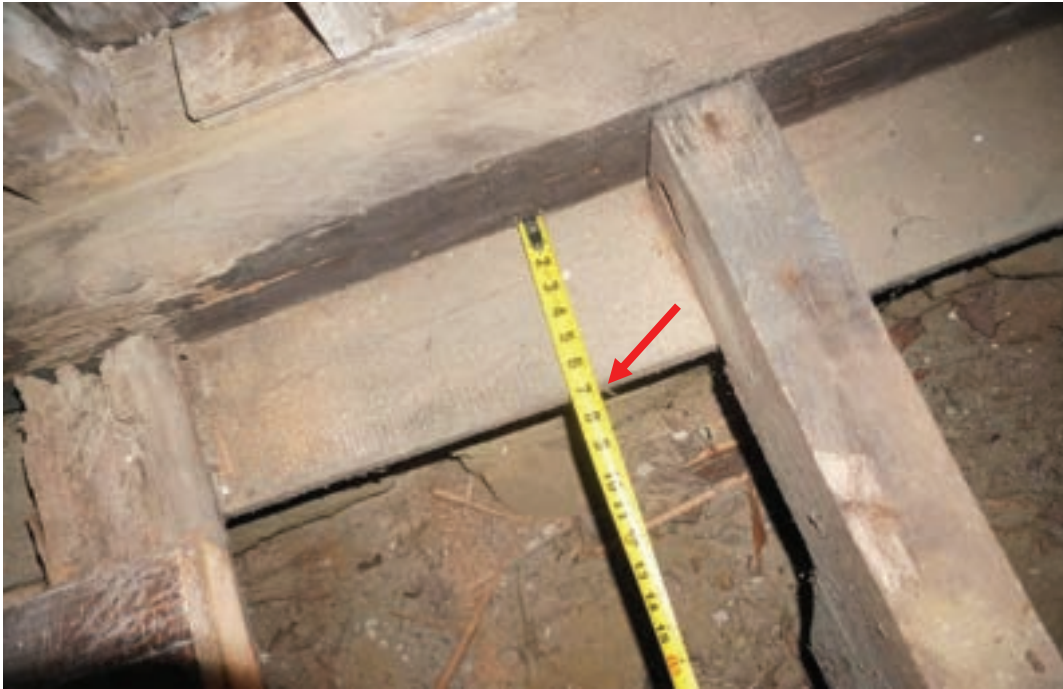
40. Crawl space joists sit on a 7-inch sill plate that is only bearing 3 inches onto deteriorating foundation wall below. Sill plate has a four-inch unsupported overhang (Probe #1) (Photo #67 - #72).

Photo #71: Crawl space joists sit on a 7-inch sill plate that is only bearing 3 inches onto deteriorating foundation wall below. Sill plate has a four-inch unsupported overhang (Probe #1).

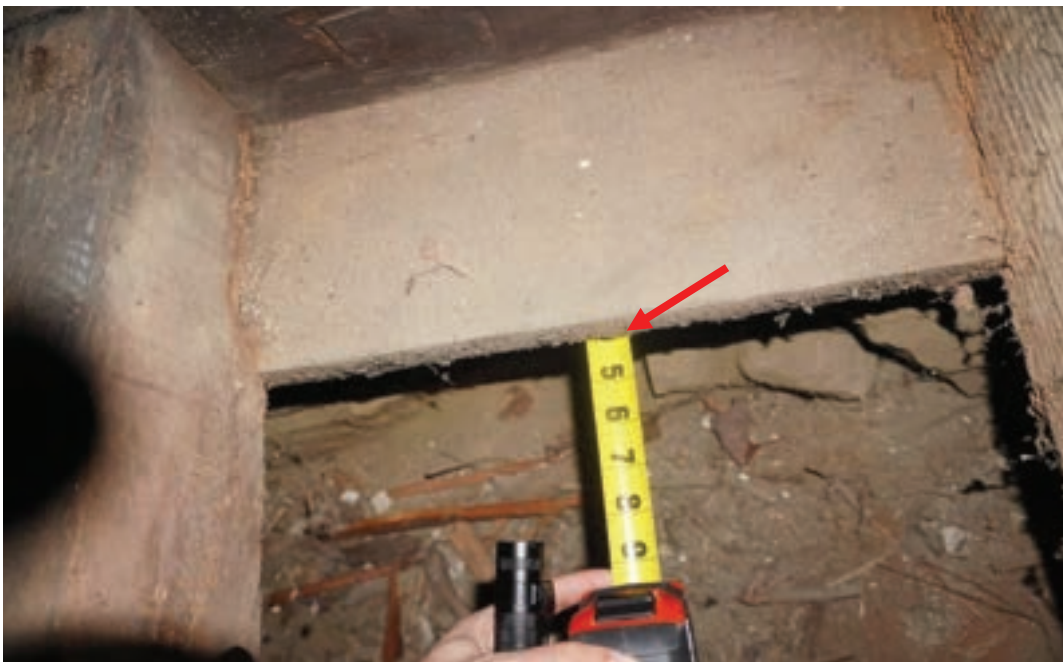
Photo #72: Crawl space joists sit on a 7-inch sill plate that is only bearing 3 inches onto deteriorating foundation below. Sill plate has a four-inch unsupported overhang (Probe #1).

informal foundations are common; if repairs are necessary a variety of techniques including grout injection are available

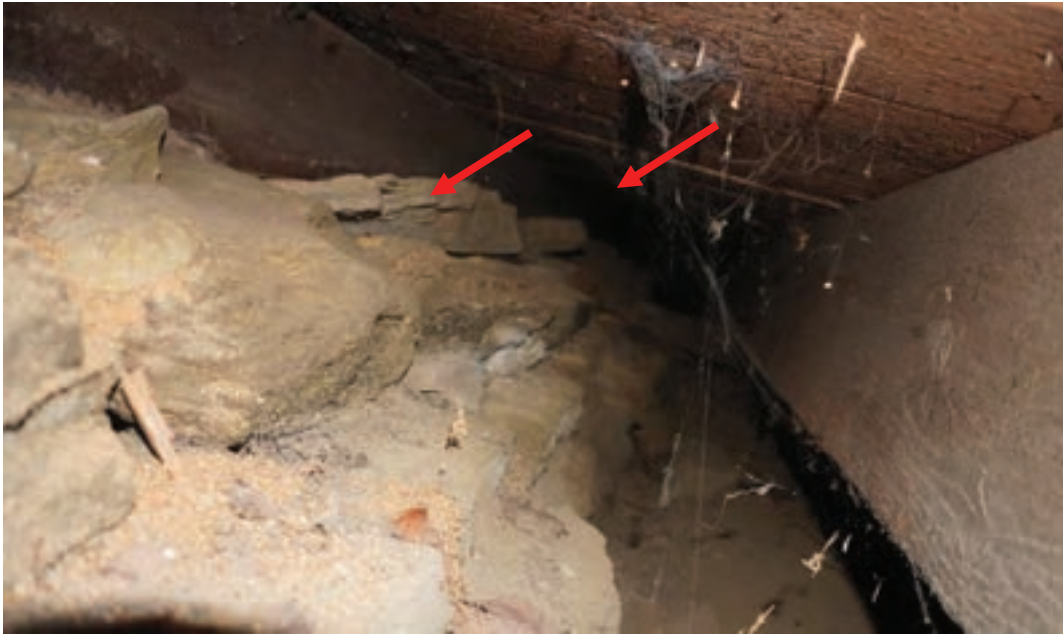
41. Exterior foundation along north side of home below sill beam is deteriorating and observed to have displaced (Probe #1) (Photo #73).
42. Wood joists spanning crawl space are being inadequately supported at midspans by wood members that are balanced above unstable pieces of stone (Probe #1) (Photo #75).

Photo #73: Exterior foundation along north side of home below sill beam is deteriorating and observed to have displaced. (Probe #1)
