**Re: *Biggest Fish Westchester LLC*
§11A-9 Economic Hardship Request (Certificate of Appropriateness)
*230 White Plains Road - Section 31. Block 3 Lot 13 ("Property")***

Property Location:	230 White Plains Road Tuckahoe, NY 10707
Inspection Dates:	Initial Inspection: 9/23/22 In Depth Inspection: 11/14/22 Probe Inspection: 12/13/22
Report Date:	1/28/23
Report By:	Peter Panagopoulos, P.E. <i>Principal</i> Pantec Engineering
Appendices:	Appendix A – Photos Appendix B – Probe Locations Appendix C – Structural Layout Appendix D – Deficiency Location Diagram Appendix E - Two Inner Chimney Georgia Colonial Layout

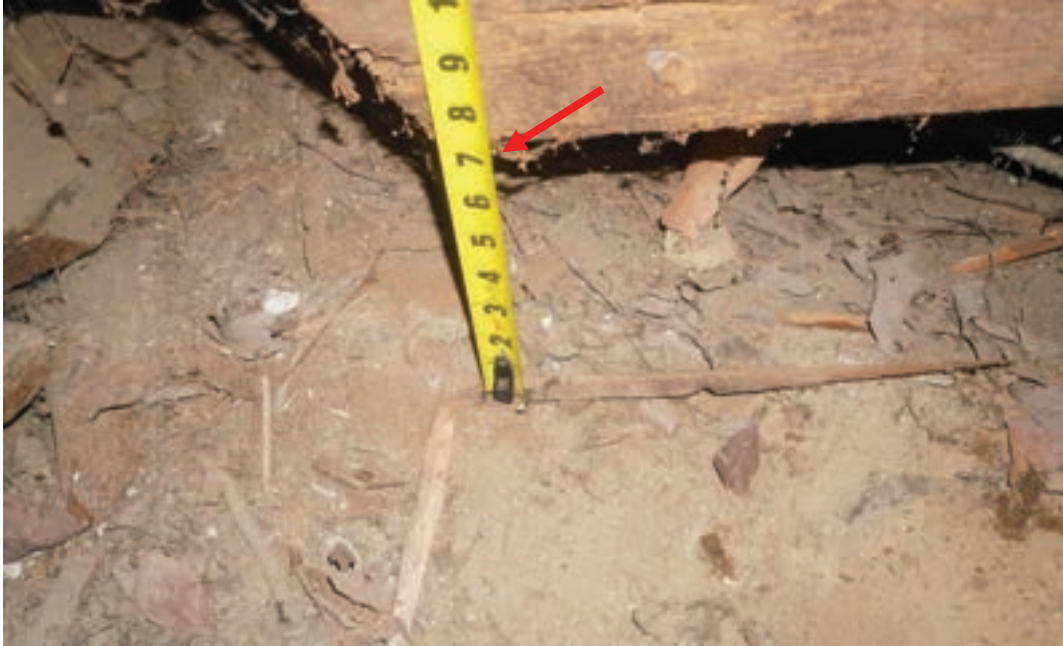
Photo #74: Wood joists in crawlspace are sitting 7 inches above exposed dirt beneath crawlspace. Crawlspace is inaccessible. Crawlspace foundation most likely does not extend below the frost line (Probe #1). Further investigation required.

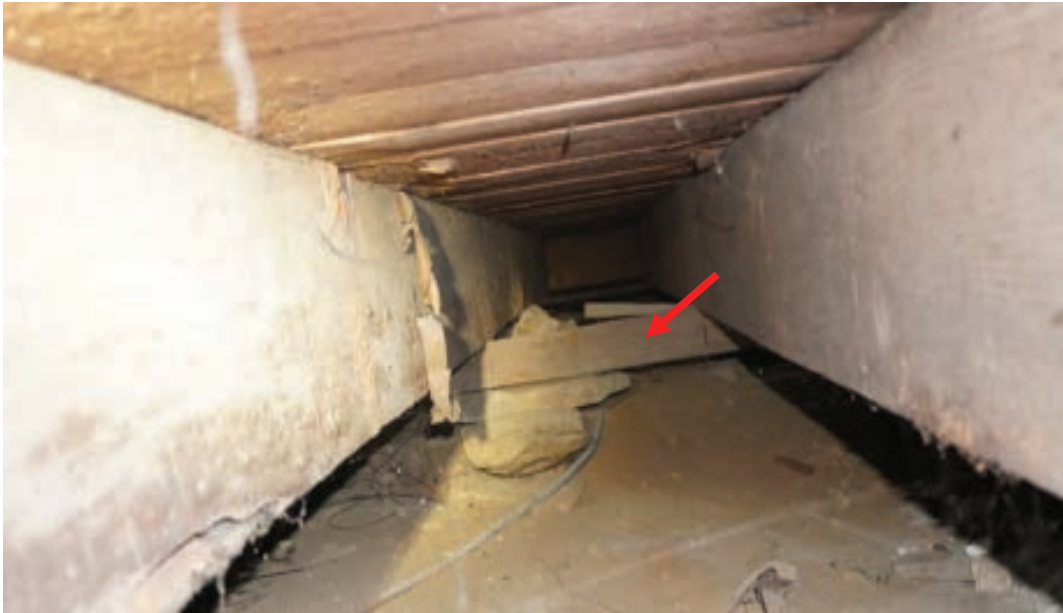
Photo #75: Wood joists spanning crawl space are being inadequately supported at midspans by wood members that are balanced above unstable pieces of stone (Probe #1).

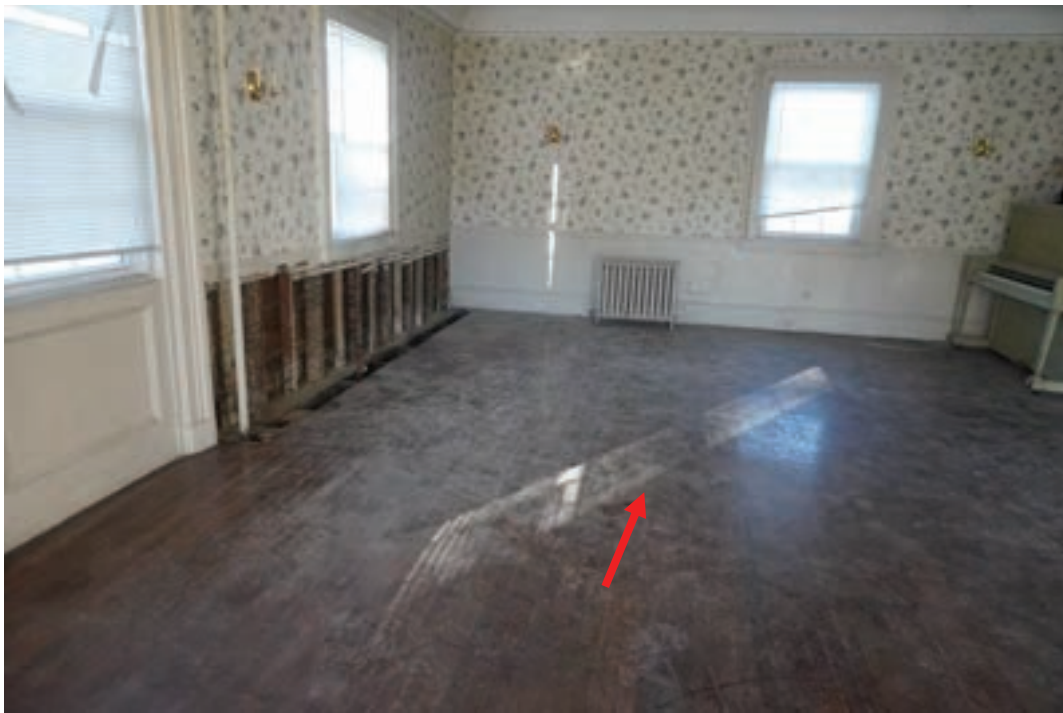
- b) Chimneys were originally built symmetrically on Georgian styled colonial homes. Viewing the home from outside it is clear the western chimney was demolished and moved more towards the center of the home. The chimney foundation is still in place and can be observed at cellar level. See Appendix E, Photo #76, & Photo #77 to see original and new chimney locations. See Photo #57 showing original chimney foundation in cellar and new chimney foundation. Chimney being moved drastically alters the layout and originality of the home.

Photo #76: Location of west chimney that was relocated at some point in the past. Foundation still in place and can be observed in cellar below.

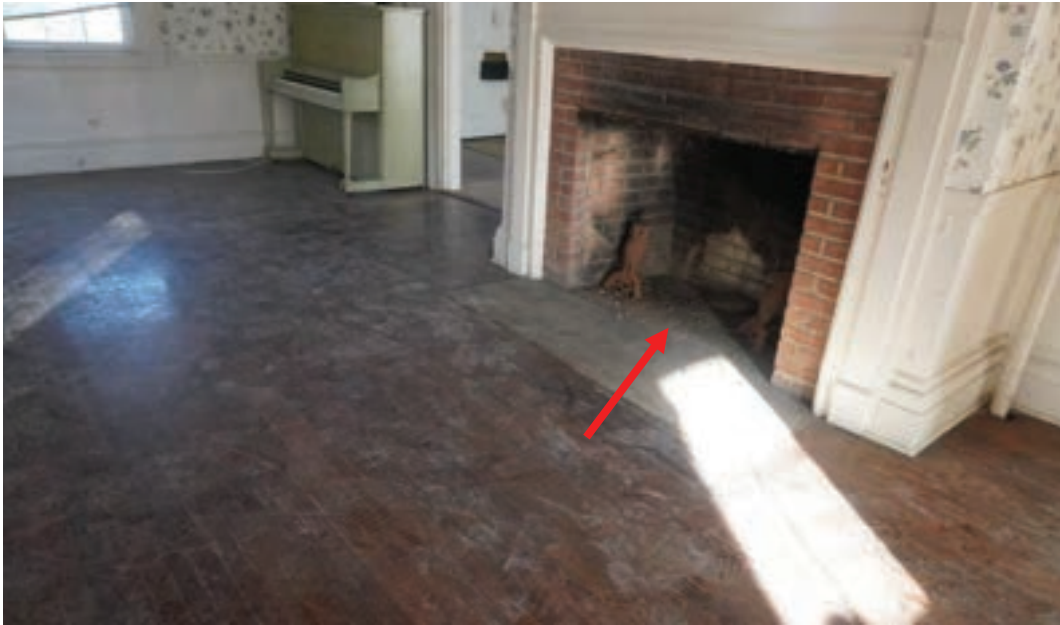
Photo #77: Chimney was added to this location at some unknown point in the past. Presumably when the original west chimney was demoed.

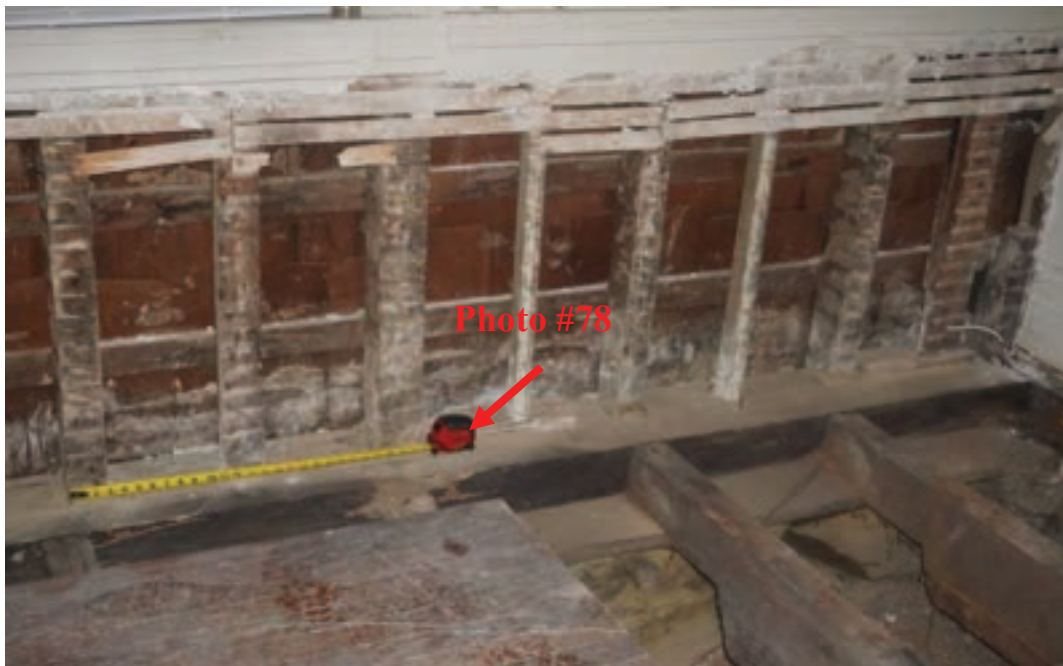
Photo #78: Vertical exterior framing members spaced at approximately 10 to 11 inches apart along west façade sitting on sill beam (Probe #1).

note skip sheathing and exterior shingles

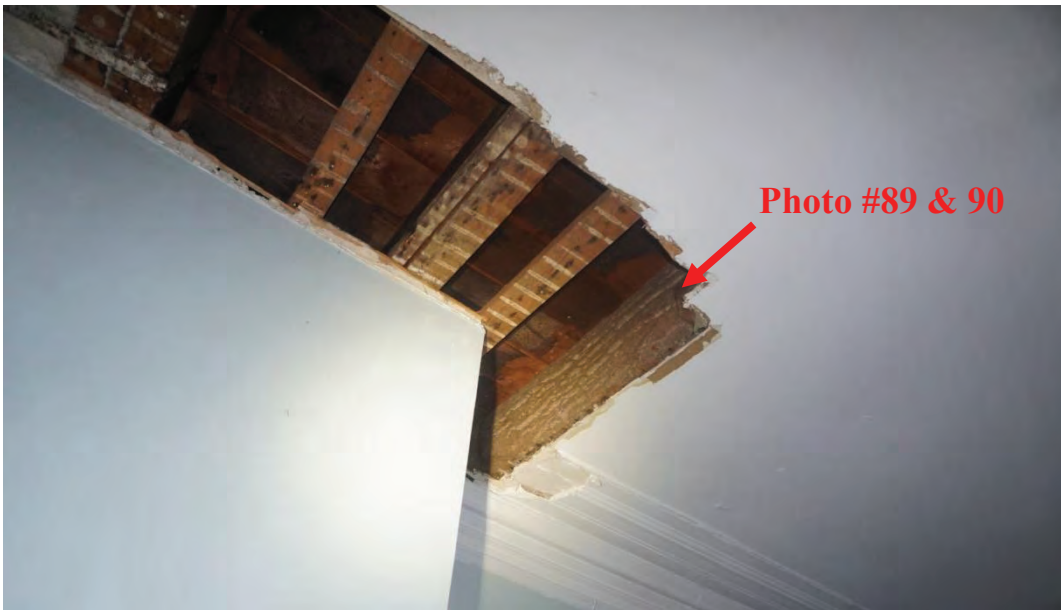
Photo #88: Ceiling joist that was never fully scored into a square framing member and still has bark exterior (Probe #4).

common in 18th century timber buildings

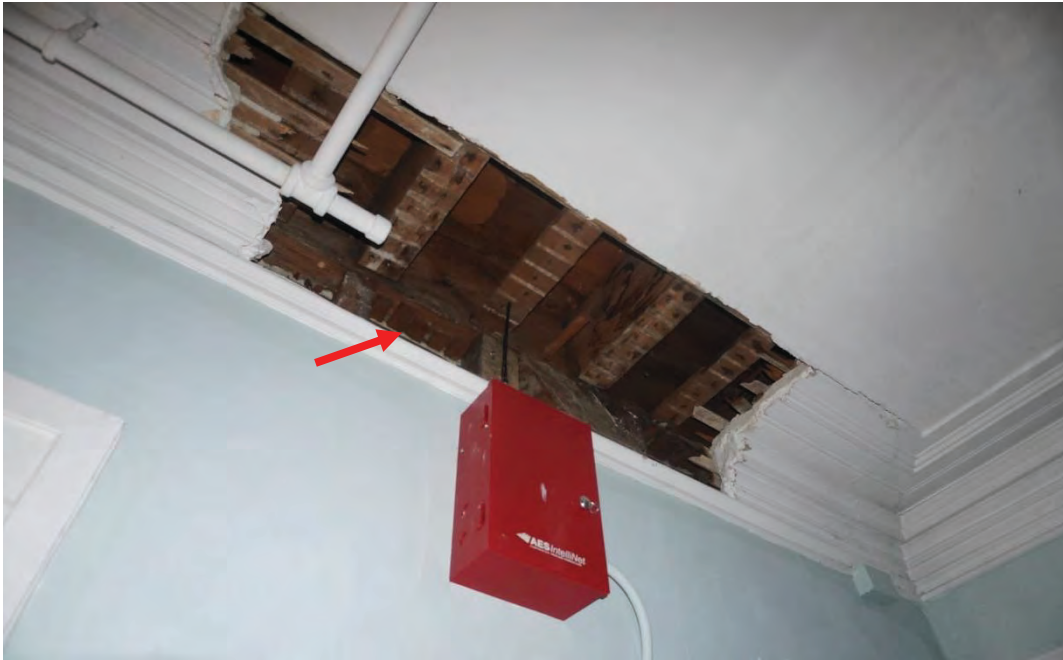
Photo #95: Interior girder that is showing signs of deflection. Girder is directly above girder that is failing in the boiler room area and is being propped up with temporary columns (Probe #5).

no sign of failure would need to see image before probe opening to determine if it moving or has just "crept"-deflected to a stable condition-- under loading

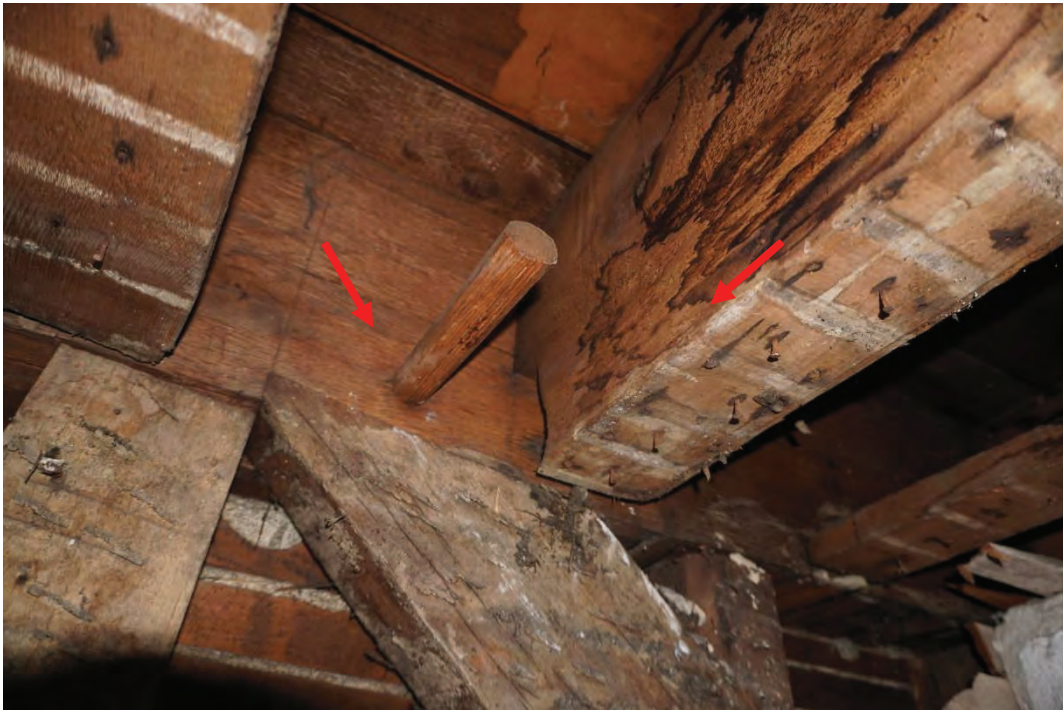
Photo #96: Mortise and tenon connection between a bracing member and interior girder being held in place with a wooden peg. (Probe #5)

thanks for the image of a still intact timber frame in this building

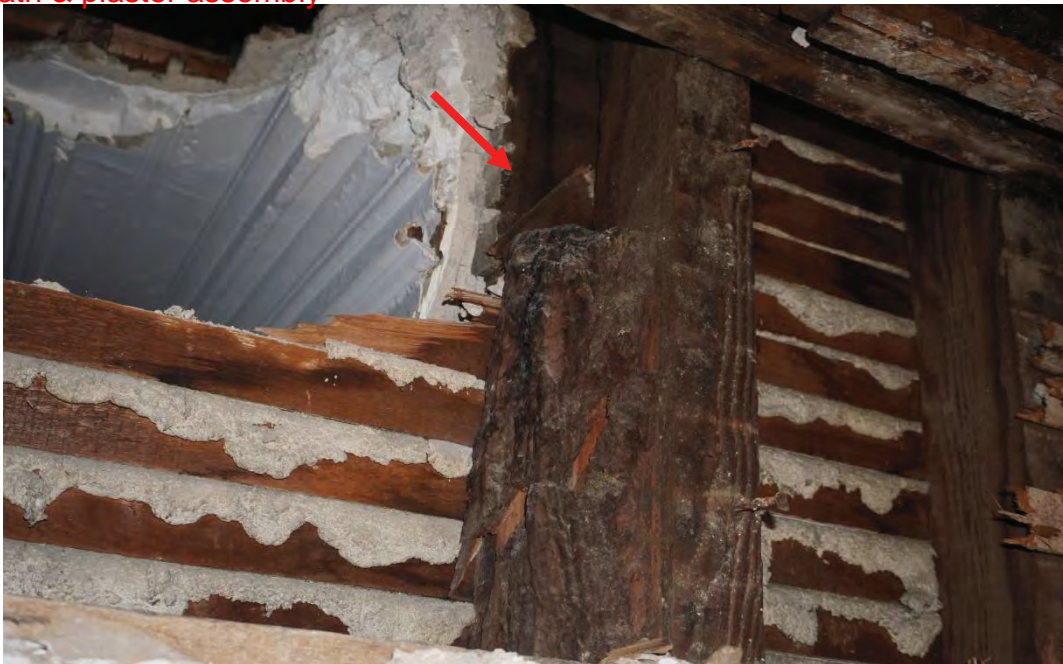
Photo #98: Old exterior wall vertical member that was never scored down into a square (Probe #6).

also note cross-section of surviving built up ceiling molding

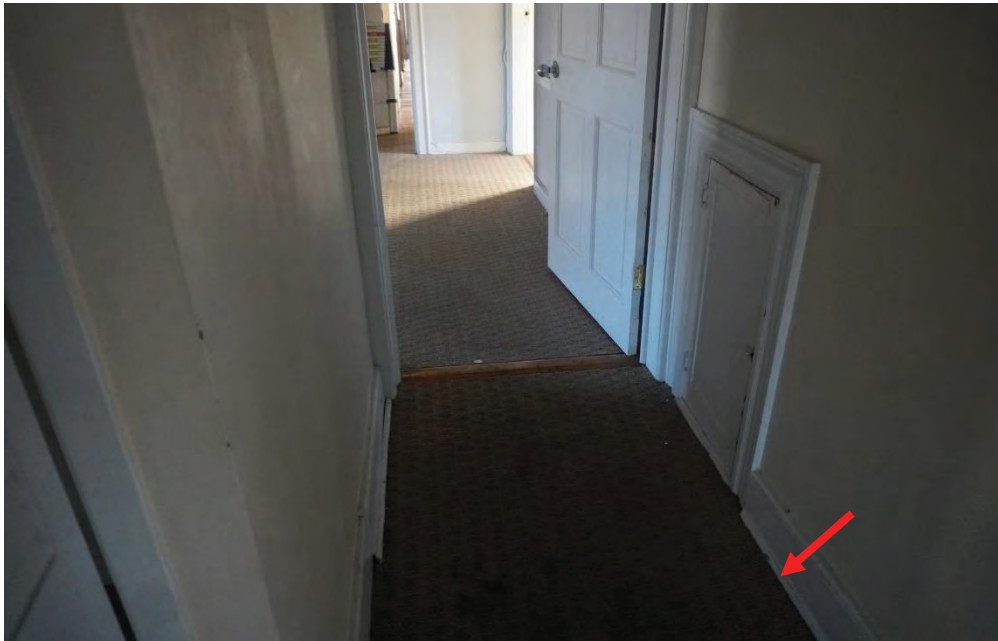
48. Stairs leading from second floor to attic have varying stair riser heights exceeding code max tolerance creating a fall hazard.
49. Depression in second floor hallway. Most likely due to weight of walls and bathroom added in this area. Further investigation would be required to figure out exact cause (Photo #99).

Photo #99: Depression in second floor hallway. Most likely due to weight of walls and bathroom added in this area. Further investigation would be required to figure out exact cause.

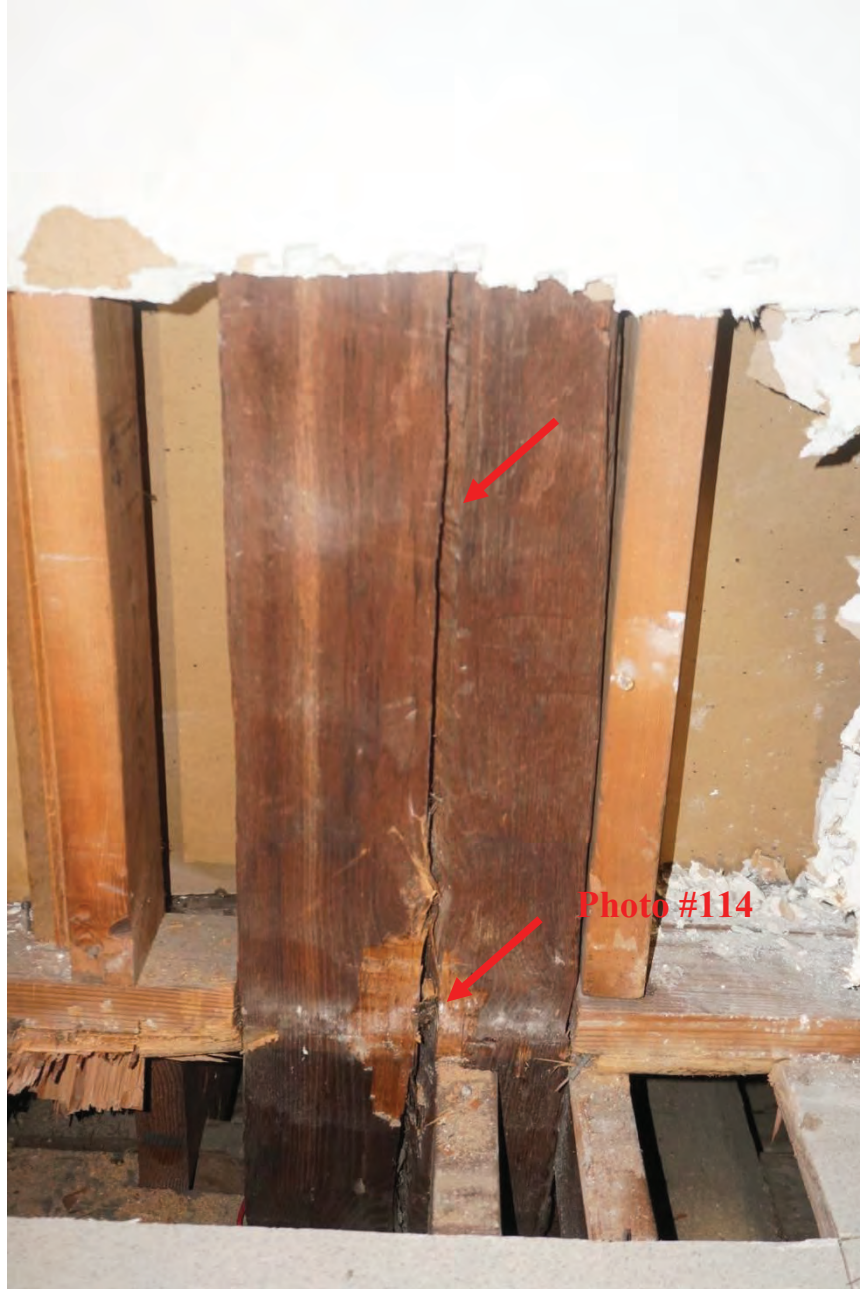
55. Post in attic space has moved out of place. Mortise and tenon joint that was connecting post to girder below has failed allowing member to rotate (Probe #11) (Photo #111 - #113).
56. Vertical crack that has opened more towards the bottom observed, attic post Unclear why this has occurred. Further investigation required (Probe #12) (Photo #114 &115).
57. Roof support beam observed to be coming apart (Photo #117 &118).

Photo #114: Vertical crack that has opened more towards the bottom observed, attic post
Unclear why this has occurred. Further investigation required (Probe #12).

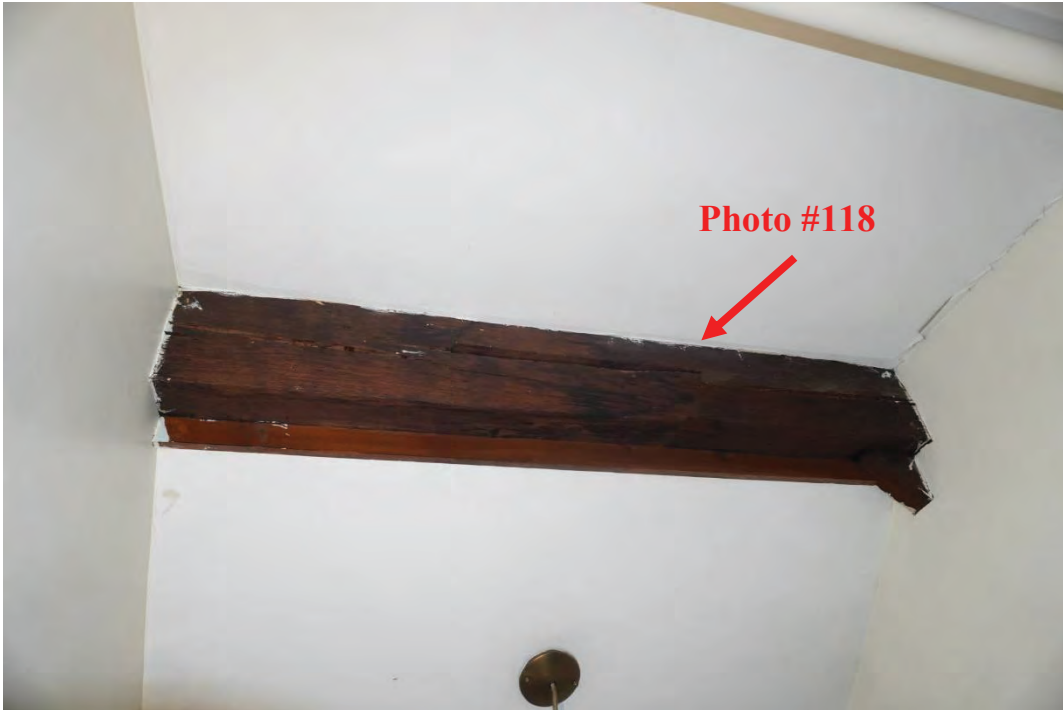
Photo #117: Roof support beam observed to be coming apart.

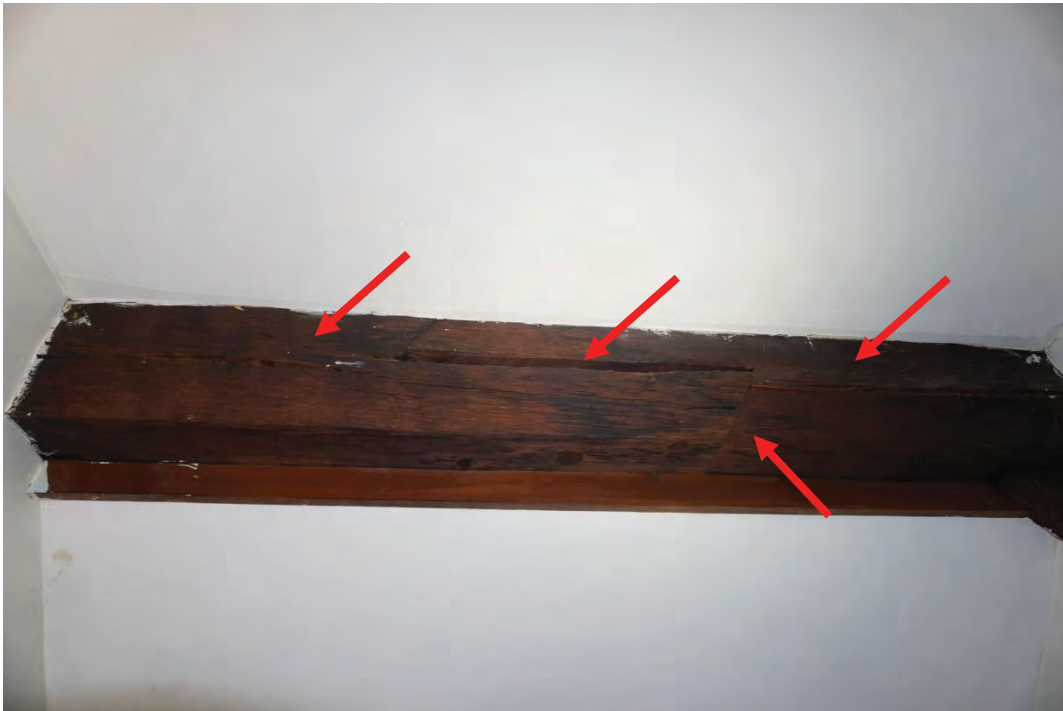
Photo #118: Roof support beam observed to be coming apart.

no sign of movement or failure at plaster boundary as the result of checking of member
