### Former Marble Quarry Landfill **109 Marbledale Road** Tuckahoe, New York

#### NYSDEC Brownfield Cleanup Program #C360143

#### **Community Meeting # 10**

**April 26, 2017**

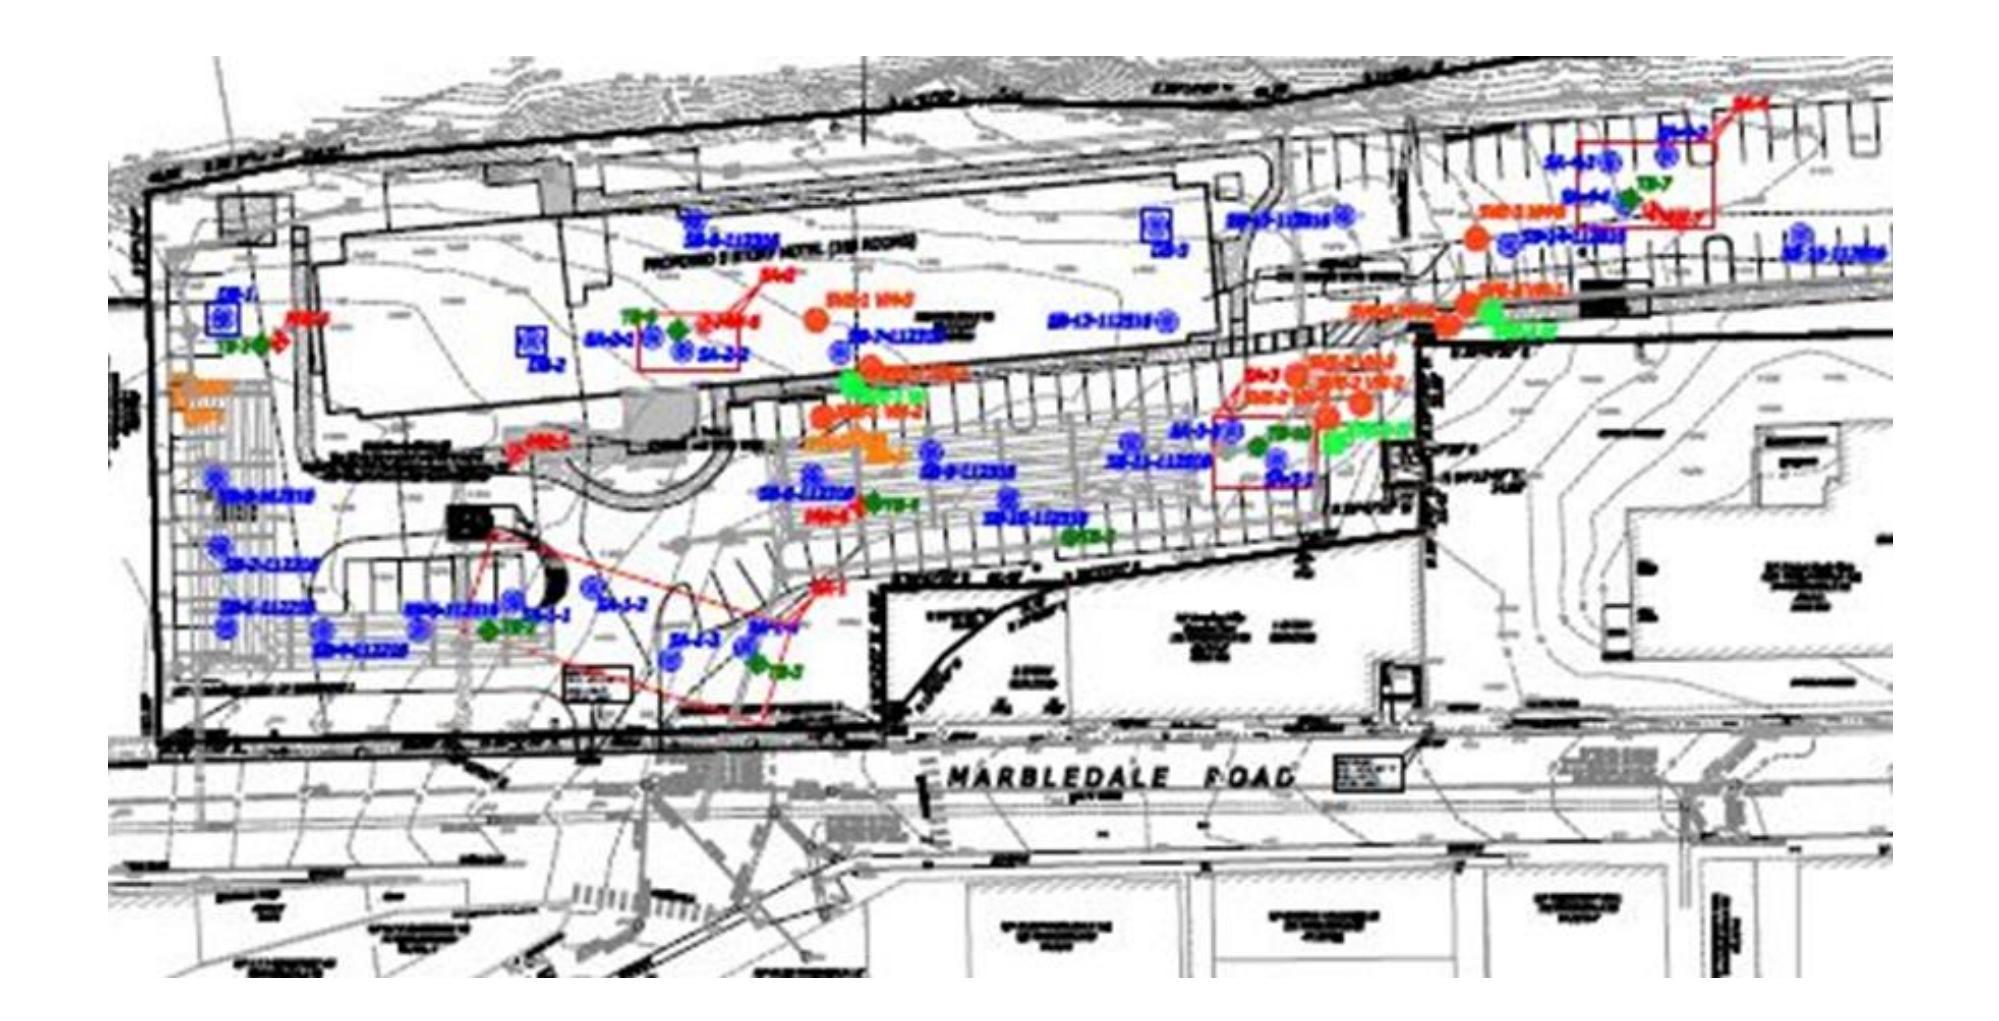
### **Source Area Locations**

- As of April 26, 2017, all source areas, Source Area 1, 2, 3, 4, 6, 7, 8, 9, 10, 11 and 12 have been removed and backfilled.
- Removed soils from SA-1, 2, 3, 6, 7, 8, 9, 10, 11 and 12 went to Bayshore Recycling located in Keasbey, New Jersey.
- Removed soils from SA-4 went to IESI PA Bethlehem Landfill Corporation located in Bethlehem, Pennsylvania.
- Source Area 5 will not be removed based on a review of all soil precharacterization data (no exceedances of CSCOs).
- Additional Source Area removals included:
  - Extension of two SA-2 sidewalls due to exceeding CSCOs for Copper and Barium at initial soil sampling locations.
  - Soils around SB-11 (SA-12) due to exceedance of Benzo(a)pyrene.

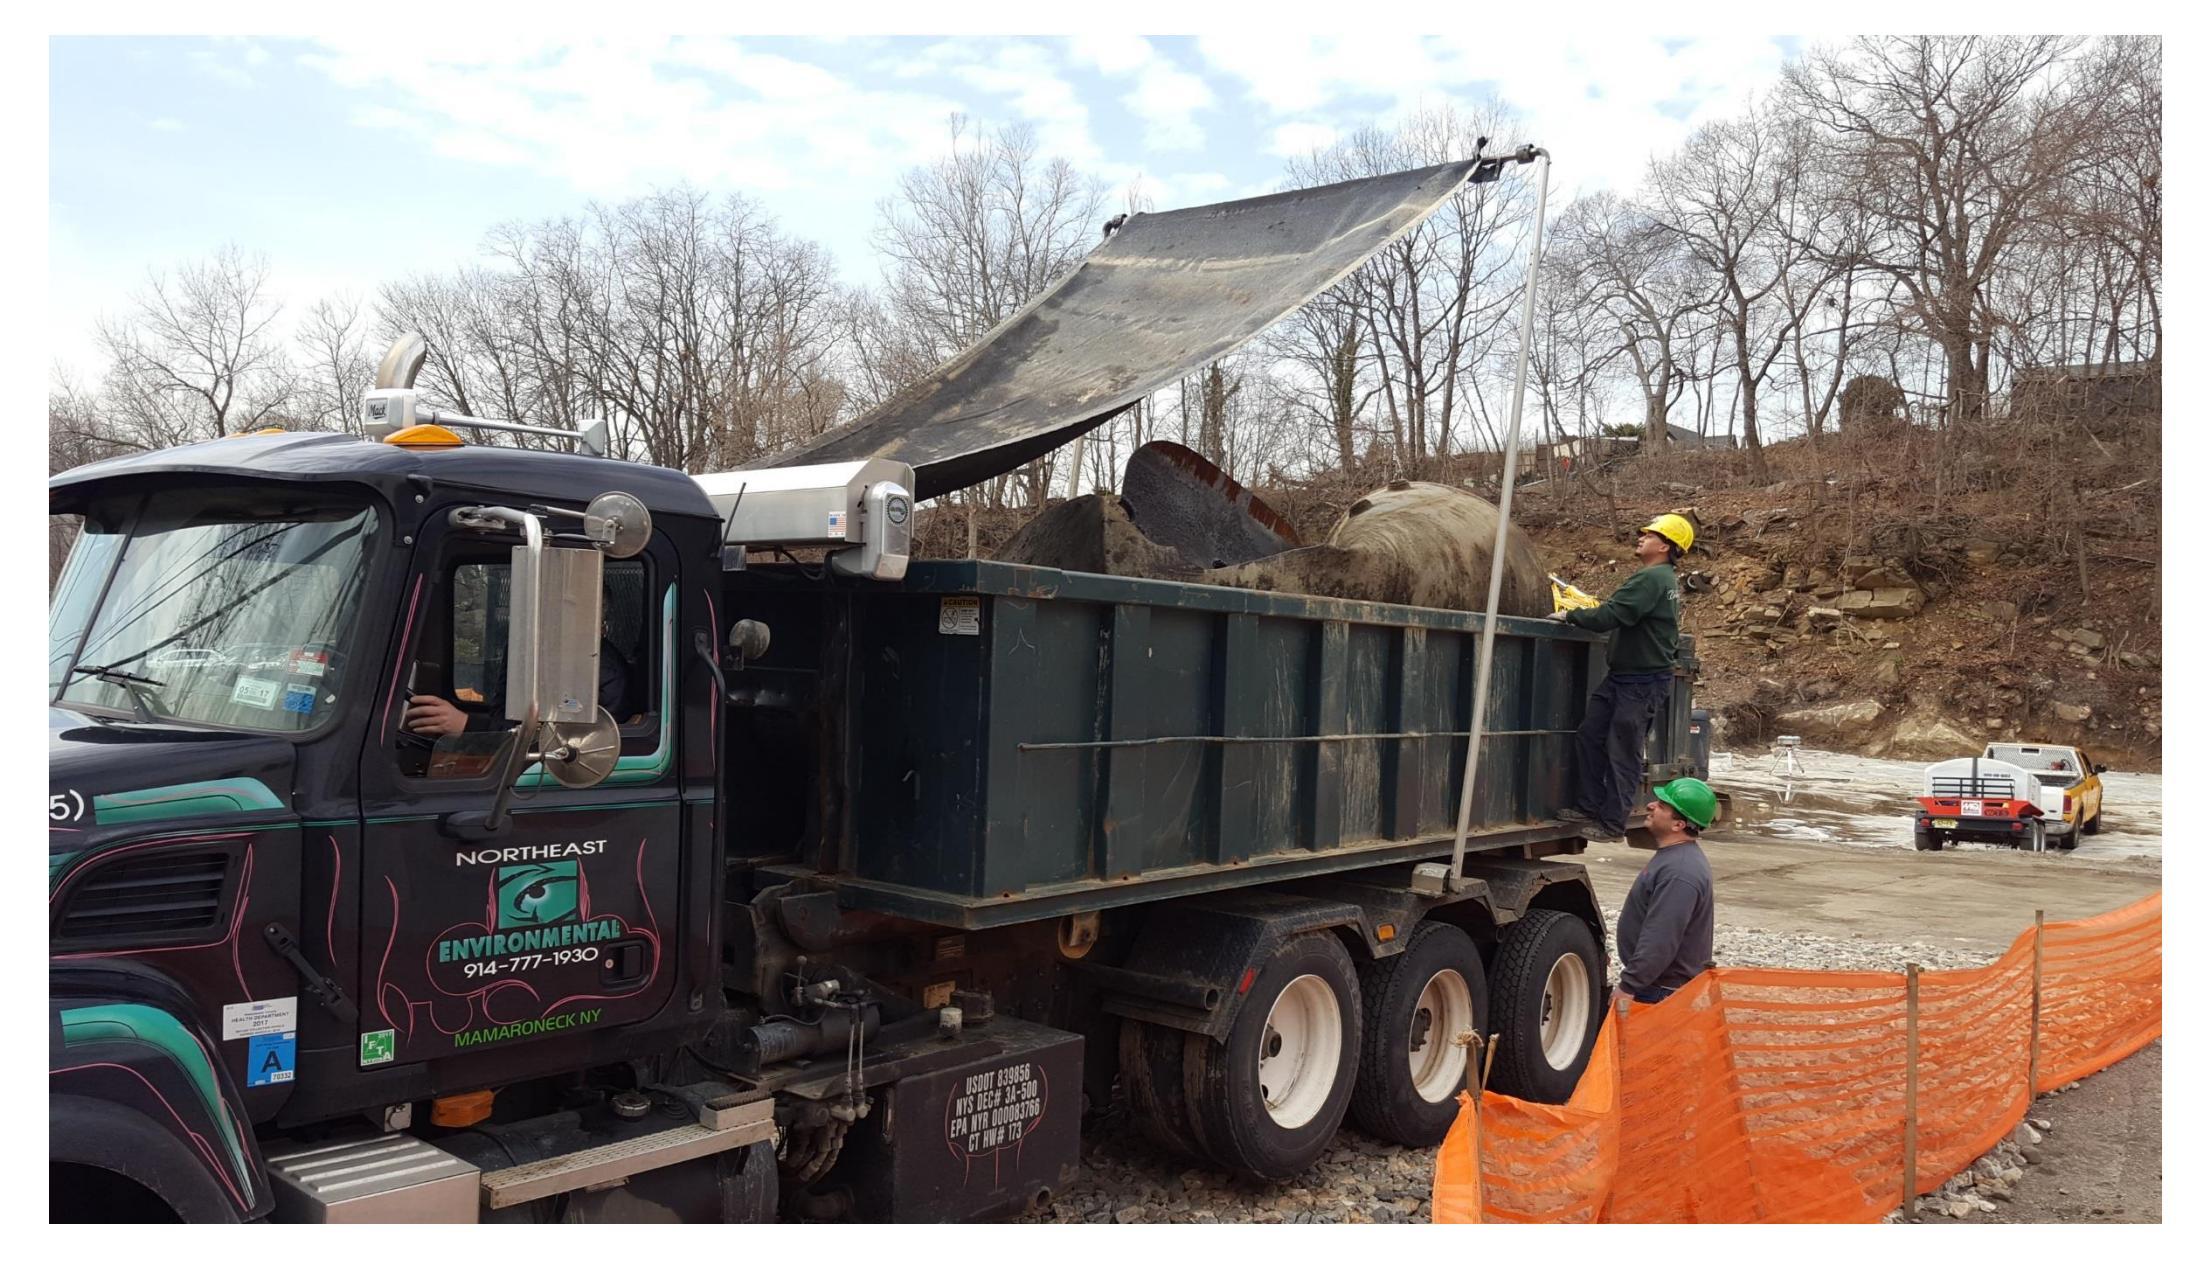
### Source Area 1B UST Removal

- On March 31, 2017 Northeast Environmental removed 2,091-gallons of waste gasoline and fuel oil from two 2,000-gallon Underground Storage Tanks in accordance with NYSDEC and WCDOH regulations for proper disposal at Tradebe Treatment and Recycling located in Bridgeport, Connecticut.
- On April 3, 2017 Northeast Environmental removed two 2,000-gallon USTs in accordance with NYSDEC and WCDOH regulations from the site for proper disposal at Pascap Co, Inc. located in Bronx, New York.
- On April 11, 2017 following soil removal activities and prior to backfilling, HES installed one Soil Vapor Extraction (SVE) Well in the excavation of SA-1B.

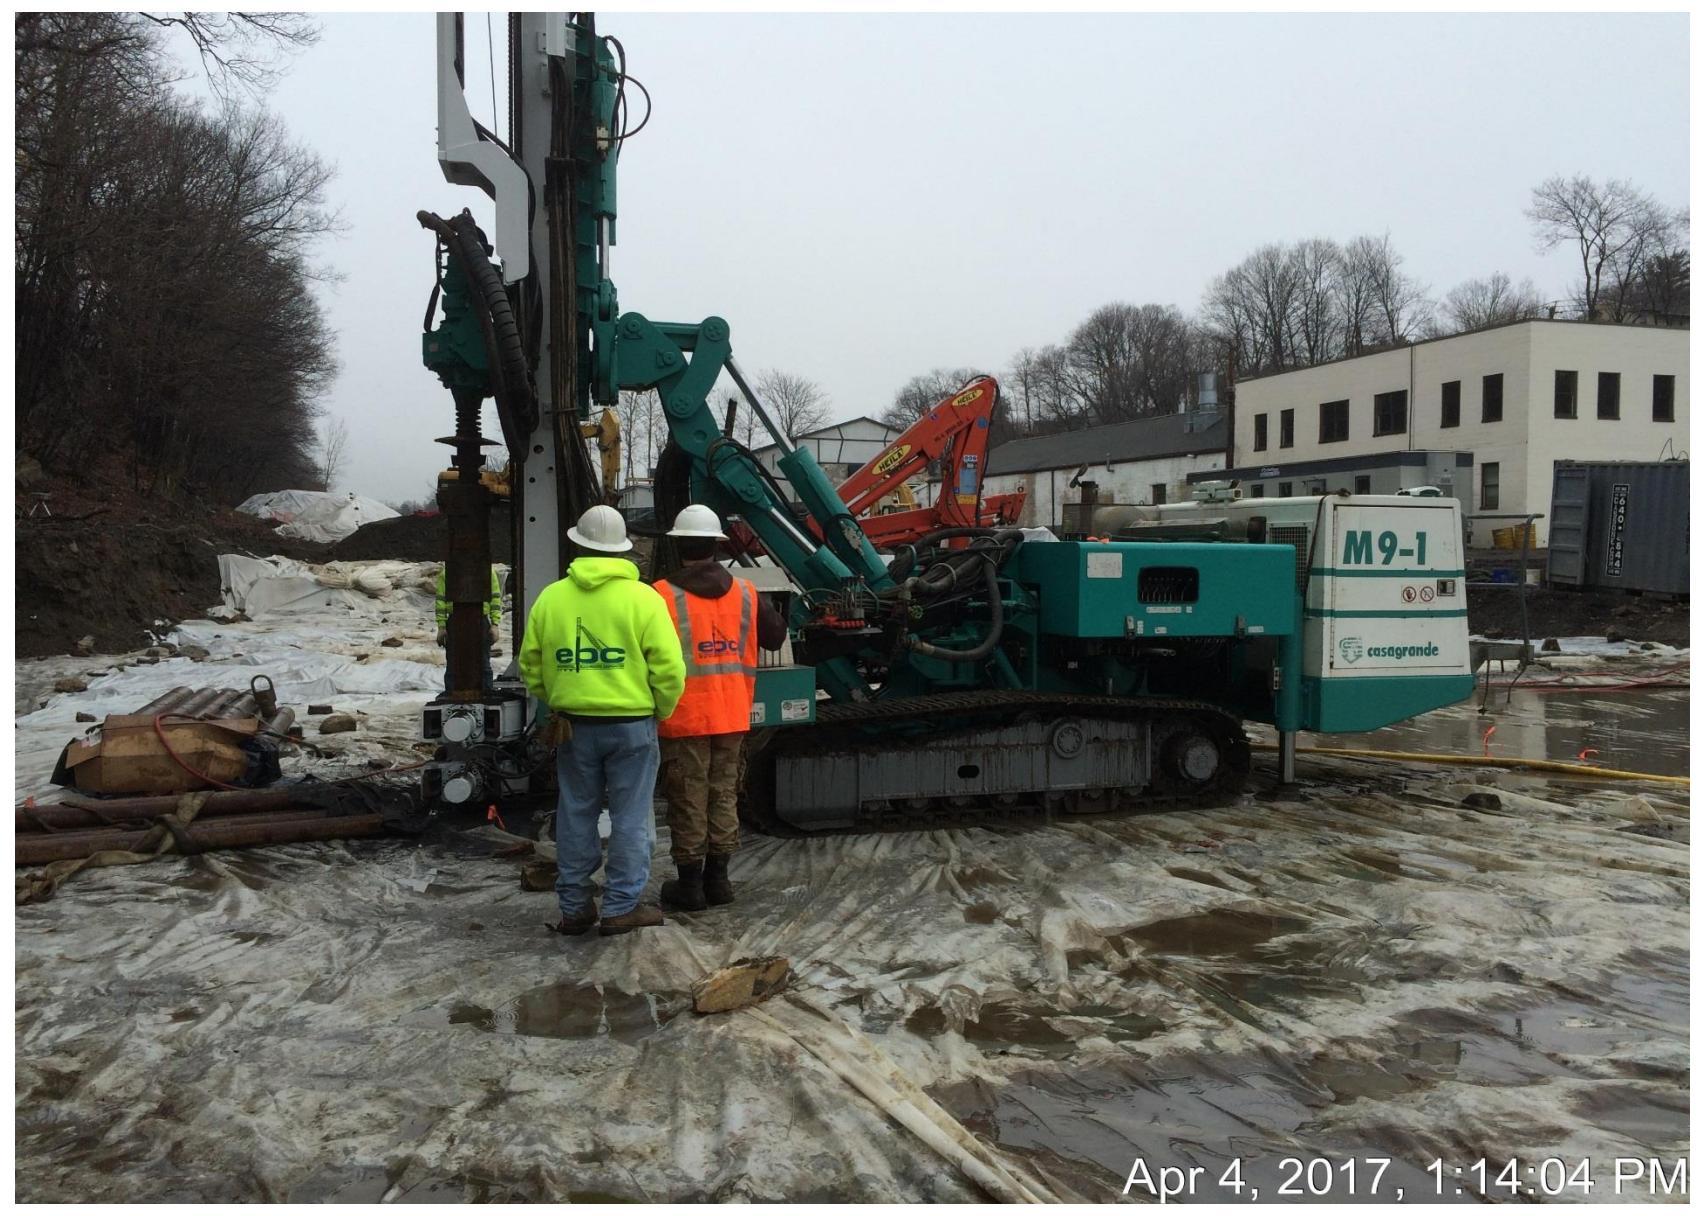
# Test Pile Drilling

- As of April 7, 2017, Environmental Bulkheading Corp. (EBC) has completed the installation of 10 test piles.
  - On April 4, 2017 EBC installed the first test pile using an air rotary drilling method.
  - On April 5, 2017 EBC continued drilling the remainder of the piles using a mud rotary drilling method. A closed circuit system was implemented for the containment of water used during the mud rotary drilling process.
  - Over the course of test pile installation, HES conducted vapor monitoring at a series of nearby well locations using a Photoionization Detector (PID) and a Flame Ionization Detector (FID). When compared to baseline readings no anomalies were observed in the data recorded.
