PHASE I ENVIRONMENTAL SITE ASSESSMENT

109-125 MARBLEDALE ROAD TUCKAHOE, NEW YORK

September 6, 2013

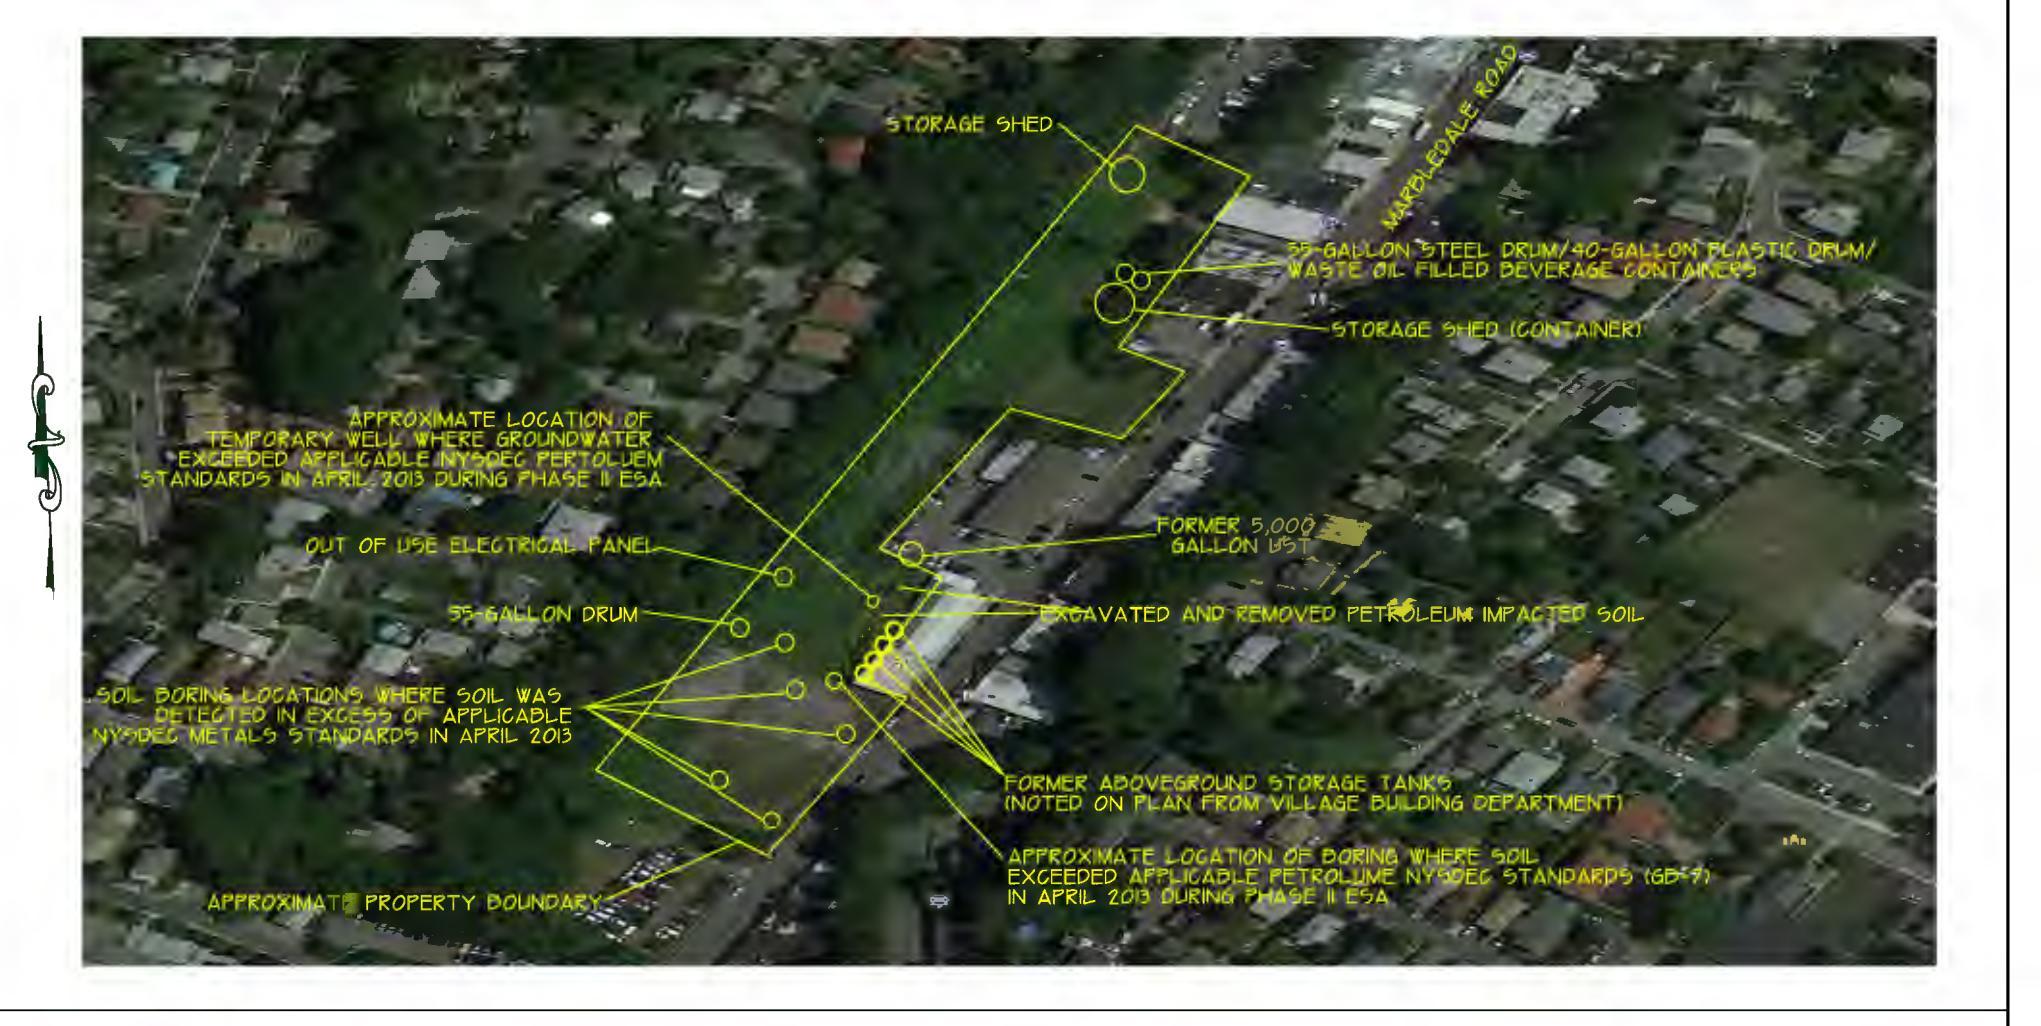
FIGURE 2

109-125 MARBLEDALE ROAD TUCKAHOE, NEW YORK	SITE PLAN	NOT TO SCALE	AUGUST 2013	
		Phase I En Site Ass	vironmental Dessment	HydroEnvironmental SolUTIONS, INC. One Deans Bridge Road Somers, New York 10589

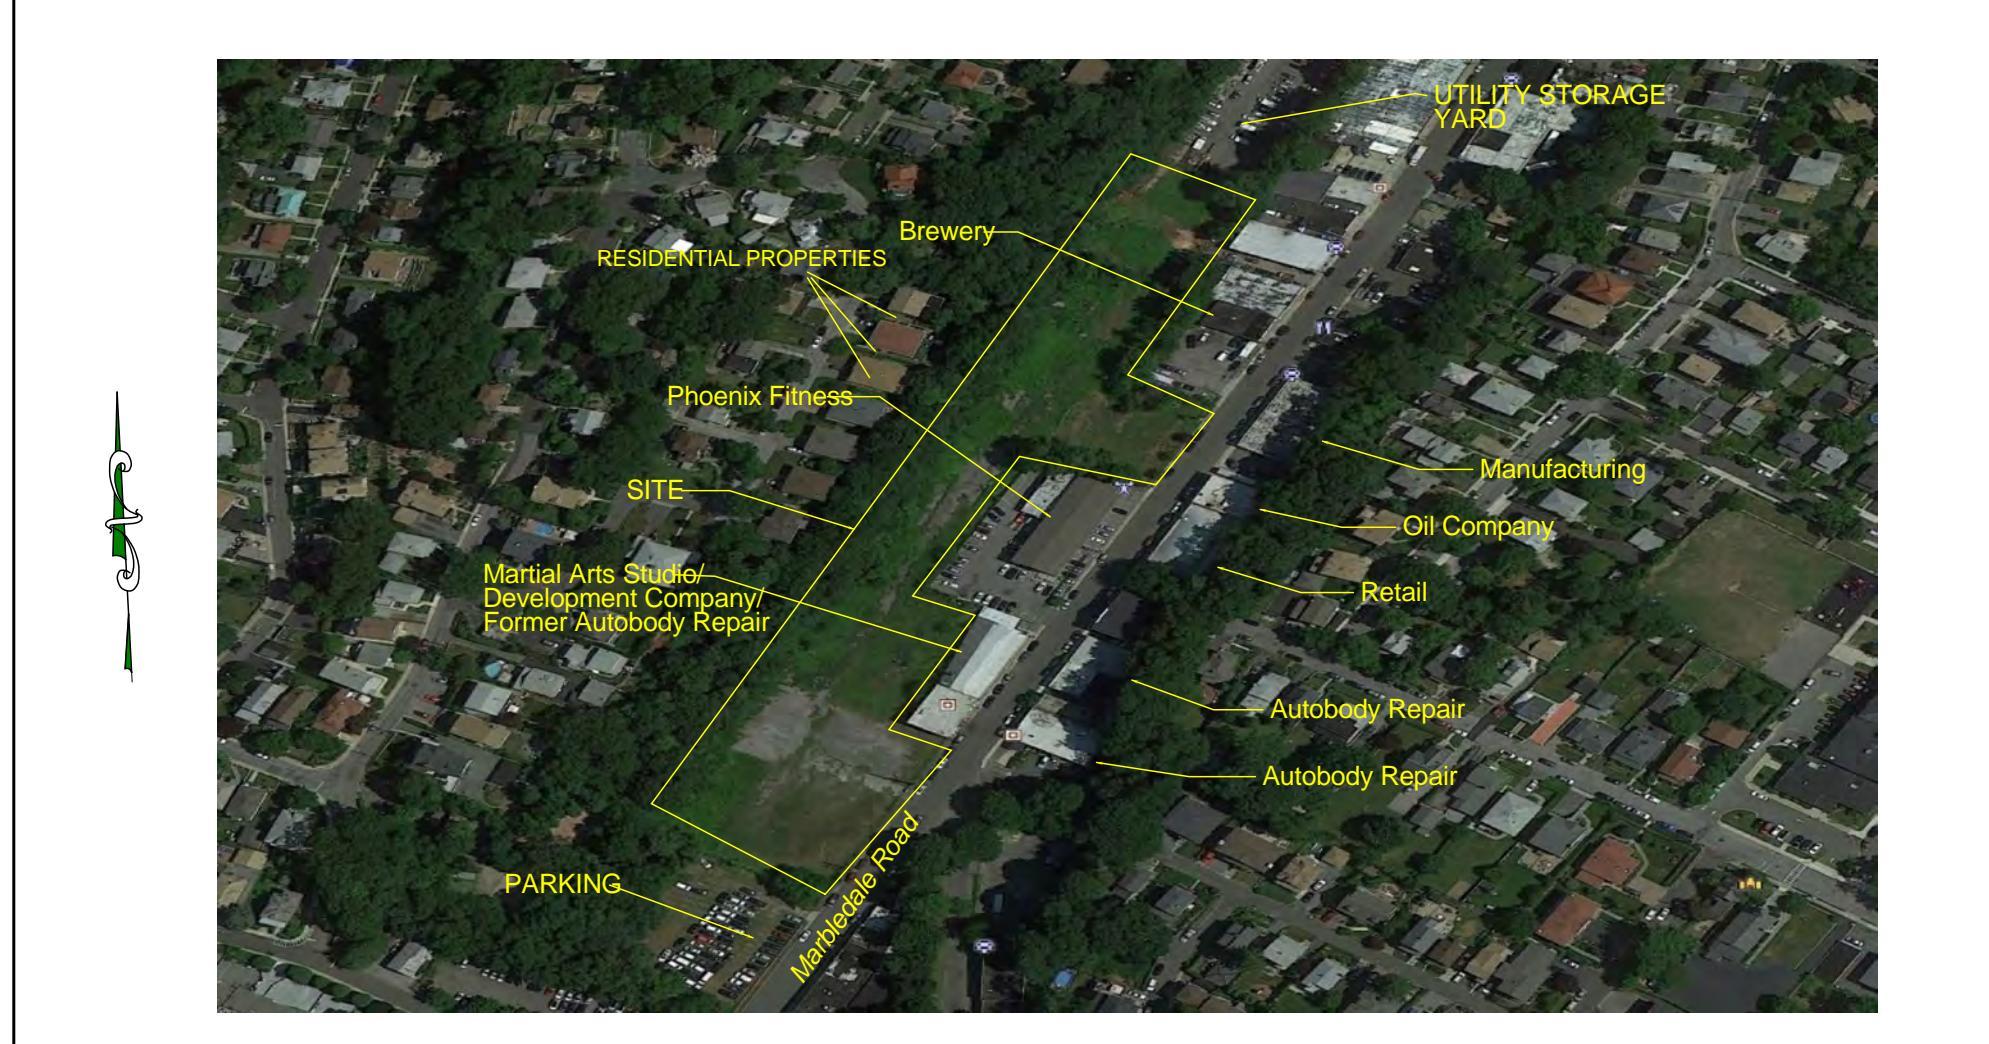
FIGURE 3

Properties adjoining the SITE are residential, commercial and/or industrial in nature. Adjoining property uses include a brewery, fitness center, auto repair, vacant land, residential properties, and an auto lot. **Figure 3** shows the surrounding land use with respect to surrounding properties.

AERIAL PHOTOGRAPH	NOT TO SCALE	August 2013	
109-125 MARBLEDALE ROAD TUCKAHOE, NEW YORK	SHOWING THE SITE AND SURROUNDING AREA	Phase Er Site As	nvironmental sessment	HydroEnvironmental SOLUTIONS, INC. One Deans Bridge Road Somers, New York 10589

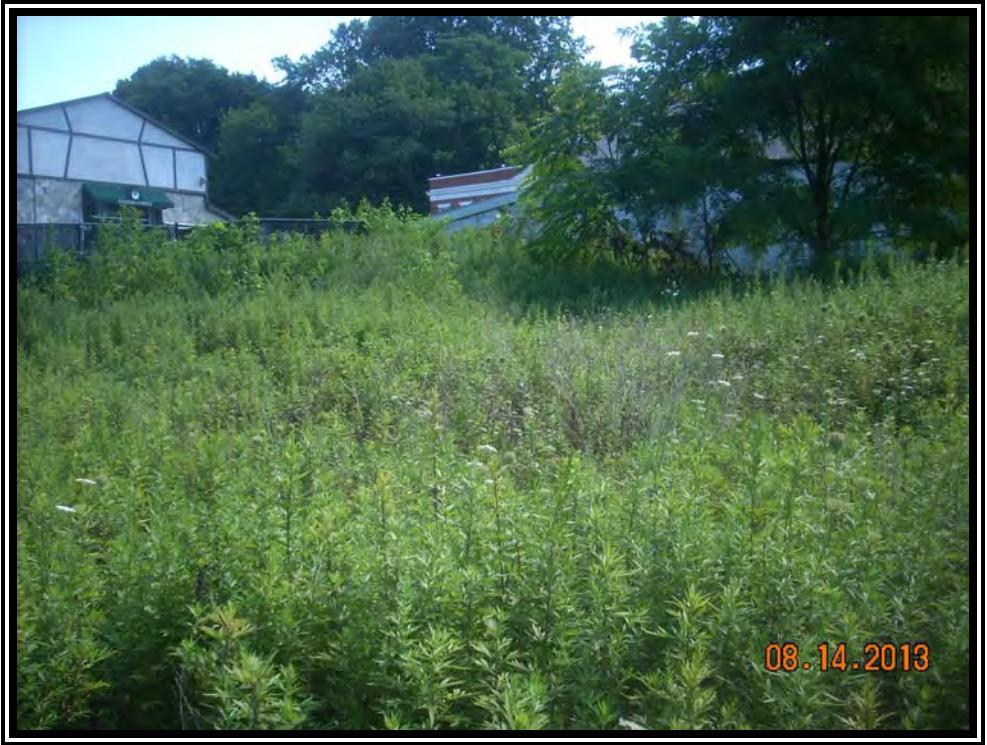
- During soil remediation efforts, an open 3" steel pipe of unknown origin was discovered terminating in the excavation. The pipe was determined to contain a flammable liquid. The pipe was traced back to a dumpster area and a 5,000 UST. While only one hand drawn sketch map was noted, the tank appears to have been located on the adjacent fitness center parcel parking lot, but the pipe and terminus appears to have been located on the SITE.

View of an overgrown area of the SITE where tank related soil remediation formerly occurred

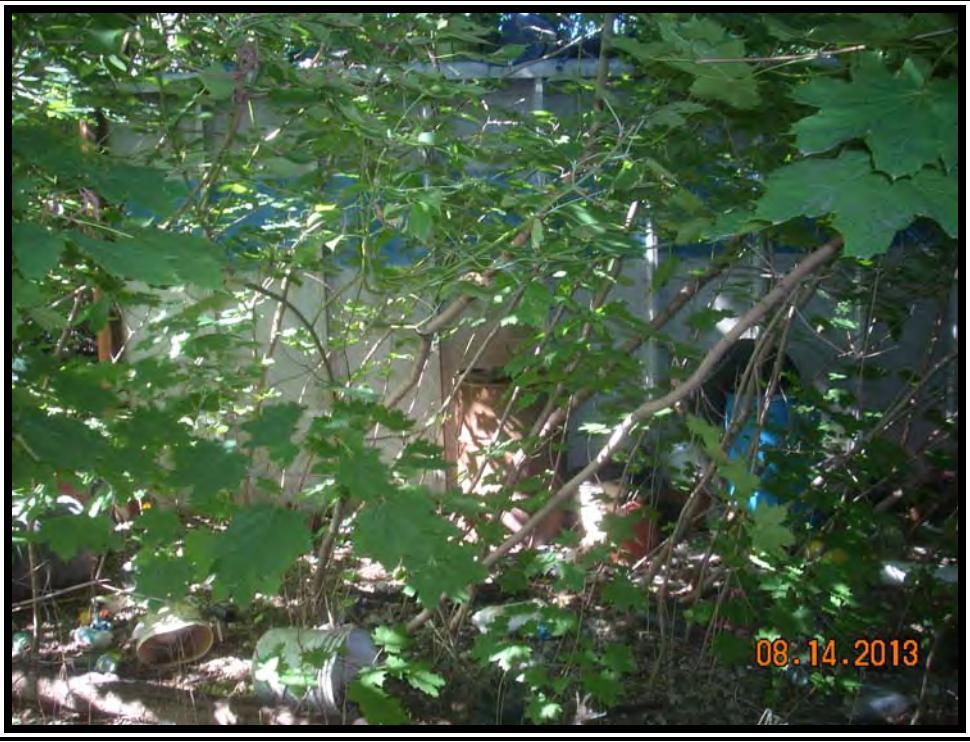
Two small (approximately 8'x12') storage sheds were observed on the SITE at the time of the inspection. One of the shed is located in the northwestern corner of the SITE and the second shed is located in the northeastern portion of the SITE. The shed in the northwestern corner of the property is wood and was mounted on a trailer. The shed in the northeastern corner of the property is metal with plywood interior walls and floors.

View of the storage shed noted in the northeastern corner of the SITE

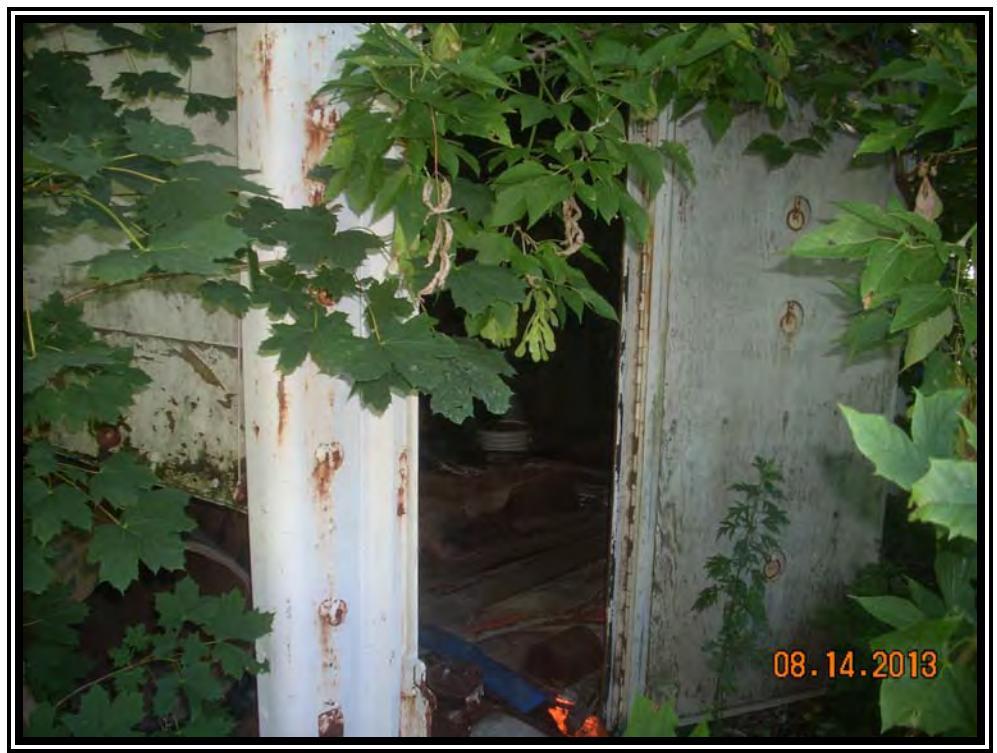
HES entered both sheds to inspect the contents and to look for evidence of RECs. The shed in the northwestern corner contained some debris and one empty 5-gallon fuel container. The shed in the northeastern portion of the SITE contained several empty and partially full paint cans and other general debris. The floor could not be viewed in the northeastern shed due to the presence of a significant amount of debris. However, the paint cans did not appear to have leaked.

View of the interior of the storage shed in the northeastern corner of the SITE

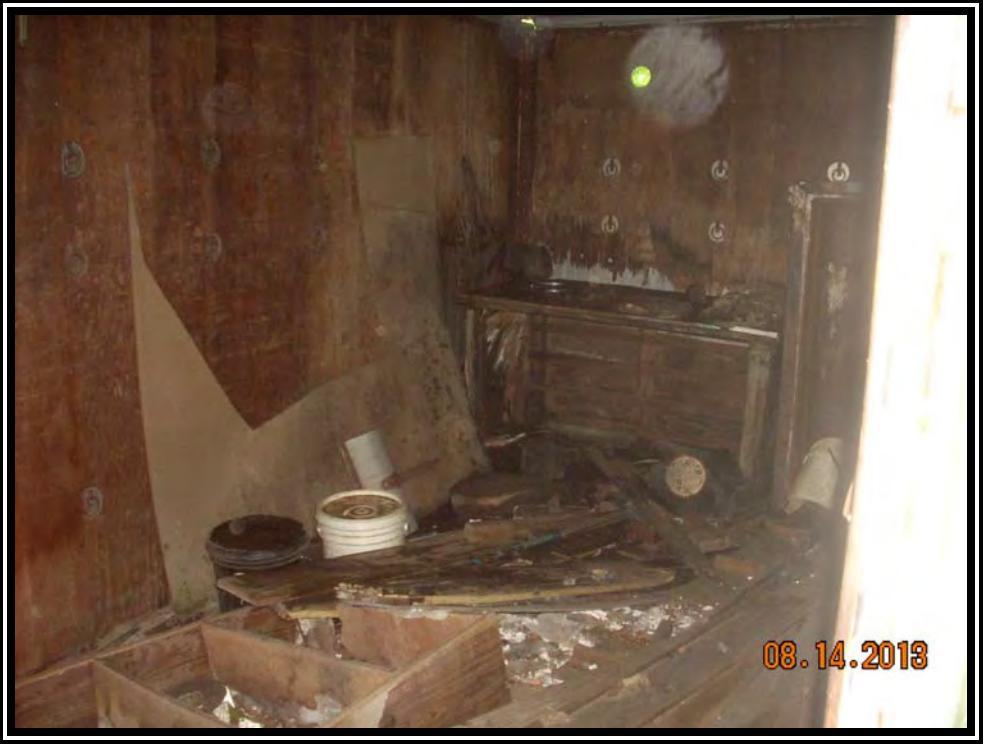
View of the interior contents of the storage shed in the northeastern corner of the SITE

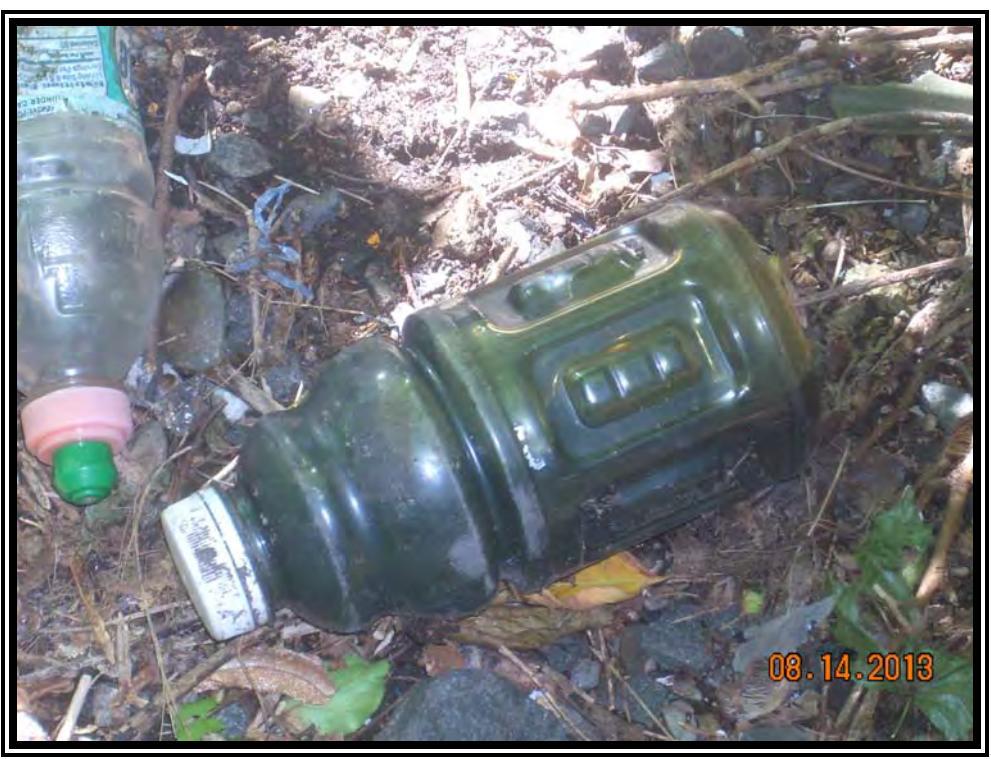
- SITE reconnaissance observations indicate the presence of drums and some waste oil filled containers near the northeastern corner of the SITE. Some rainwater filled drums were noted at other locations on the SITE. The unattended storage of these drums and their condition (i.e. open to the atmosphere and rusted) suggest that releases of their contents, which may have included petroleum and/or hazardous substances, may have occurred to the environmental media at the SITE.

View of one of the beverage containers observed to contain waste oil near the storage shed in the northeastern corner of the SITE

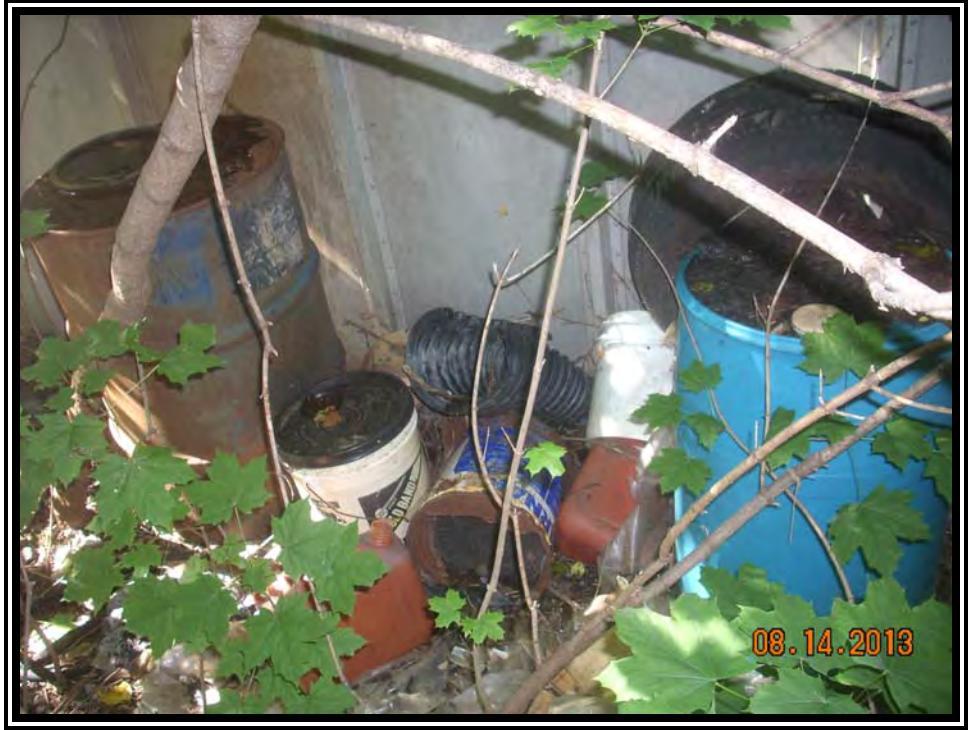
View of the drums and other containers adjacent to the storage shed in the northeastern corner of the SITE

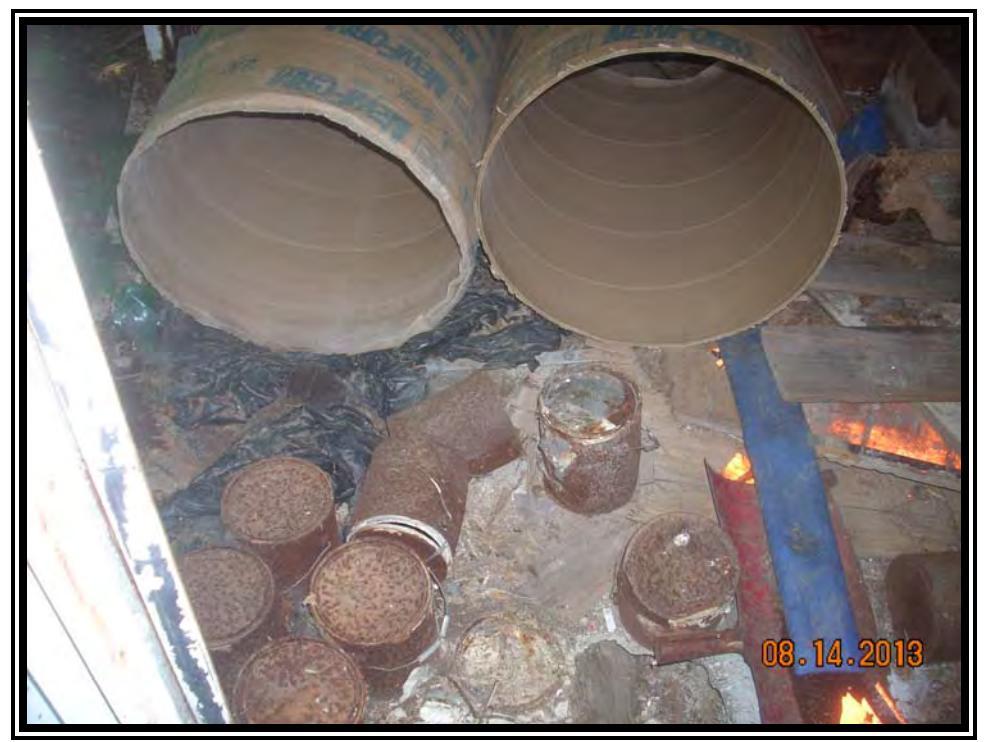
View of rusted paint containers inside the storage shed in the northeastern corner of the SITE

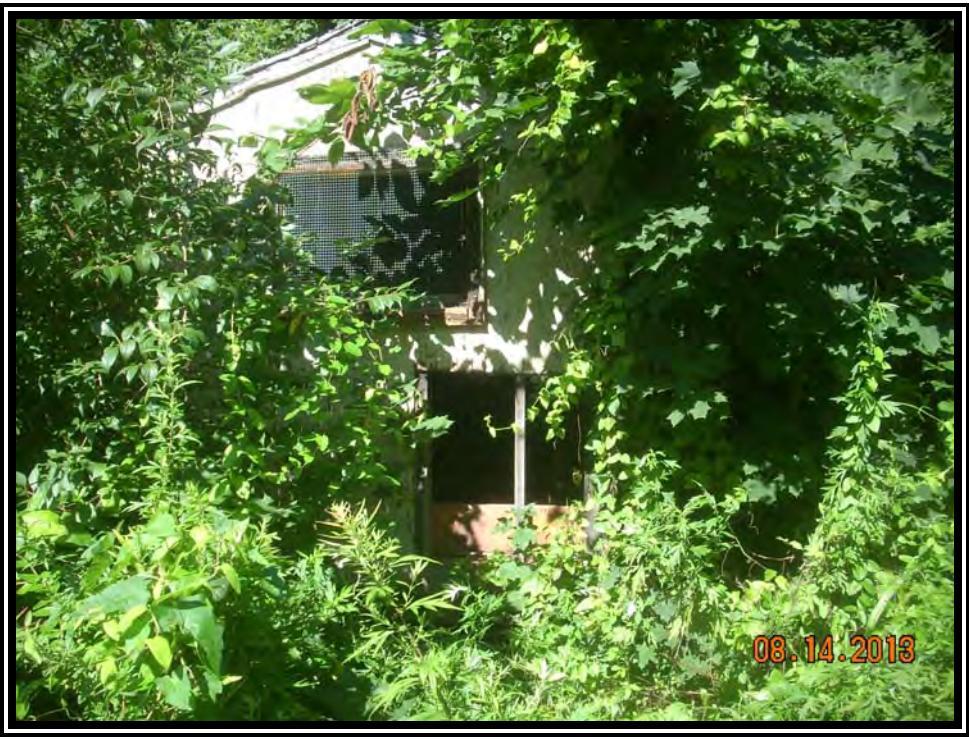
View of the storage shed noted in the northwestern corner of the SITE

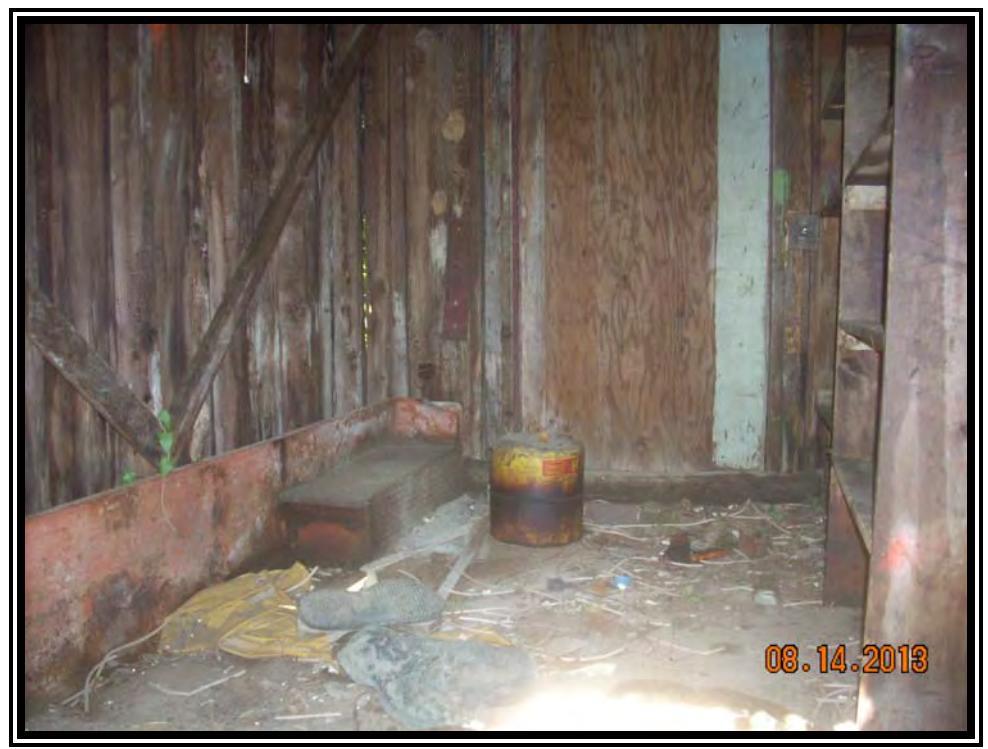
View of the interior contents of the storage shed noted in the northwestern corner of the SITE

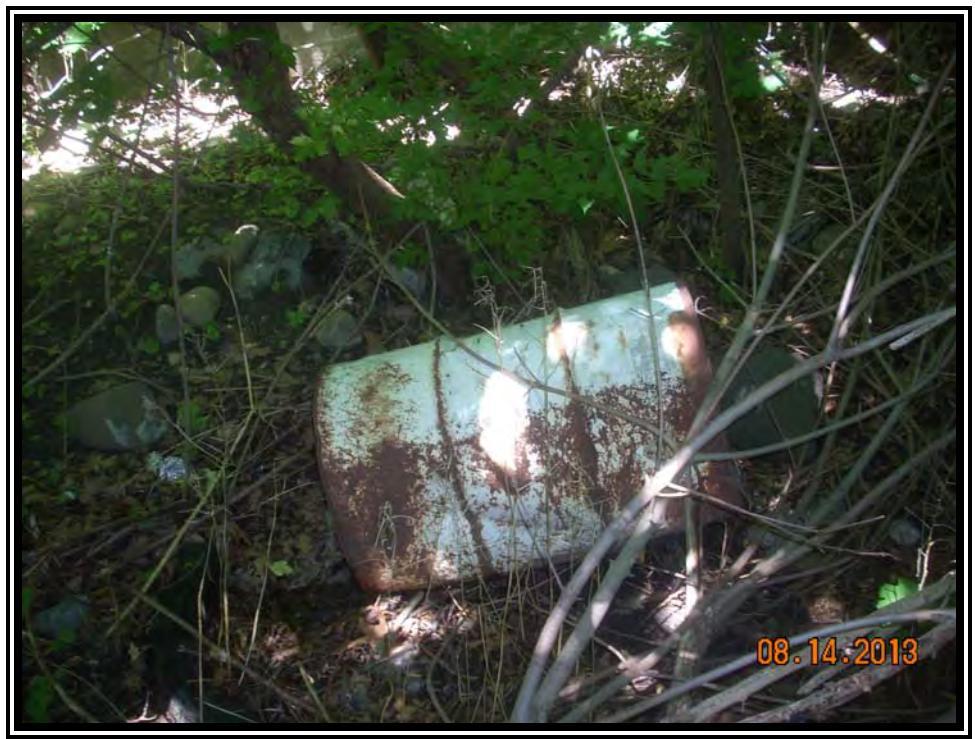
Along the western edge of the SITE, HES noted a wooded area where there was also a rock ledge wall that rose approximately 30 feet above grade. In the wooded area HES observed a 55-gallon drum which was lying on its side and contained a liquid which was attributed to rainwater. An empty propane cylinder was also noted in this area of the SITE.

View of a discarded drum noted along the western SITE boundary

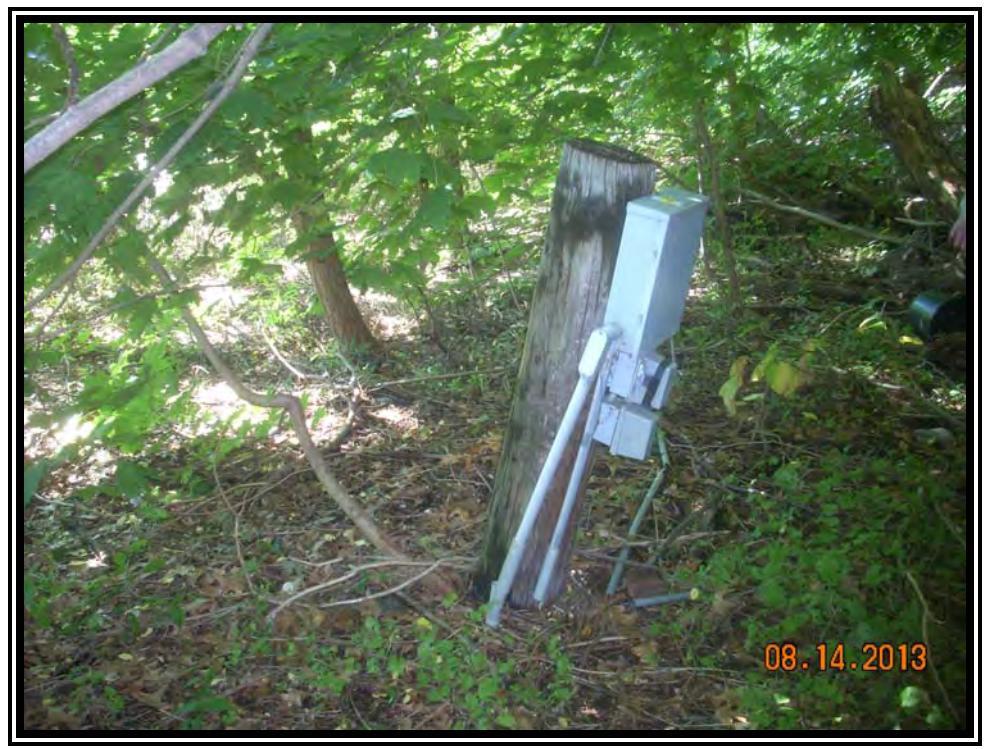
No Electric service appears to enter the SITE. However, a disconnected utility pole was noted in the central portion of the SITE as well as an out-ofservice electric panel which was noted along the western property boundary.

View of an abandoned electric service noted along the western SITE boundary
